**RESOURCE CONSERVATION AND RECOVERY ACT
CURRENT CONDITIONS SUMMARY**

**FORMER GM ROMULUS ENGINEERING CENTER
37350 ECORSE ROAD
ROMULUS, MICHIGAN
USEPA ID #MID000809905**

**Haley & Aldrich of Michigan, Inc.
Ann Arbor, Michigan**

**File No. 37515-003
30 December 2011**

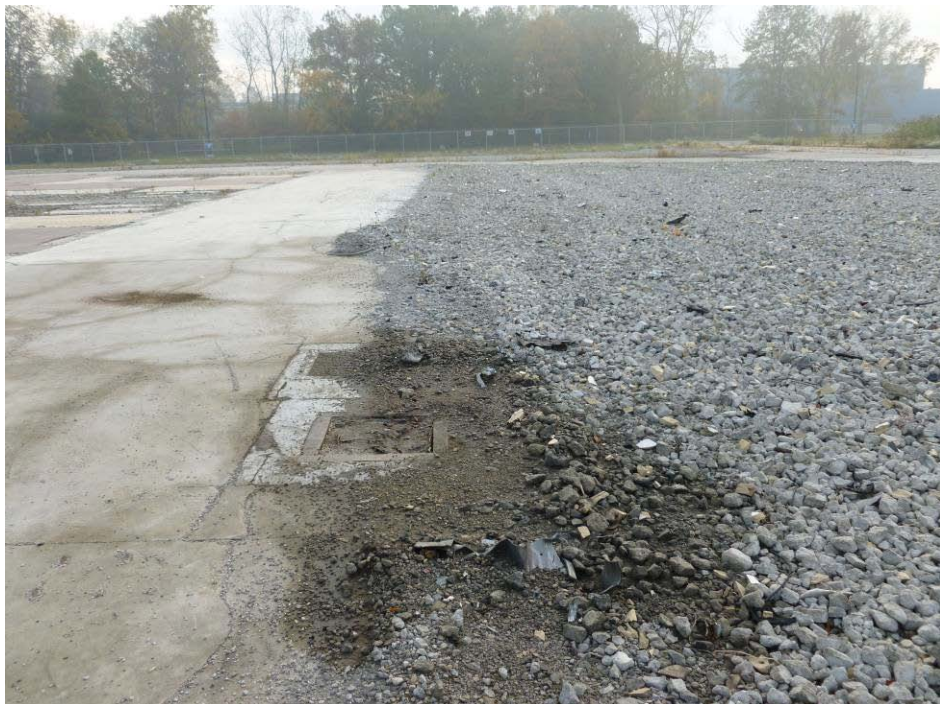
Photograph 32. (AOI-05) Staining observed on concrete and gravel in east central portion of former facility footprint. Location believed to be northeast area of Test Cell "E" Wing. Photo taken facing east.

03	Former Pump House	Northeast area of Site	Site walk /Facility drawings	Feature identified on Site Plan as pump house. Use of pump house unknown; possibly associated with oil or fuel conveyance. Area of former pump house pad was covered by standing water at time of Site reconnaissance and could not be observed.	Dimensions unknown. Area inaccessible at time of Site reconnaissance.	25	Diesel fuel, oils	Yes
04	Evidence of Release in Test Cell "D" Wing Area	Southeast test cell	Site walk	Area of dark staining and oily residue observed on concrete and gravel near northeast corner of former Test Cell "D" Wing. Staining may be associated with demolition or subsequent activities.	4x4	27, 28	Fuel, oil	Yes
05	Evidence of Release in Test Cell "E" Wing Area	Northeast test cell	Site walk	Staining observed on concrete and gravel near southwest area of the Test Cell "E" Wing. Staining may be associated with demolition or subsequent activities.	6x4	31, 32	Fuel, oil	Yes

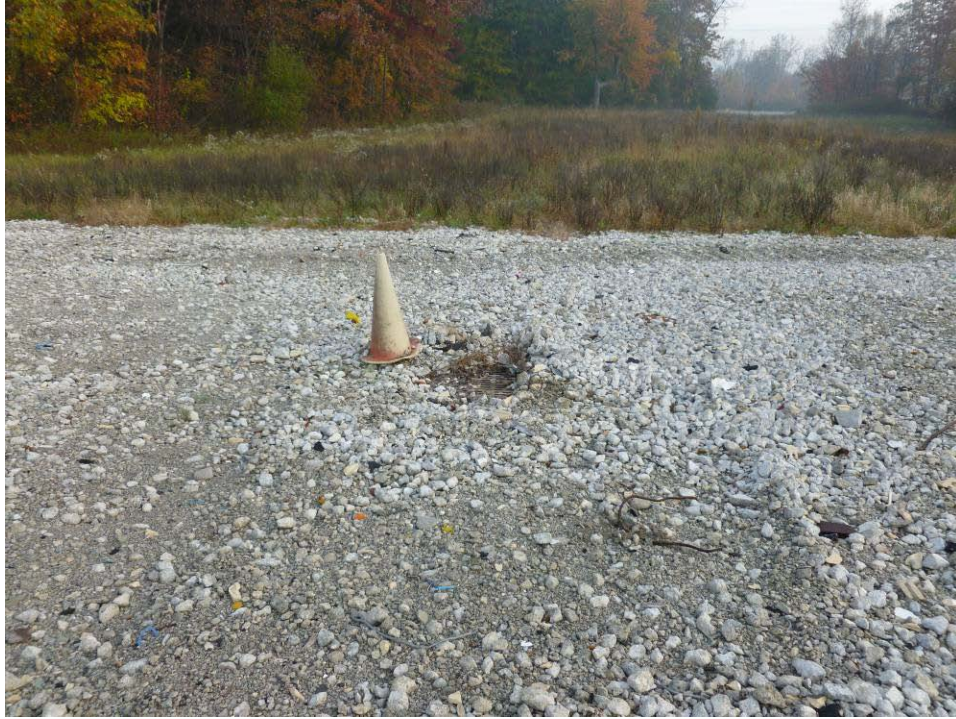
Photograph 33. Storm drain located at edge of former exterior concrete parking area, north side of former facility footprint.

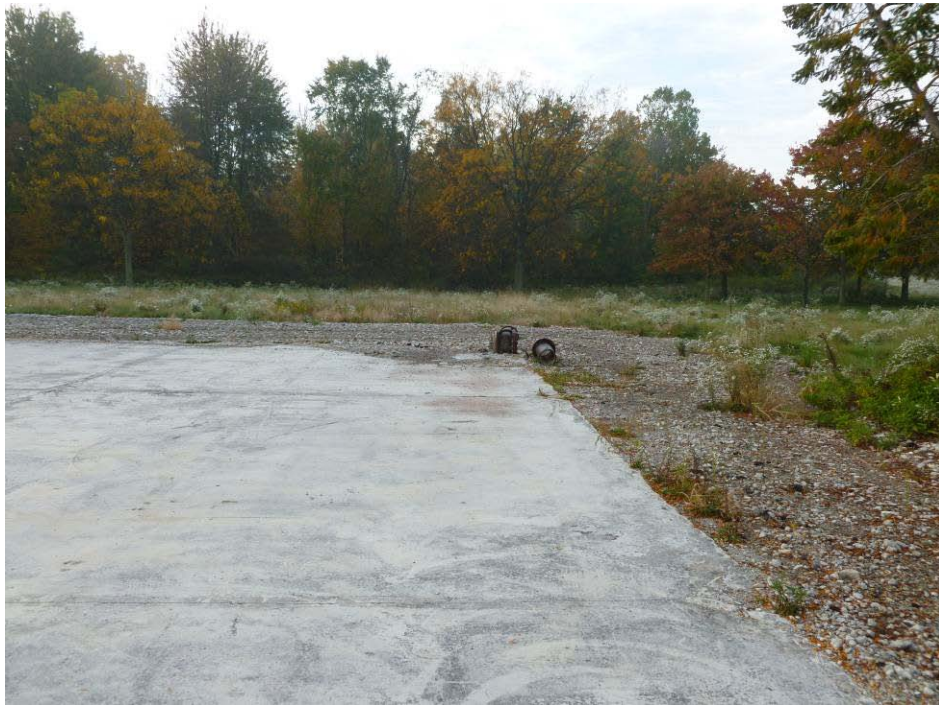
Photograph 34. Southwestern-most corner of former facility. Photo taken facing south. Objects in background believed to be components of former fire suppression system.

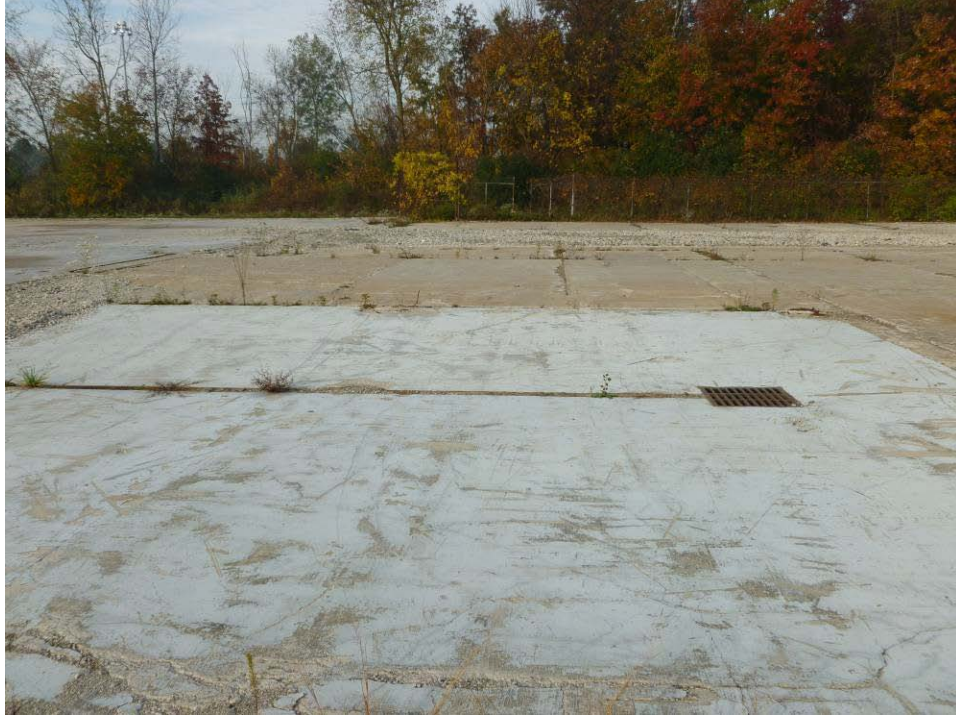
Photograph 35. (AOI-07) Area of former shipping dock and drum storage shed. Photo taken facing west.
