MDEQ PROJECT UPDATE

(2015 4Q PROGRESS REPORT)

RACER Lansing, Plants 2, 3 & 6

January 26, 2016

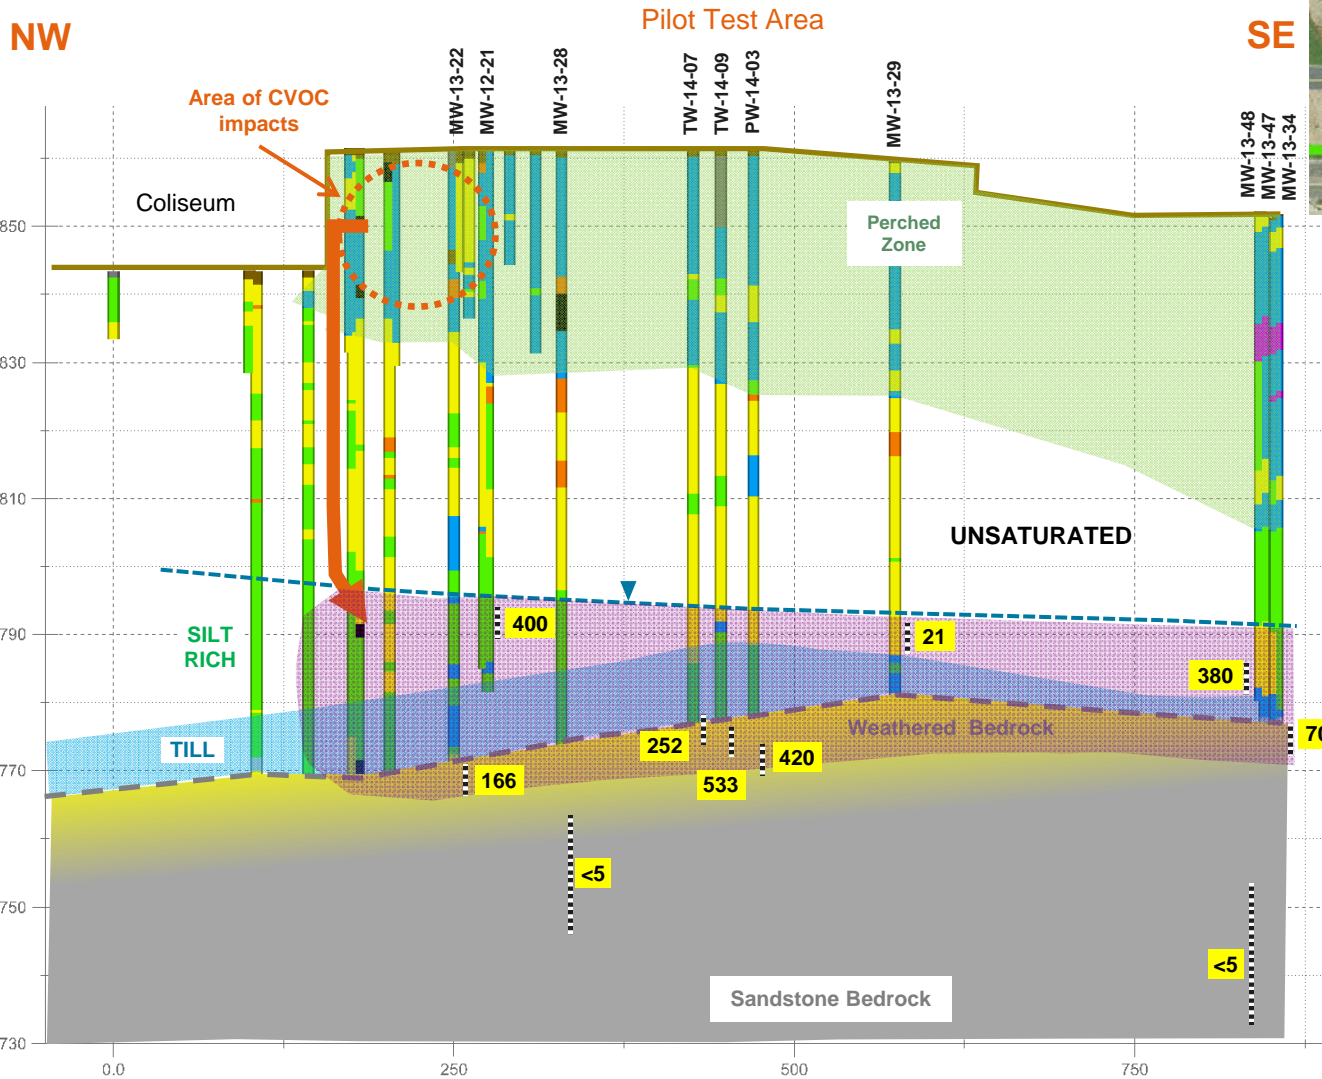
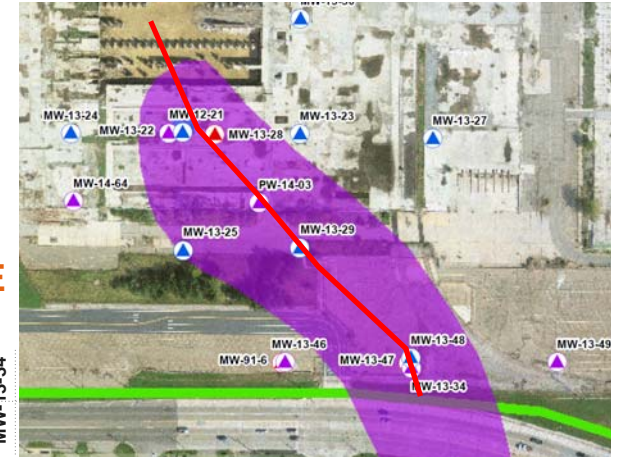
Lower 1,4-Dioxane Source Area Conceptual Model

34 1,4-dioxane in GW (µg/L)
(December 2015)

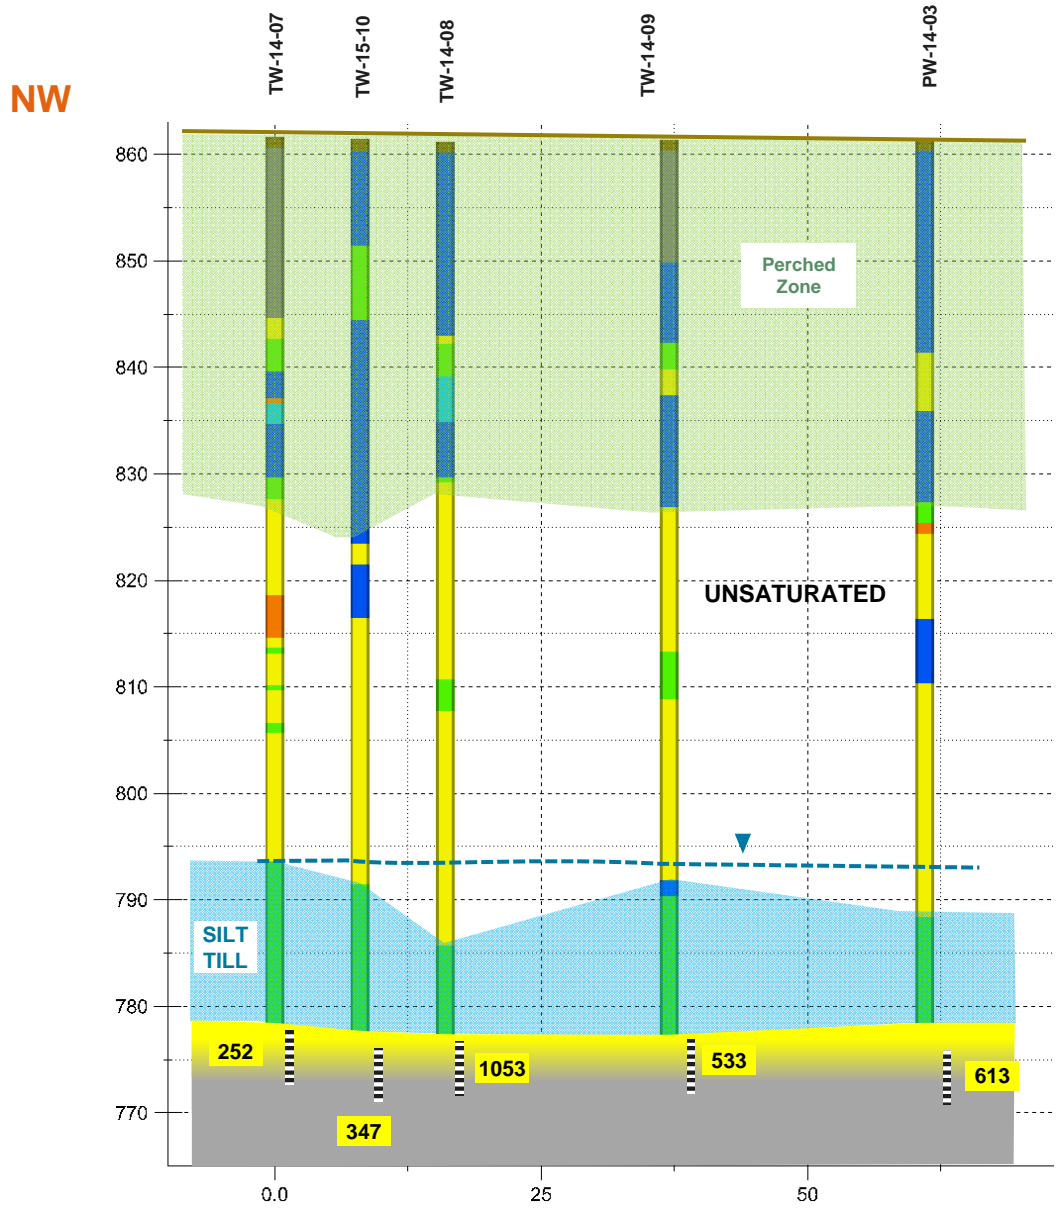
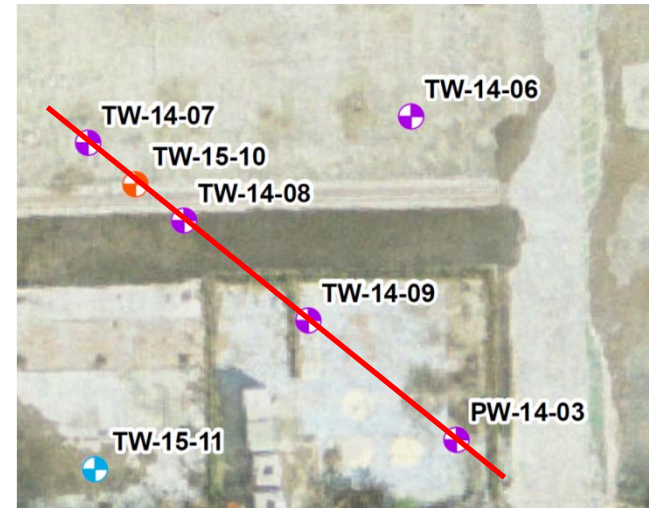
Plant 3 Pilot Test Area

34 1,4-dioxane in GW (µg/L)
(December 2015)

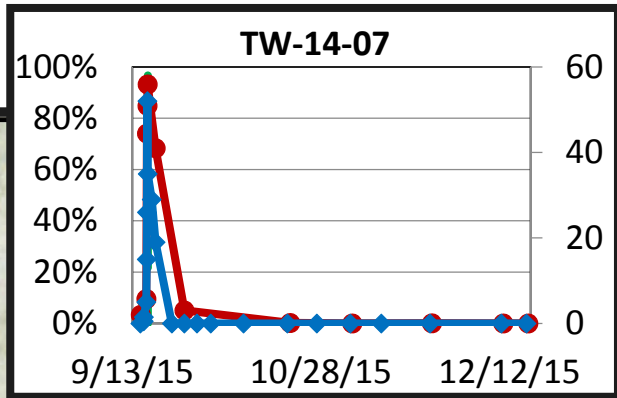
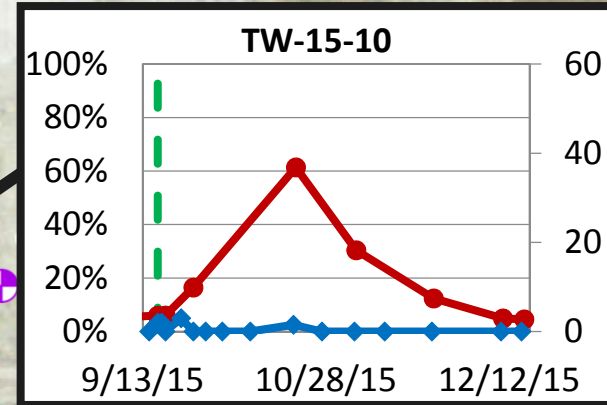
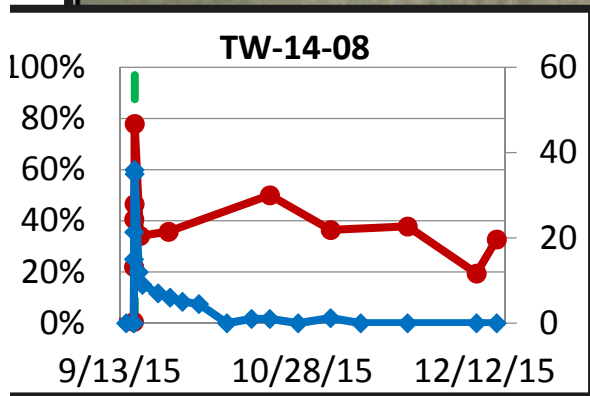
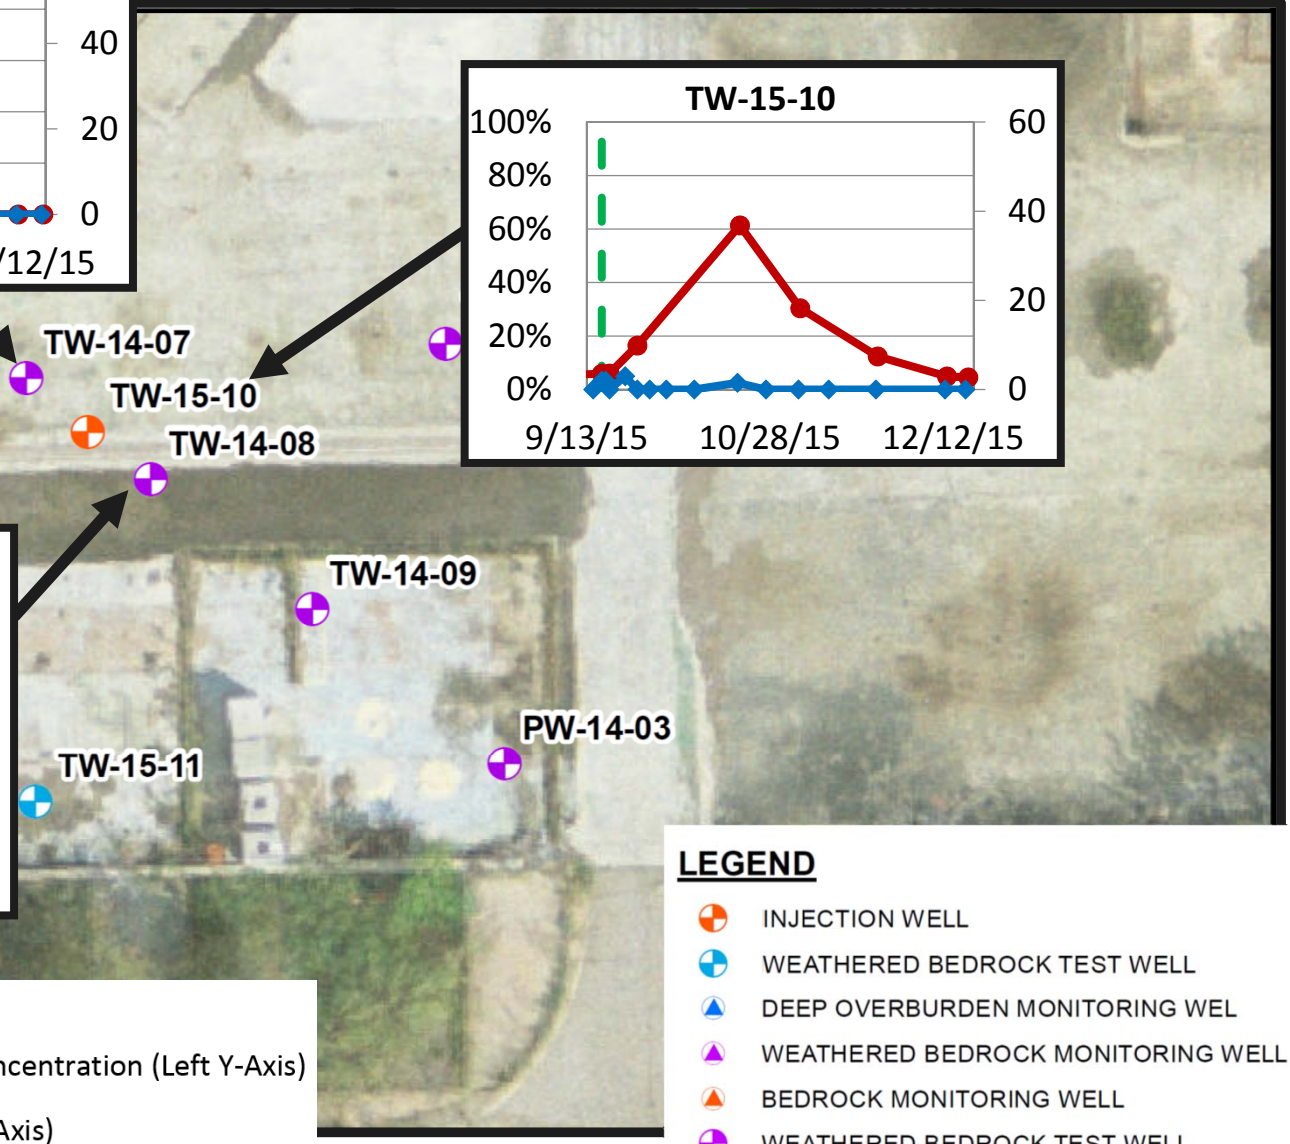
Tracer and Oxidant – Plant 3

- End of TW-15-10 Injection
- Normalized Deuterium Oxide Concentration (Left Y-Axis)
- ◆— Sodium Persulfate (g/L) (Right Y-Axis)

- Washout in DR wells indicates south easterly flow direction
- Mobile porosity ~19%
 - Calculated based on volume to reach 50% of max concentrations
 - Assumption for thickness of weathered rock
- Groundwater velocity based on washout ranges from 0.1 to 10 ft/day
- Sustained tracer concentrations:
 - Pushed tracer into storage fraction of weathered bedrock, slowing moving out
 - Mounding into overlaying till, slowly dissipating

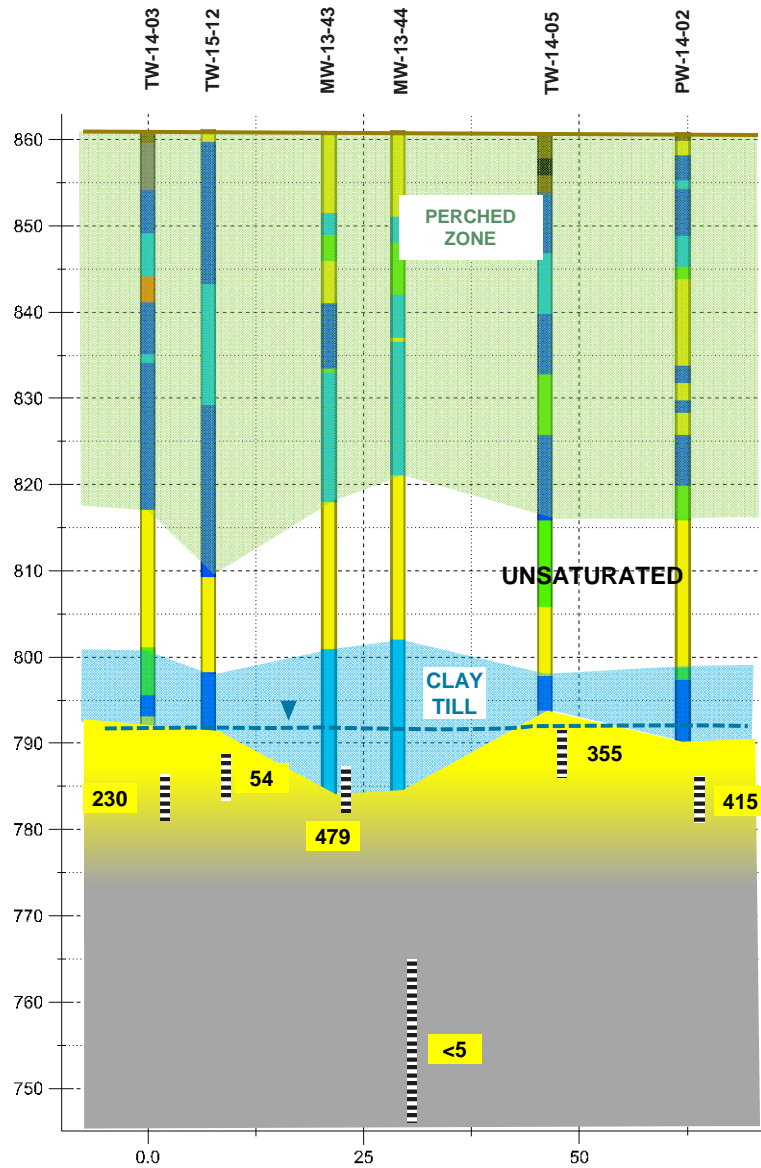
Plant 2 Pilot Test Area

34 1,4-dioxane in GW ($\mu\text{g/L}$)
(December 2015)

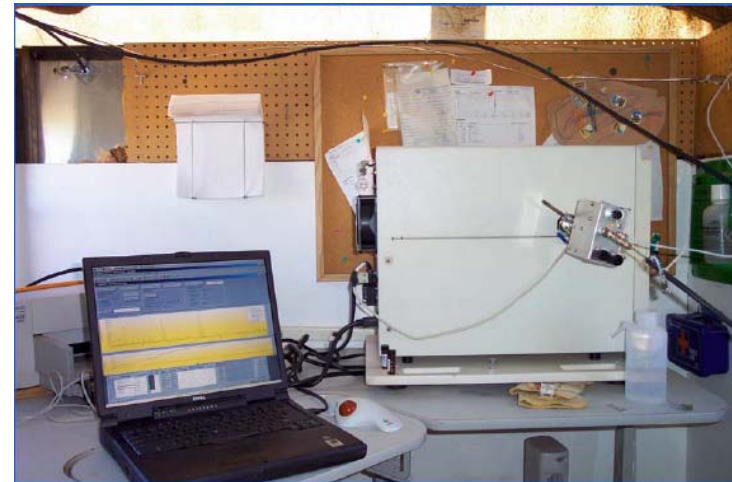
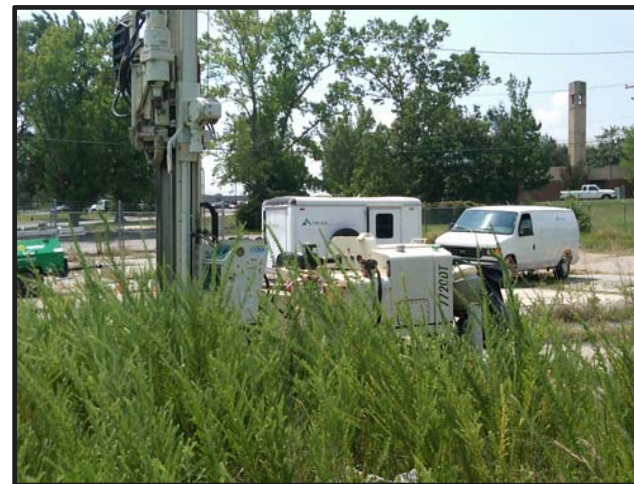
Comparison of Groundwater Analytical Methods

- USEPA 8265 (DSITMS)
- On this mobilization the DL for 1,4-dioxane in soil: 40 µg/Kg
- DL for 1,4-dioxane in groundwater: 20 µg/L
- Split samples sent to Merit Laboratories

Good agreement between the methods

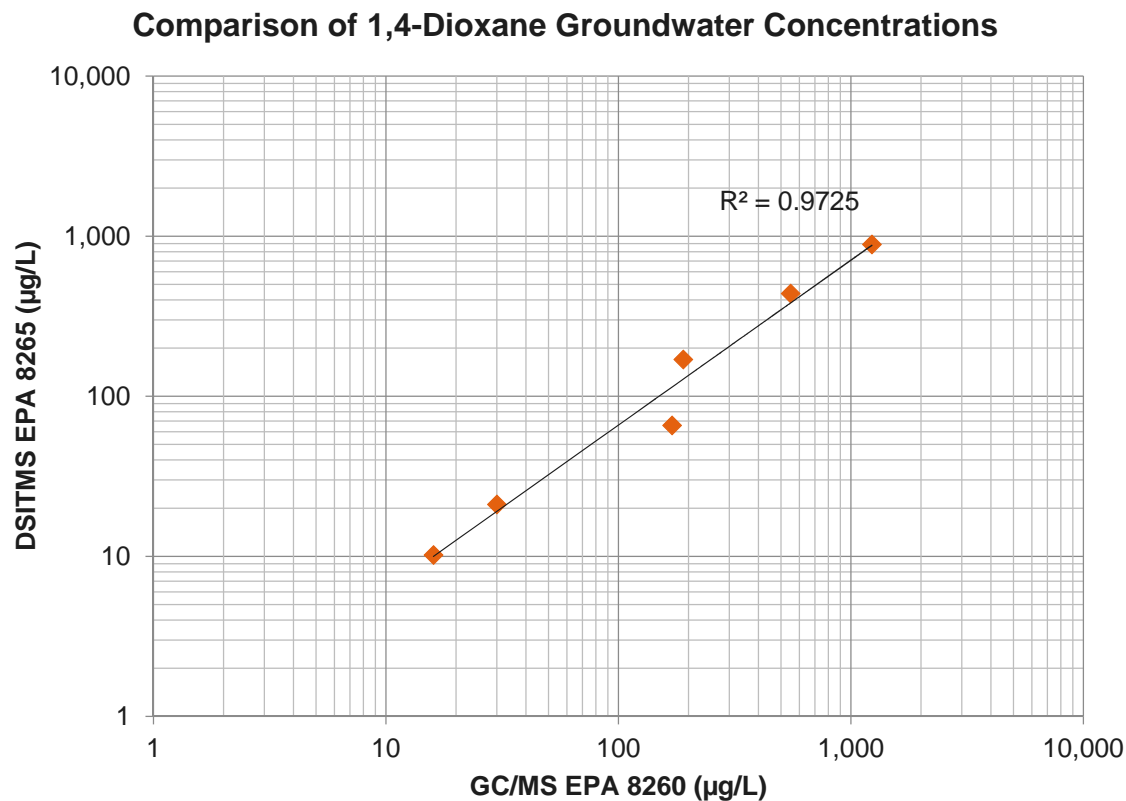
- DSITMS reliable indicator of 1,4-dioxane in groundwater
 - Bias slightly low for groundwater (~50%)

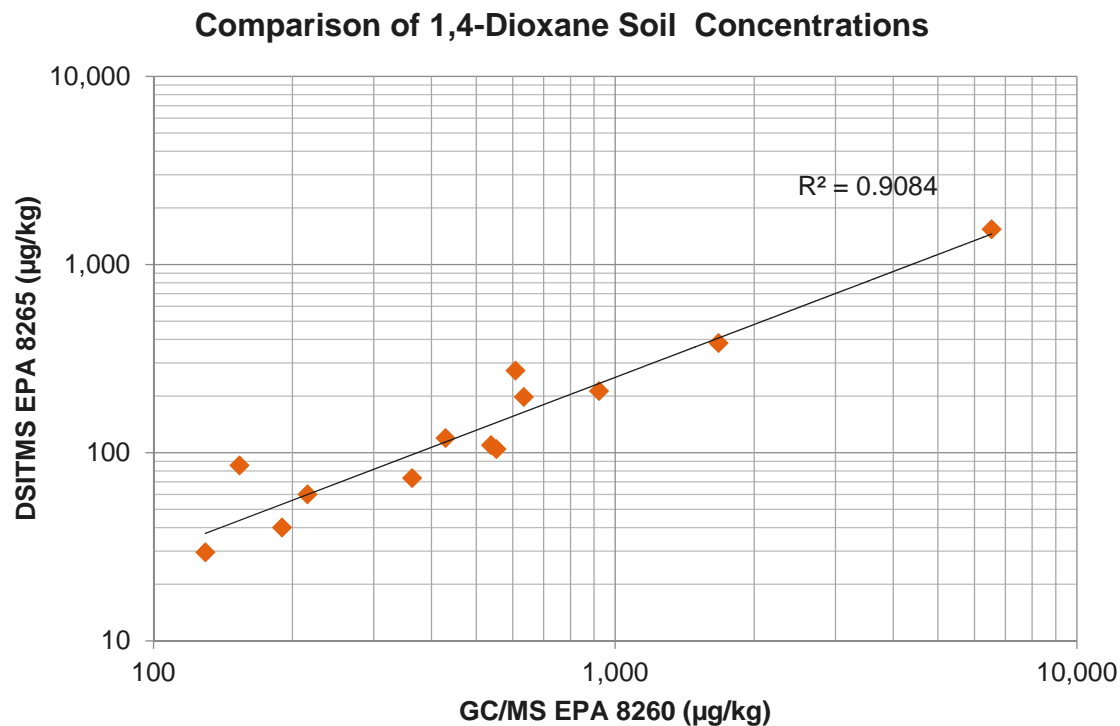
Comparison of Soil Analytical Methods

DSITMS reliable indicator of 1,4-dioxane in soil

- Biased low for soil by a about a factor of ~3X
- Effects of continued extraction were not significant

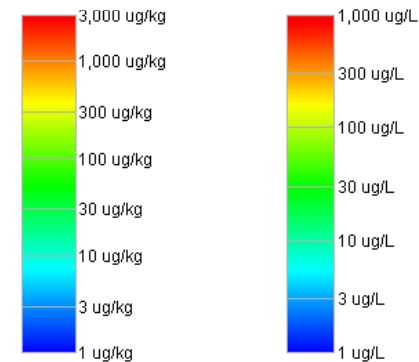
Investigation Results

1,4-Dioxane Soil (spheres) 1,4-Dioxane Groundwater (cylinders)

A correction value of 3x has been applied to all soil samples based on correlations between mobile and fixed laboratory split sample results

- Concentration of 1,4-dioxane in core of the plume is variable and characterized by higher concentrations of 1,4-dioxane in narrow zones
- The results of the investigation suggest that some 1,4-dioxane migrates from the perched zone to the lower zone, or has in the past
 - Contribution may be minor relative to the core migrating south from Plant 3
- There is an indication the former APC may contribute 1,4-dioxane to the weathered bedrock impacts
- Initial sampling at the MW-13-42 replacement well (aka MW-15-73) indicated 1,4-dioxane below 8.5 µg/L
- The nested well adjacent to well MW-12-05 (aka MW-15-72) indicates a concentration of 1,4-dioxane generally consistent with the core of the plume.
