**PRELIMINARY ASSESSMENT/VISUAL SITE INSPECTION REPORT
FOR
PEREGRINE, INC.
(FORMER GENERAL MOTORS CORPORATION INLAND FISHER GUIDE
COLDWATER ROAD MANUFACTURING FACILITY)
G-1245 E. COLDWATER ROAD
FLINT, MI 48559-001
EPA ID NO. MIR000020743**

August 19, 1998

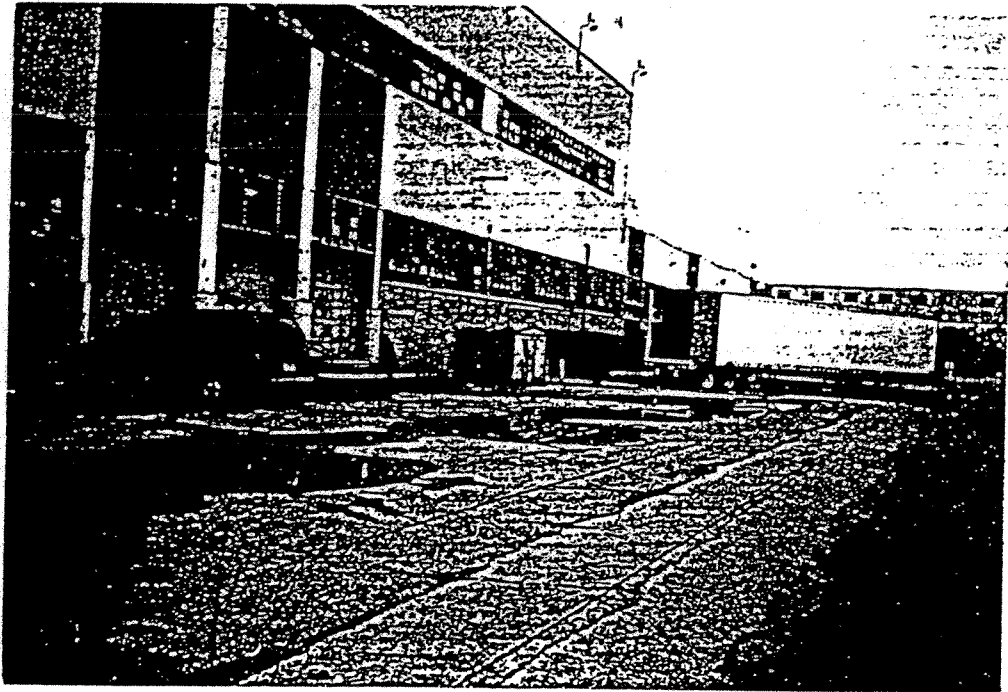
Report Photograph No.: 1
Logbook Photograph No.: 1-4
Date: July 7, 1998

Description: View across the Former Drum Storage Area (SWMU 1). The sump is enclosed in the light blue shed in center of photograph. The containment curb is visible surrounding the pad. The Caustic Tanks (AOC B) may be seen immediately to the right of the Sump shed against Building 44.

It is recommended that U.S. EPA maintain contact with MDEQ regarding the completion of the closure activities for the Former Drum Storage Area (SWMU 1) and the Waste Pile Pad (SWMU 2).

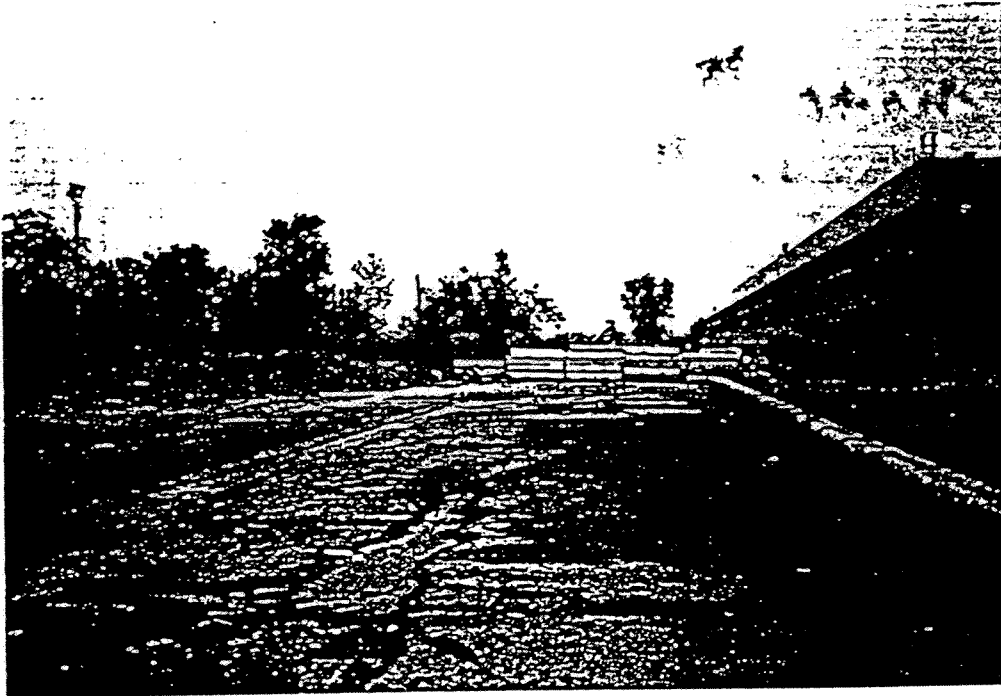
Report Photograph No.: 3
Logbook Photograph No.: 1-9
Date: July 7, 1998

Description: The Waste Pile Pad (SWMU 2) with Building 63 visible on the right side of the photograph. The line drain which manages runoff from the pad may be seen toward the left side of the photograph.

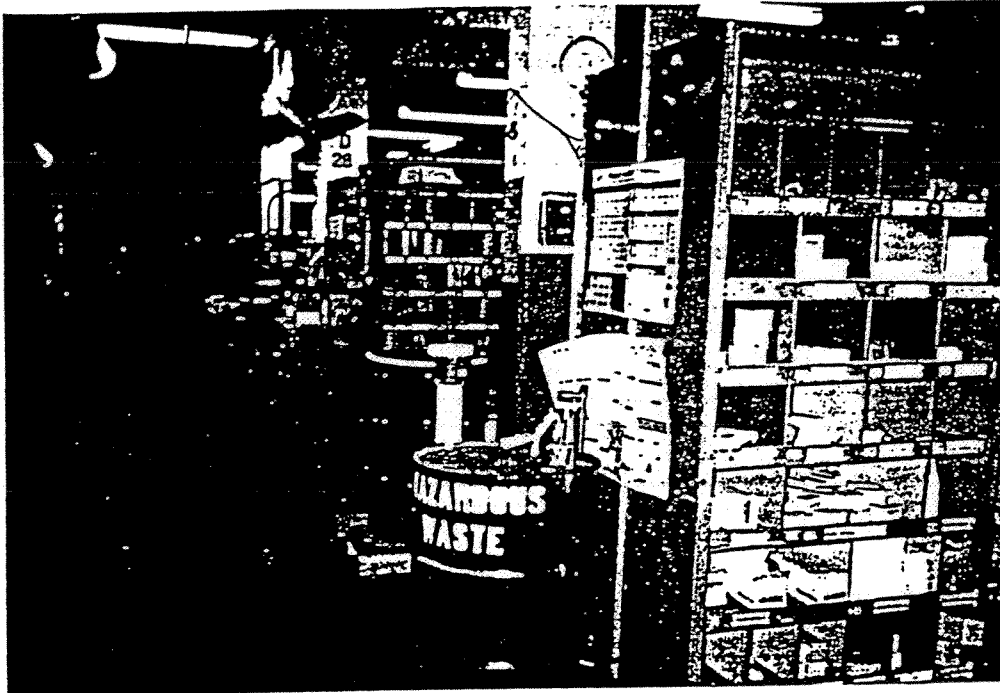
Report Photograph No.: 5
Logbook Photograph No.: 1-13
Date: July 7, 1998

Description: Satellite Accumulation Area (SWMU 4) drums in General Stores portion of the basement of Building 44. The red drum (near) is used for the temporary storage of waste aerosol cans and the black drum (far) is used to store waste batteries.

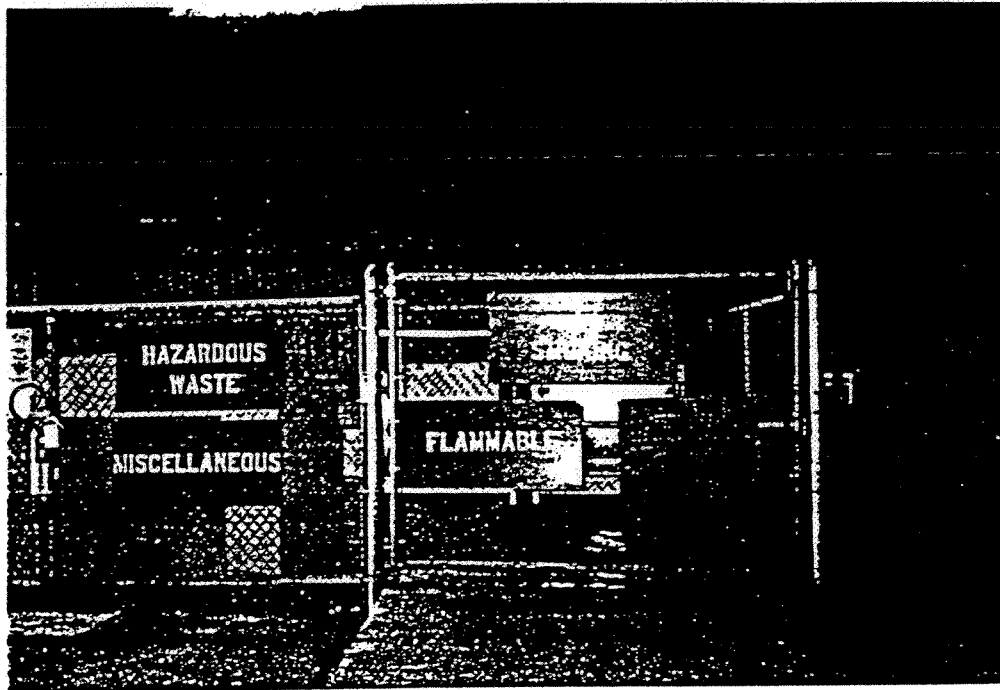
Report Photograph No.: 7
Logbook Photograph No.: 1-6
Date: July 7, 1998

Description: Current Hazardous Waste Storage Area (SWMU 5) located in the northwest portion of Building 66.

Conclusions: Based on the condition and location of this unit, it appears that no action is warranted for this unit at this time.

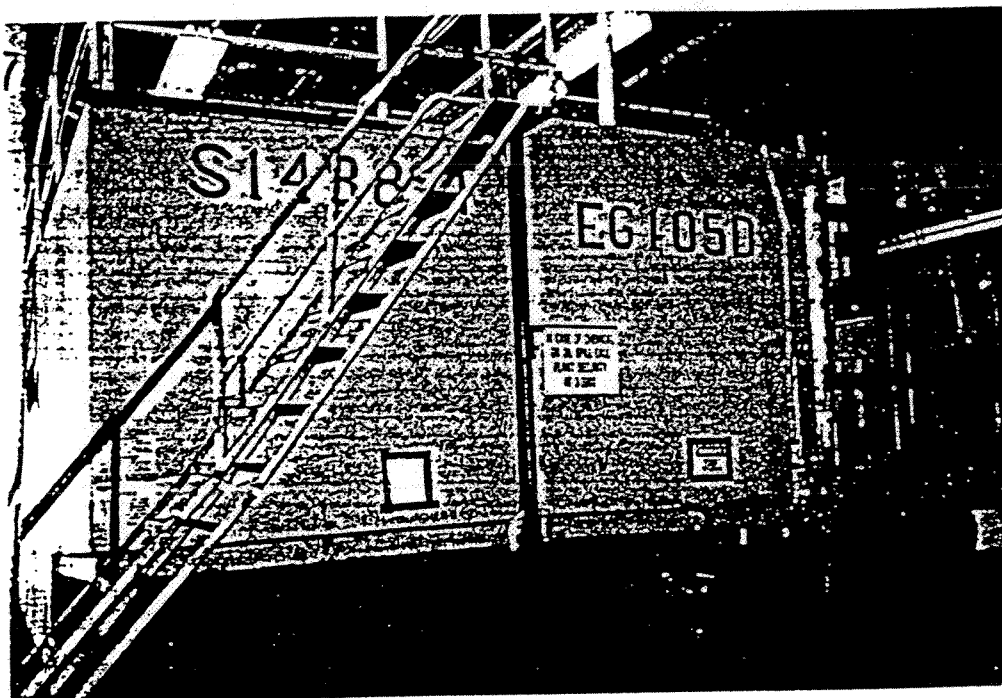
Report Photograph No.: 9
Logbook Photograph No.: 1-1
Date: July 7, 1998

Description: View of the two 20,000 gallon Wastewater Storage Tanks (SWMU 6) located in the northwest corner of Building 44. The tank on the left handles the facility's wastewater. The tank on the right is present to manage overflow. The facility currently plans to remove the tank on the right from the site in August 1998.

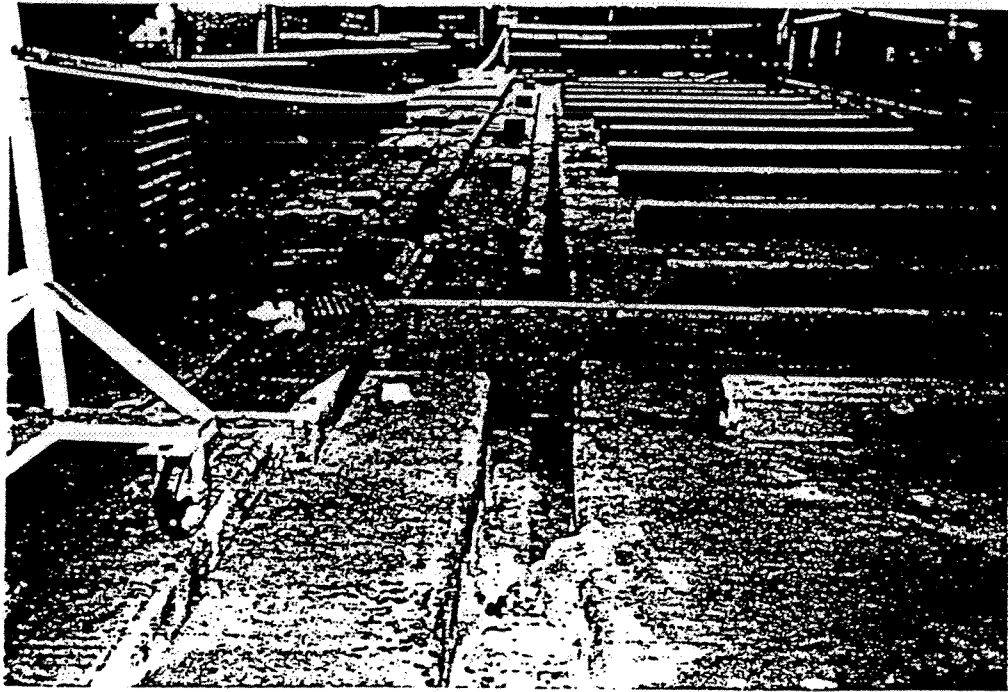
Report Photograph No.: 13
Logbook Photograph No.: 1-16
Date: July 7, 1998

Description: View of the concrete platforms and sump associated with the zinc barrel plater (a portion of SWMU 9 - Former Plating Areas) in the southern portion of Building 44.

Conclusions: Little information was available during the PA/VSI to determine the integrity, release history, waste management practices and decommissioning of the plating tanks and associated waste plating solution collection areas related to this unit. It is recommended that concrete coring followed by soil sampling be conducted for the former plating operations in Building 44 where the concrete waste plating solution collection areas are underlain by soil in order to determine whether these areas have released plating solutions to the soil or groundwater at the facility.

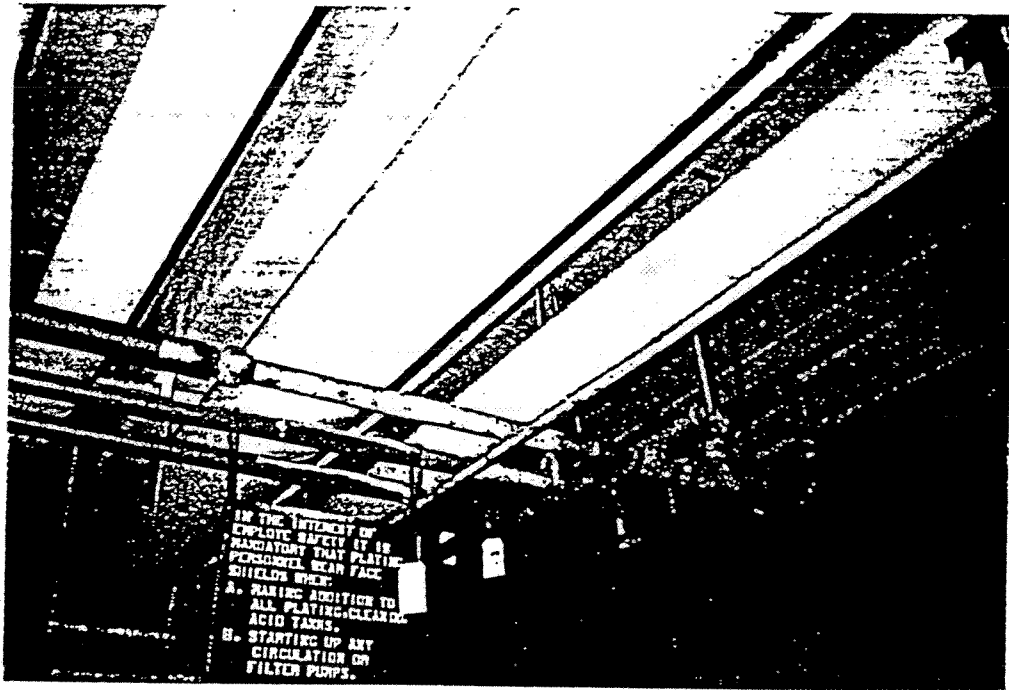
Report Photograph No.: 15
Logbook Photograph No.: 1-15
Date: July 7, 1998

Description: Overhead Waste Pipes (SWMU 10) near former spent plating solution collection area (a component of SWMU 9 - Former Plating AREAS). The orange pipes are color coded to indicate that they were used to manage waste. Several of the pipes in the photograph may appear to have been cut and capped.

Little information was available during the PA/VSI to determine the integrity, release history, waste management practices and decommissioning of the plating tanks and associated waste plating solution collection areas related to the Former Plating Areas (SWMU 9). It is recommended that concrete coring followed by soil sampling be conducted for the former plating operations in Building 44 where the concrete waste plating solution collection areas are underlain by soil in order to determine whether these areas have released plating solutions to the soil or groundwater at the facility.

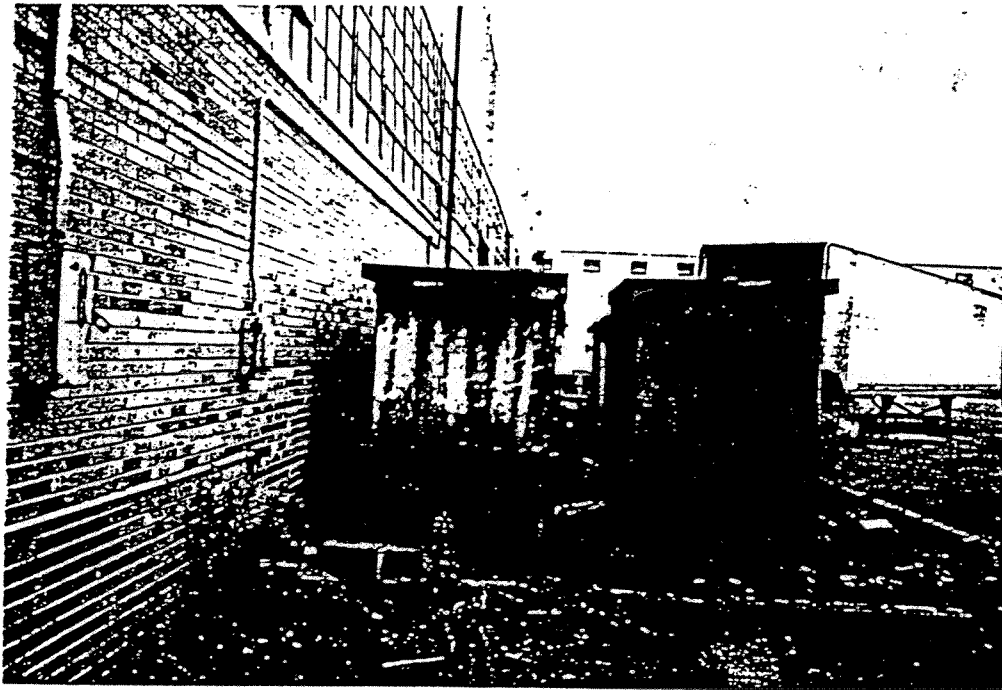
Report Photograph No.: 17
Logbook Photograph No.: 1-3
Date: July 7, 1998

Description: Eleven above-ground, steel Caustic Tanks (AOC B) with dimensions of approximately four feet by six by six feet, were observed immediately west of the Former Drum Storage Area (SWMU 1) against building 44. All of the tanks were covered with lids. Two tanks were inspected during the VSI and were observed to be empty. One of the two tanks which was inspected during the VSI was observed to have a crack along the bottom edge suggesting that the tanks were not going to be put back into service. There was no indication how long the tanks had been located in this area or what length of time the crack that was observed had existed. The crack appeared to be a result of rusting.

Description: A view of two of the 11 Caustic Tanks (AOC B) located adjacent to the Former Drum Storage Area (SWMU 1).

Conclusions: Little information was available during the PA/VSI to determine the integrity, release history, waste management practices and decommissioning of the Caustic Tanks (AOC B). It is recommended that soil samples be collected from beneath the asphalt in the area of the Caustic Tanks in order to determine whether the Caustic Tanks (AOC B) have released metals to the soil or groundwater at the facility.
