Subject: **Notification of Newly Identified 310 Plater Pit in Bay B-49, General Motors Corporation, MLK Facility, IND 980700801**

LOCATION OF 310 PLATER PIT

LOCATION OF FORMER 310 PLATER
AND FORMER 310 PLATER PIT

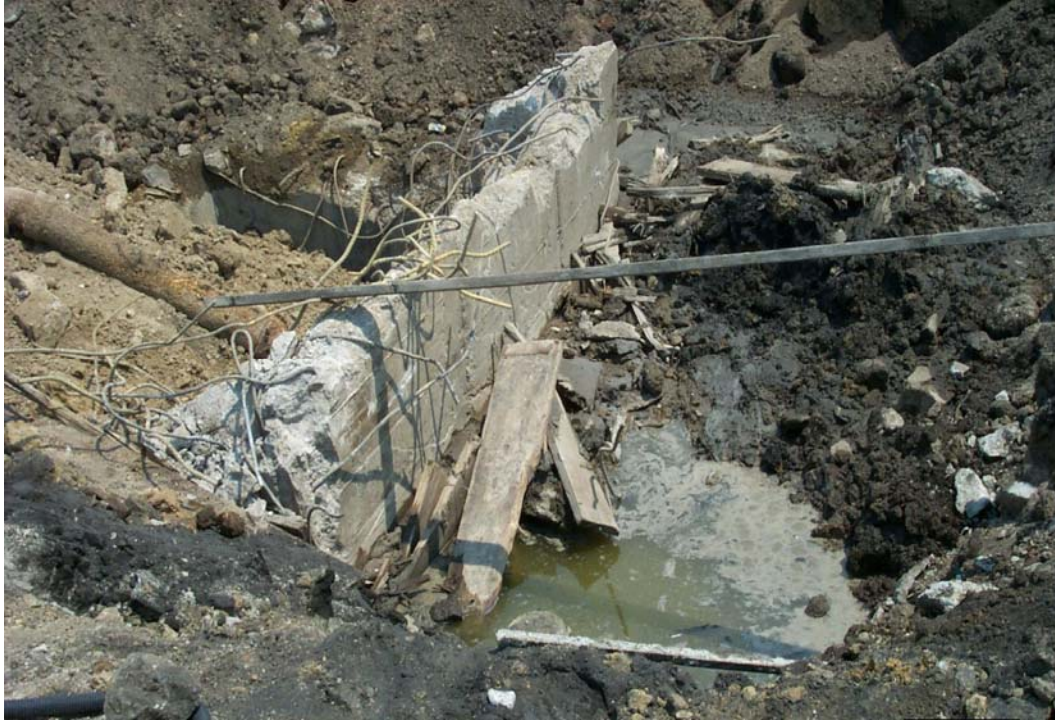
During excavation of the fill material and removal of the concrete, the concrete walls were broken. Water and sand flowed outside the pit and the water was observed to have a yellow color. During and following removal of the fill material and concrete walls and bottom of the sump, approximately 600 gallons of water was pumped from the excavation over a five-day period. The pumped water was contained in two totes and held for characterization and proper disposal. The open excavation was observed to slowly recharge after pumping.

Photo 1. Excavation adjacent to 310 Plater pit.

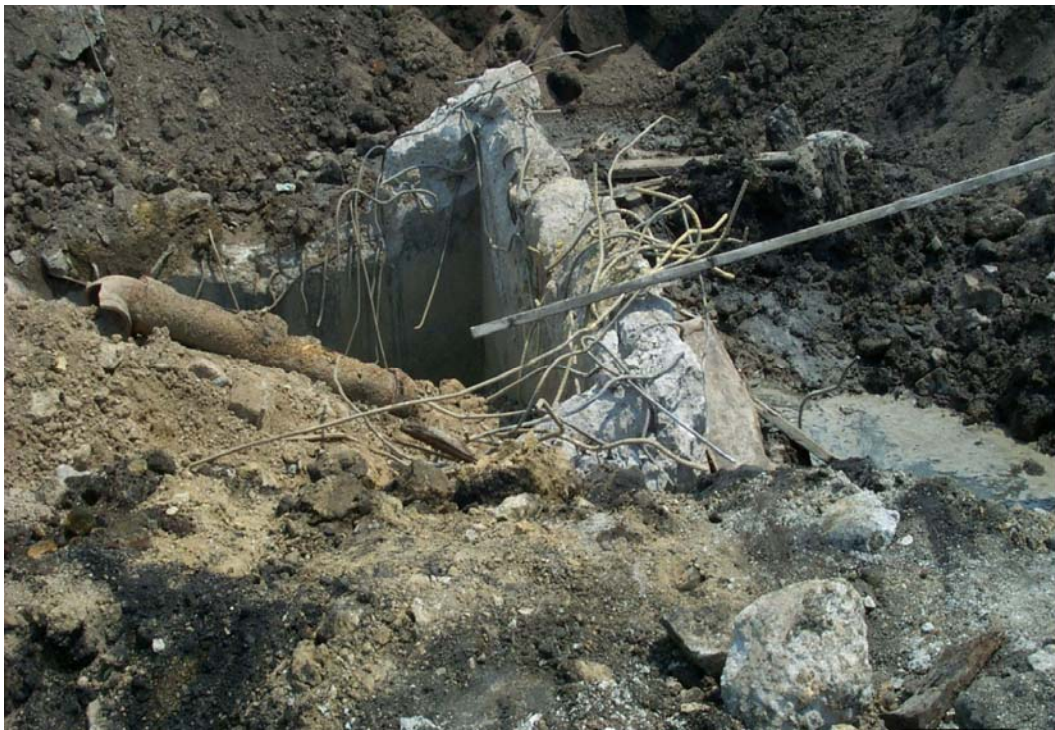
Upon removal of the concrete floor, the pit was observed to be filled with sand and gravel and did not display any staining. The pit was rectangular in shape measuring 8 x 10 feet, and upon excavation was found to be about 10 feet deep. The concrete pit walls were observed to be intact, and no fractures were observed in the pit floor. The walls and floor of the pit had a rubber liner. The concrete pit walls and floor were removed and the soil around the pit was excavated. Excavated material was placed in four roll-off boxes and disposed of as chromium-impacted hazardous waste.

Photo 2. 310 Plater pit.

There are several known pits and sumps within the former Main Plant Building that will be inspected and evaluated during the demolition process. Following the inspection and evaluation of all pits and sumps, GM will prepare a work plan to further evaluate those pits and sumps, including the 310 Plater Pit, that warrant additional subsurface investigation. The purpose of the investigation will be to determine if hazardous constituents have been released to the environment, and if so, to determine the potential impact to human health using a risk screening evaluation.
