# **Resource Conservation Recovery Act Facility Investigation Work Plan Addendum No. 1**

Former Willow Run Company Vehicle Operations Area  
Ypsilanti, Michigan

Revitalizing Auto Communities Environmental Response Trust (RACER)

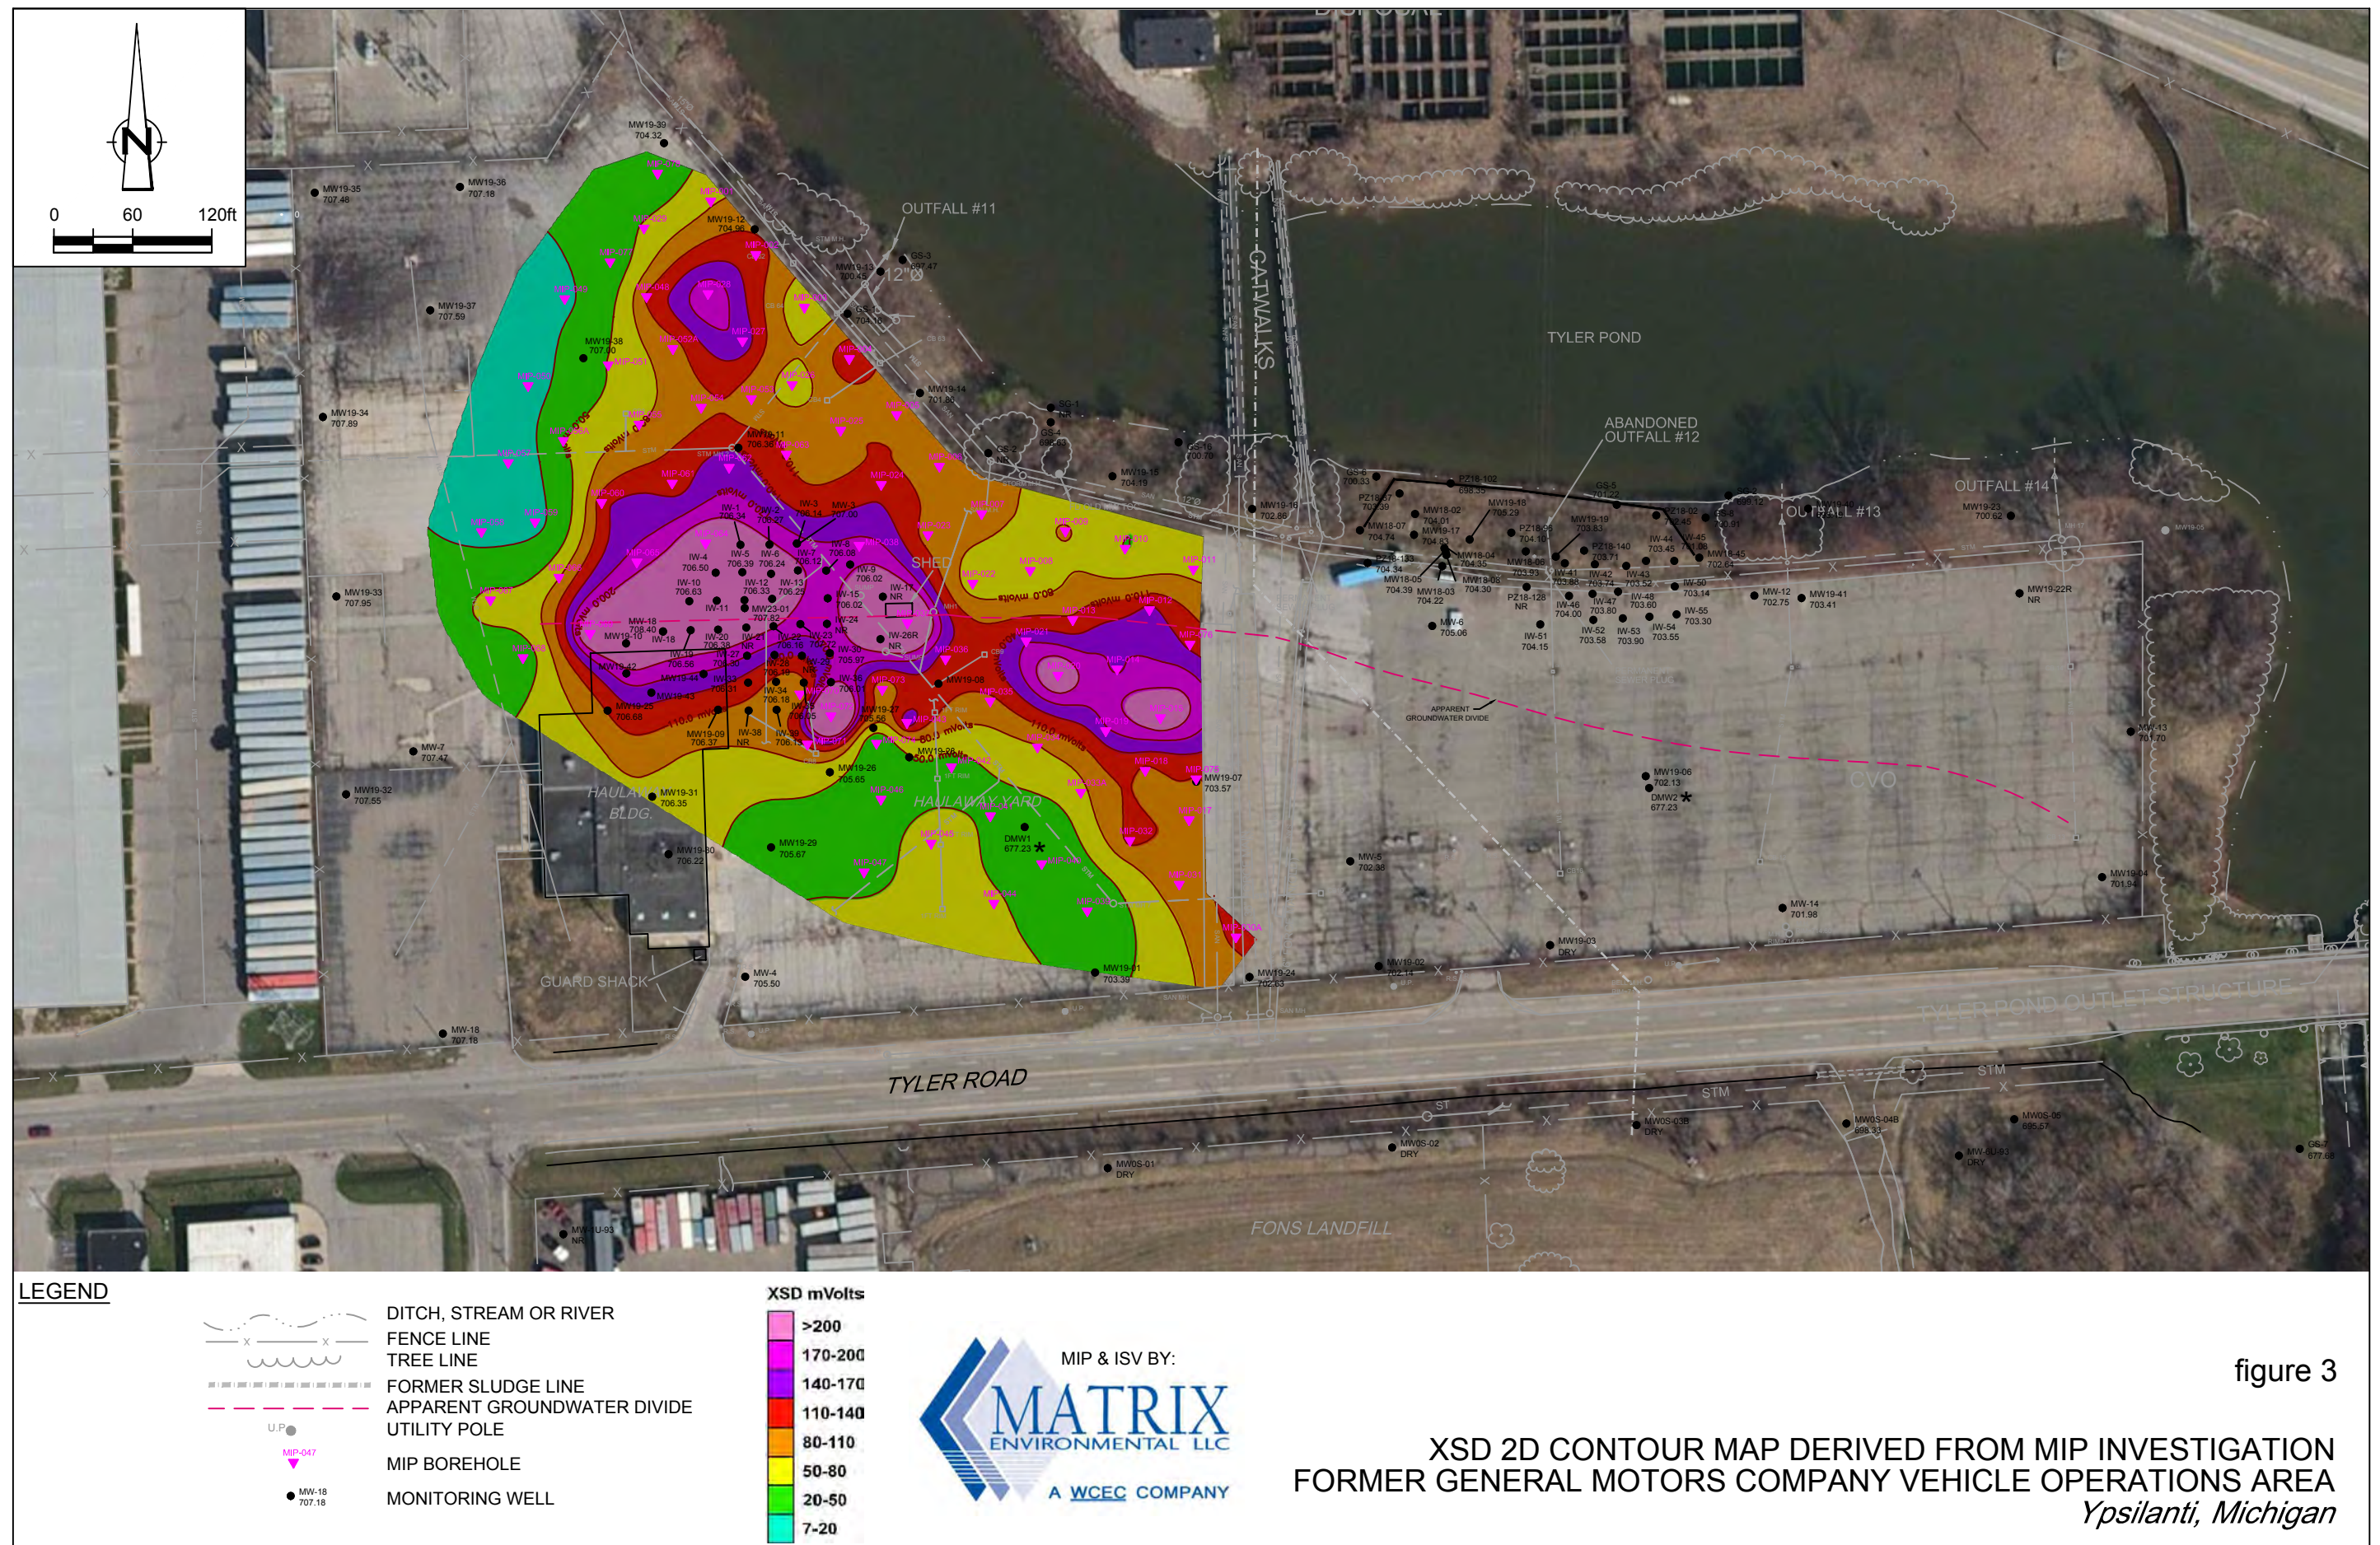
figure 2

**MEMBRANE INTERFACE PROBE (MIP) BOREHOLE LOCATIONS**  
**FORMER GENERAL MOTORS COMPANY VEHICLE OPERATIONS AREA**  
*Ypsilanti, Michigan*

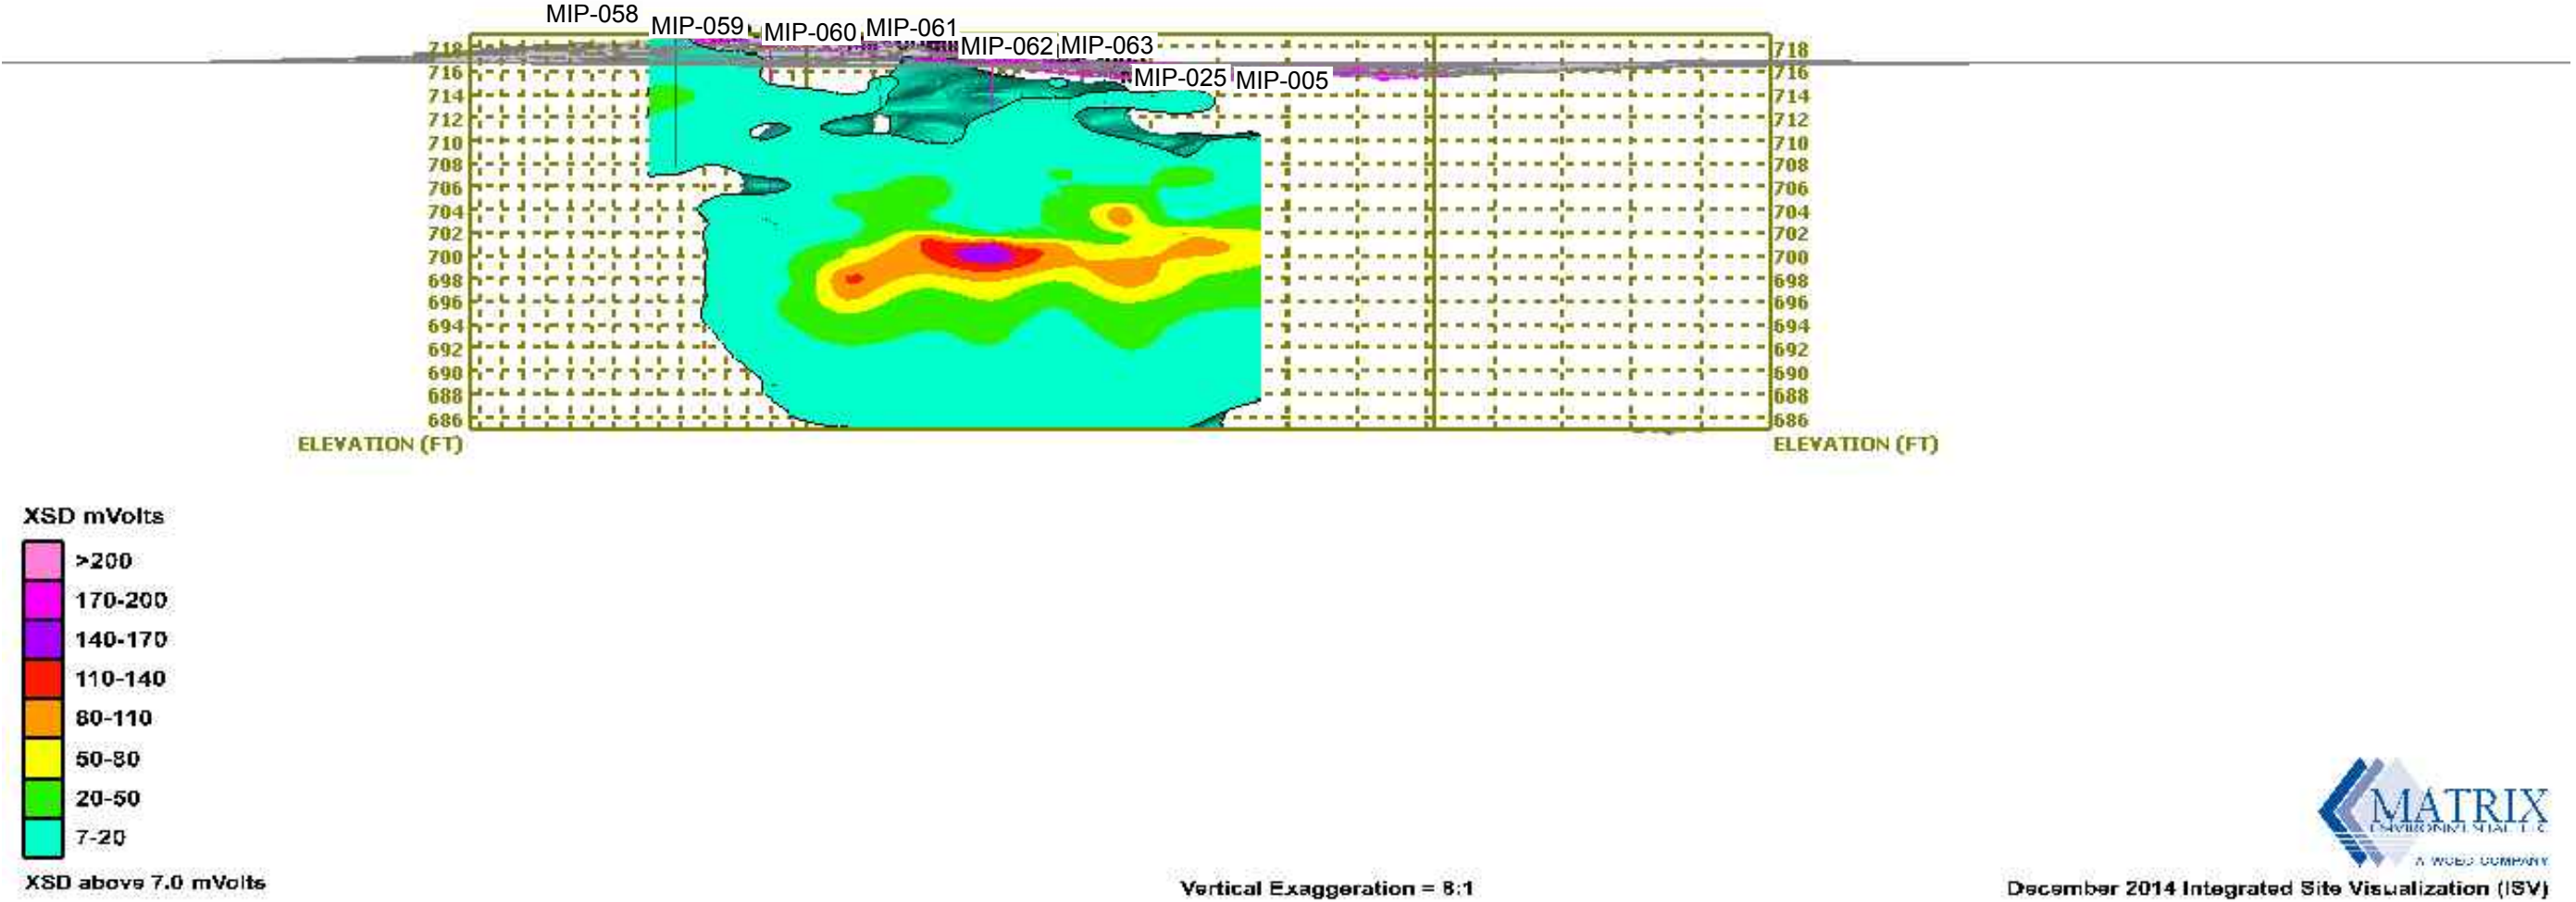
figure 12  
NORTHING SLICES C-C' - XSD RESPONSE  
2014 MIP INVESTIGATION SUMMARY  
FORMER COMPANY VEHICLE OPERATIONS AREA  
Ypsilanti, Michigan

Vertical Slice, Northing = 268,497.5 ft  
Slice Azimuth = 72 degrees
