**PHASE I ENVIRONMENTAL SITE ASSESSMENT  
GENERAL MOTORS CORPORATION/UNITED AUTO WORKERS  
EMPLOYEE DEVELOPMENT CENTER  
65 EAST UNIVERSITY DRIVE  
PONTIAC, MICHIGAN**

**ENCORE ENVIRONMENTAL CONSORTIUM, LLC**

**DATE: JULY 1, 2005**

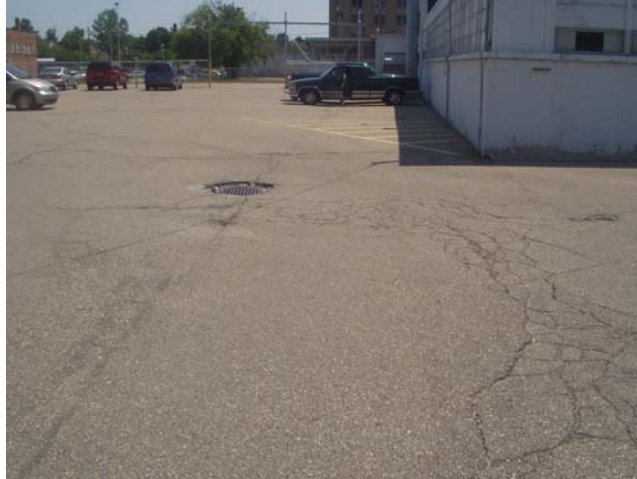
**Photograph 7. View of the location of the two former USTs, facing southeast.**

At the time of the Site reconnaissance, no evidence of existing underground storage tanks (USTs) was observed by EEC. According to previous reports and a 1986 Notification of Underground Storage Tanks, fourteen USTs formerly existed at the Site, which included one 1,000-gallon gasoline UST and an associated dispenser, one 1,000-gallon waste oil UST, one 1,000-gallon spill UST for dilute sulfuric acid, and eleven 50-gallon hydraulic oil USTs. The eleven 50-gallon USTs refer to hydraulic lift reservoirs which are no longer considered regulated USTs by the Michigan Department of Environmental Quality (MDEQ). According to previous reports and historical documentation, the 1,000-gallon waste oil UST was converted to a spill tank for dilute sulfuric acid prior to 1986. Previous reports indicated that no evidence of a third 1,000-gallon UST was identified during previous investigations. Based on historical documentation and observations from previous investigations, only two of three former 1,000-gallon USTs listed on the 1986 Notification of Underground Storage Tanks existed at the Site. At the time of the Site reconnaissance, EEC observed the concrete pad where the former gasoline dispenser was located northwest of the Site building.

- CRA prepared this Release Closure Report to address the closure of two leaking USTs at the Site. Nine soil samples were collected from four boreholes and analyzed for BTEX, lead, TCL VOC, TAL Metals, TCL PCB/Pesticides, TCL SVOC, TCL VOC, and TAL Metals. On March 16 and 17, 1995, four boreholes, BP-PH13-1 through 4, were installed. Continuous split spoon sampling was conducted and the collected samples were subjected to visual and olfactory observations and headspace screening with a PID. Boreholes BH-P13-1 and -2 were installed to a depth of approximately 48 feet bgl. Boreholes BH-PH13-1 and -2 were located near each of the two former UST locations. Three soil samples were collected from each borehole. Soil samples were collected from BH-P13-1 at 0-2 feet bgl, 16-18 feet bgl and from BH-P13-2 at 2-4 feet bgl, 16-18 feet bgl, and 40-42 feet bgl. Collected samples were analyzed for BTEX and Lead. BTEX and lead were not detected above the Michigan Tier 1 Residential Direct Contact Criteria for soil. Borehole BH-PH13-3 was installed to a depth of approximately 18 feet bgl. Two soil samples were collected at 2-4 feet bgl and 14-16 feet bgl. Collected samples were analyzed for pesticides, PCBs, and TCL VOC. Except for arsenic, no parameters were detected above the Michigan Tier 1 Residential Direct Contact Criteria for soil or the Michigan Generic Cleanup Criteria in BH-PH13-3. Arsenic was detected at a concentration of 13 mg/kg in BH-PH13-3 at 2-4 feet bgl. This concentration exceeded the Michigan Generic Residential Cleanup Criteria, however, it is close to the background for arsenic in Erie Lobe clays (11 mg/kg) and was not considered to be associated with the former USTs. Borehole BH-PH13-4 was installed to a depth of approximately 5 feet bgl. One soil sample was collected at 0-2 feet bgl and analyzed for BTEX and lead. BTEX and lead were not detected above the Michigan Tier 1 Residential Direct Contact Criteria for soil. No groundwater was encountered at the Site to a depth of 48 feet bgl. Based on the geology of the area, CRA concluded that it was not expected that offsite soil or groundwater was impacted by the release. CRA concluded that the release had been remediated to current Michigan Residential Criteria and no exposure pathways were identified.

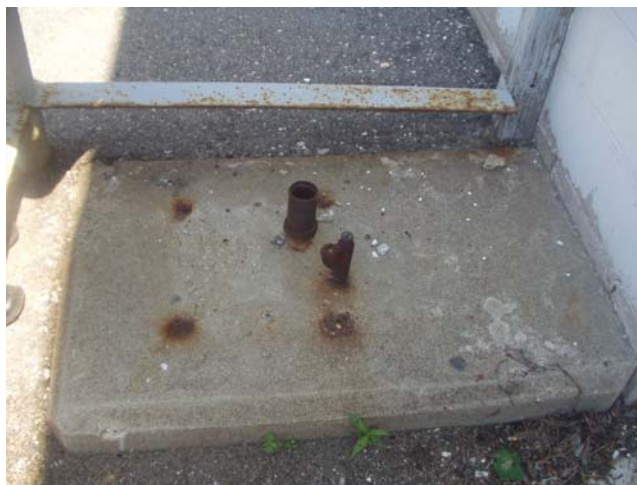
**Photograph 9. View of former gasoline dispenser location outside the northeast corner of the Site building.**

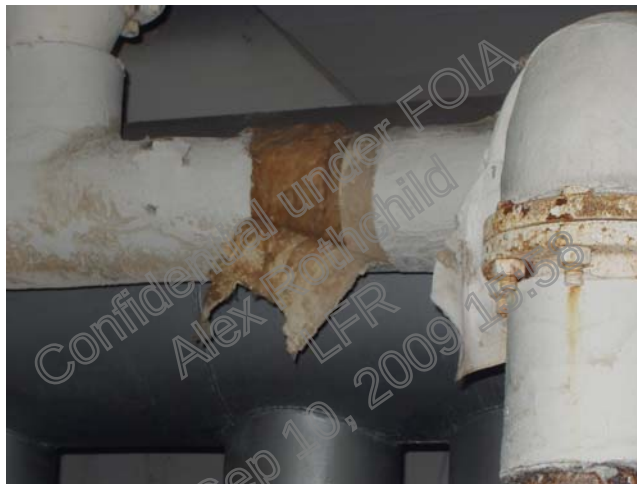
**Photograph 11. View of exposed and damaged suspect asbestos containing piping insulation in the boiler room of the basement.**

disrupted plant operations. Identified suspect ACMs included all mudded joints on fiberglass straight pipe, all non-fiberglass straight pipe insulation and associated fittings, and HVAC fiberglass blanket with canvas and paper backing throughout the Site building. At the time of the Site reconnaissance, ACM stickers were observed on piping insulation throughout the Site building. According to Site personnel, there is no Operation and Maintenance Program (O&M) in place at the Site, which represents an other environmental issue. In addition, EEC observed exposed suspect ACM on piping insulation in the hallway of the first floor and damaged piping insulation in the boiler room of the basement and in the air conditioning room on the second floor, which represents an other environmental issue.

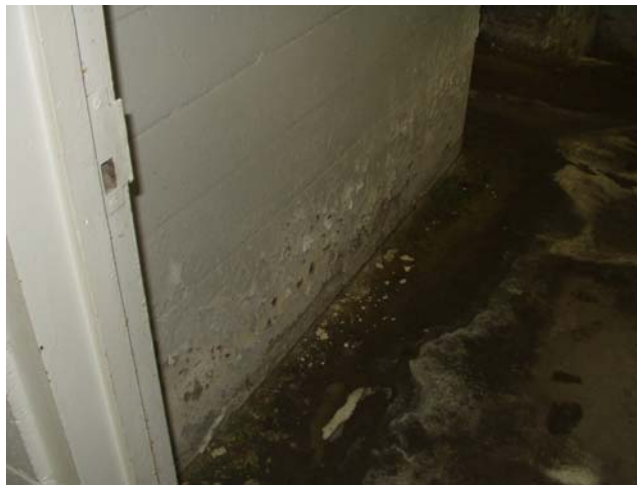
**Photograph 12. View of peeling paint in the hallway to the boiler room in the basement.**

- A lead-based paint survey was not conducted as part of this Phase I ESA. Due to the construction date of the Site building (1950s) lead-based paint is potentially present. Site personnel had no knowledge of any lead-based paints being used at the Site. At the time of the Site reconnaissance, EEC observed peeling of paint in the hallway and staircase near the boiler room in the eastern portion of the basement, which represents a potential exposure issue. EEC observed no evidence or documentation indicating that potential lead-containing discarded painted materials from the eighteen former residences, nine former associated garages, and the former office building exist below the ground surface. Painted surfaces in the remainder of the Site building appeared to be in good condition at the time of the Site visit with no visible evidence of peeling or flaking. The potential presence of lead-based paint in the Site building is considered an other environmental issue.

A lead-based paint survey was not conducted as part of this Phase I ESA. Due to the construction date of the Site building (1950s) lead-based paint is potentially present. Site personnel had no knowledge of any lead-based paints being used at the Site. At the time of the Site reconnaissance, EEC observed peeling of paint in the hallway and staircase near the boiler room in the eastern portion of the basement, which represents a potential exposure issue. EEC observed no evidence or documentation indicating that potential lead-containing discarded painted materials from the eighteen former residences, nine former associated garages, and the former office building exist below the ground surface. Painted surfaces in the remainder of the Site building appeared to be in good condition at the time of the Site visit with no visible evidence of peeling or flaking. The potential presence of lead-based paint in the Site building is considered an other environmental issue.

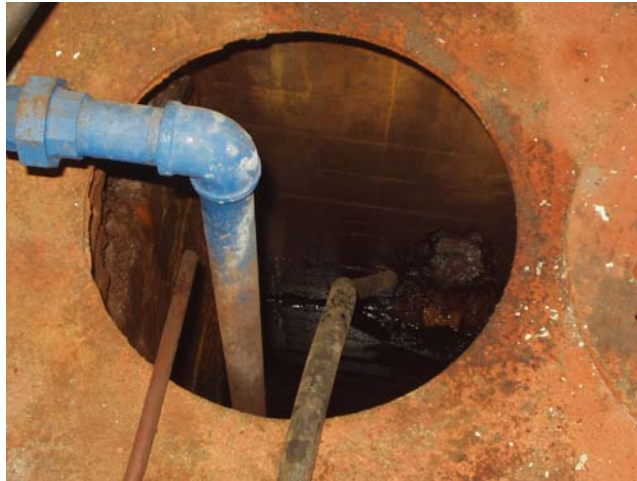
**Photograph 13. View of the sump located in the boiler room of the basement.**

EEC observed one floor drain in the air conditioning room on the second floor. EEC observed one floor drain in the auto maintenance lab room and one floor drain in the auto laboratory during the Site reconnaissance. Two additional floor drains were observed by EEC in the boiler room of the basement. According to Site personnel, these drains lead to a sump located in the boiler room of the basement, which was observed by EEC to be full of liquid during the Site reconnaissance. In addition, EEC observed one trench-style floor drain in the basement which leading to an adjacent sump also observed by EEC to be full of liquids during the Site reconnaissance located adjacent to the trench-style floor drain. According to Site personnel, drainage from the two sumps lead to the City of Pontiac's sanitary sewer system. The two sumps in the basement represent RECs.

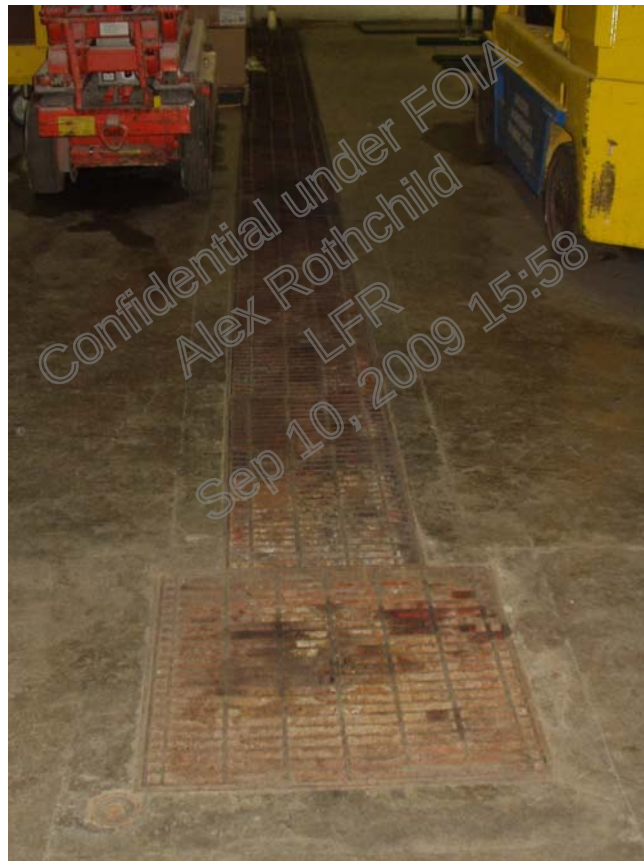
**Photograph 14. View of the trench drain and adjacent sump located in the basement.**

According to historical documentation, four trench-style floor drains existed on the first floor of the Site building. At the time of the Site reconnaissance, EEC observed two abandoned trench-style floor drains. One abandoned floor drain extended from the auto maintenance lab room to the auto laboratory, while the second was observed in the garage area. A third floor drain was located in the garage area, while the fourth was located where the main hallway exists that is currently covered with floor tile. No evidence of these two remaining trench-style floor drains was observed by EEC during the Site reconnaissance. Site personnel indicated that the former trench-style floor drains led to the sump in the boiler of the basement, which discharges to the City of Pontiac's sanitary sewer system.

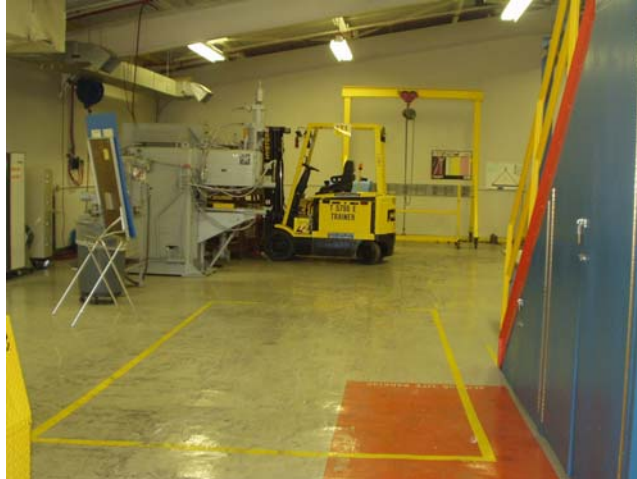
**Photograph 15. View of garage area in 1<sup>st</sup> floor where abandoned underground hydraulic lifts and floor drain were observed.**

According to historical documentation, eleven underground hydraulic lifts were installed in 1978 in the first floor of the Site building. At the time of the Site reconnaissance, EEC observed four abandoned underground hydraulic lifts in the garage area of the Site building. Site personnel were unaware if the remaining seven underground hydraulic lifts were abandoned or removed from the ground. A former dynamometer pit was formerly located in the northwest corner of the first floor. At the time of the Site reconnaissance, locations of four abandoned or former underground hydraulic lifts and the former dynamometer pit were in classrooms with carpeted floors. Evidence of the remaining three underground hydraulic lifts in the auto maintenance lab room was not observed by EEC during the Site reconnaissance. One dual-post aboveground electric lift was observed in the auto maintenance lab room at the time of the Site reconnaissance. Site personnel were unable to provide documentation regarding removal and/or abandonment dates or any sampling activities associated with the removal and/or abandonment of the underground hydraulic lifts or the former dynamometer pit. Therefore, each of the eleven abandoned or former underground hydraulic lift locations and the former dynamometer pit represent RECs.

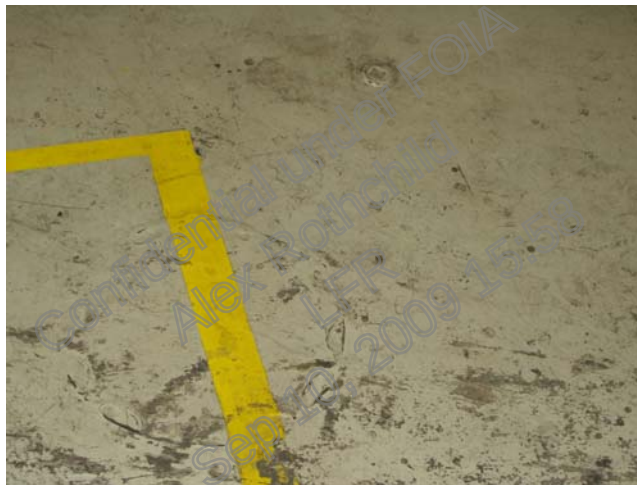
**Photograph 16. View of abandoned underground hydraulic lift and fill port in garage area.**

abandoned fill ports for hydraulic oil reservoirs were observed in the garage area. It is unknown if the eleven 50-gallon hydraulic oil reservoirs were removed from the ground or abandoned in place. RECs associated with the four abandoned underground hydraulic lifts and seven other abandoned or former underground hydraulic lifts are described in Section 2.1.5.

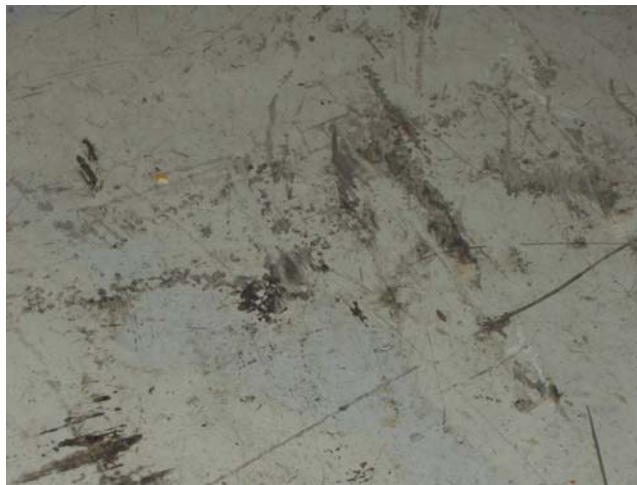
**Photograph 17. View of abandoned underground hydraulic lift in the garage area.**

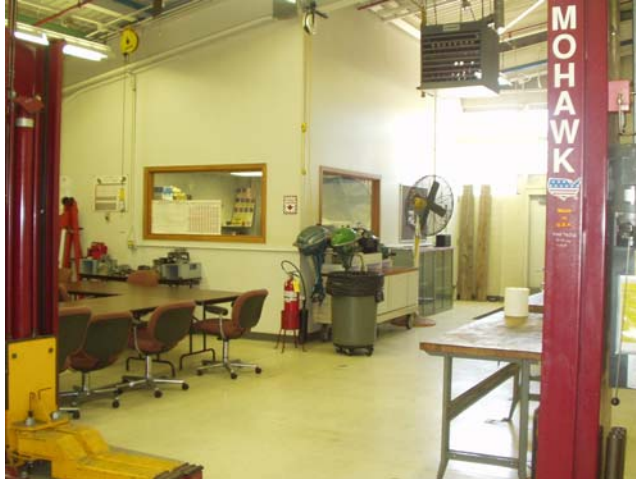
**Photograph 18. View of aboveground electric-hydraulic lift in auto maintenance lab room in the first floor.**

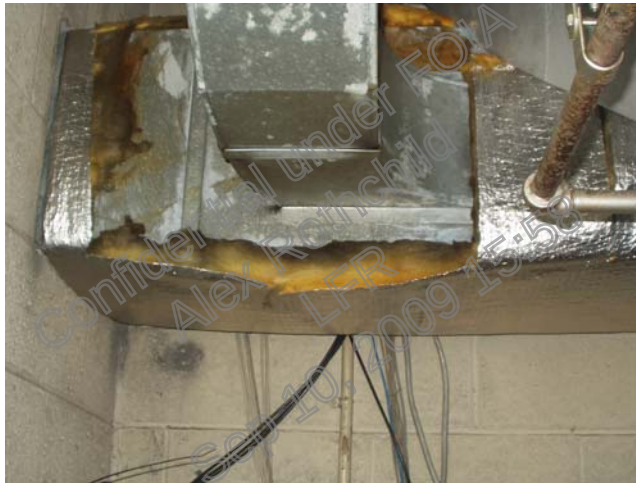
**Photograph 19. View of exposed and damaged suspect asbestos containing insulation in air conditioning room on the second floor.**

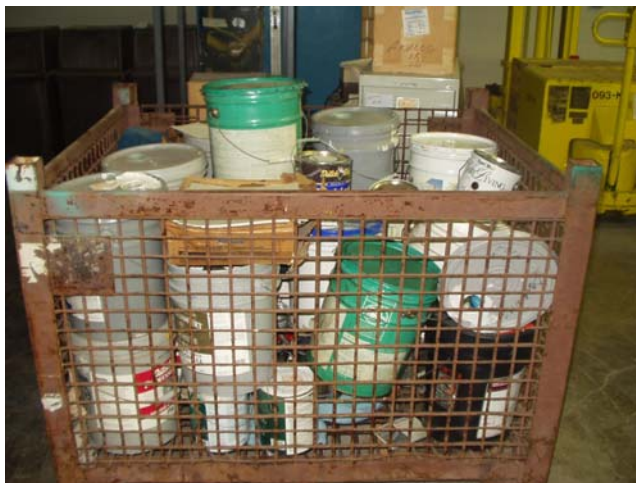
**Photograph 20. View of 1-gallon and 5-gallon cans of interior in the basement.**

Various petroleum and hazardous substances associated with Site activities are stored and used at the Site. These substances include parts washing fluids, hydraulic oil, elevator lubricator, and interior and exterior paint. In addition, knowledge of former Site activities and UST documentation indicates that gasoline, sulfuric acid, motor oil and other automobile fluids were used at the Site. EEC observed approximately ten one-gallon and fifteen five-gallon containers of interior and exterior paint in the basement of the Site building. Six one-gallon containers of elevator lubricants were observed in the compressor room in the basement. Two five-gallon containers of hydraulic oil were observed in the compressor room in the basement. Minor staining was observed in the vicinity of the elevator lubricant and hydraulic oil containers. However, the concrete in the area appeared to be in good condition with no evidence of significantly compromised integrity. Containers appeared to be properly stored and labeled at the time of the Site reconnaissance. According to Site personnel, once paint is utilized, empty paint cans are picked up by Environmental Recycling for proper disposal.
