**WETLAND DETERMINATION  
AND DELINEATION REPORT**

**THE 75.69± ACRE PROPERTY LOCATED  
Northwest of the Intersection of  
Denton Road and Ecorse Road  
Van Buren Township  
Wayne County, Michigan**

*Atwell-Hicks, LLC Project No. 06001622*

**December 15, 2006**

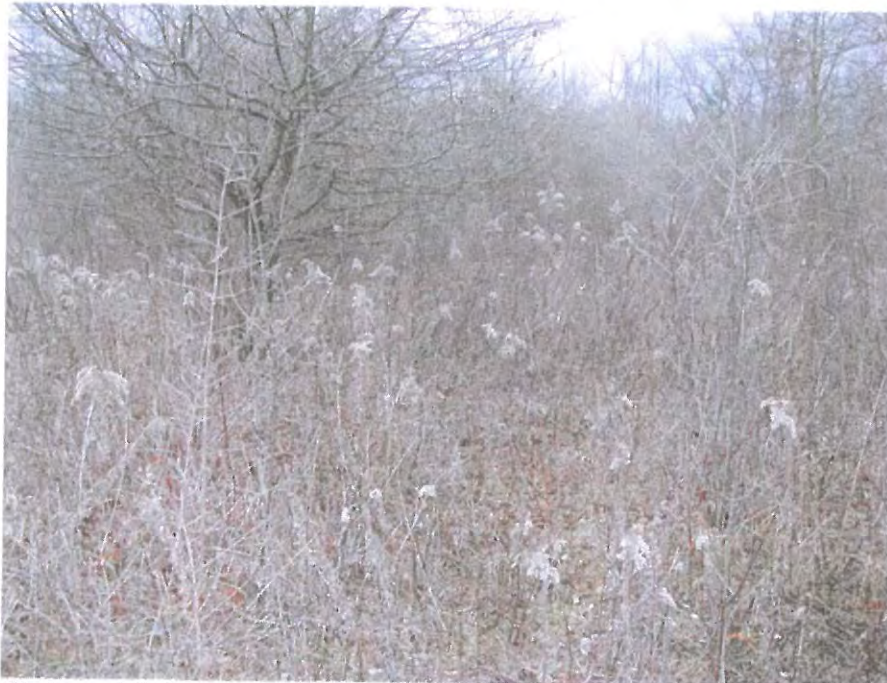
**Photograph 1:** Photograph of an area of old field in the northern portion of the property.  
Note the dense shrubs in the background, which were characteristic of the site.

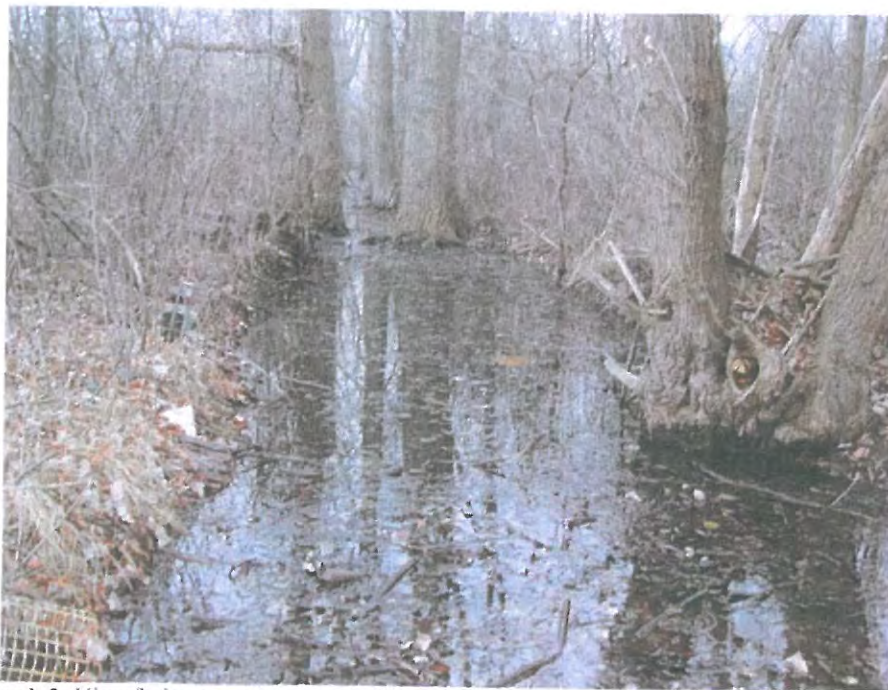
**Photograph 2:** View facing west (upstream) along the watercourse in the southern portion of the property.

plant to the west. The watercourse extended south and then east across the property. At Denton Road the watercourse connected to a roadside ditch that extends north-south before exiting the property via a culvert beneath the road. At the time of the delineation, approximately 6 to 8 inches of water was observed. The watercourse had a sediment bed and shallow banks.

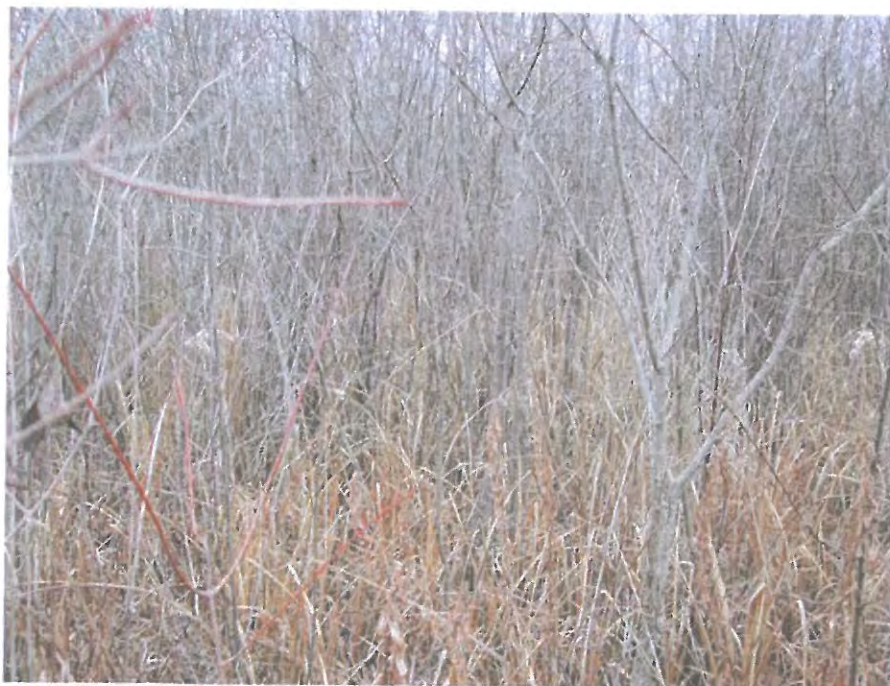
**Photograph 3:** Wetland A included areas of dense shrubs, including glossy buckthorn and silky dogwood.

Wetland A is a 4.84-acre multi-classified wetland located in the southern portion of the property. Refer to the *Wetland Location Map* in *Appendix III*. The wetland is associated with an unnamed watercourse that originates at the western property boundary, where it receives runoff from the

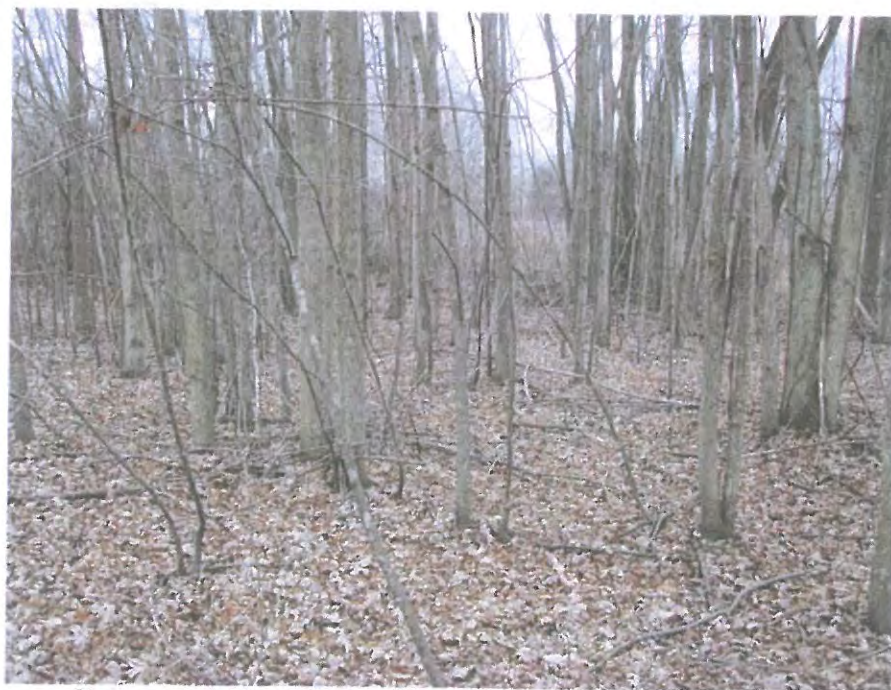
**Photograph 4:** View of Wetland B, which was dominated by silver maples.  
Note the watermarks and open understory.

Wetland B is an isolated 0.20-acre forested and scrub-shrub wetland located on the eastern side of the property. Refer to the *Wetland Location Map* in *Appendix III*. The forested portion consisted of a depressional pocket of silver maples (*Acer saccharinum*). The western side of the wetland included a portion of scrub-shrub wetland dominated by silky dogwood and glossy buckthorn. These species range in wetland indicator status from FAC+ to FACW+, which indicates that they typically occur in wetlands (see *Common Wetland Definitions*). Watermarks and a predominance of wetland vegetation provided evidence of hydrology. Runoff from the surrounding uplands and precipitation appear to provide the sources of hydrology, resulting in a seasonally inundated hydrologic regime.

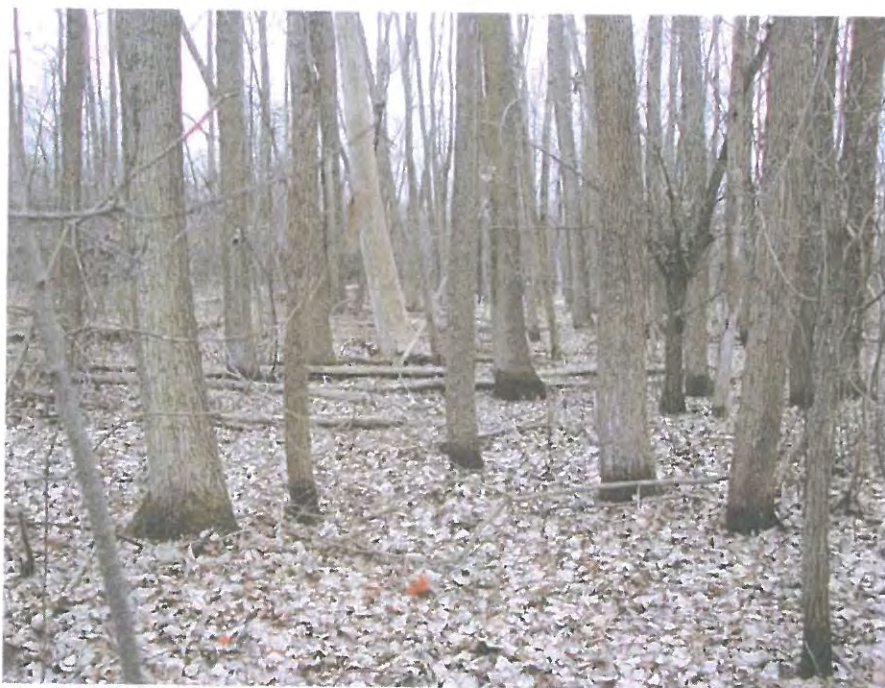
**Photograph 5:** The central portion of Wetland C consisted of a semi-mature wooded wetland.

Wetland C is a 1.89-acre forested/scrub-shrub wetland located in a depressional area on the eastern side of the property. Refer to the *Wetland Location Map* in *Appendix III*. The system consisted of forested wetland with a scrub-shrub fringe, which extended east to the roadside ditch along Denton Road. The central forested portion was dominated by eastern cottonwood and silver maple. This area contained mature trees with an open understory, and little herbaceous vegetation was observed other than fowl manna grass (*Glyceria striata*). Vegetation in the scrub-shrub portions included silky dogwood, redosier dogwood, gray dogwood (*Cornus foemina*), glossy buckthorn, young silver maples, goldenrods (*Solidago canadensis*, *S. gigantea*), purple loosestrife, reed canary grass (*Phalaris arundinacea*) and sedges (*Carex* spp.). The majority of these species range in wetland indicator status from FAC- to OBL, which indicates

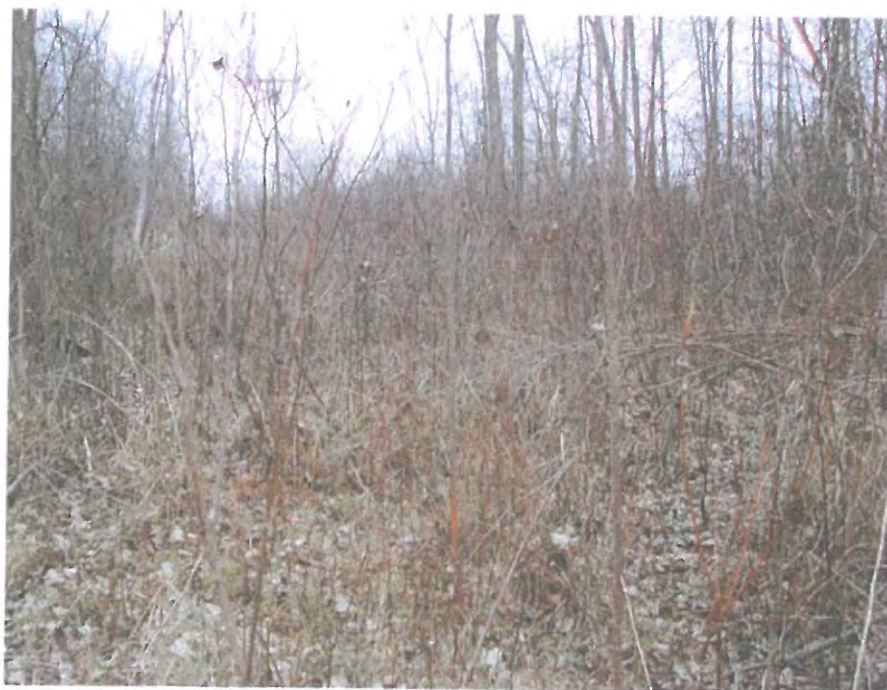
**Photograph 6:** The perimeter of Wetland C and the eastern portions near Denton Road possessed scrub-shrub characteristics.

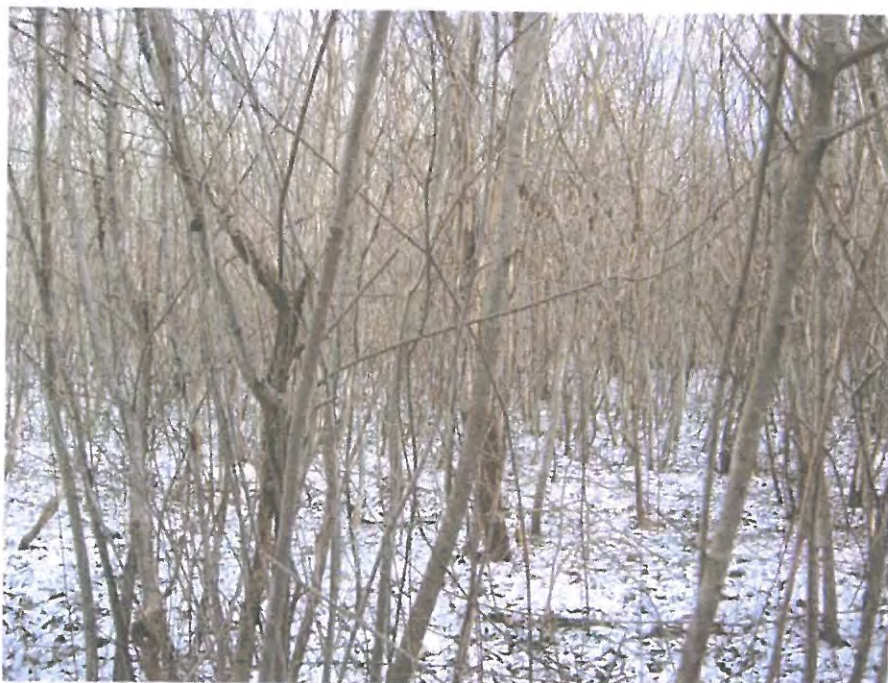
**Photograph 7:** Wetland D included portions of thickly vegetated scrub-shrub wetland.

Wetland D is a multiclassified 7.84-acre wetland that extends across the center of the property. Refer to the *Wetland Location Map* in *Appendix III*. The majority of the wetland consisted of scrub-shrub wetland dominated by glossy buckthorn. Additional species included silver maple, box elder (*Acer negundo*), and avens (*Geum* spp.). In contrast to the scrub-shrub wetland areas that contained excessively dense shrub vegetation, the central portion of the wetland was comprised of a semi-mature forested wetland with an open understory. Eastern cottonwood, red maple, silver maple and American elm were the dominant canopy species. The southeast corner of the wetland extends into a disturbed open area where a building was located historically. This portion of the wetland would be characterized as wet meadow wetland. Observed vegetation includes purple loosestrife, reed canary grass, cattails (*Typha* spp.), water plantain (*Alisma plantago-aquatica*), grass-leaved goldenrod, soft rush (*Juncus effusus*), and beggar-ticks (*Bidens frondosus*). These species range in wetland indicator status from FAC+ to OBL, which indicates that they typically occur in wetlands (see *Common Wetland Definitions*).

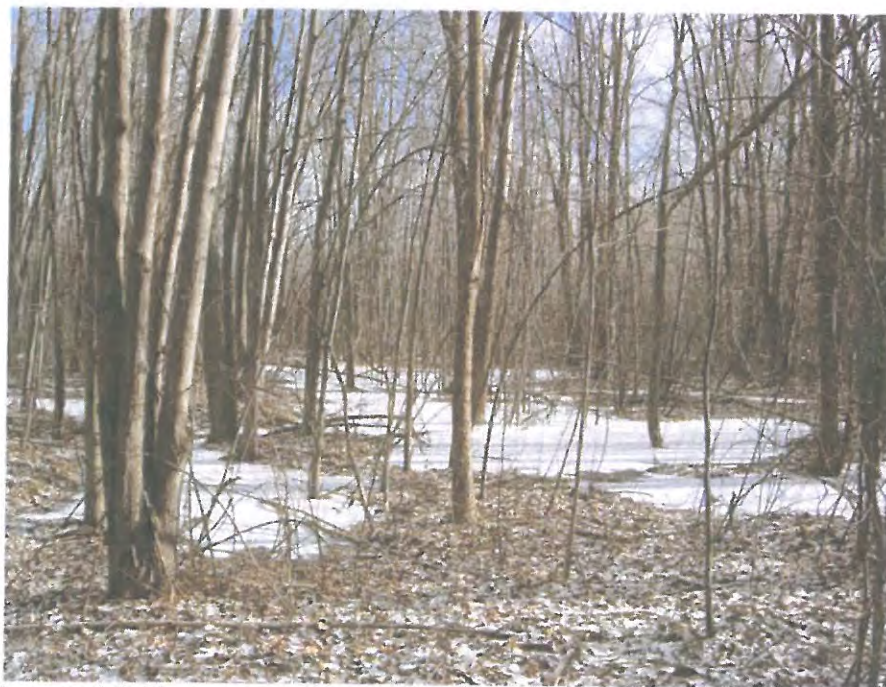
**Photograph 8:** The west-central portion of Wetland D was forested with an open understory.

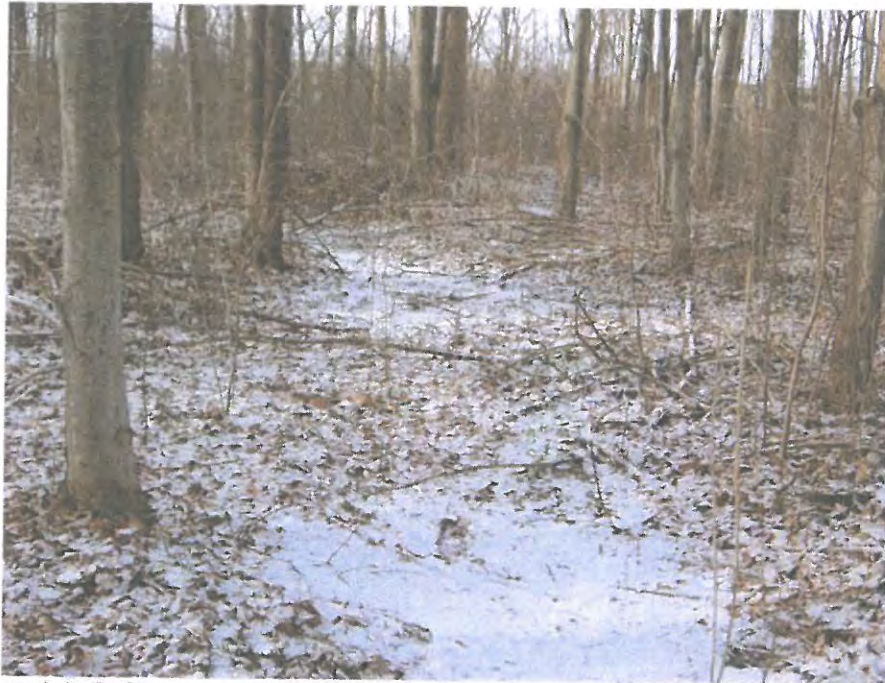
**Photograph 9:** Facing west across Wetland E. Pockets of ice provided evidence of wetland hydrology.

Wetland E is a 0.41-acre forested wetland located on the western side of the property. Refer to the *Wetland Location Map* in *Appendix III*. This wetland possessed characteristics similar to the semi-mature forested portions of Wetland D. The dominant vegetation included Eastern cottonwood, red maple, silver maple and American elm. These species range in wetland indicator status from FAC to OBL, which indicates that they typically occur in wetlands (see *Common Wetland Definitions*). Small amounts of young glossy buckthorn were present, but otherwise the understory was relatively open. Pockets of inundation and ice provided evidence of hydrology, which appears to be provided from precipitation and runoff. The wetland is likely seasonally inundated.

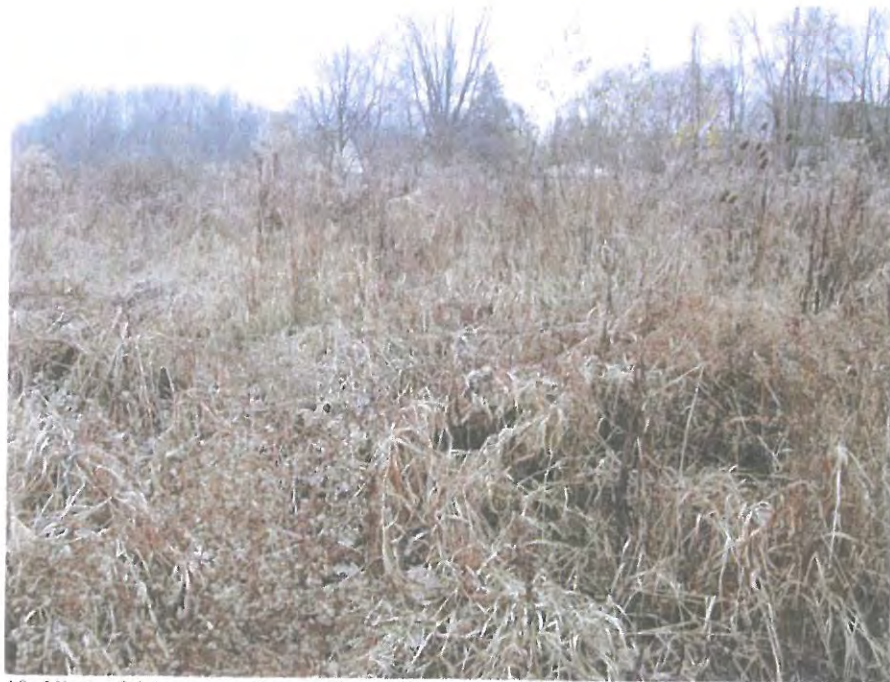
**Photograph 10:** View of the wet meadow portion of Wetland F. The railroad tracks that form the northern property boundary separate the wetland from the residential development farther north.

Wetland F is a 5.28-acre multiclassified wetland located along the northern property boundary. The northern portion of the wetland extends along the railroad tracks through a utility corridor. Dominant vegetation in this area was characteristic of wet meadow wetland, including reed canary grass, purple loosestrife, grass-leaved goldenrod, sedges, spotted joe-pye-weed (*Eupatorium maculatum*) and blue vervain (*Verbena hastata*). A pocket of forested wetland extended south from the utility corridor in the northeast corner of the property. This depressional area was dominated by cottonwood, red maple and boxelder. To the west, the wetland possessed characteristics of scrub-shrub wetland. Young red maple and silver maple, glossy buckthorn, and sensitive fern (*Onoclea sensibilis*) were present. These species range in wetland indicator status from FAC to OBL, which indicates they typically occur in wetlands (see *Common Wetland Definitions*).

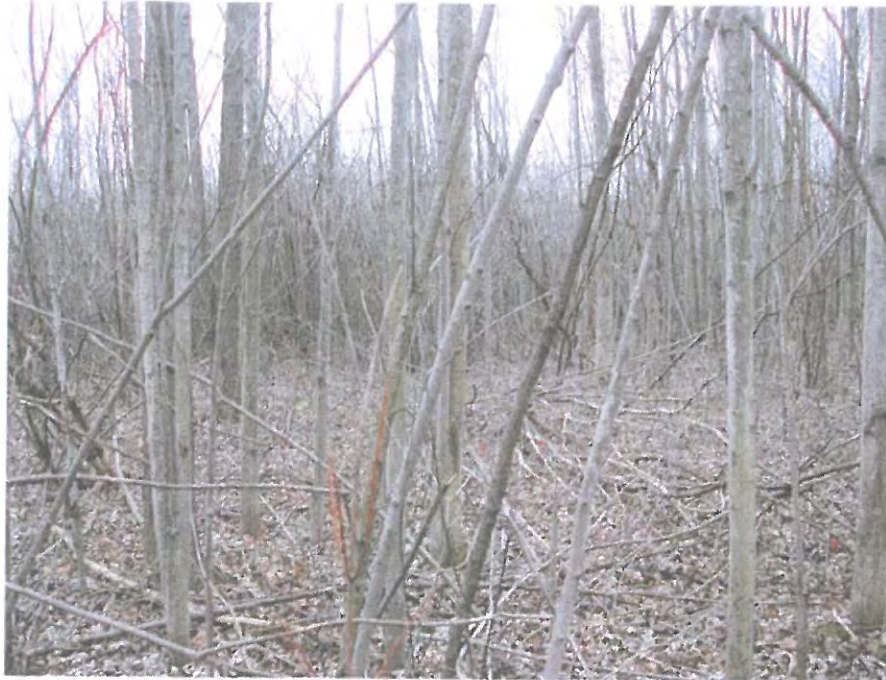
Photograph 11: View of the scrub-shrub portion of Wetland F dominated by young maples and glossy buckthorn.

As stated previously, the northern portion of the site drains to the north. In the more southern scrub-shrub portions of the wetland, surface water runoff and precipitation appear to be retained by the thick shrub cover, resulting in seasonal saturation and inundation. Significant amounts of water collect within the utility corridor, forming a drainage swale at the base of the railroad tracks. In this area the hydrology appears to be seasonally inundated.

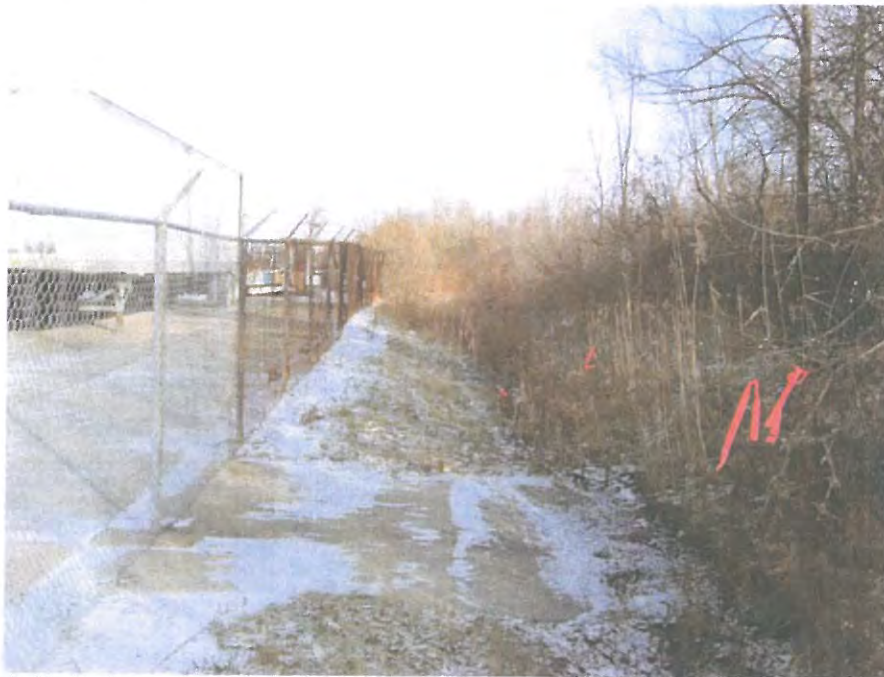
Photograph 12: Facing north at Wetland G, which receives runoff from the plant west of the subject property.

Wetland G is a small, 0.01-acre, wet meadow wetland located along the western property boundary in the northern portion of the property. This linear wetland is located within a swale that appears to receive water from the General Motors plant to the west, most likely associated with the stormwater management pond located behind the plant buildings. Purple loosestrife, common reed (*Phragmites australis*), horsetail (*Equisetum* spp.), cattails and willows (*Salix* spp.) were the dominant vegetation. These species range in wetland indicator status from FAC to OBL, which indicates that they typically occur in wetlands (see *Common Wetland Definitions*). The wetland is likely inundated seasonally, as well as after large storm events when runoff from the west increases. A predominance of wetland vegetation and saturated soils provided evidence of wetland hydrology.
