RE: Windiate Park/Dixieland Subdivision Landfill, Pengelly Road Site, Genesee County, Michigan  
(Site ID No. 25000689)

FILE: 1088190/1940102168 - Soil Cover Inspection Report

## WINDIATE PARK SOIL COVER MAINTENANCE CHECKLIST

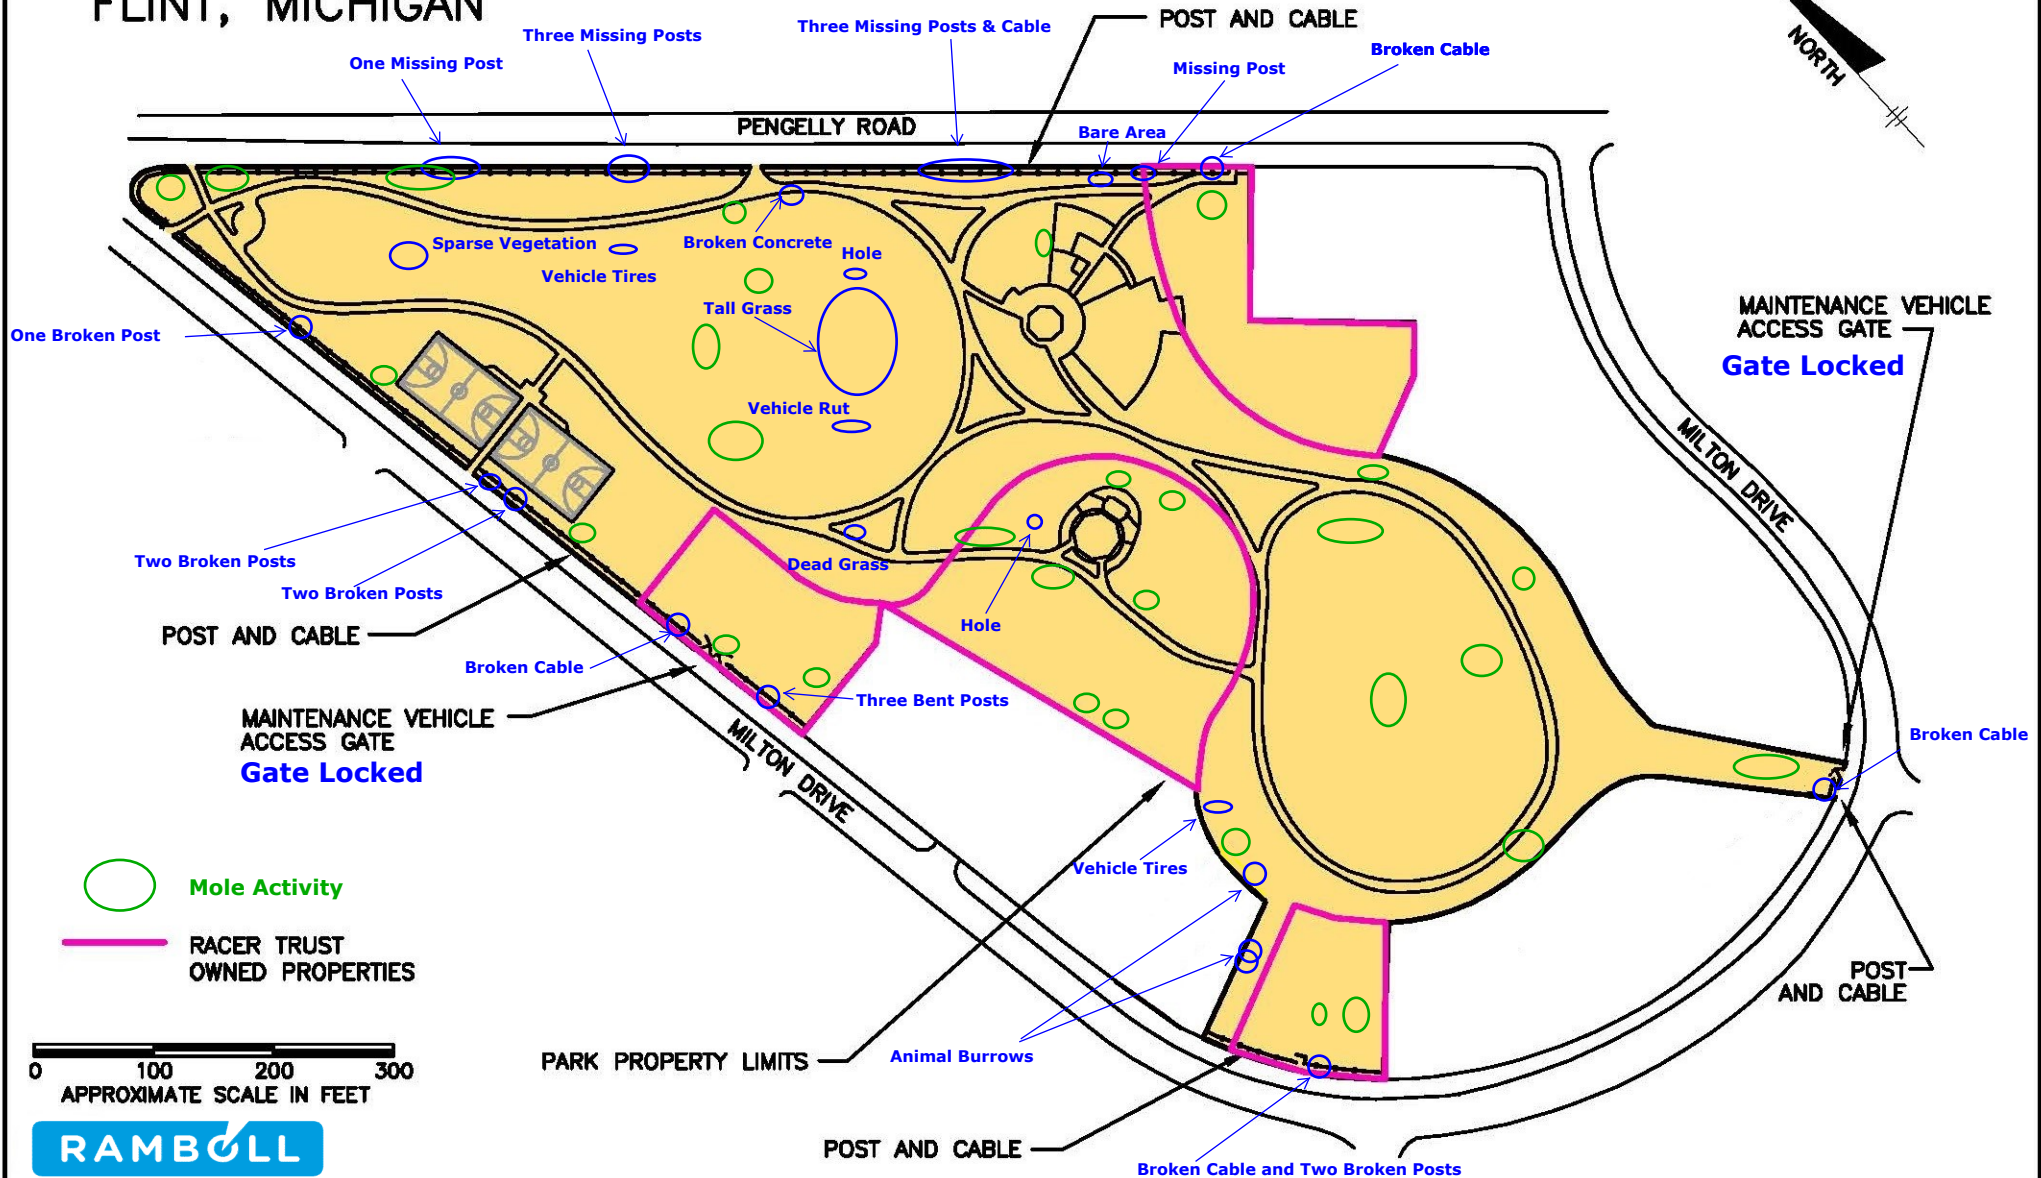
# INSPECTION MAP

| Inspected Item: | Comments: |
|---|---|
| POST & CABLE / VEHICLE GATES | Approximately ten damaged posts were observed during the site inspection (either partially down or completely down). Approximately eight posts were missing. Approximately five sections of down cable were observed. The south and west maintenance vehicle access gates were locked. |
| OTHER OBSERVATIONS | A number of mole mounds and/or trails were observed. Unable to determine if the mounds are from recent activity or from older activity. Two animal burrows were observed. At one burrow an entry and exit were observed and at the other burrow only an entry was observed. Attempts have been made to manage the burrows, but additional efforts may be needed to remove the animals if burrows are still active. No signs of waste were observed in the animal burrow spoils. One section of concrete was observed where the concrete collapsed around manhole on sidewalk along Pengelly Road. Vehicle ruts were observed near the area with tall vegetation. Two other locations on the City of Flint property had vehicle tracks present with minimal rutting. |

Grass has been mowed

Add grass seed to area of sparse vegetation.  
Manage animal burrows.  
Replace cable and posts that are missing or damaged.
