**RESOURCE CONSERVATION AND RECOVERY ACT  
CURRENT CONDITIONS SUMMARY / FACILITY  
INVESTIGATION WORK PLAN FOR THE**

**FORMER GM POWERTRAIN DIVISION LIVONIA  
12200 MIDDLEBELT ROAD, LIVONIA, MICHIGAN**

**Haley & Aldrich of Michigan, Inc.  
Ann Arbor, Michigan**

**File No. 37290-009  
29 December 2011**

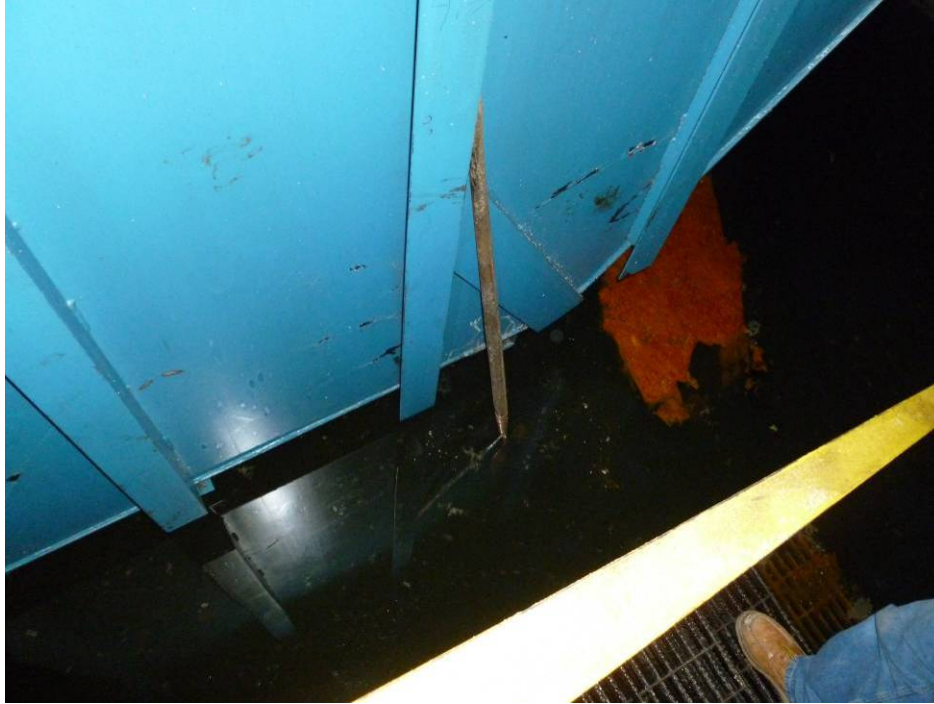
*Photograph 1. (AOI-02) South Gallery, west side, sub-basement. Note level of water accumulated in basement, approximately 12" to 18" deep with possible oil and coolant content.*

| AOI # | AOI Title | Location Column/Bay | AOI Source | Description / Components | Photos | Materials Managed | Further Action Recommended (Yes or No) | General Description of Further Action | | | | |
|---|---|---|---|---|---|---|---|---|---|---|---|---|
| 02 | South Gallery | D23-M23 x D2-M20 | Site walk /Facility drawings | Management of metal grinding, coolant, lubricant, cutting fluid | Photographs: 1 - 5 | Metals, oils, cutting fluid, coolant | Yes | | | | | |

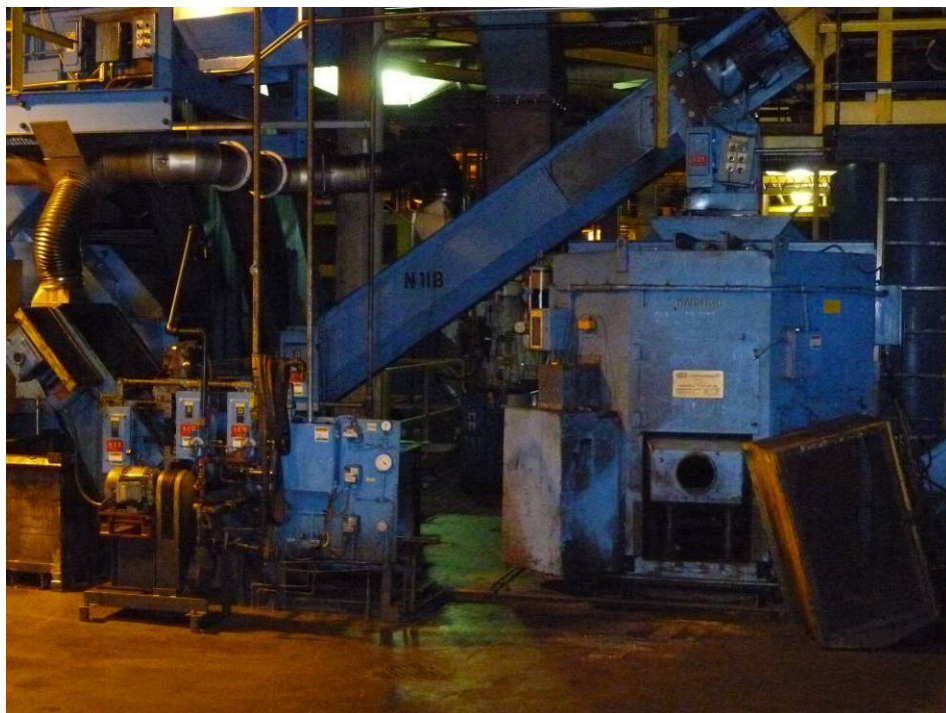
*Photograph 2. (AOI-02) South Gallery, west side. Oily residue on honing/chip processing equipment. Oily residue also observed on floor surrounding equipment.*

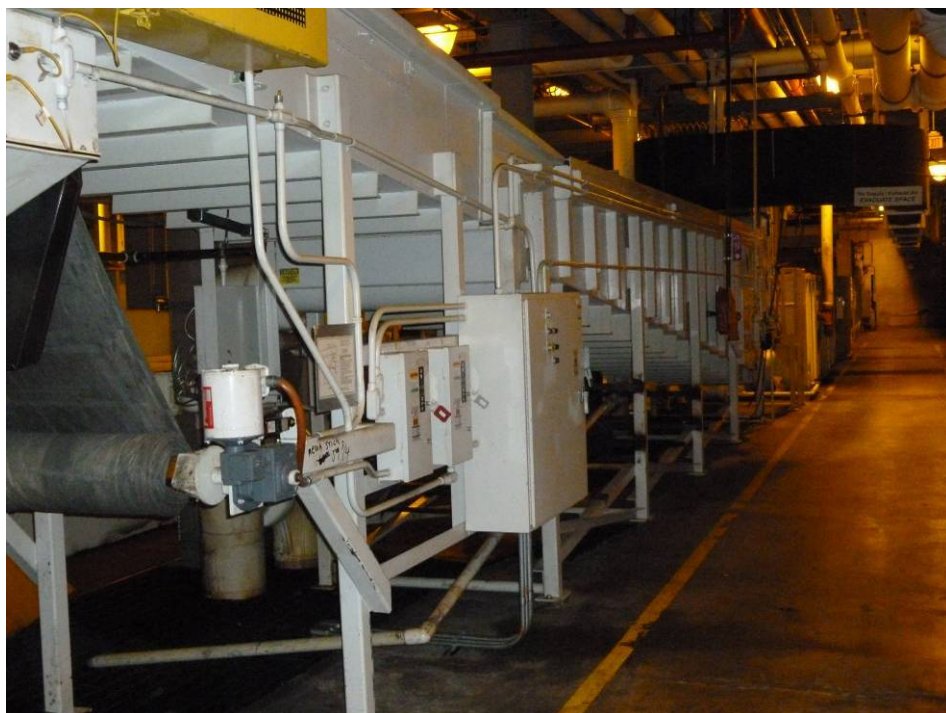
*Photograph 4. (AOI-02) South Gallery, east side. Block grinding equipment.*

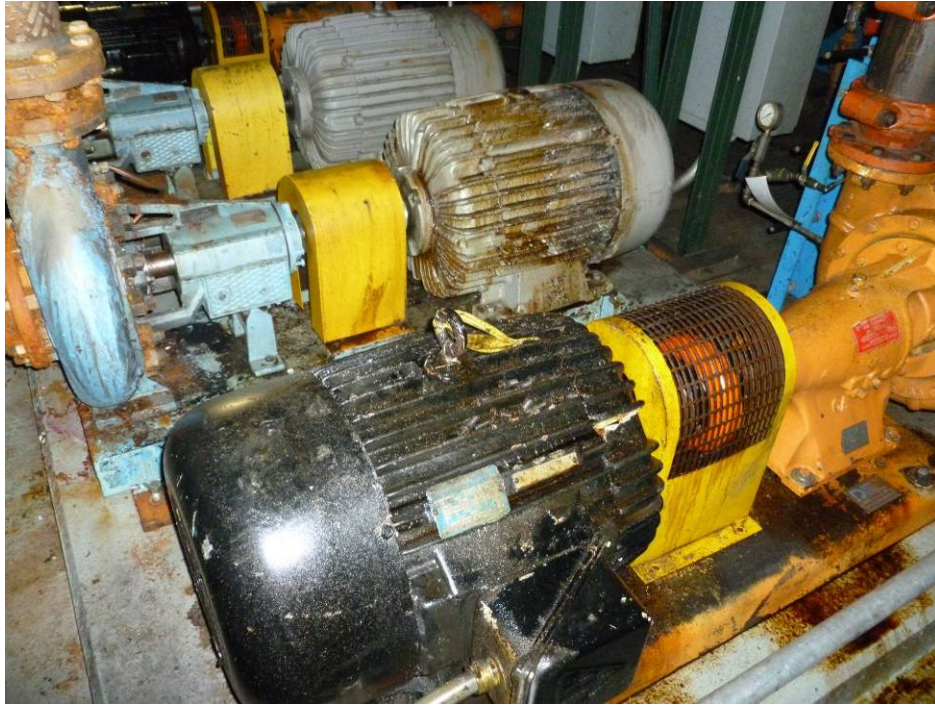
*Photograph 9. (AOI-04) East Gallery. Oily residue on rod machining equipment.*

| AOI # | AOI Title | Location Column/Bay | AOI Source | Description / Components | Photos | Materials Managed | Further Action Recommended (Yes or No) | General Description of Further Action | | | | |
|---|---|---|---|---|---|---|---|---|---|---|---|---|
| 04 | East Gallery | M14-P14 | Site walk /Facility drawings | Management of metal grindings, coolant, lubricants, cutting fluid | Photographs: 8 - 11 and 90 - 91 | Metals, oils, cutting fluid, coolant | Yes | 4 | 4 | 4 | 4 | None |

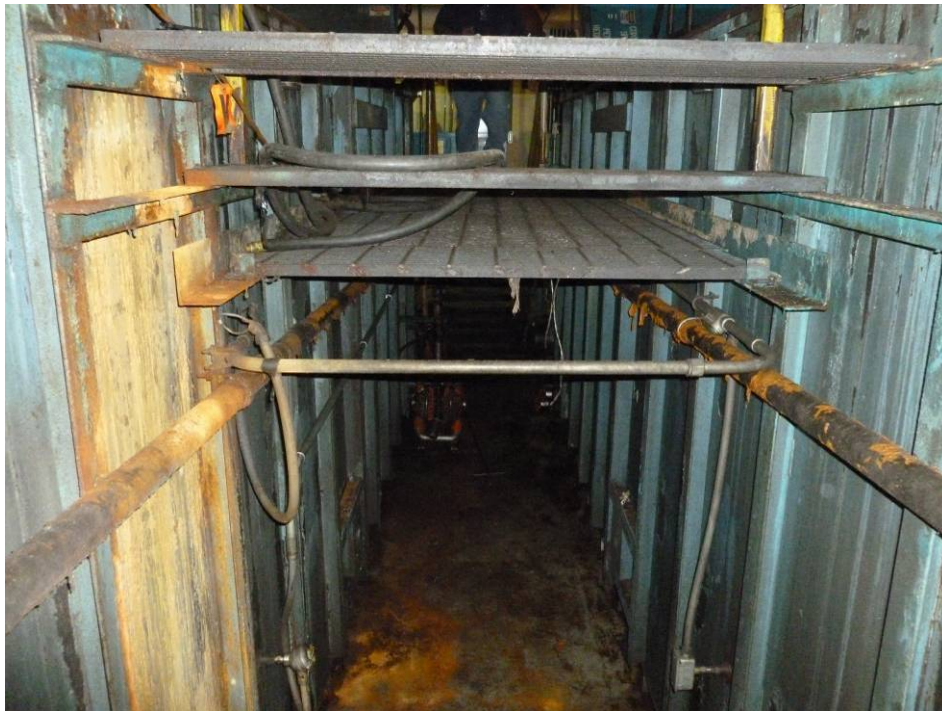
*Photograph 10. (AOI-04) East Gallery. Sub-basement.*

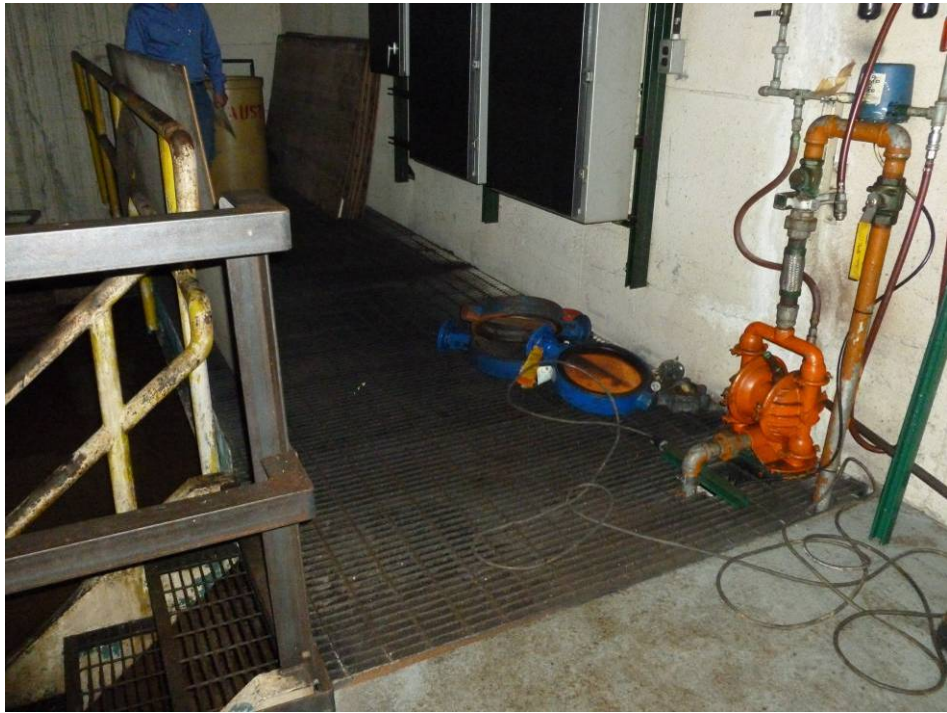
*Photograph 11. (AOI-04) Sump located in southeast area of East Gallery.*

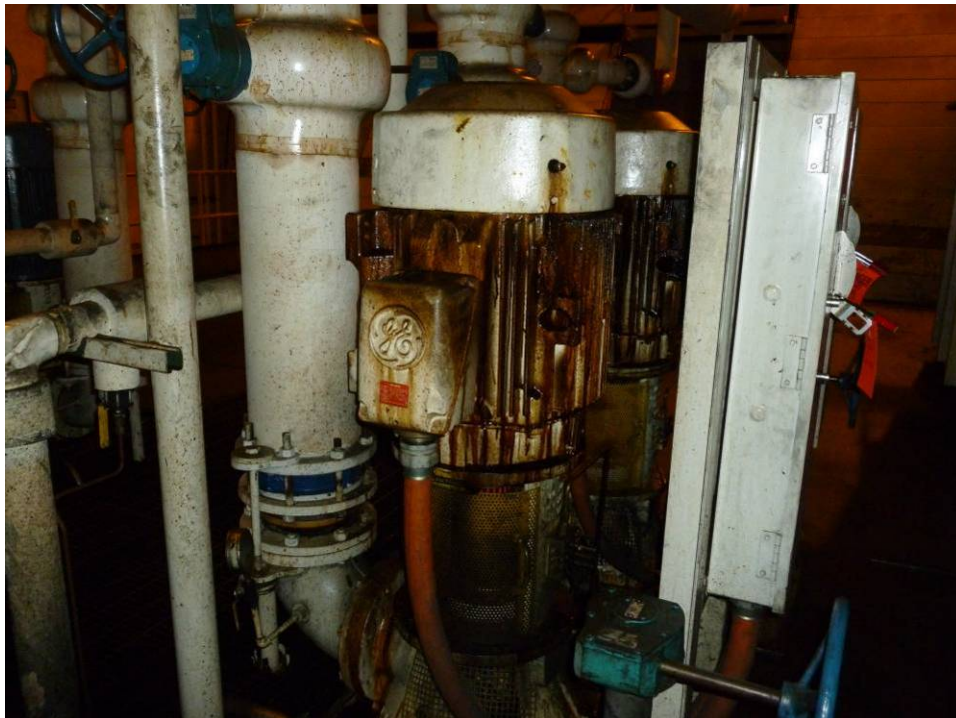
*Photograph 14. (AOI-06) West Gallery. Oily residue on crank shaft machining equipment.*

| AOI # | AOI Title | Location Column/Bay | AOI Source | Description / Components | Photos | Materials Managed | Further Action Recommended (Yes or No) | General Description of Further Action | | | | |
|---|---|---|---|---|---|---|---|---|---|---|---|---|
| 06 | West Gallery | D3-E13 | Site walk /Facility drawings | Management of metal grindings, coolant, lubricants, cutting fluid | Photographs: 12 - 16 | Metals, oils, cutting fluid, coolant | Yes | 4 | 4 | 4 | 4 | None |

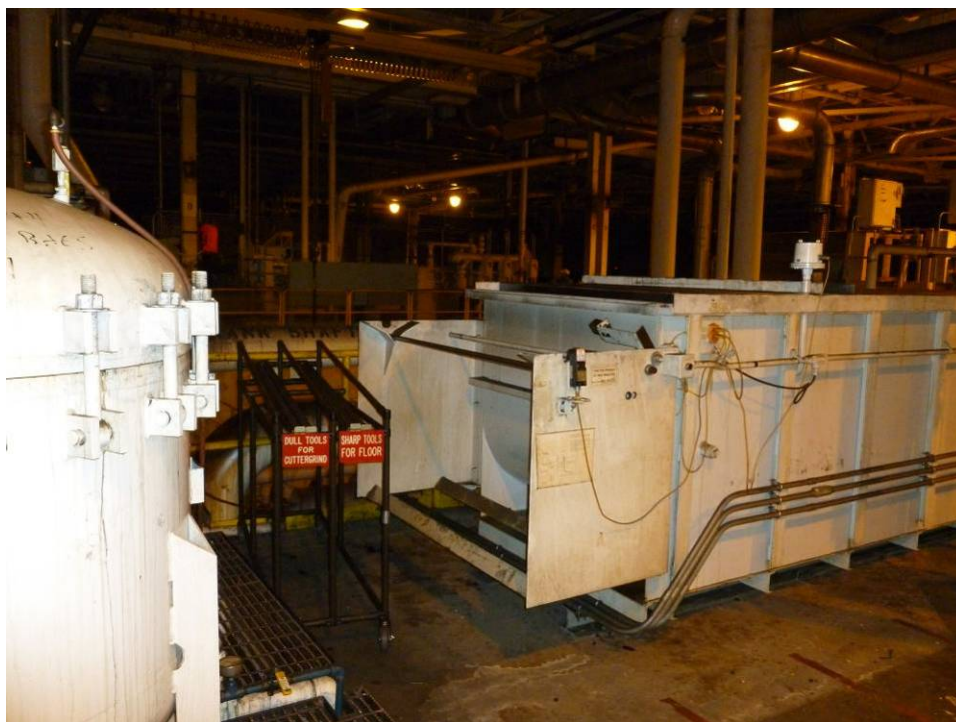
*Photograph 16. (AOI-06) Equipment in West Gallery.*

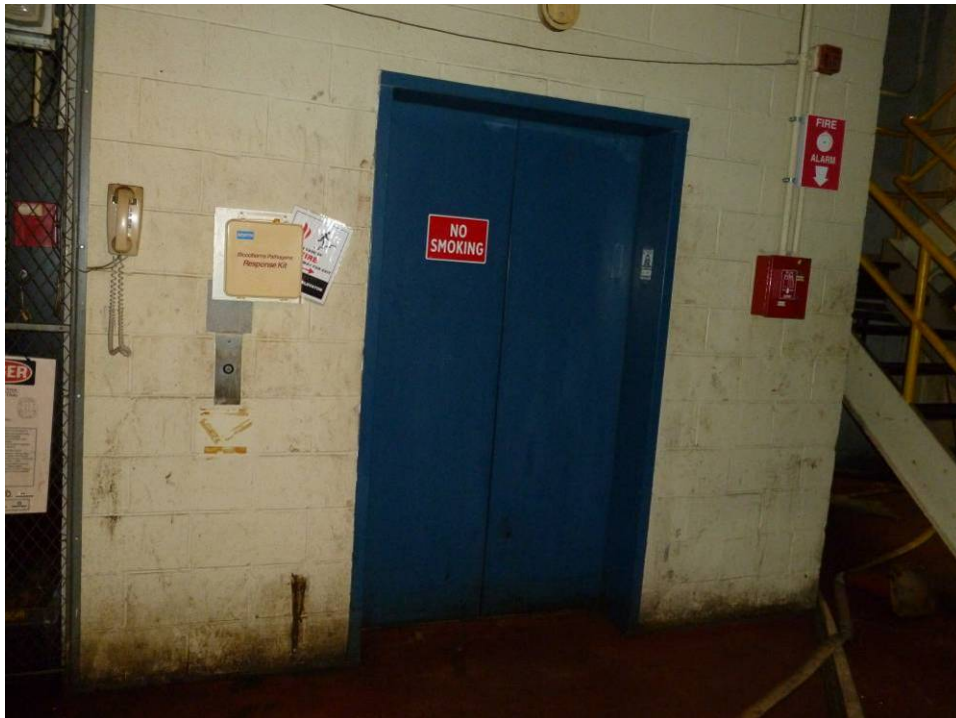
*Photograph 18. (AOI-33) Elevator in Wastewater Treatment Plant. Photo taken in basement level of WWTP.*

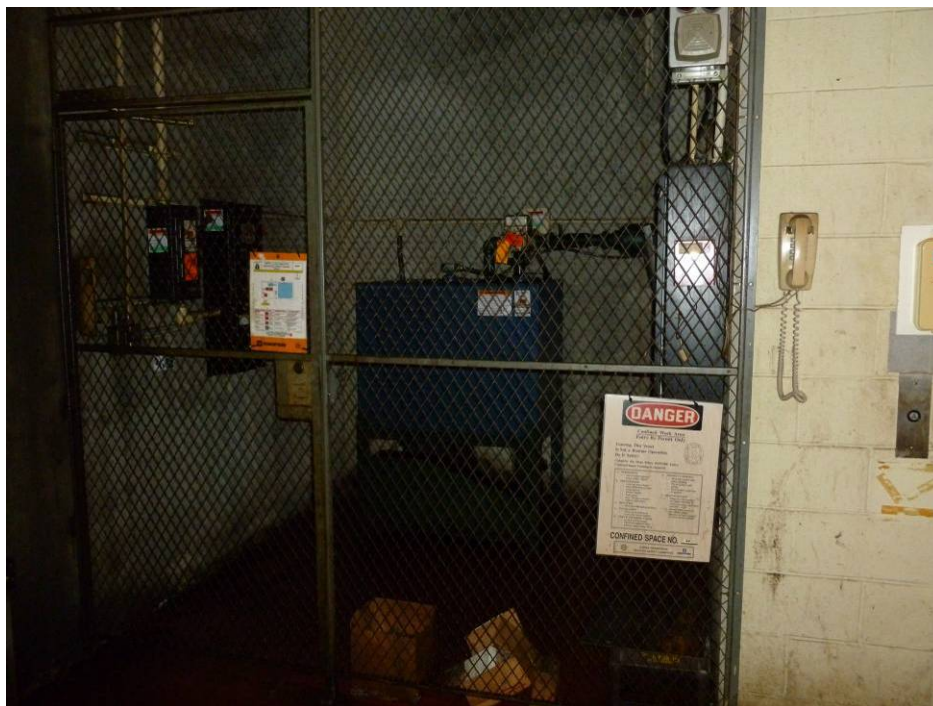
*Photograph 19. (AOI-33) Control room for WWTP elevator.*

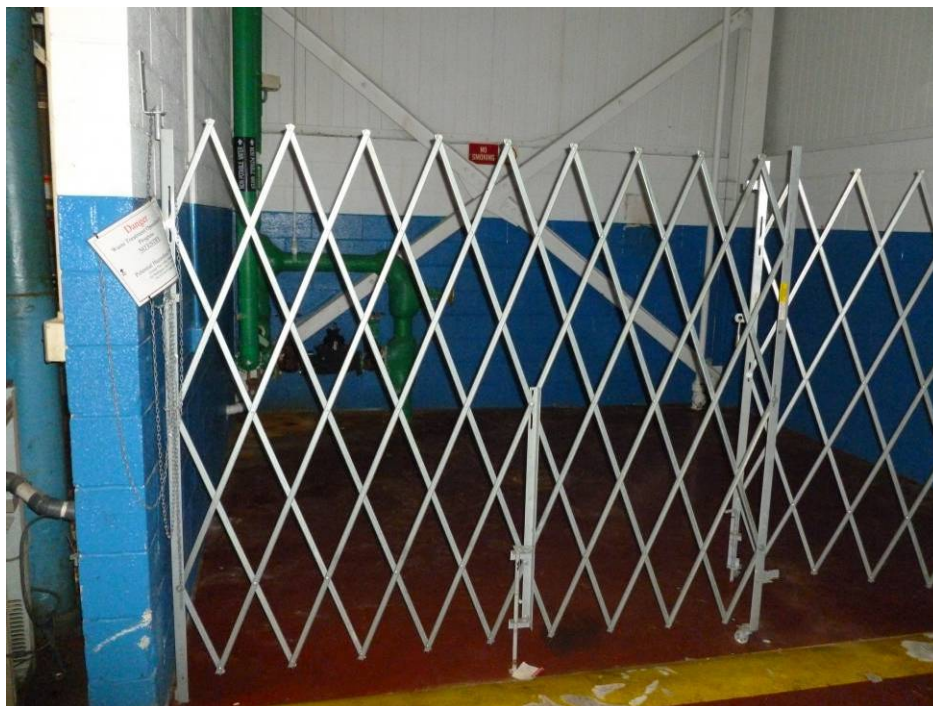
*Photograph 20. (AOI-33) Coolant storage tanks in WWTP. Note evidence of release near floor drain in foreground.*

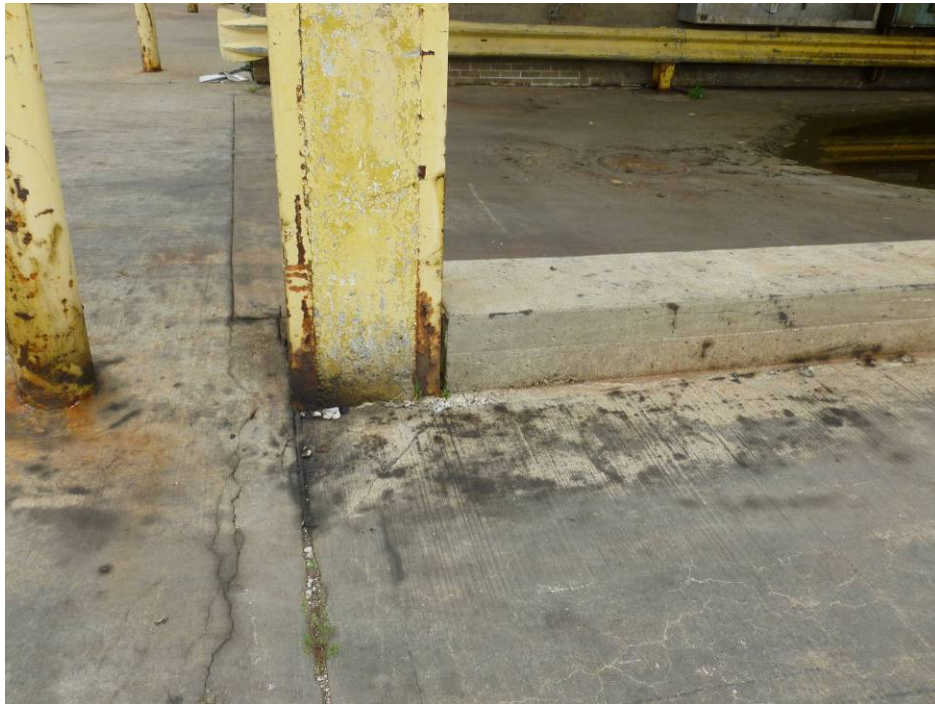
*Photograph 22. (AOI-33) WWTP wash pad. Photo taken facing east.*

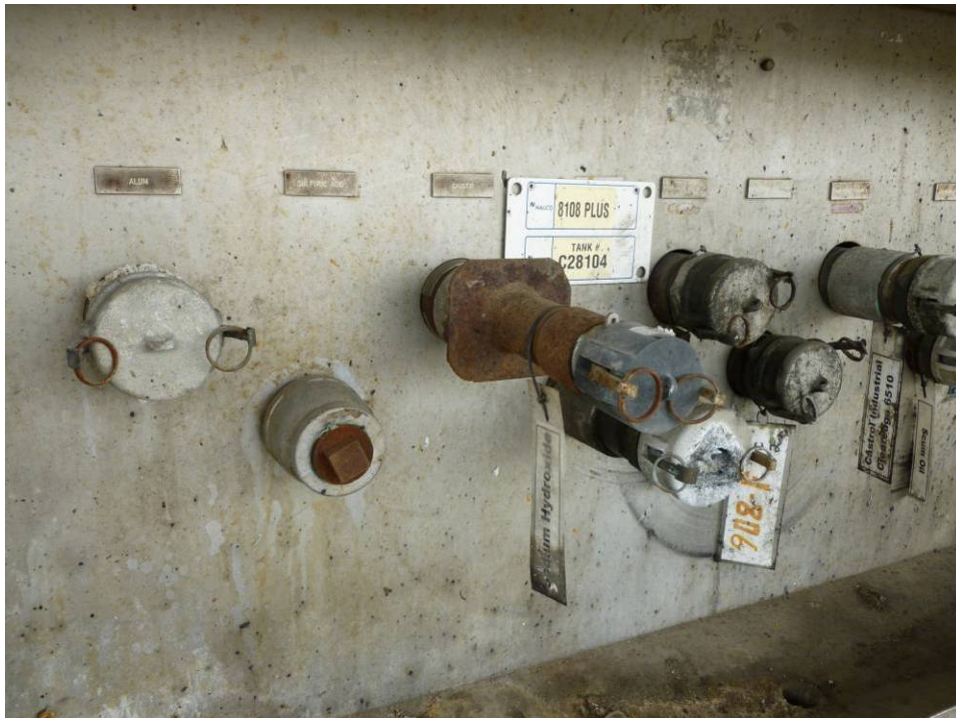
*Photograph 23. (AOI-33) Wash pad located exterior to WWTP, north. Note staining.*

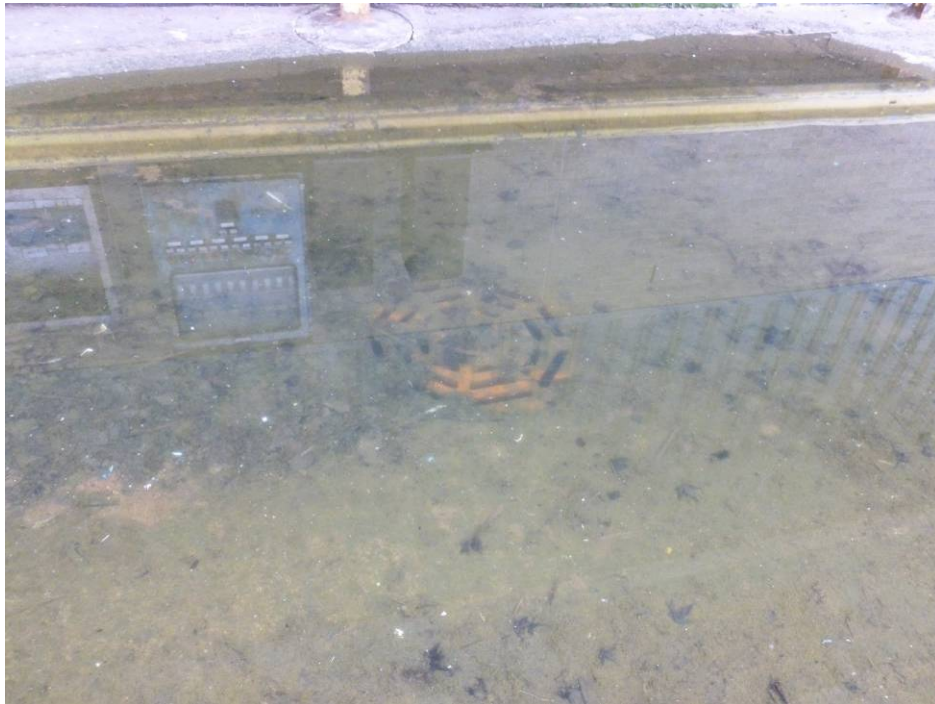
*Photograph 25. (AOI-33) Drain located within wash pad, exterior north side of WWTP.*

| AOI # | AOI Title | Location Column/Bay | AOI Source | Description / Components | Photos | Materials Managed | Further Action Recommended (Yes or No) | General Description of Further Action | | | | |
|---|---|---|---|---|---|---|---|---|---|---|---|---|
| 33 | WWTP main building and exterior wash pad | Northeast portion of site | Site walk /Facility drawings | Basement constructed beneath majority of WWTP main building. Basement may extend 20' below grade. Sumps are constructed in basement | Photographs: 17 - 20, 22 - 26 | Process waste, alkaline cleaners, laboratory waste | Yes | 4 | 4 | 4 | 4 | Administrative investigation/Locate and review facility drawings; Intrusive work pending. |

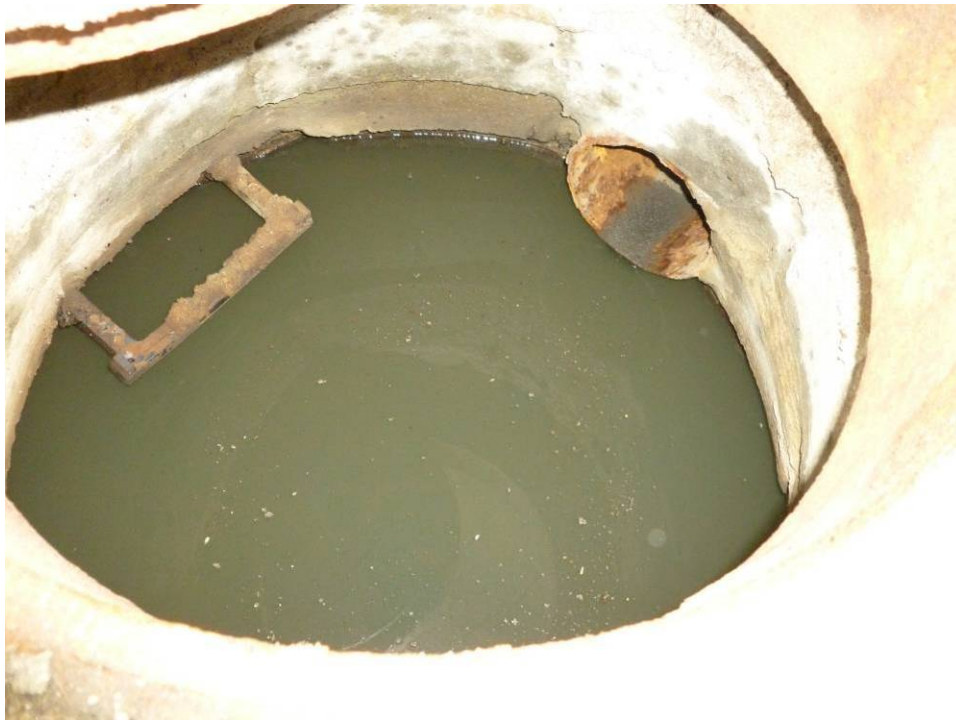
*Photograph 26. (AOI-33) Drain located within wash pad. Removed cover to take photo.*

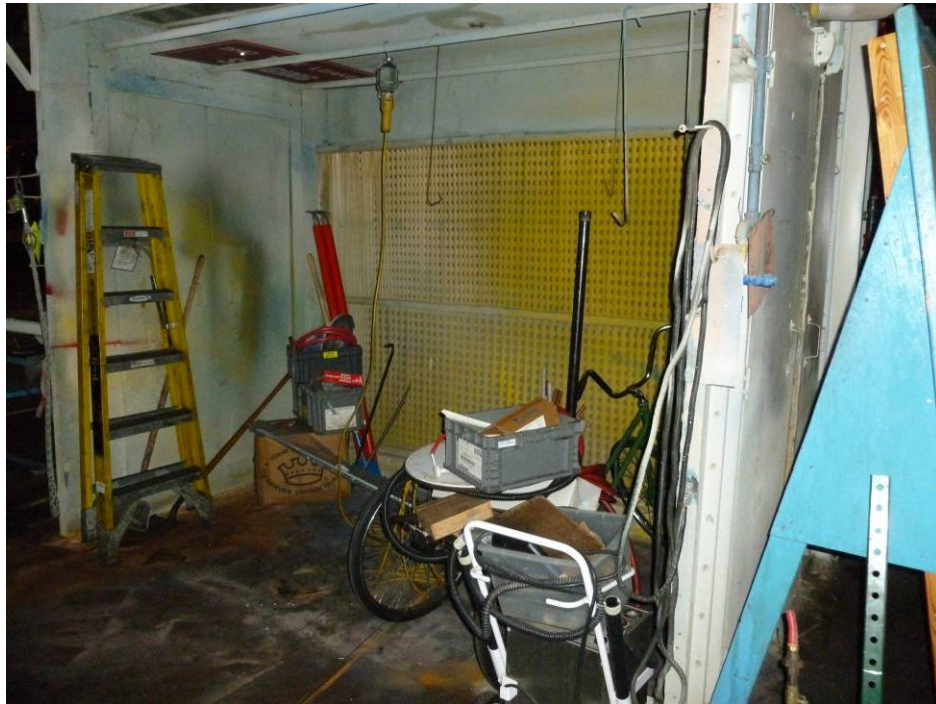
*Photograph 27. (AOI-26) Paint booth near Columns D20/D21. Interior view of paint booth.*

| AOI # | AOI Title | Location Column/Bay | AOI Source | Description / Components | Photos | Materials Managed | Further Action Recommended (Yes or No) | General Description of Further Action | | | | |
|---|---|---|---|---|---|---|---|---|---|---|---|---|
| 26 | Paint booth area | D20/D21 | Site Walk / Drawing Review - Tetra Tech site plan material storage areas, 10/22/07; Arcadis report refers to "Tank 8" | Paint booth observed with signage "Only aerosol can spraying". No floor drains observed in area. Sump covers located approximately 20' west of booth, 18' east of booth. Arcadis report refers to paint reserve "Tank 8". Location is not described. | Photographs: 27 and 28 | Paint-related material | Yes | See AOIs 01, and 02 | | | | GPR to locate possible "Tank 8" |

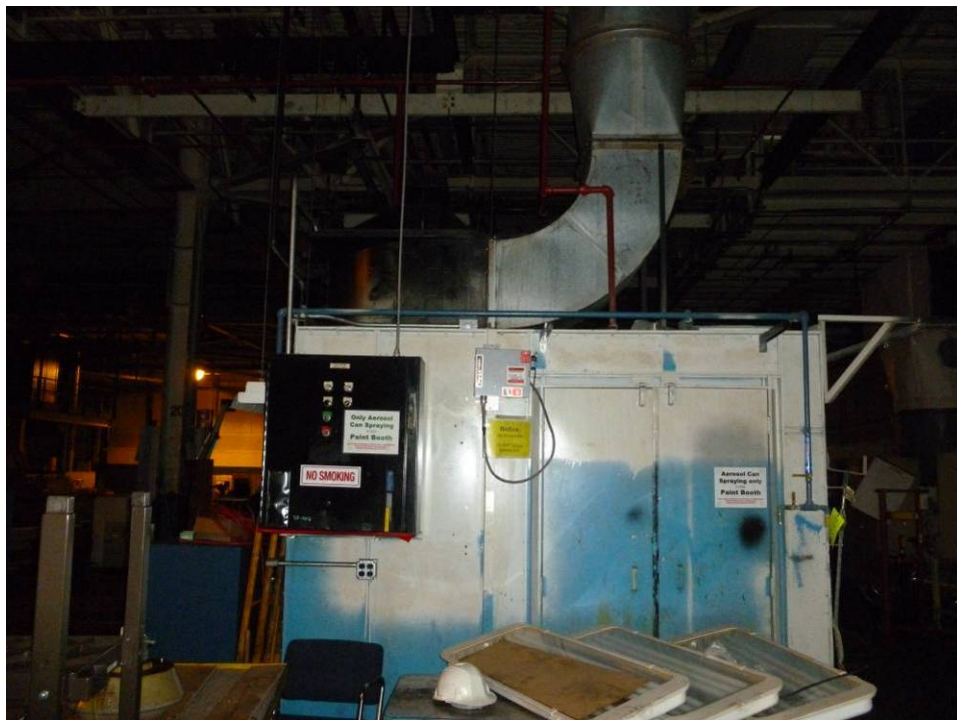
*Photograph 28. (AOI-26) Paint booth near Columns D20/D21. Exterior view of paint booth.*

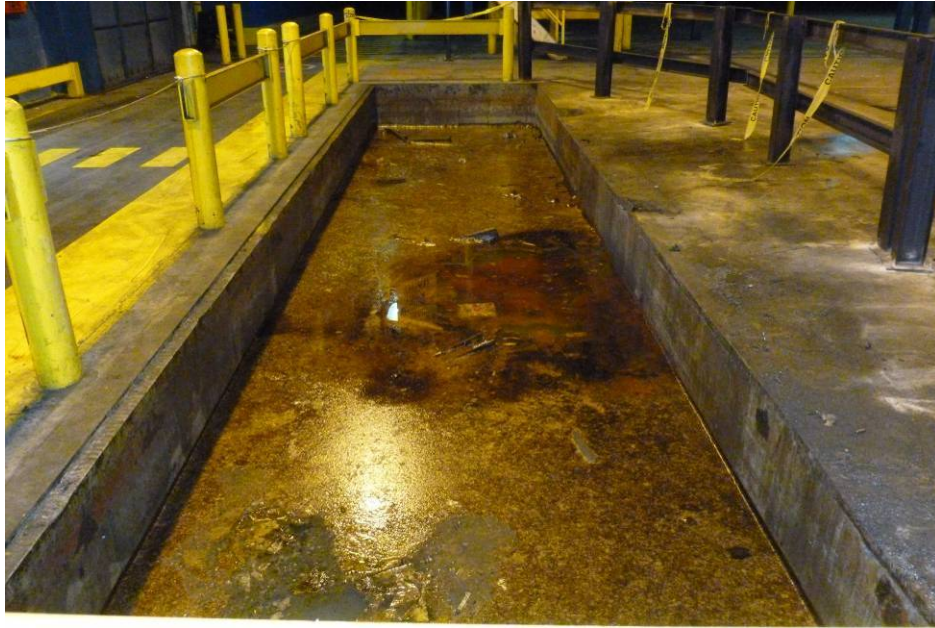
| AOI # | AOI Title | Location Column/Bay | AOI Source | Description / Components | Photos | Materials Managed | Further Action Recommended (Yes or No) | General Description of Further Action | | | | |
|---|---|---|---|---|---|---|---|---|---|---|---|---|
| 14 | Equipment pit - containment beneath heavy equipment | A3-B3 | Site walk /Facility drawings | Containment beneath heavy equipment. Slopes downward toward south end of feature. Approximately 6" of oily/coolant water toward south end, 2-4" of oil/coolant water at north end of feature. Outlets located in south and east corners. Poured concrete. Minor cracking in side walls. A shallow trench drain is located south of this AOI. | Photographs: 29 and 30 | Metals, oils, cutting fluid, coolant | Yes | 2 | 2 | 2 | 2 | None |

*Photograph 29. (AOI-14) Equipment Pit near Columns A3/A2. Note oily coolant/water remaining in pit. Photo taken facing south.*

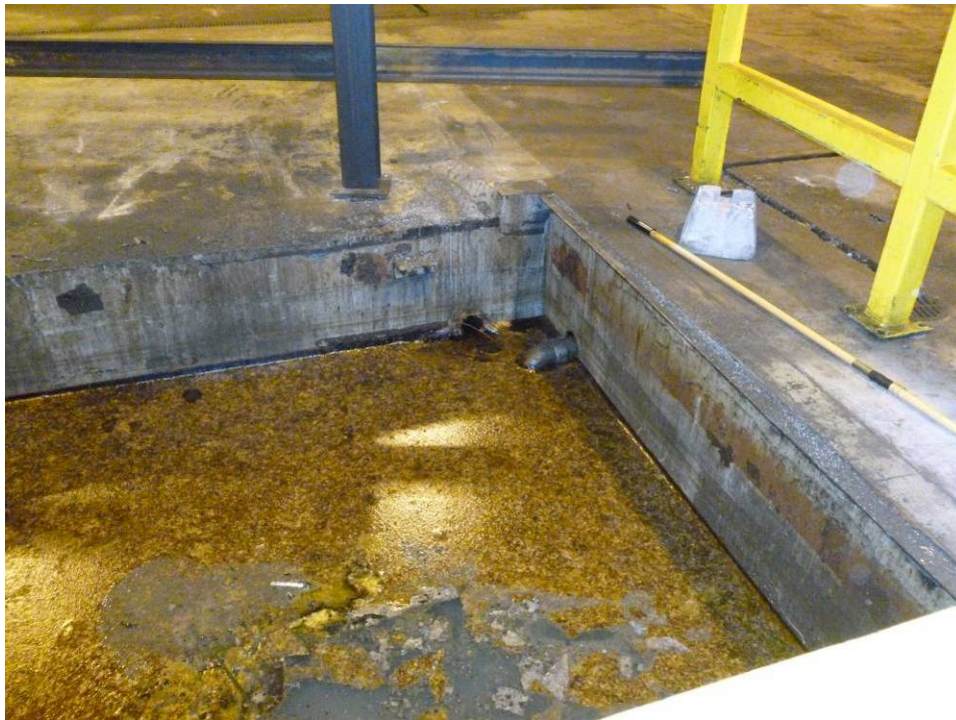
*Photograph 30. (AOI-14) Equipment Pit near Columns A3/A2. Note outfalls in southeast corner.*

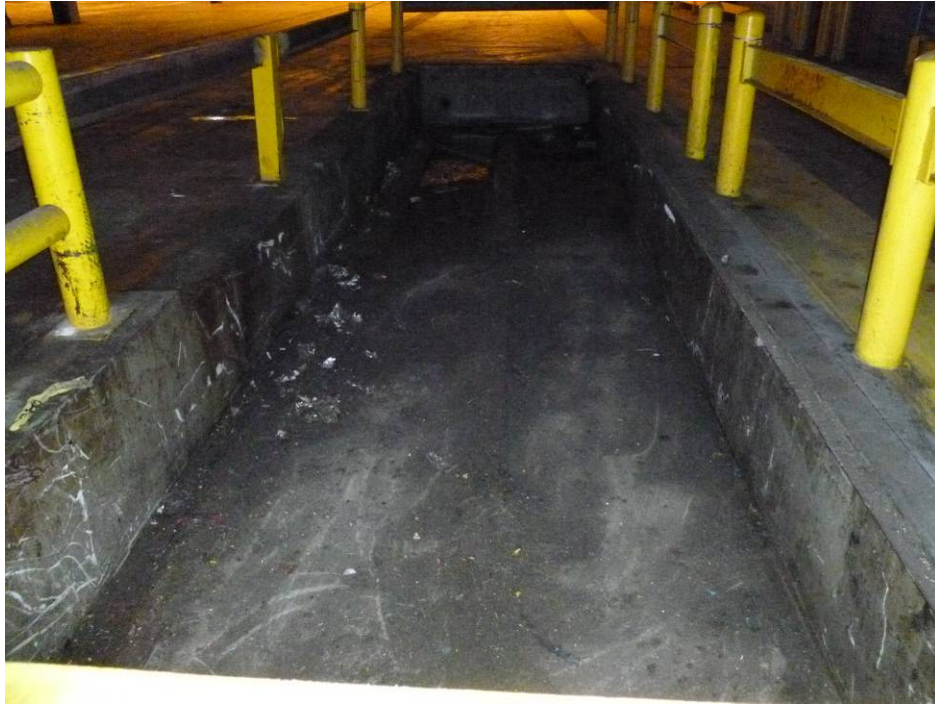
*Photograph 31. (AOI-39) Equipment Pit near Columns A15/A14. Photo taken facing south.*

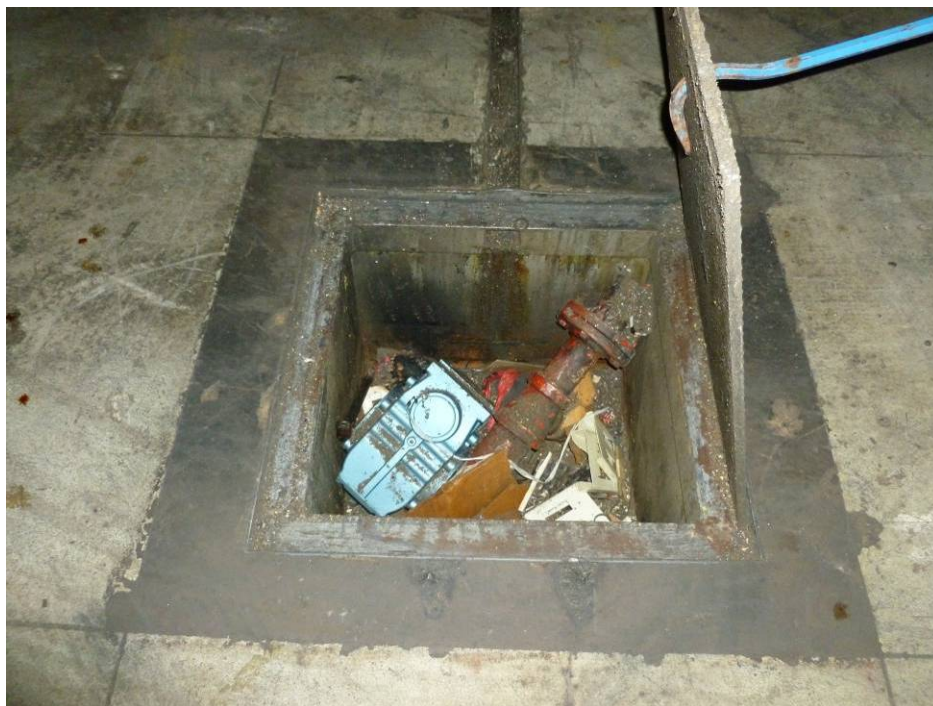
*Photograph 33. (AOI-40) Sump near Columns A11/A12, near west wall of Plant. Steel construction. Contains miscellaneous debris, possibly associated with plant decommissioning.*

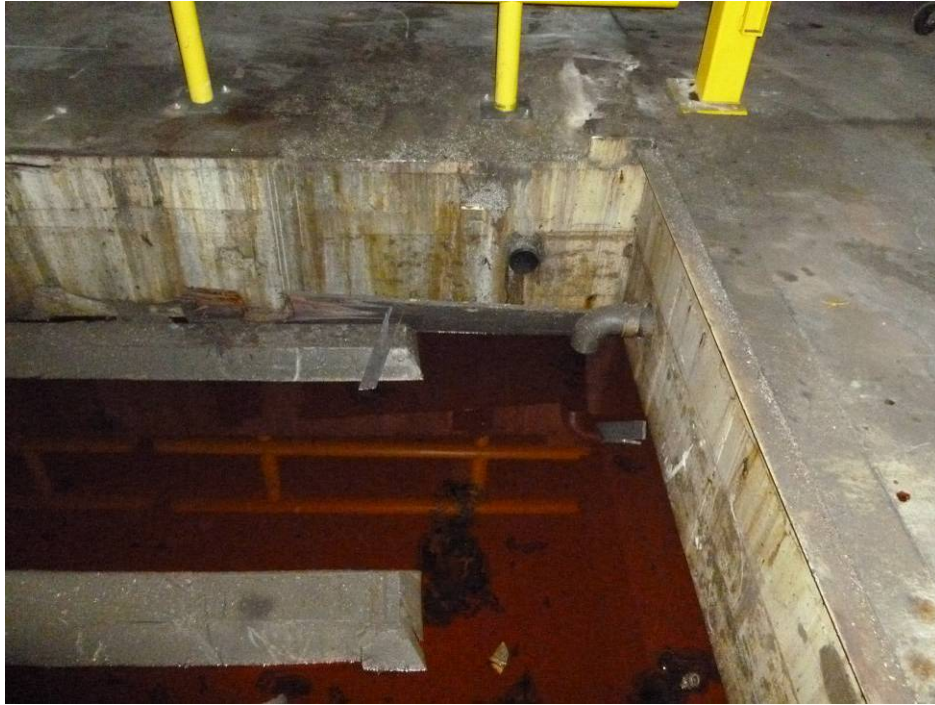
*Photograph 35. (AOI-41) Equipment Pit near Columns A7/A6. South end of pit. Note outfalls in southeast corner and several inches of oily/coolant water.*

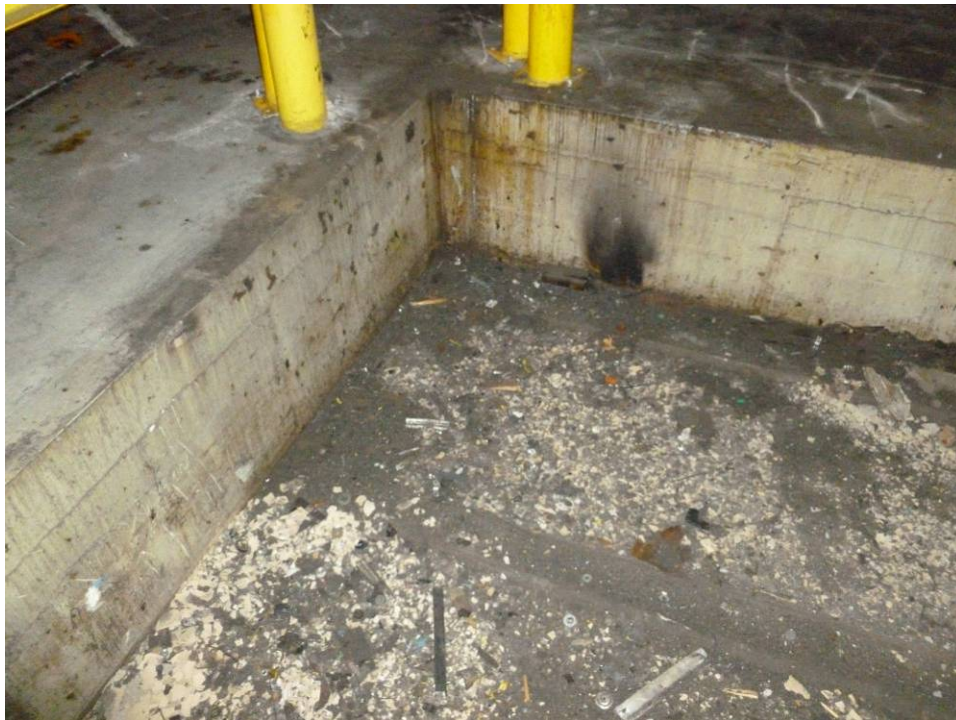
*Photograph 36. (AOI-41) Equipment Pit near Columns A7/A6. Northeast area of pit.*

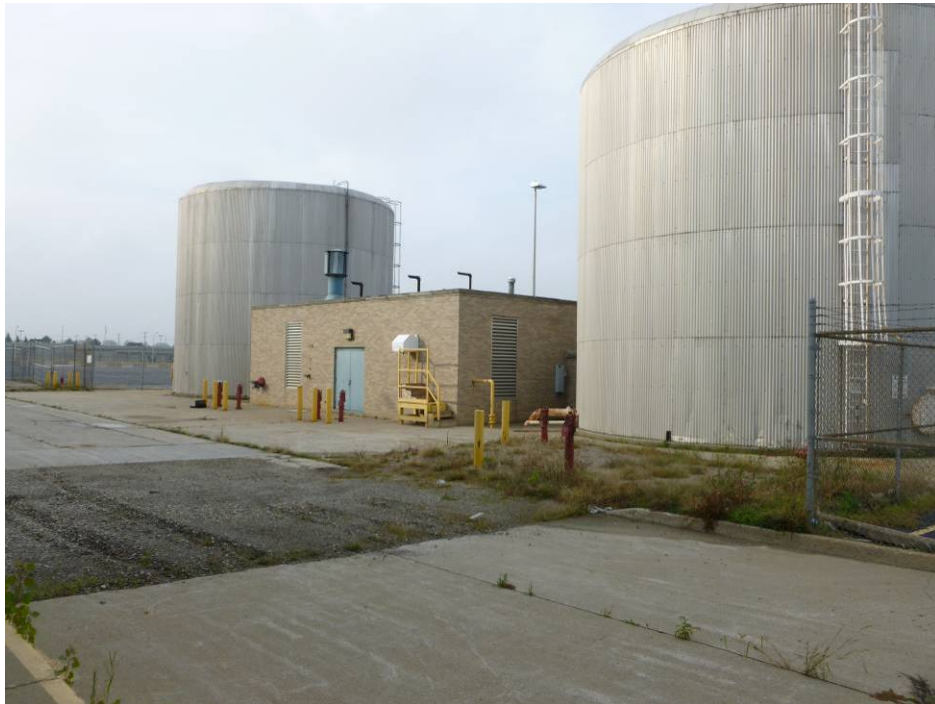
*Photograph 37. (AOI-31) Fire Pump House and 2 water tanks. Photo taken facing southwest.*

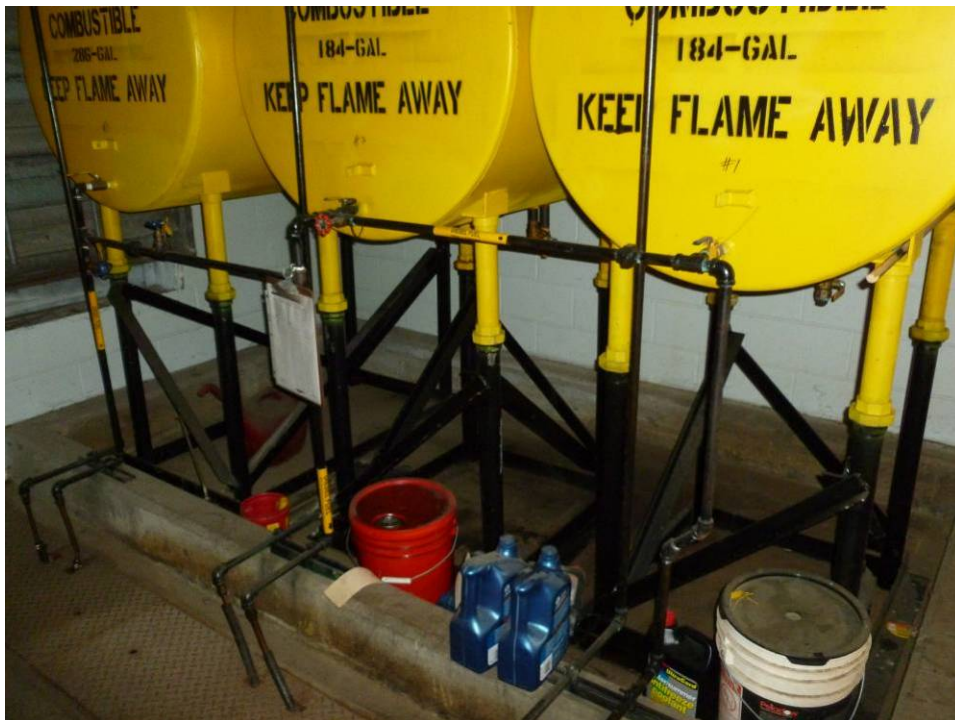
| AOI # | AOI Title | Location Column/Bay | AOI Source | Description / Components | Photos | Materials Managed | Further Action Recommended (Yes or No) | General Description of Further Action | | | | |
|---|---|---|---|---|---|---|---|---|---|---|---|---|
| 31 | Fire pump house (post 1989) | wG6-wG10 | Site walk /Facility drawings | 3 fire pump generators, 3 184-gallon diesel fuel ASTs. Evidence of staining associated with the oldest (as reported by Securitas) of the three diesel fire pump engines. Floor drains located in building. Blow down/condensate drains from engines. Staining in proximity to drains. | Photographs: 37 - 42 | Diesel, oils | Yes | 2 | 2 | 2 | 2 | None |

*Photograph 38. (AOI-31) Fire Pump House. Three aboveground diesel fuel storage tanks located along interior northeast wall.*

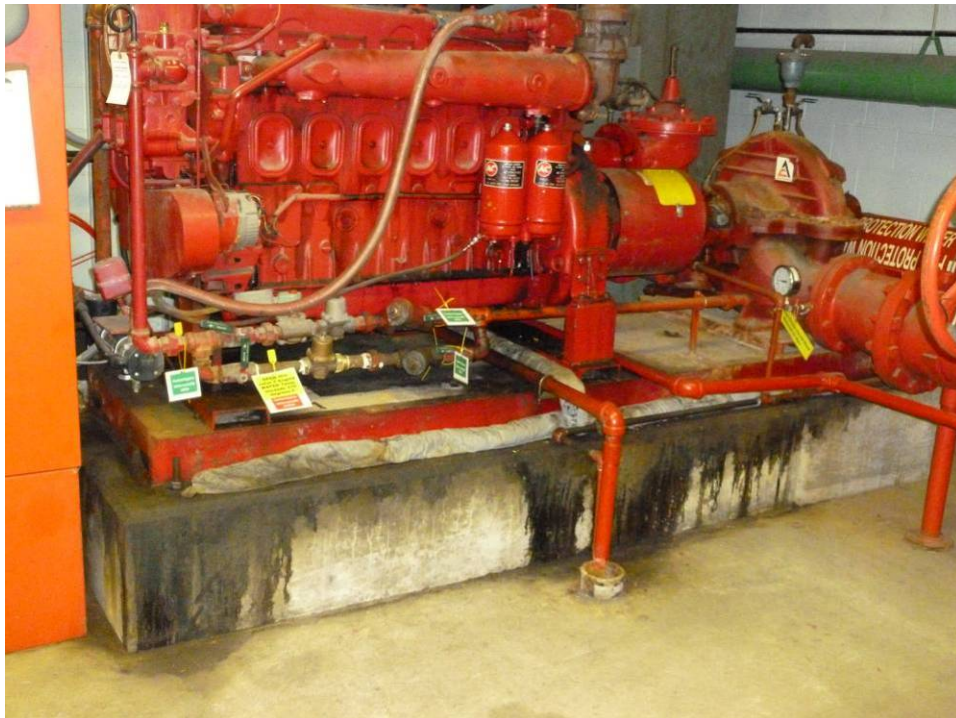
*Photograph 39. (AOI-31) Fire Pump House. Oily staining on concrete floor near floor drain, located in northwest area of building.*

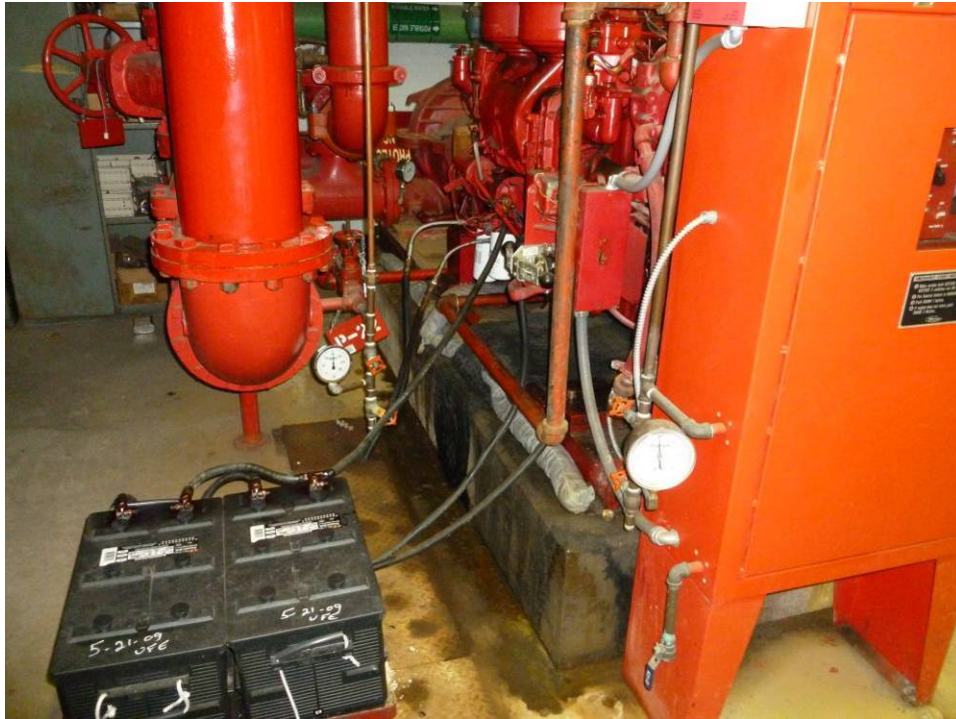
*Photograph 40. (AOI-31) Fire Pump House. Diesel fire pump engine #3. Note oily staining beneath engine and blow down/condensate drain in foreground.*

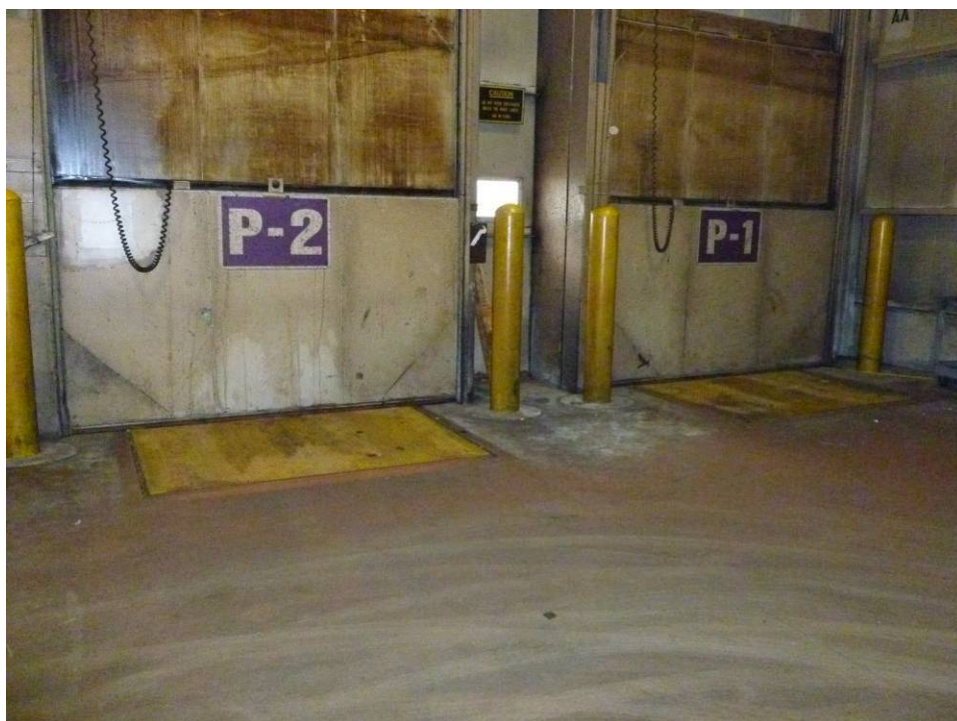
*Photograph 43. Northwest area of Plant, area between Columns WB and WJ, facing north wall. Dark brown spots appear to be oily condensate dripping from overhead lines.*

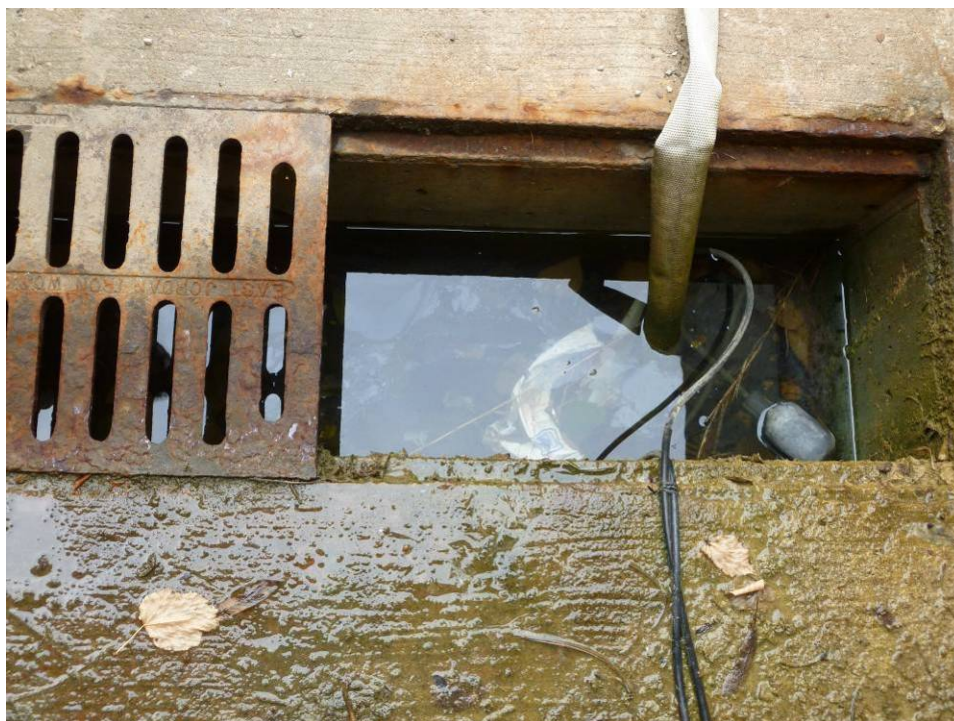
*Photograph 45. (AOI-25) Purple dock exterior. Photo taken facing east. Dark areas near blind trench are likely associated with recent precipitation event at time of reconnaissance.*

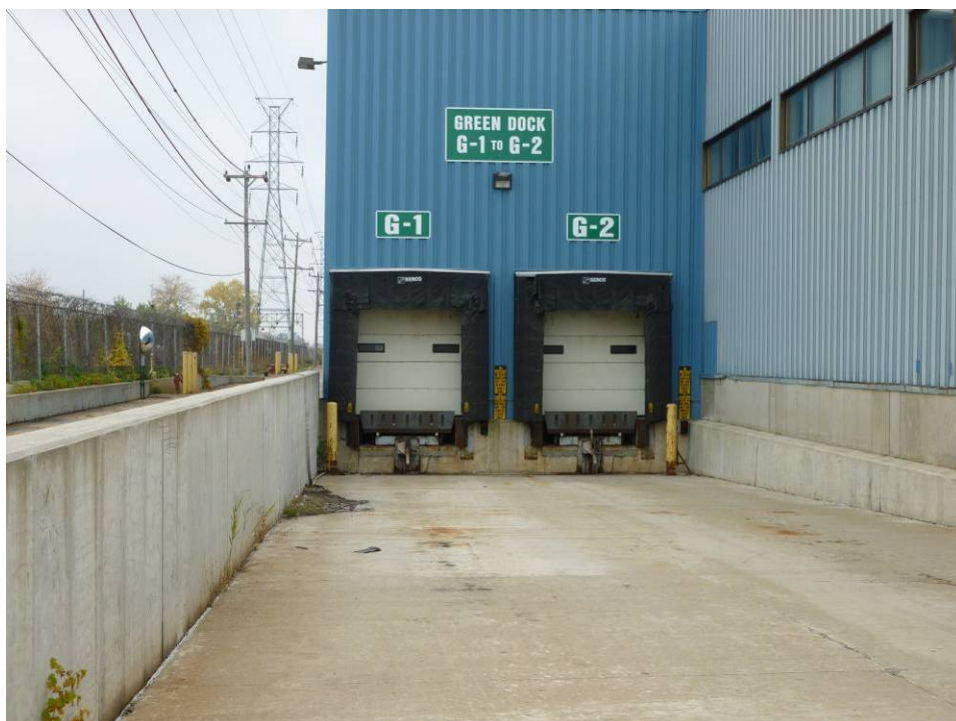
*Photograph 48. (AOI-24) Green dock exterior. Photo taken facing east.*
