**RESOURCE CONSERVATION AND RECOVERY ACT  
CURRENT CONDITIONS SUMMARY / FACILITY  
INVESTIGATION WORK PLAN FOR THE**

**FORMER GM POWERTRAIN DIVISION LIVONIA  
12200 MIDDLEBELT ROAD, LIVONIA, MICHIGAN**

**Haley & Aldrich of Michigan, Inc.  
Ann Arbor, Michigan**

**File No. 37290-009  
29 December 2011**

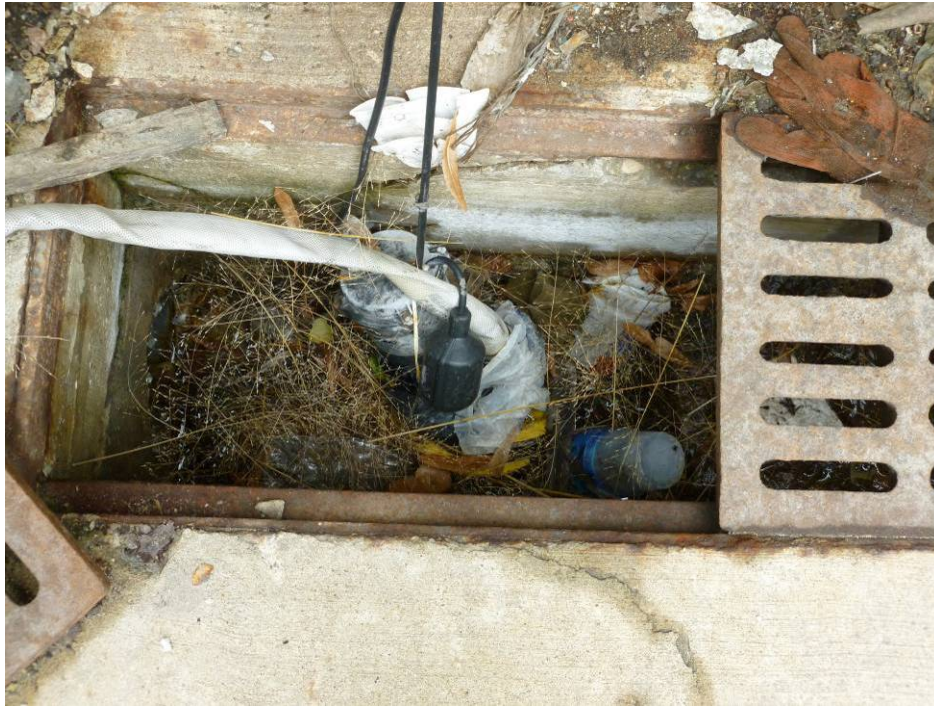
| AOI # | AOI Title | Location Column/Bay | AOI Source | Description / Components | Photos | Materials Managed | Further Action Recommended (Yes or No) | General Description of Further Action | | | | |
|---|---|---|---|---|---|---|---|---|---|---|---|---|
| 24 | Green Dock | WM1-WN1 | Site walk /Facility drawings | No staining observed on concrete. Negligible amount of sheen observed on water in blind trench. Blind trench constructed of poured concrete with steel grate covers. | Photographs: 48 - 50 | Various | No | Not Applicable | | | | |

*Photograph 49. (AOI-24) Green dock. Blind trench at exterior of dock.*

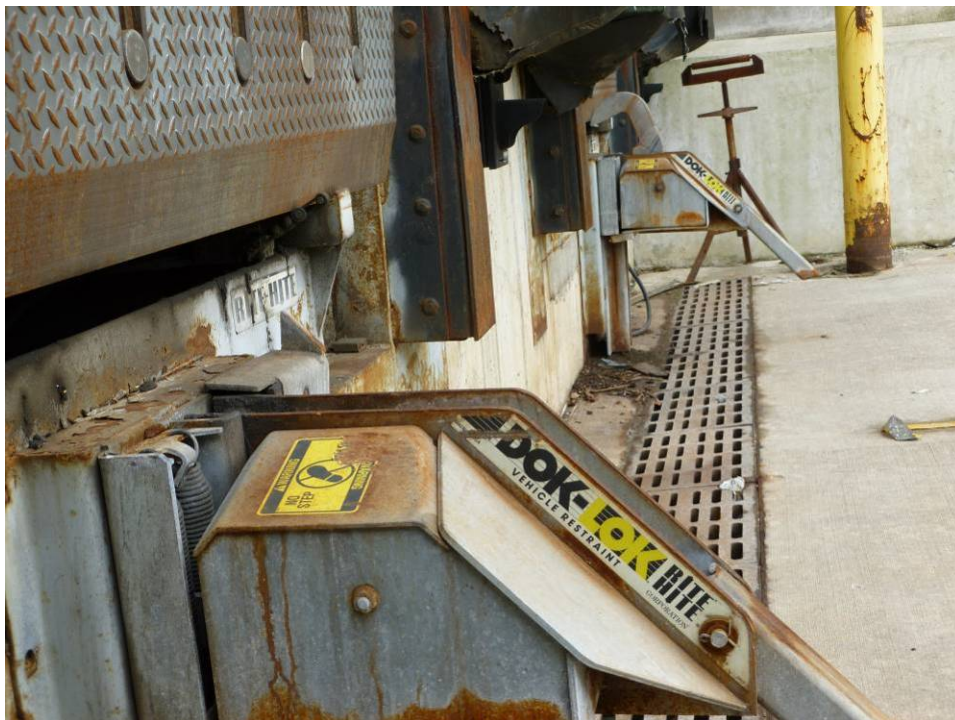
*Photograph 50. (AOI-24) Green dock. Photo taken facing south.*

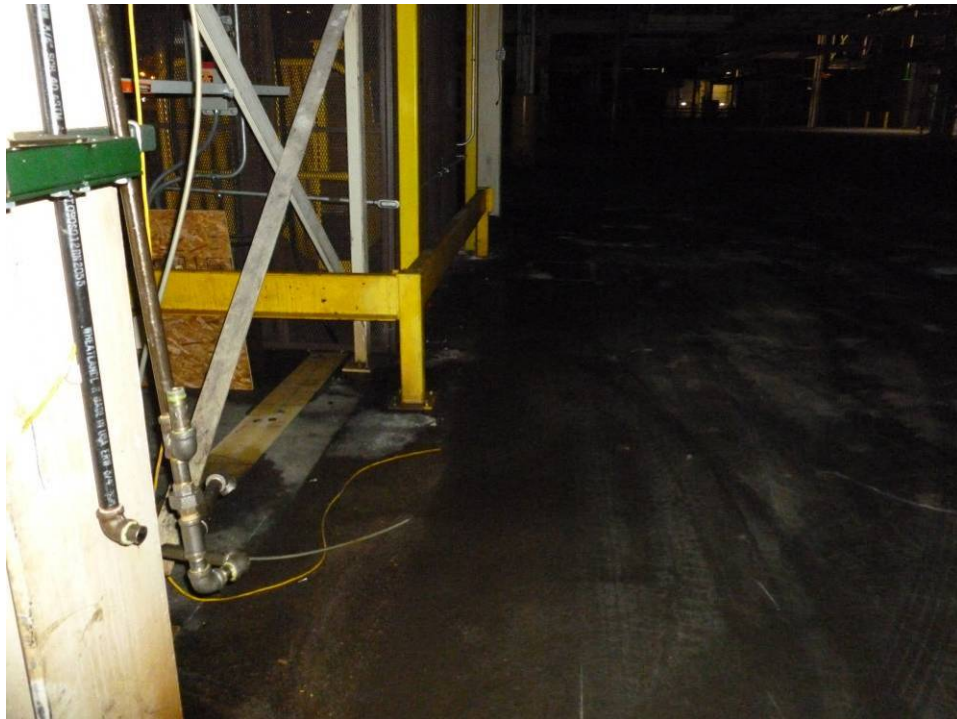
*Photograph 52. (AOI-21) Oil dispensing ports near heavy equipment lift (to mezzanine). Near Columns 6A/K.*

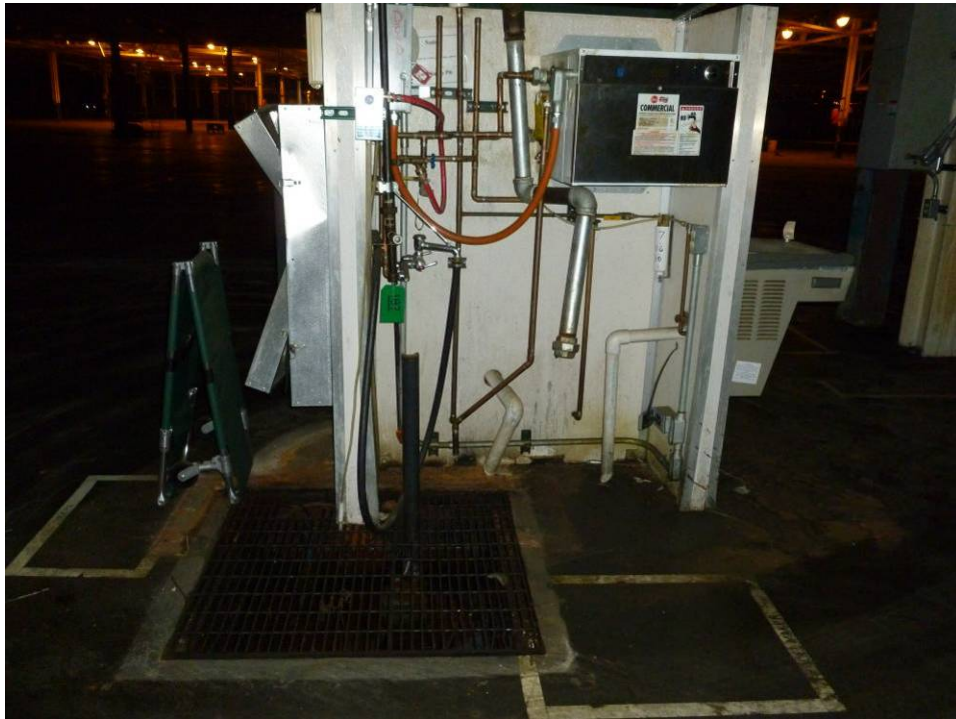
*Photograph 54. (AOI-21) Heavy equipment lift. Staining in proximity to hydraulic oil reservoir. Note all components appeared to be located above the grade of the Plant concrete floor.*

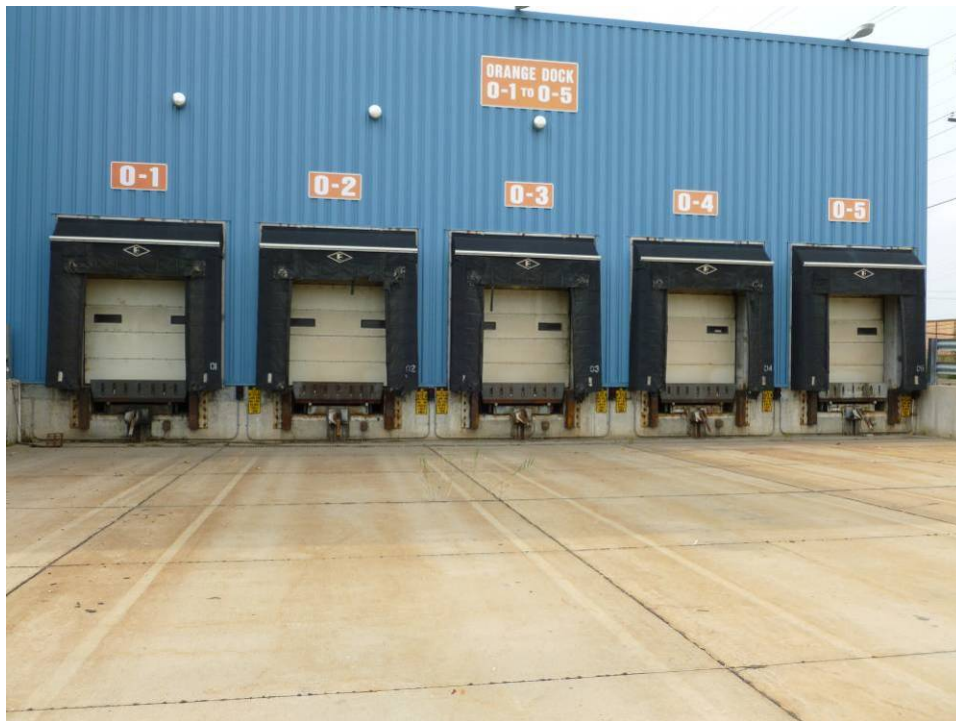
| AOI # | AOI Title | Location Column/Bay | AOI Source | Description / Components | Photos | Materials Managed | Further Action Recommended (Yes or No) | General Description of Further Action | | | | |
|---|---|---|---|---|---|---|---|---|---|---|---|---|
| 20 | Orange Dock | M8A-P8A | Site walk /Facility drawings | No staining observed on concrete. | Photographs: 57 and 58 | Various | No | Not Applicable | | | | |

*Photograph 57. (AOI-20) Orange dock exterior. Photo taken facing west.*

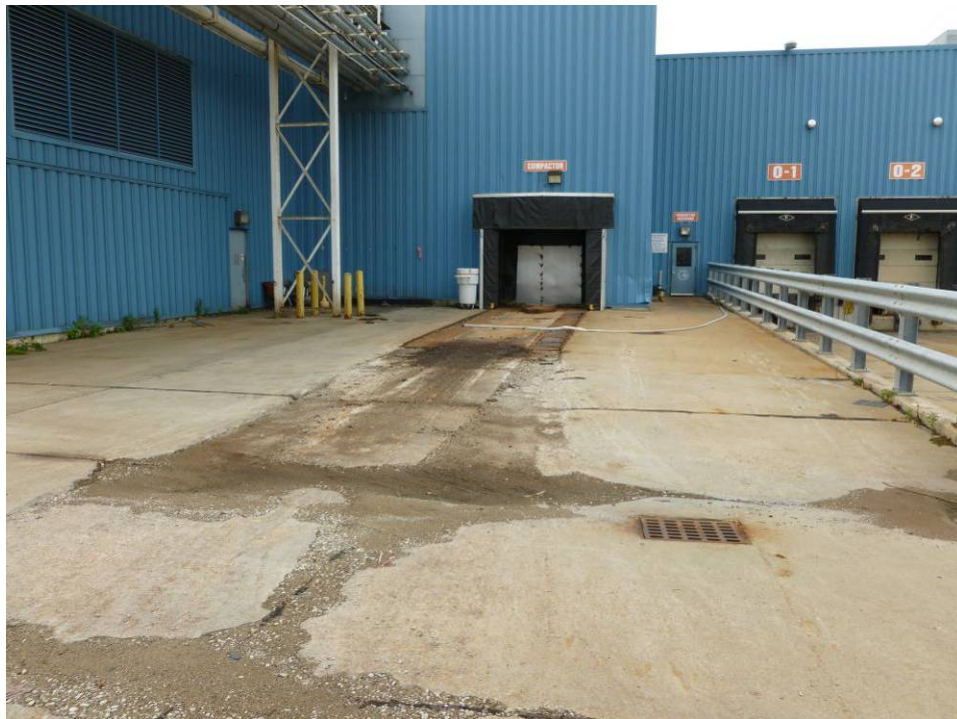
*Photograph 59. (AOI-19) Trash compactor area exterior. Photo taken facing west. Note dark staining / oily residue at east end of trash compactor bay. Note deteriorated condition of concrete.*

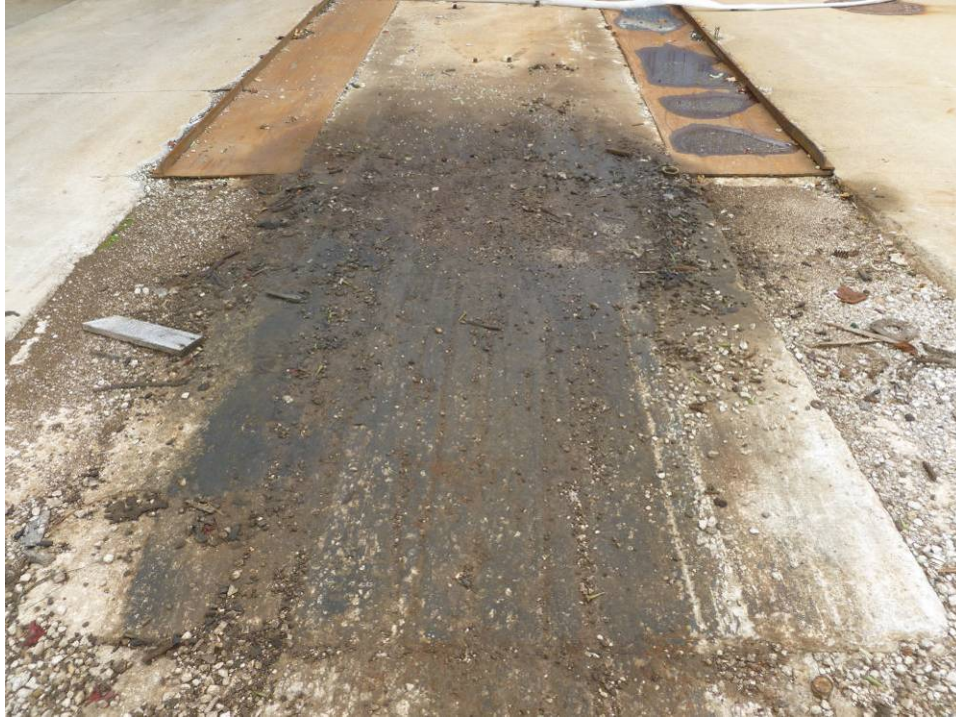
*Photograph 60. (AOI-19) Trash compactor area exterior. Note storm drain in northeast area of compactor bay. Note deteriorated condition of concrete.*

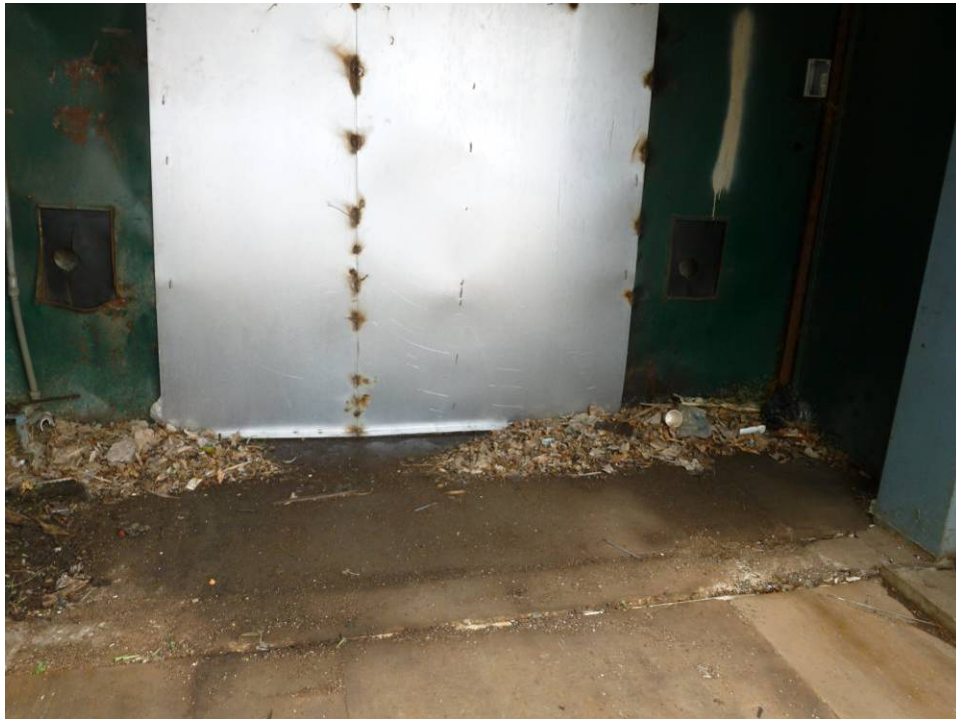
*Photograph 61. (AOI-19) Trash compactor area exterior. Close-up of dark staining / oily residue. Pools of liquid on metal rails are likely result of recent precipitation event. No sheen was observed on the water.*

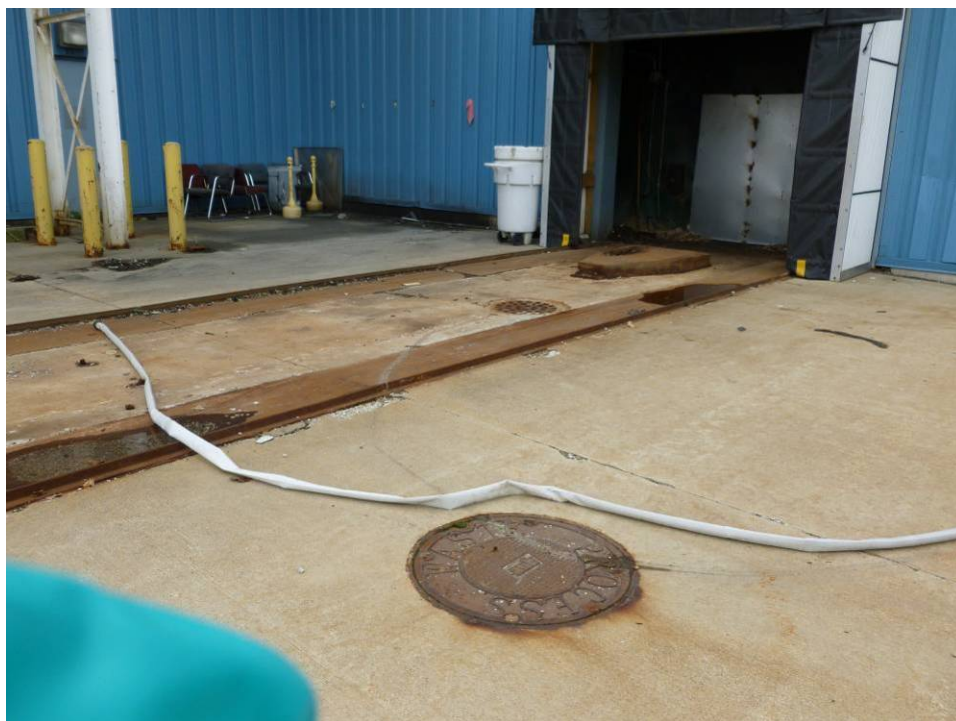
*Photograph 62. (AOI-19) Trash compactor area exterior. Bay entrance to building. Photo taken exterior to bay, facing west. Note dark staining / oily residue on concrete pad.*

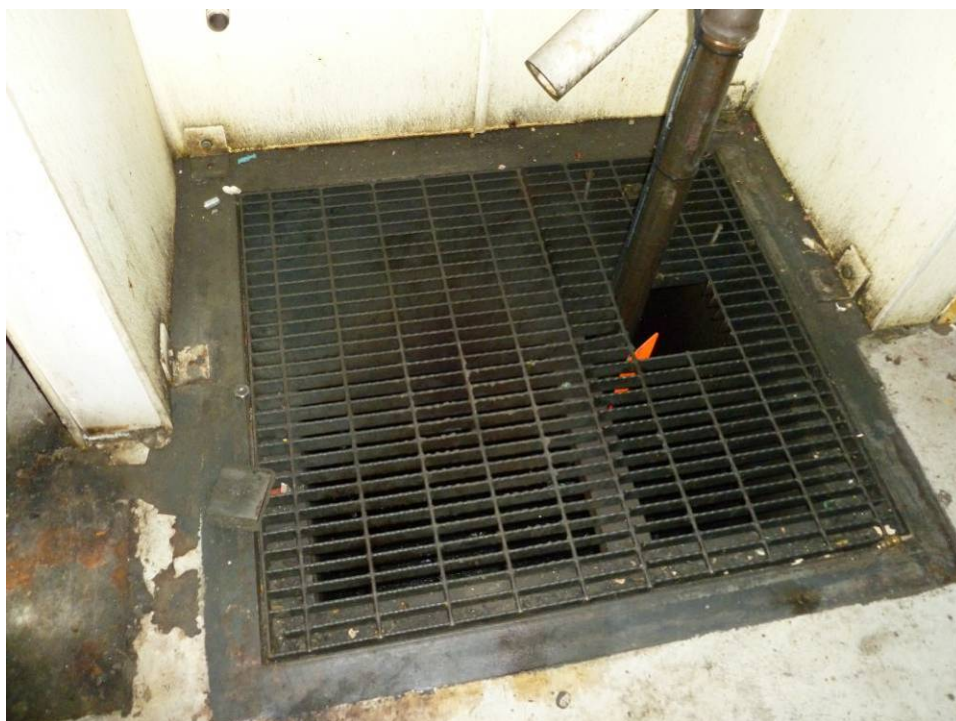
*Photograph 67. (AOI-16) Dump Station near Column M/1A. Appears to be routed to process waste. Oily sludge observed in pit.*

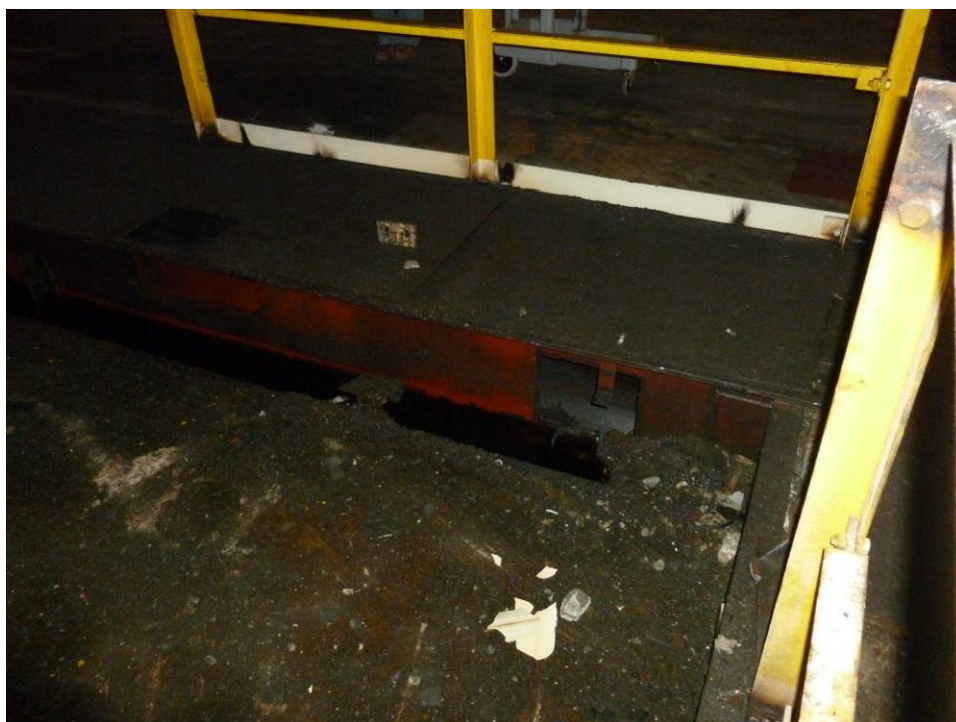
| AOI # | AOI Title | Location Column/Bay | AOI Source | Description / Components | Photos | Materials Managed | Further Action Recommended (Yes or No) | General Description of Further Action | | | | |
|---|---|---|---|---|---|---|---|---|---|---|---|---|
| 15 | Equipment pit - containment beneath heavy equipment | D2-E2 | Site walk /Facility drawings | Containment beneath heavy equipment. Oil/coolant observed in trough connected to adjacent flume. Poured concrete. Minor chipping, minor delamination observed at southeast end. | Photographs: 69 - 71 and 93 | Metals, oils, cutting fluid, coolant | Yes | 1 | 1 | 1 | 1 | None |

*Photograph 70. (AOI-15) Equipment Pit near Columns D2/E2. Dark staining, some debris observed in pit.*

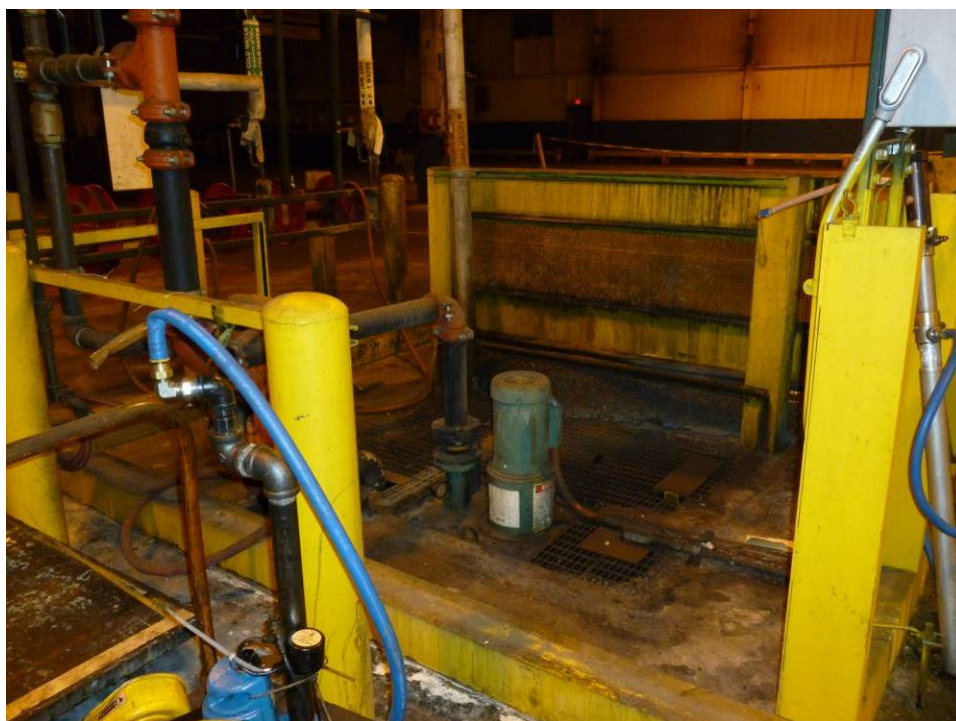
*Photograph 73. (AOI-13) Wash / Dump Station. Observed hot and cold water lines, compressed air line, and process water line associated with this pit.*

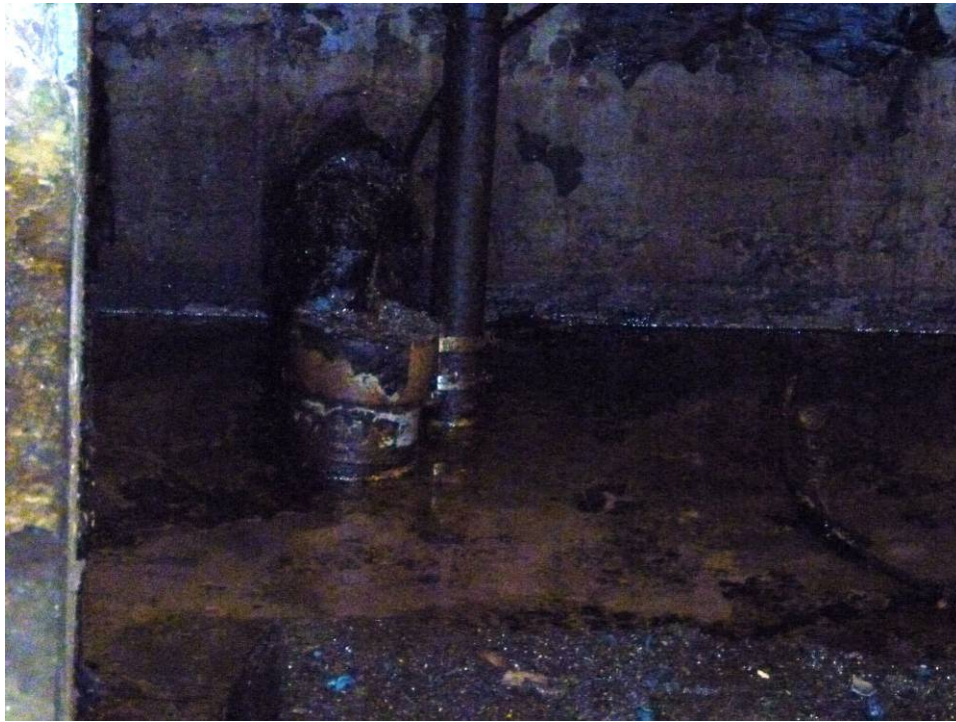
*Photograph 76. (AOI-12) Equipment Pit. Picture taken facing north and east. Note accumulation of oily / coolant sludge in pit and metal grindings on concrete berm.*

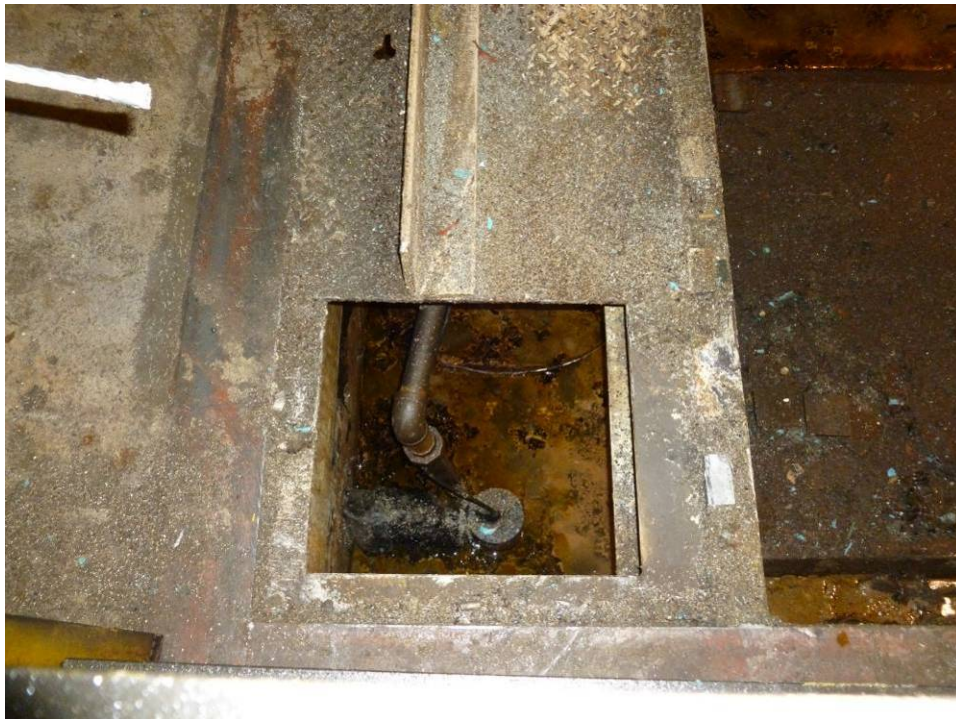
*Photograph 77. (AOI-12) Oil-filled trench/flume located approximately 25 feet from equipment pit, extending approximately 100 feet north of the pit. Float observed in northwest corner of pit.*

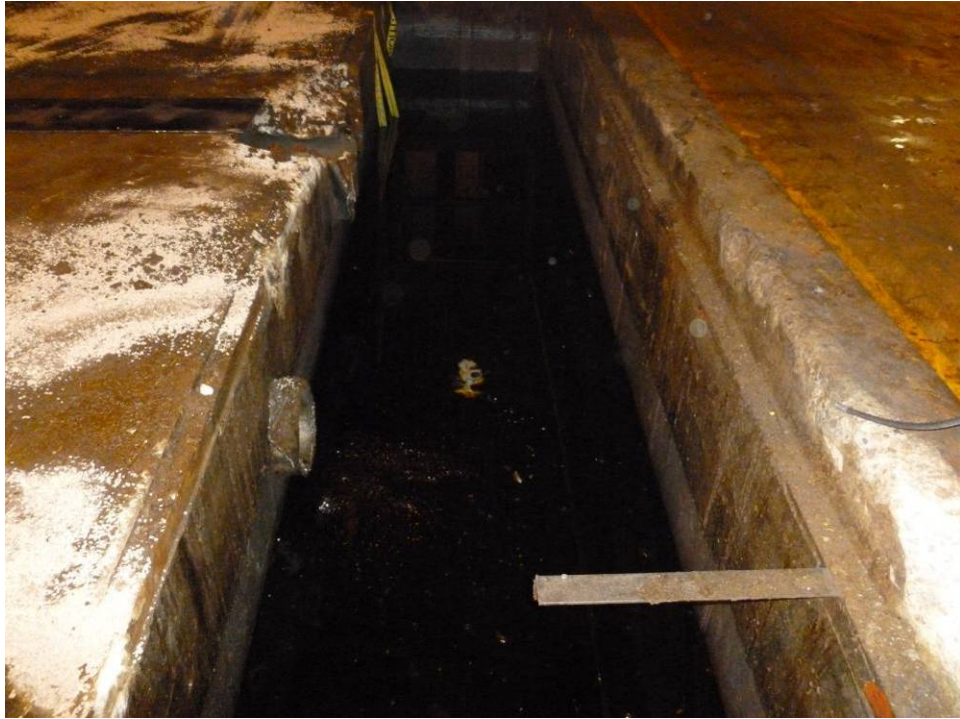
*Photograph 78. (AOI-12) Oil-filled trench / flume system, may be associated with equipment pit.*

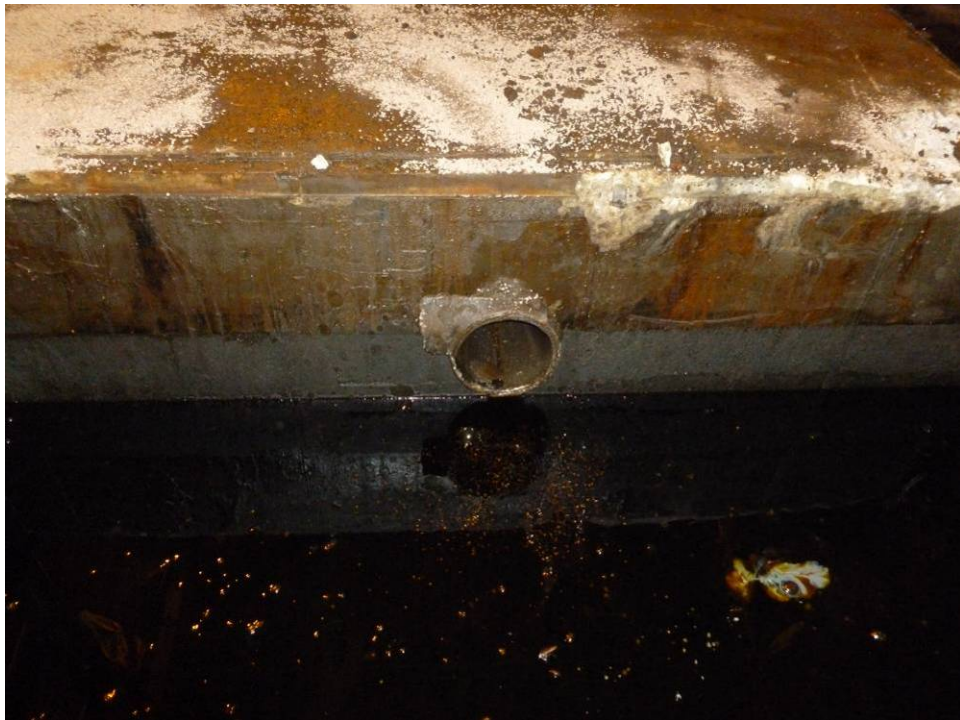
*Photograph 79. (AOI-12) Oil-filled pit near Column G4.*

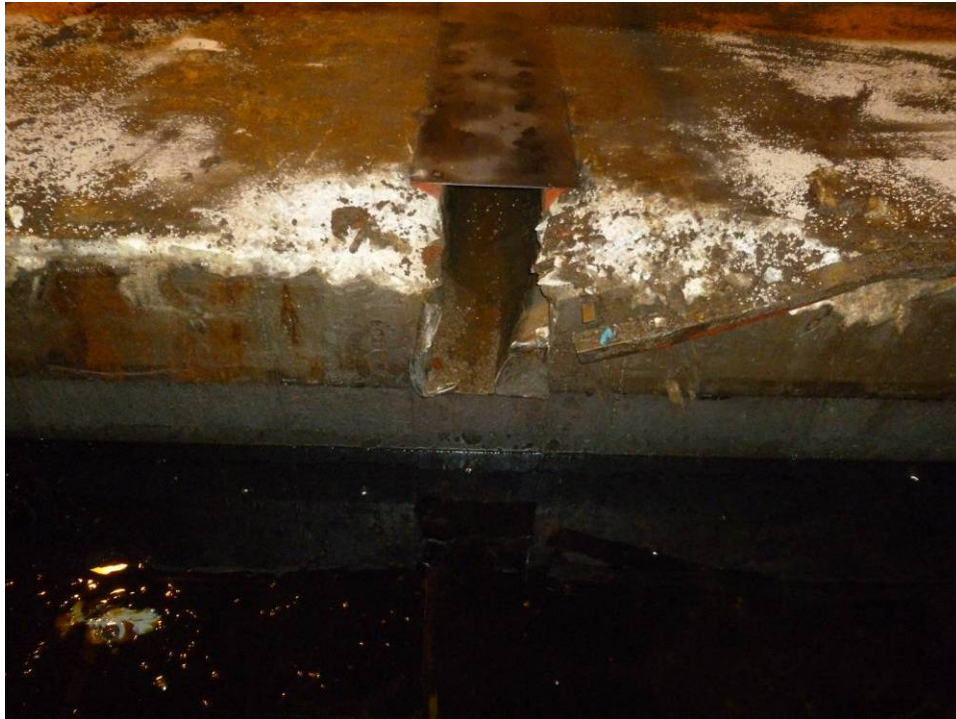
*Photograph 81. (AOI-12) Oil-filled pit near Column G4.*

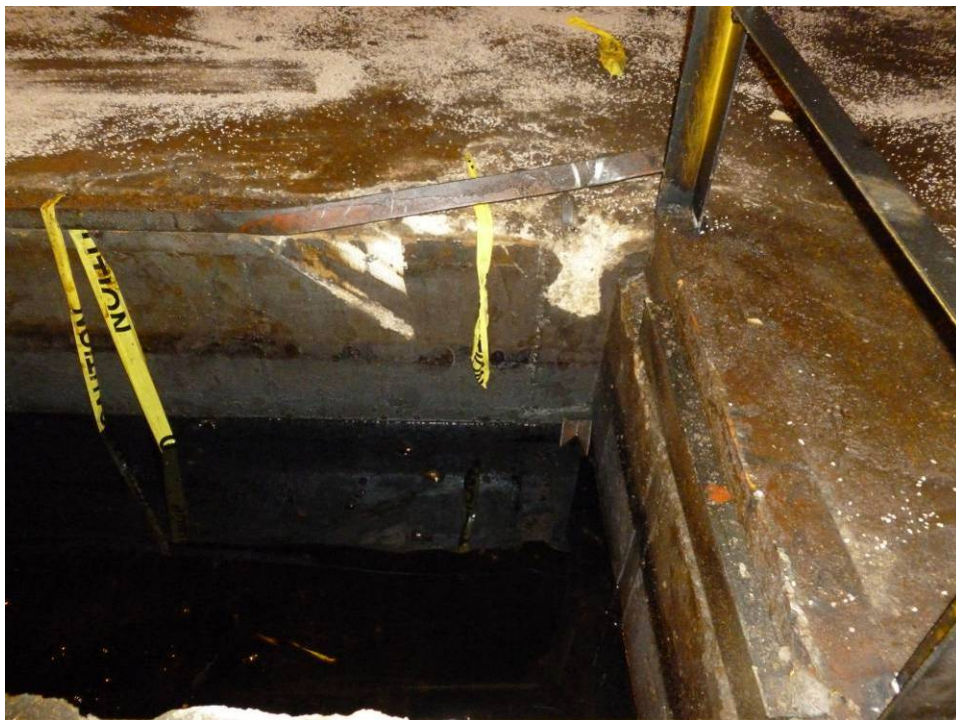
*Photograph 82. (AOI-12) Oil-filled pit near Column G4.*

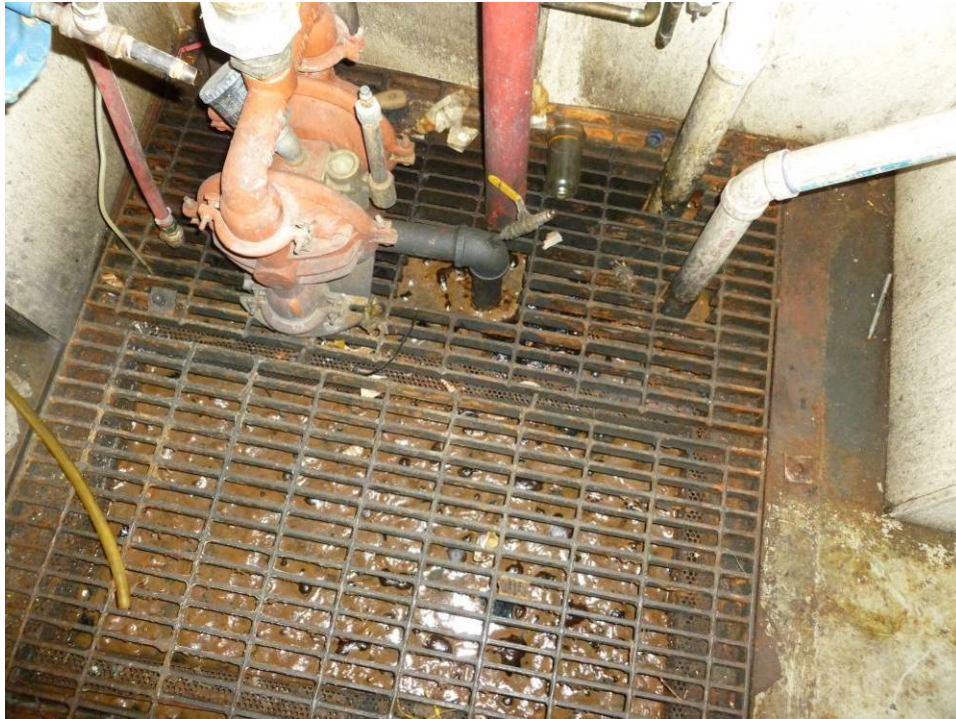
| AOI # | AOI Title | Location Column/Bay | AOI Source | Description / Components | Photos | Materials Managed | Further Action Recommended (Yes or No) | General Description of Further Action | | | | |
|---|---|---|---|---|---|---|---|---|---|---|---|---|
| 11 | Dump station | J6-K6 | Site walk /Facility drawings | Process waste, floor cleaning. Dump Station near Columns J5/K5 pit is filled with oily / coolant sludge. | Photographs: 83 and 84 | Process waste, oily waste, floor cleaning | Yes | 1 | 1 | 1 | 1 | None |

*Photograph 83. (AOI-11) Dump Station near Columns J5/K5. Note, the pit is filled with oily / coolant sludge.*

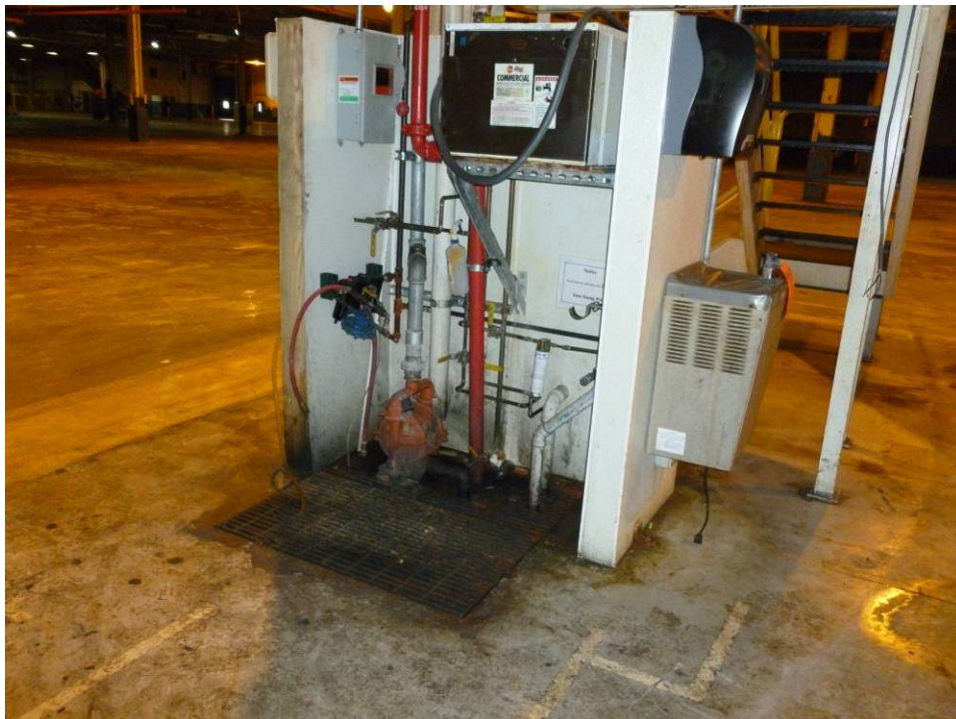
*Photograph 84. (AOI-11) Dump Station near Columns J5/K5.*

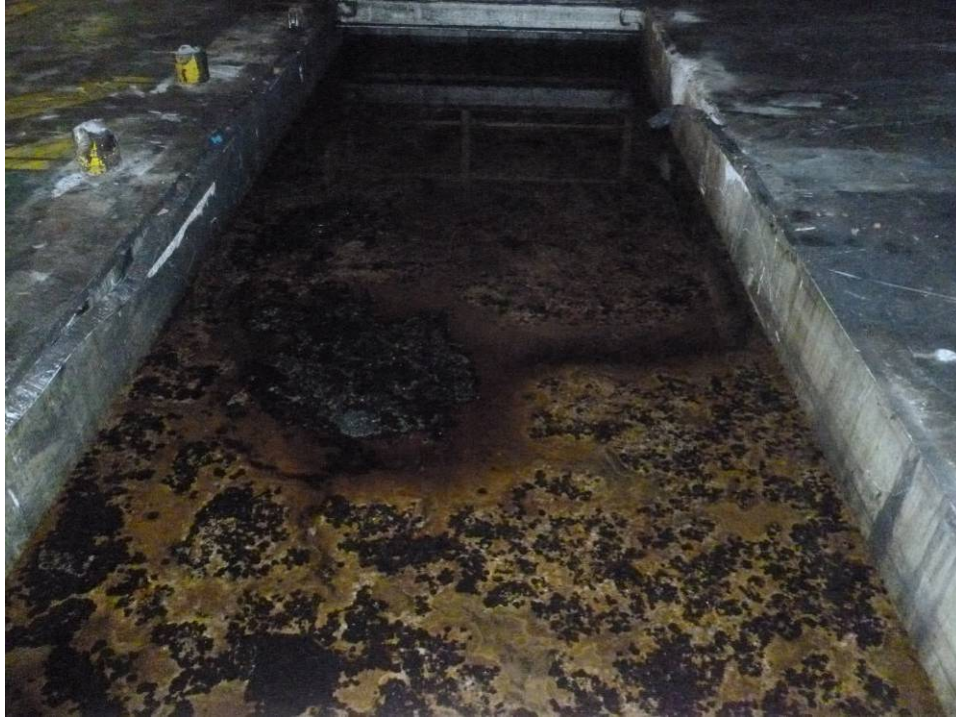
| AOI # | AOI Title | Location Column/Bay | AOI Source | Description / Components | Photos | Materials Managed | Further Action Recommended (Yes or No) | General Description of Further Action | | | | |
|---|---|---|---|---|---|---|---|---|---|---|---|---|
| 10 | Equipment pit | L7-M7 | Site walk /Facility drawings | Containment for heavy equipment. Equipment Pit contains approximately 3 feet of oily / coolant water. | Photographs: 85 and 86 | Oils, cutting/honing coolant, metal working oils | Yes | 1 | 1 | 1 | 1 | None |

*Photograph 85. (AOI-10) Equipment Pit. Note pit contains approximately 3 feet of oily / coolant water.*

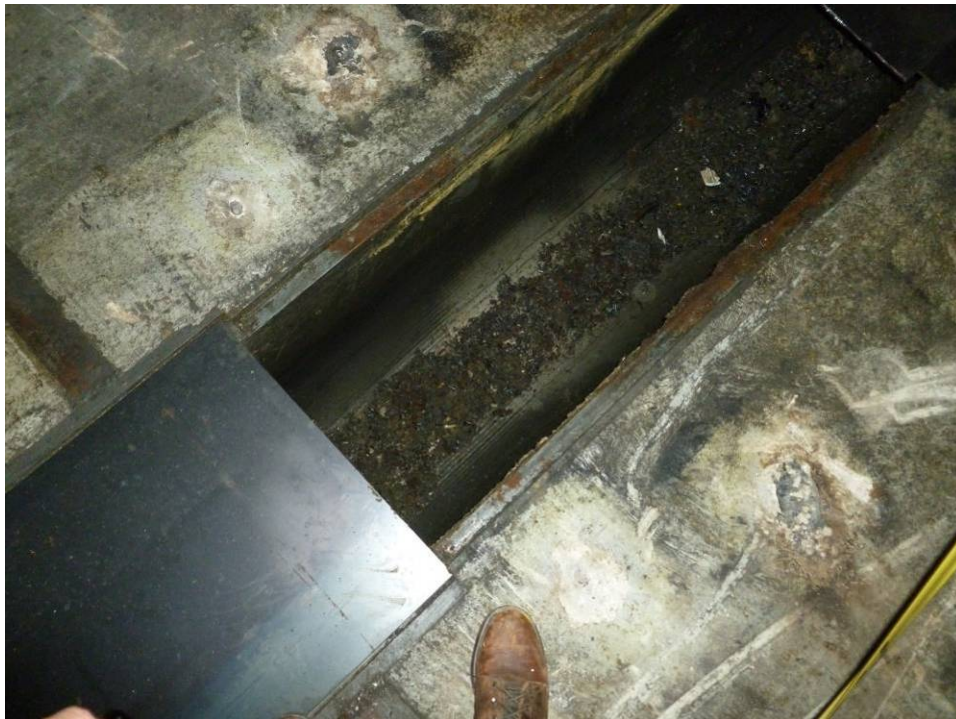
*Photograph 86. (AOI-10) Flume conveyance between Equipment Pit (AOI-10) and Oil Sump (AOI-09). Flume extends approximately 22 feet from southeast area of AOI-10 to AOI-09.*

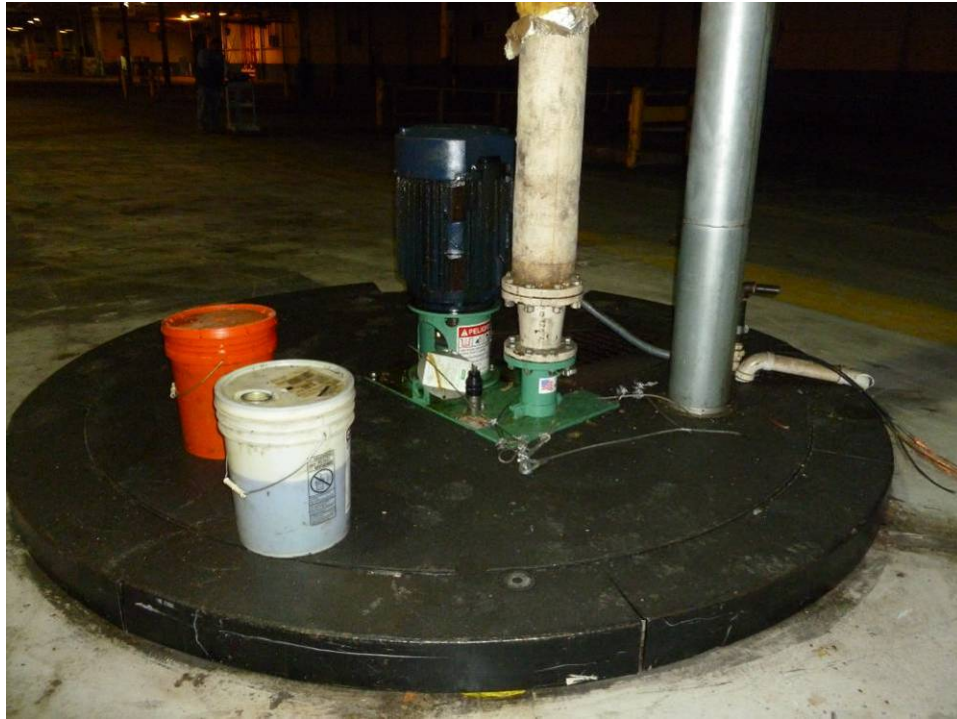
| AOI # | AOI Title | Location Column/Bay | AOI Source | Description / Components | Photos | Materials Managed | Further Action Recommended (Yes or No) | General Description of Further Action | | | | |
|---|---|---|---|---|---|---|---|---|---|---|---|---|
| 09 | Oil supply sump | L8-M8 | Site walk /Facility drawings | May have been associated with operation of East Gallery. Oil Sump near columns L8/M8 is approximately five feet in diameter. Oil Pit near 8N maybe associated with Oil Sump near L8/M8, contains oily material. | Photographs: 86 - 89 | Oils, cutting/honing coolant, metal working oils | Yes | 1 | 1 | 1 | 1 | None |

*Photograph 87. (AOI-09) Oil Sump near Columns L8/M8. Sump is approximately 5 feet in diameter.*

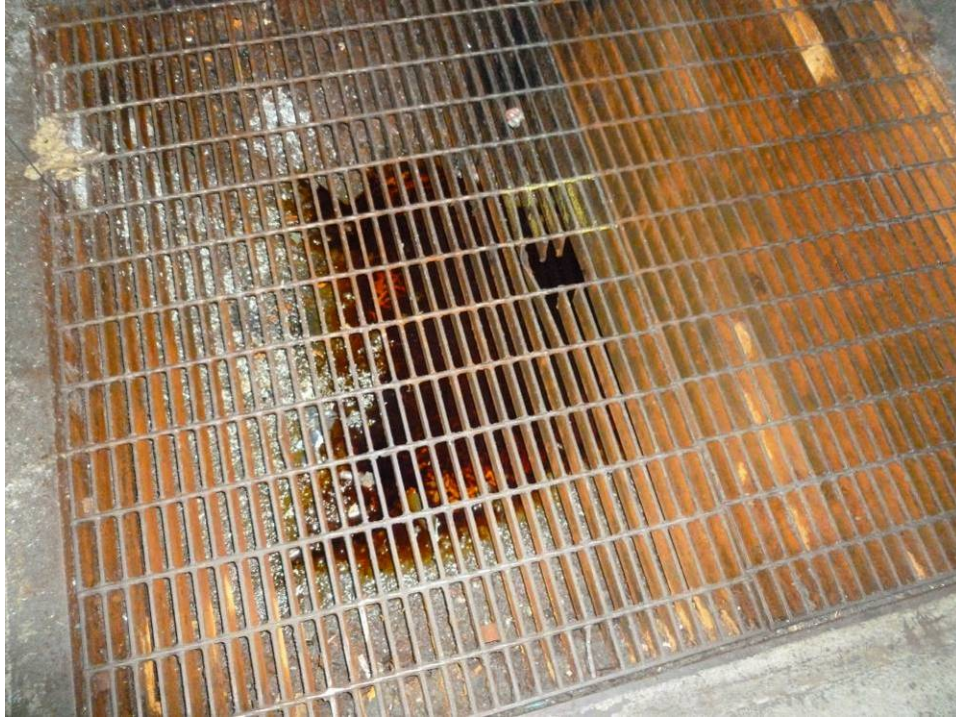
*Photograph 89. (AOI-09) Oil pit, possibly associated with Oil Sump (AOI-09). Note pit contains oily material.*

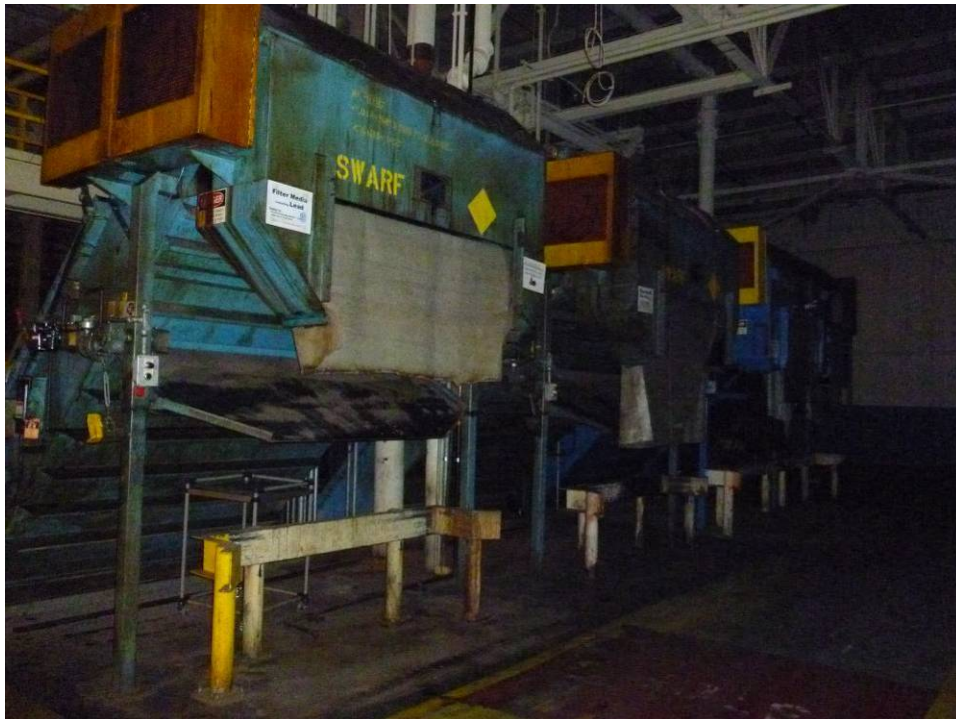
*Photograph 90. (AOI-04) Swarf management associated with East Gallery (AOI-04). Located on main level of Plant. Note signage: "Filter Media Contains Lead."*

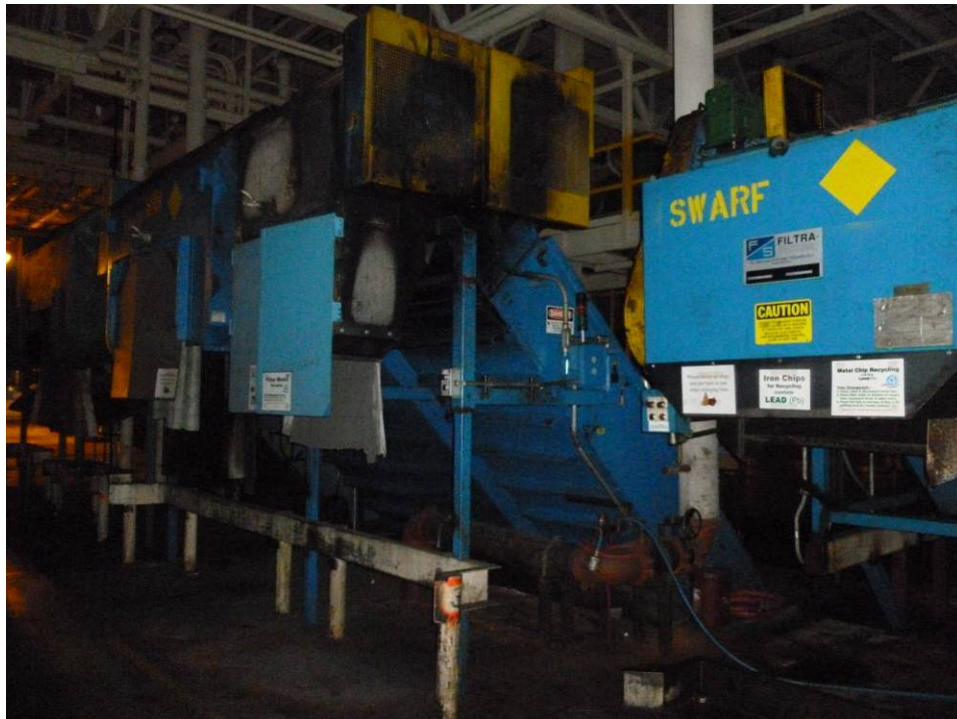
*Photograph 91. (AOI-04) Swarf management associated with East Gallery (AOI-04). Located on main level of Plant. Note signage: "Iron Chips for Recycling Contain Lead."*

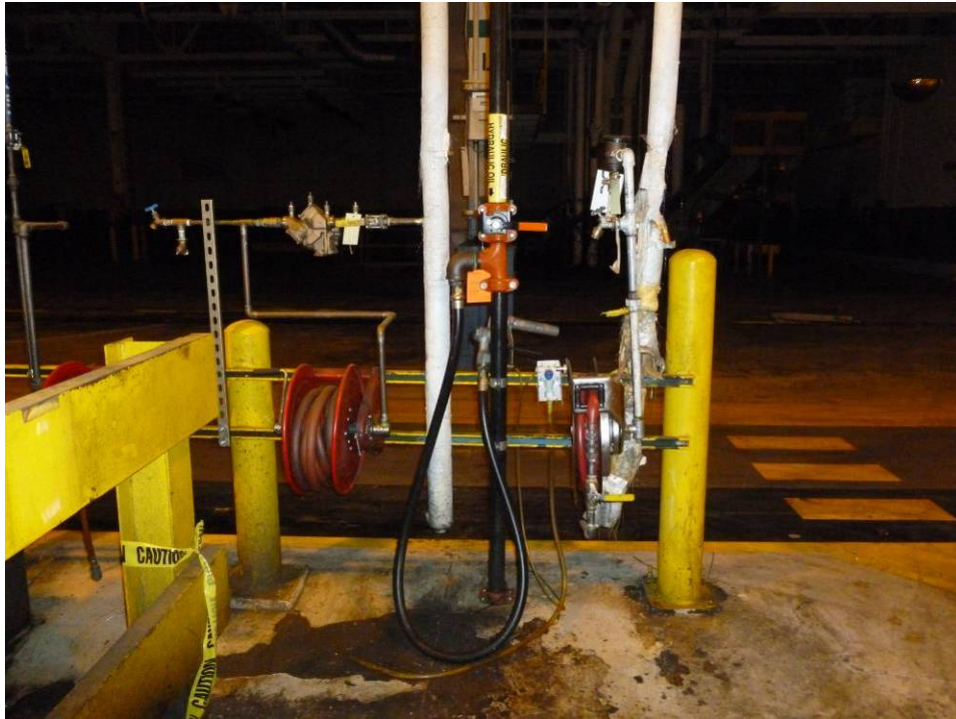
*Photograph 92. (AOI-05) Clean / Dump Station near Column L14. Note dark staining / oily residue around station.*

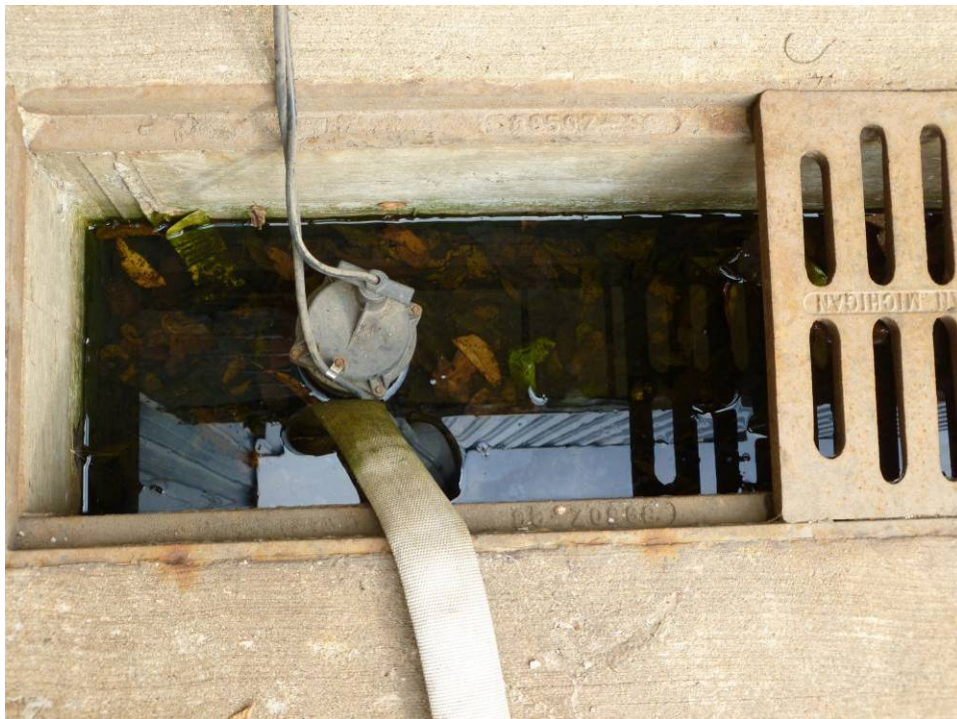
*Photograph 96. (AOI-03) Blue Dock exterior. Close-up of blind trench drain. Negligible amount of sheen observed.*

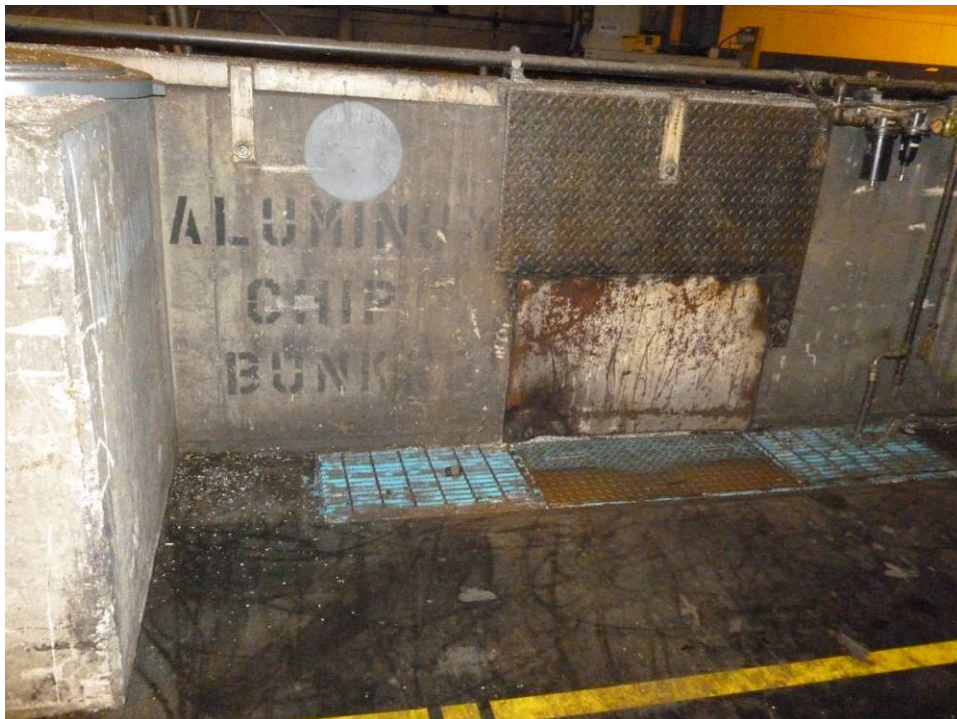
*Photograph 100. (AOI-01) Chip Bunkers. Close-up of aluminum chip bunker. Photo taken facing south.*

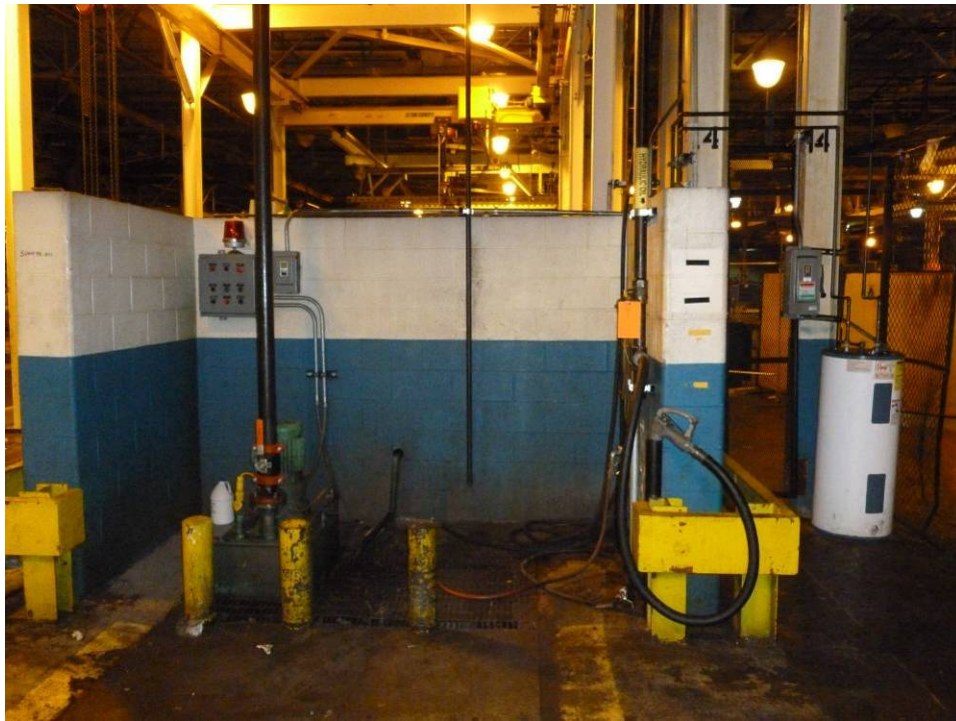
*Photograph 105. (AOI-07) Dump Station near Column E14. Note hydraulic oil distribution line. Oily material was observed in the pit at the time of the site reconnaissance.*
