**RESOURCE CONSERVATION AND RECOVERY ACT  
CURRENT CONDITIONS SUMMARY / FACILITY  
INVESTIGATION WORK PLAN FOR THE**

**FORMER GM POWERTRAIN DIVISION LIVONIA  
12200 MIDDLEBELT ROAD, LIVONIA, MICHIGAN**

**Haley & Aldrich of Michigan, Inc.  
Ann Arbor, Michigan**

**File No. 37290-009  
29 December 2011**

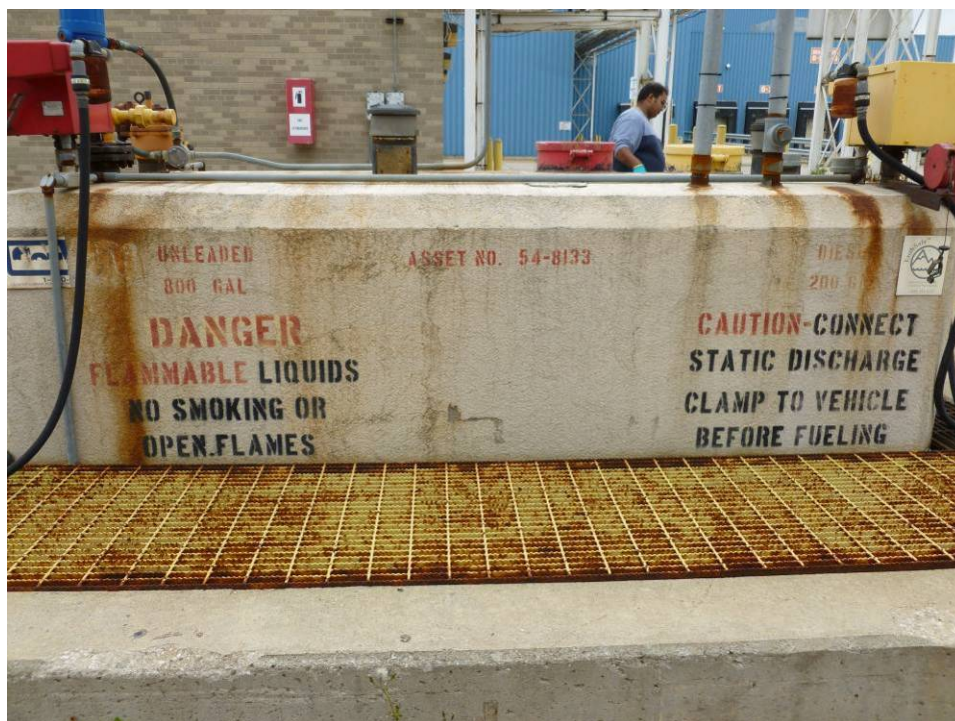
*Photograph 107. (AOI-37) Two Aboveground Storage Tanks. Photo taken facing east. Tank at north end is labeled, "Diesel 200 Gallons." Tank at south end is labeled, "Unleaded 800 Gallons." Note Fluid Storage Building aka Oil Storage Building (AOI-36) in the background.*

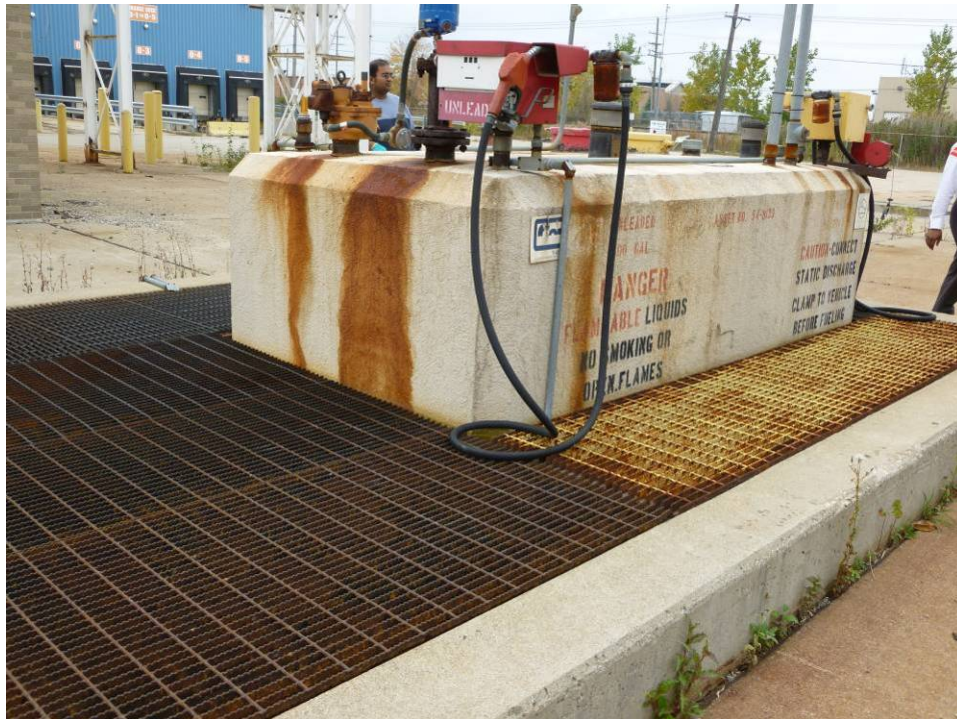
*Photograph 108. (AOI-37) Two Aboveground Storage Tanks. Photo taken facing west.*

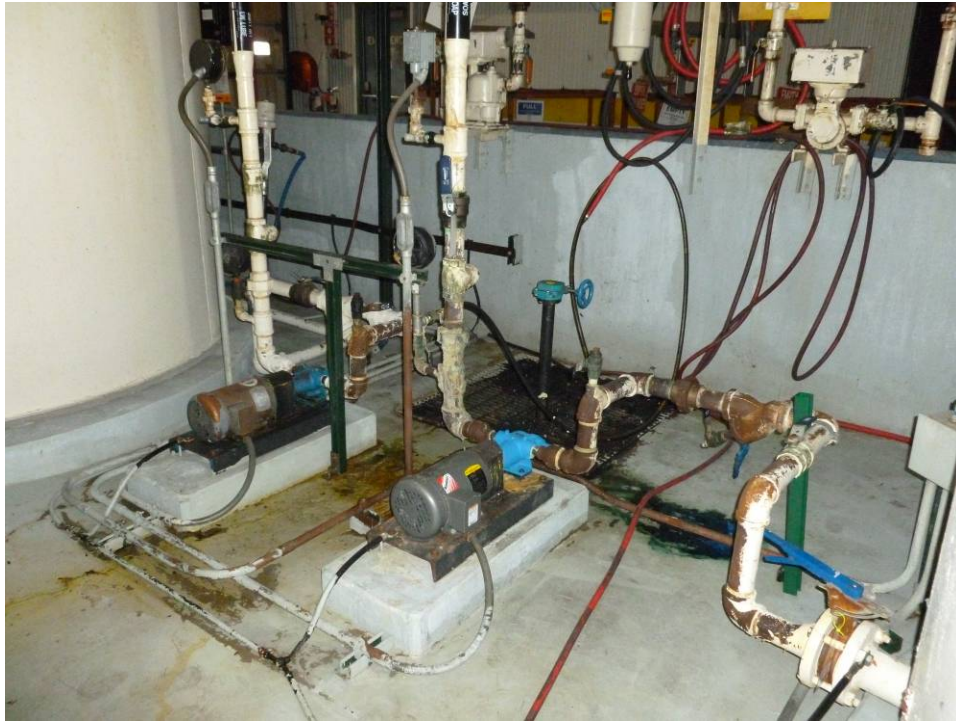
*Photograph 116. (AOI-36) Oil Storage Building. Floor drain located in aisle outside of secondary containment for bulk product storage.*

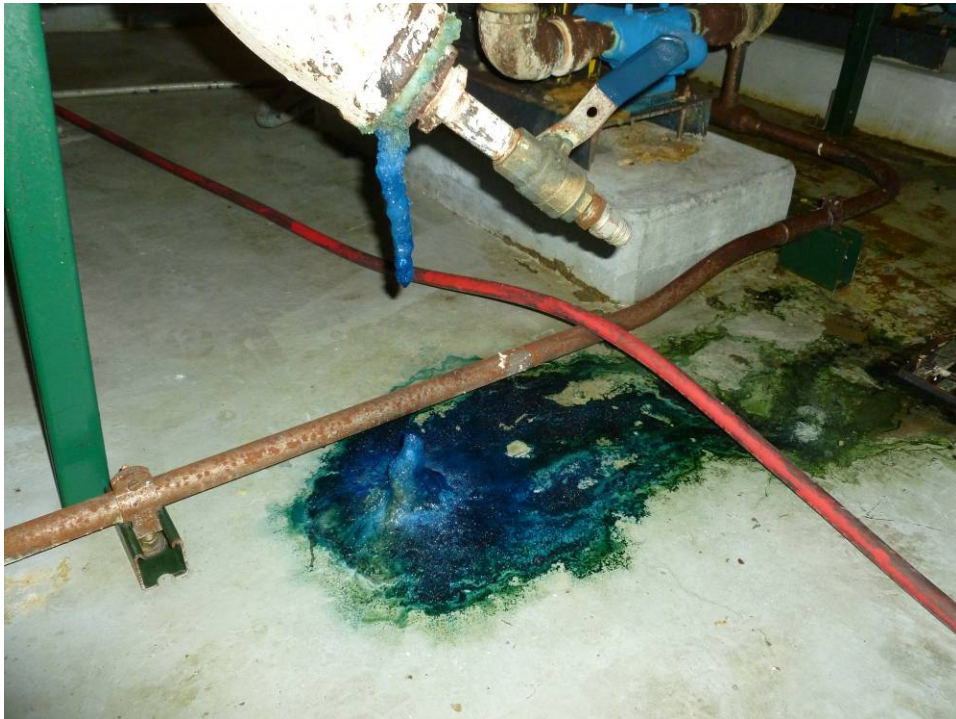
*Photograph 117. (AOI-36) Oil Storage Building. Photo taken from inside area of secondary containment, facing north. Note sump and evidence of release (blue colored material on/beneath pipes east of sump).*

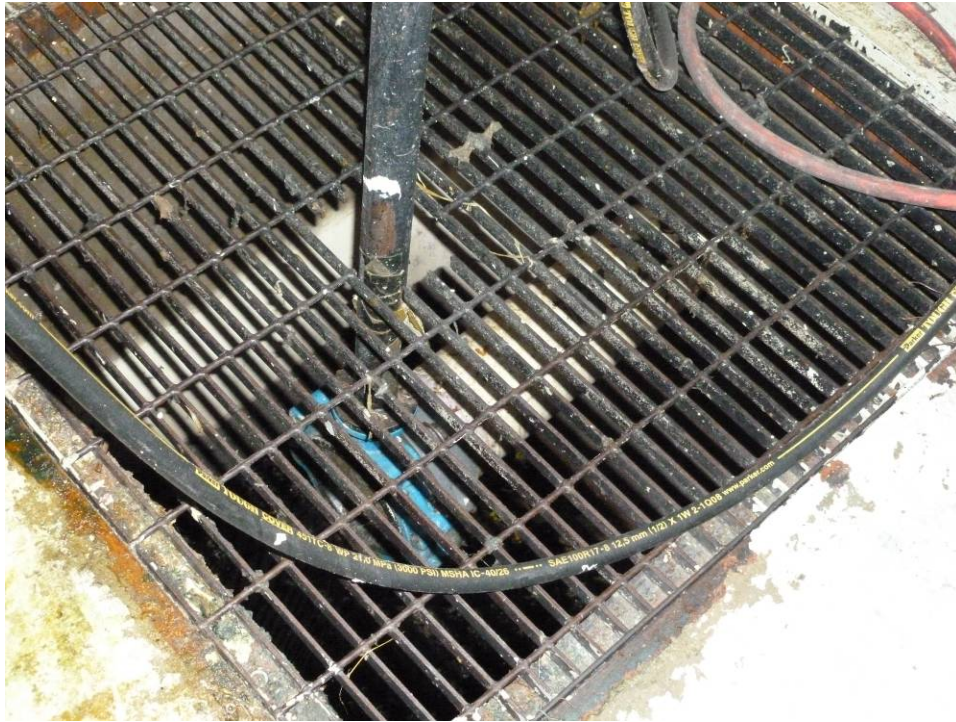
*Photograph 118. (AOI-36) Oil Storage Building. Evidence of release from caustic product tank.*

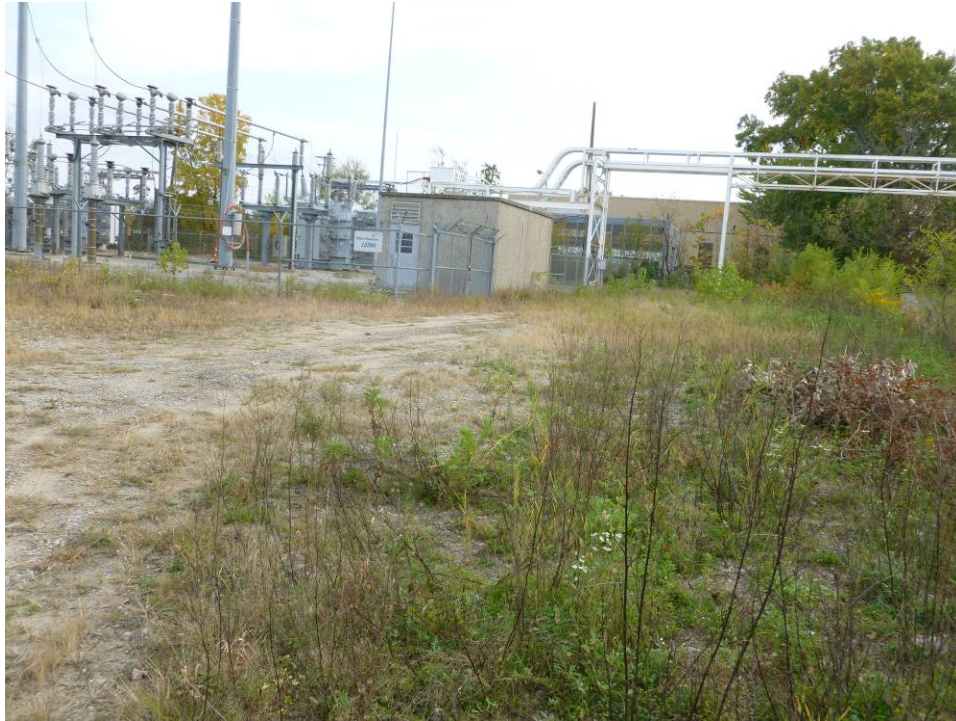
*Photograph 128. (AOI-29) Former railroad spur. Gate 8, believed to be the entrance of the former railroad spur, is located in the northeast area of the photo. Components of the Detroit Edison Substation (AOI-38) are located to the south of Gate 8.*
