SECOND QUARTER 2018 PROGRESS REPORT

(Overall Site Status Review)

RACER Trust Plants 2, 3 & 6

July 16, 2018

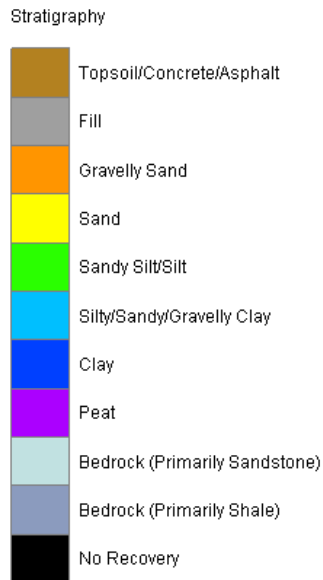
Cross-Section

Coliseum Source Area

Perched zone

- Depleted source in low-K zones
 - Unlikely to leach based on SPLP

Deep Overburden

- Deep overburden consists of dense low-k silt and silty sand (10^{-4} to 10^{-5} cm/s)
- Concentrations consistent with downgradient plume
- Trend analysis suggests ongoing discharge from deep overburden to weathered bedrock decreasing
 - below target concentration ($72 \mu\text{g/L}$) within remediation timeframe

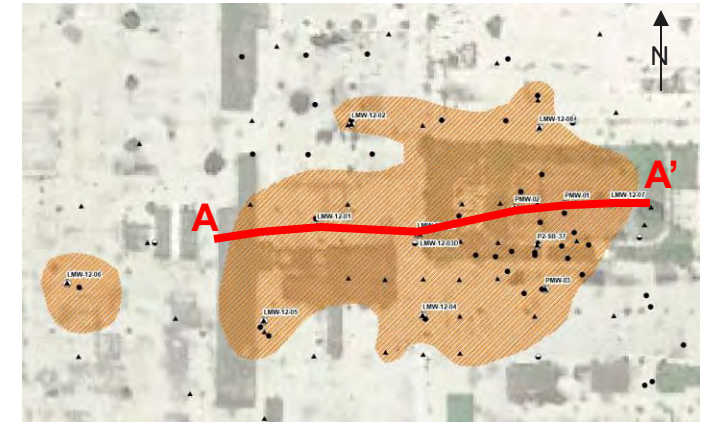
Plant 2 LNAPL Cross-Section

- Residual LNAPL impacts based on LIF response (>15 %RE), visual observations in soil borings, and/or positive shake test results.

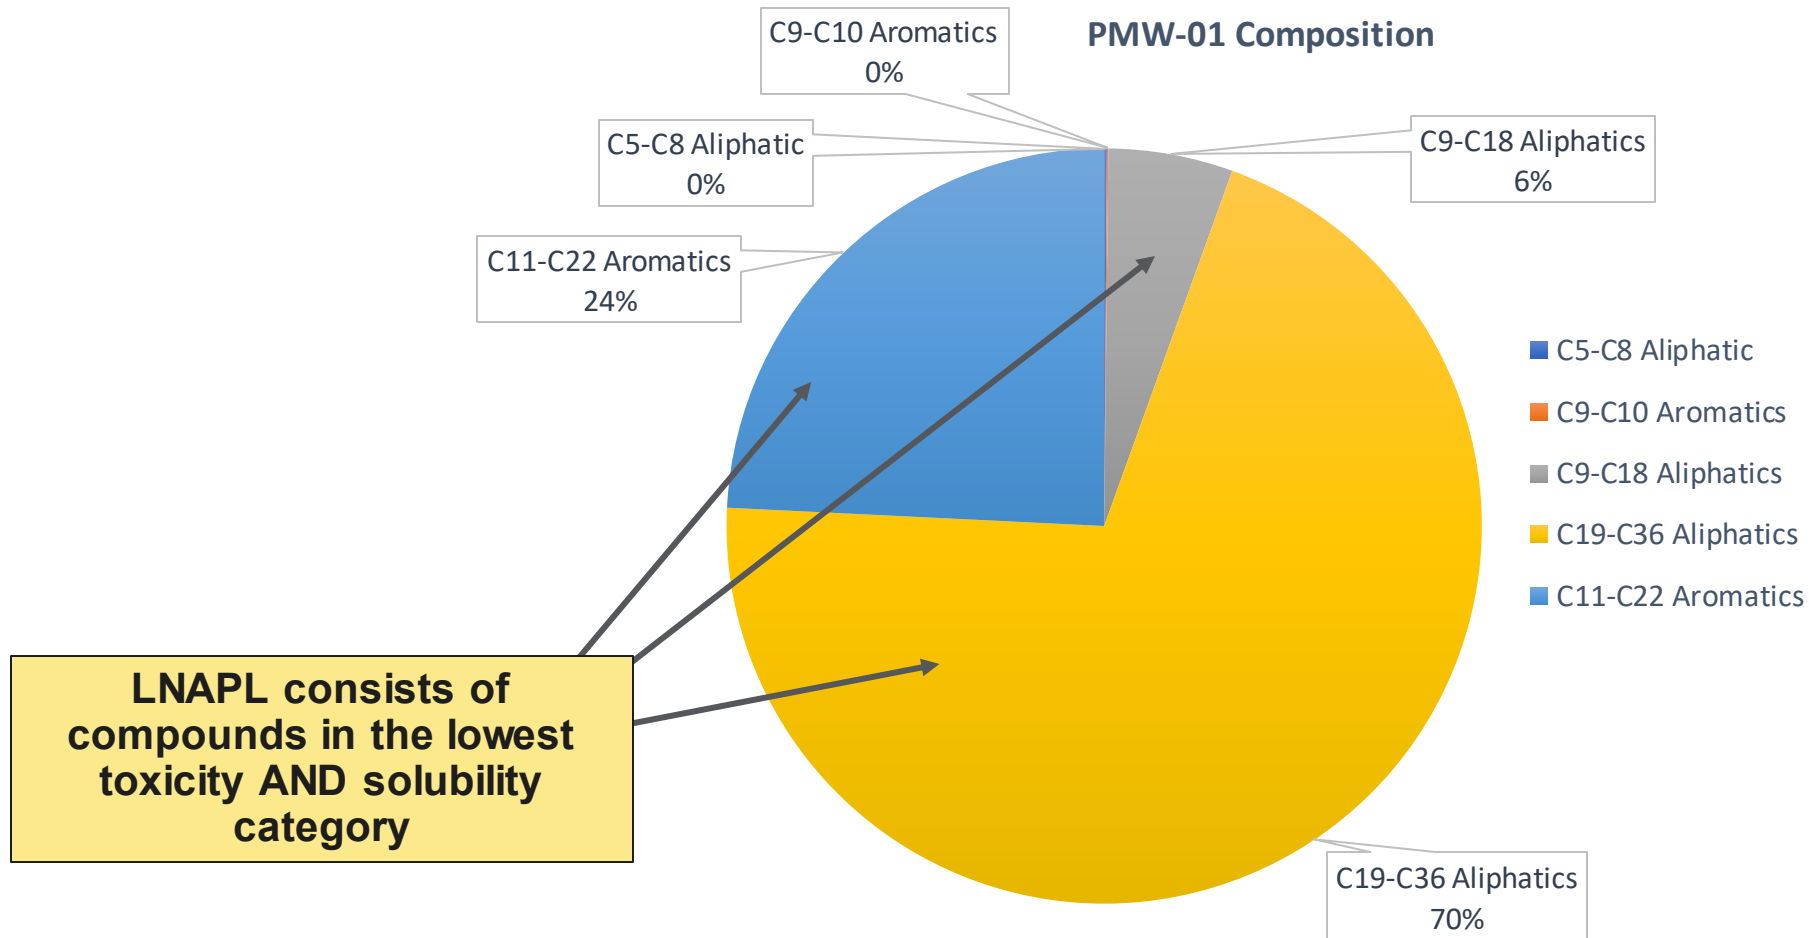
Plant 2 LNAPL Composition

**TPH fractions indicate low overall risk related to toxicity and solubility.
LNAPL potentially addressed with NSZD and institutional controls.**

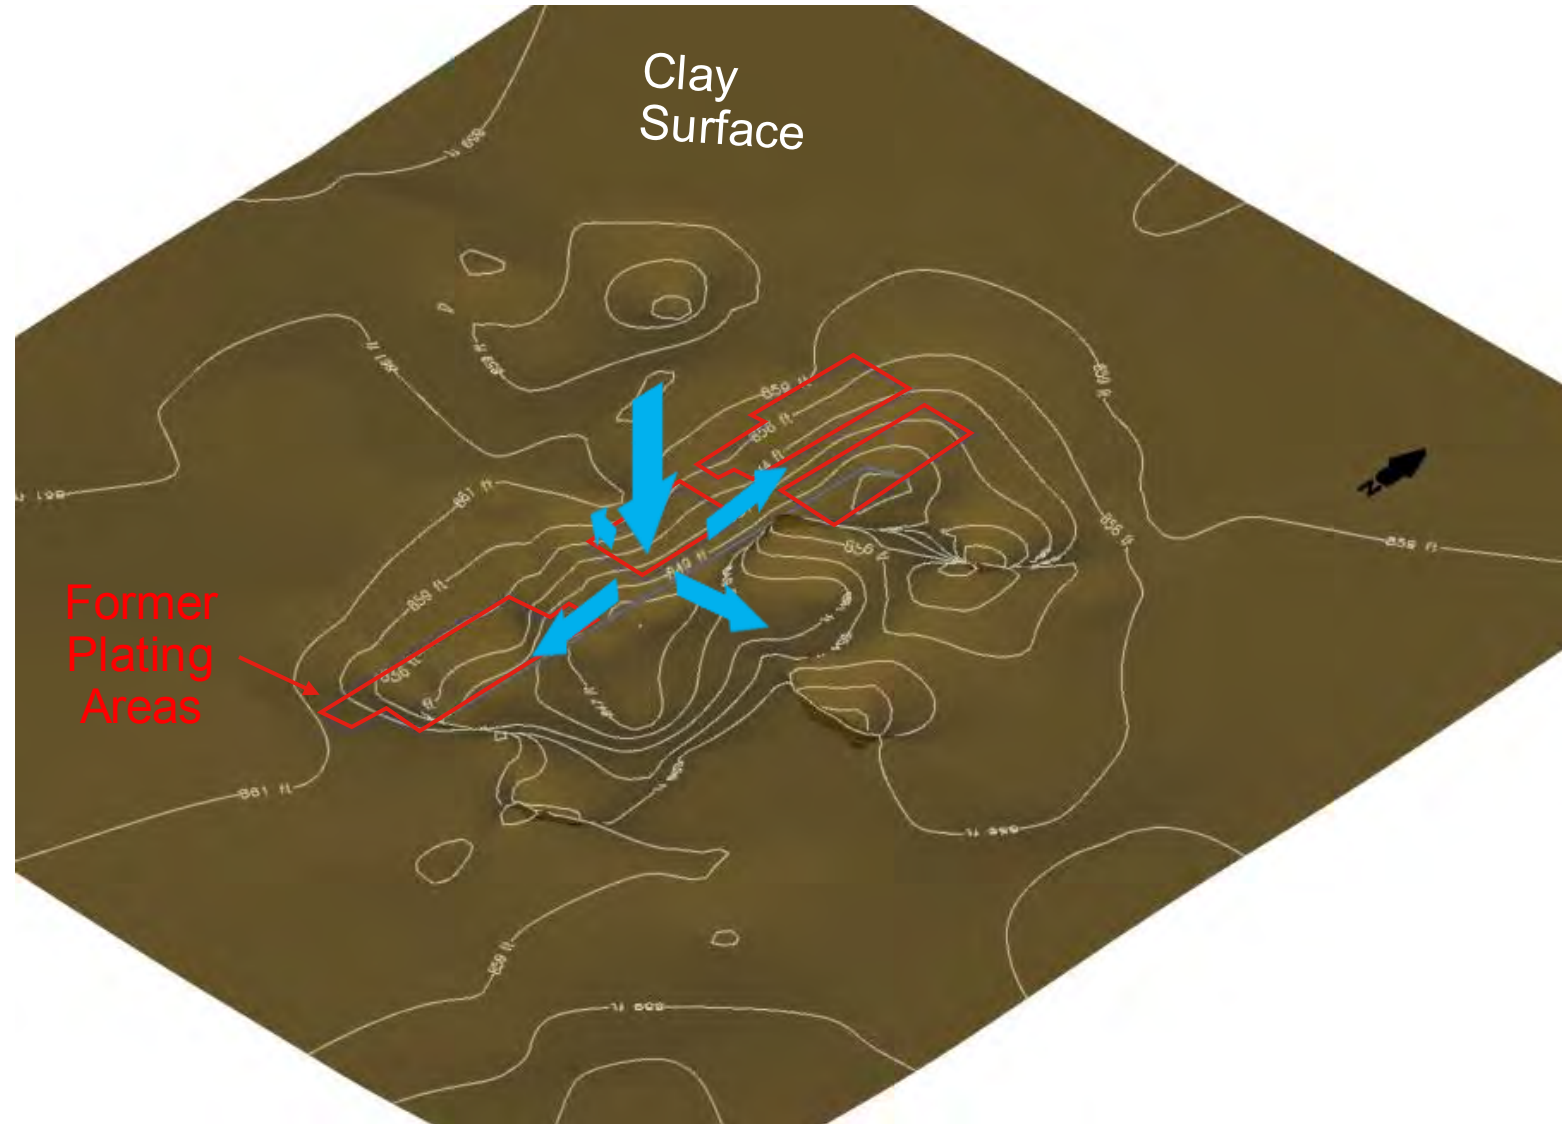
Site Geology

Clay surface underlying the shallow fill

- Fill placed following demolition of plating line
- Area repurposed as press pits
- Outside fill, transport is controlled by thin sand seams in clay till matrix
- Advection driven by recharge with radial flow in sand seams

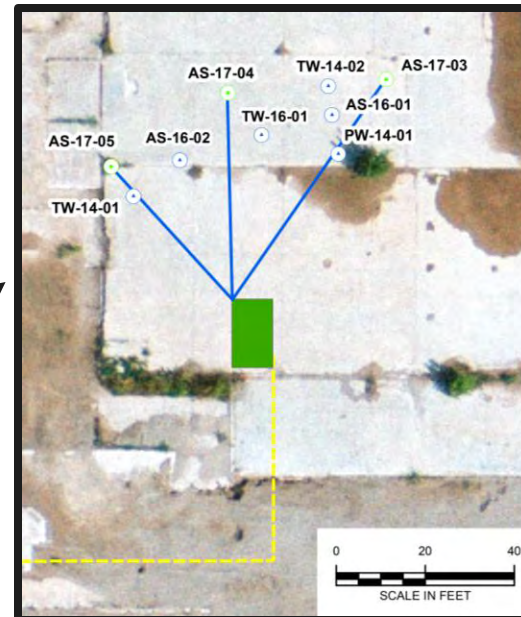
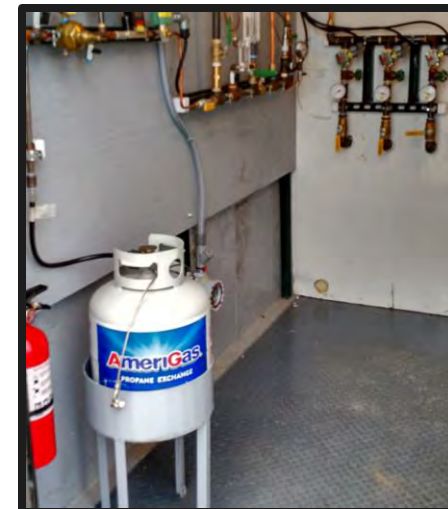
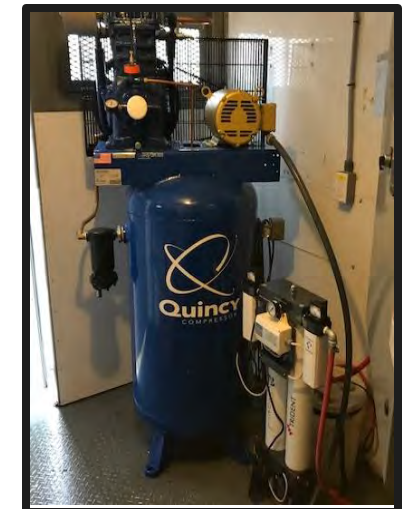
Biosparge Pre-Design Testing

- Co-metabolic biodegradation of 1,4-dioxane utilizing biosparge of air and propane
- Installed sand lens enhancements to consistently distribute gases in weathered zone
- 4 month test sparging 3 sparge wells
- 6 hours of air flow per point per day, 1 hour intervals,
- 2 hours of propane flow per day, 1/2 hour intervals @ 15% LEL
- Bioaugmentation (ENV 425) and nutrient addition (DAP)
- Greater than 97% up time during testing

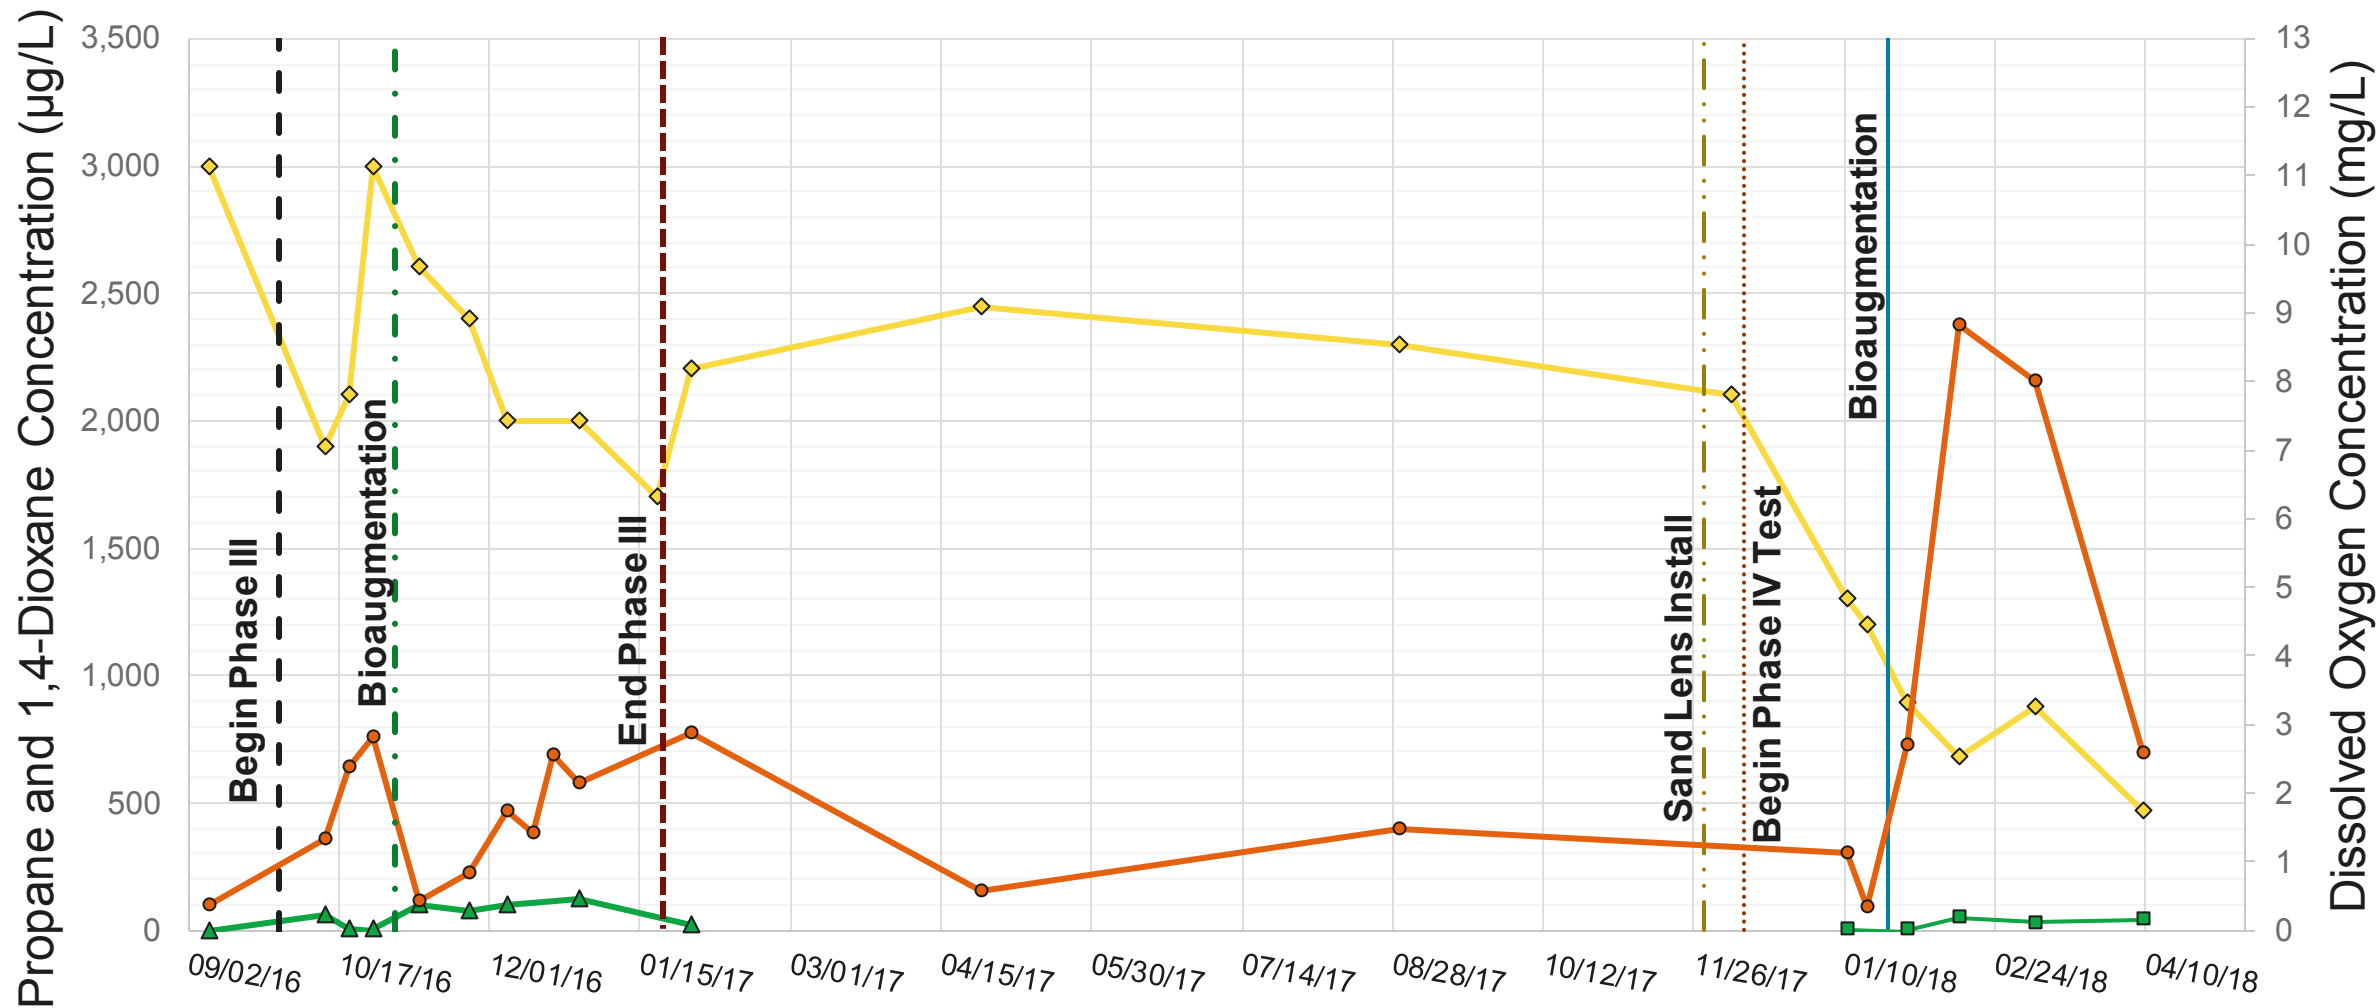
TW-14-02

- ◆ 1,4-Dioxane
- ▲ Propane
- Dissolved Oxygen

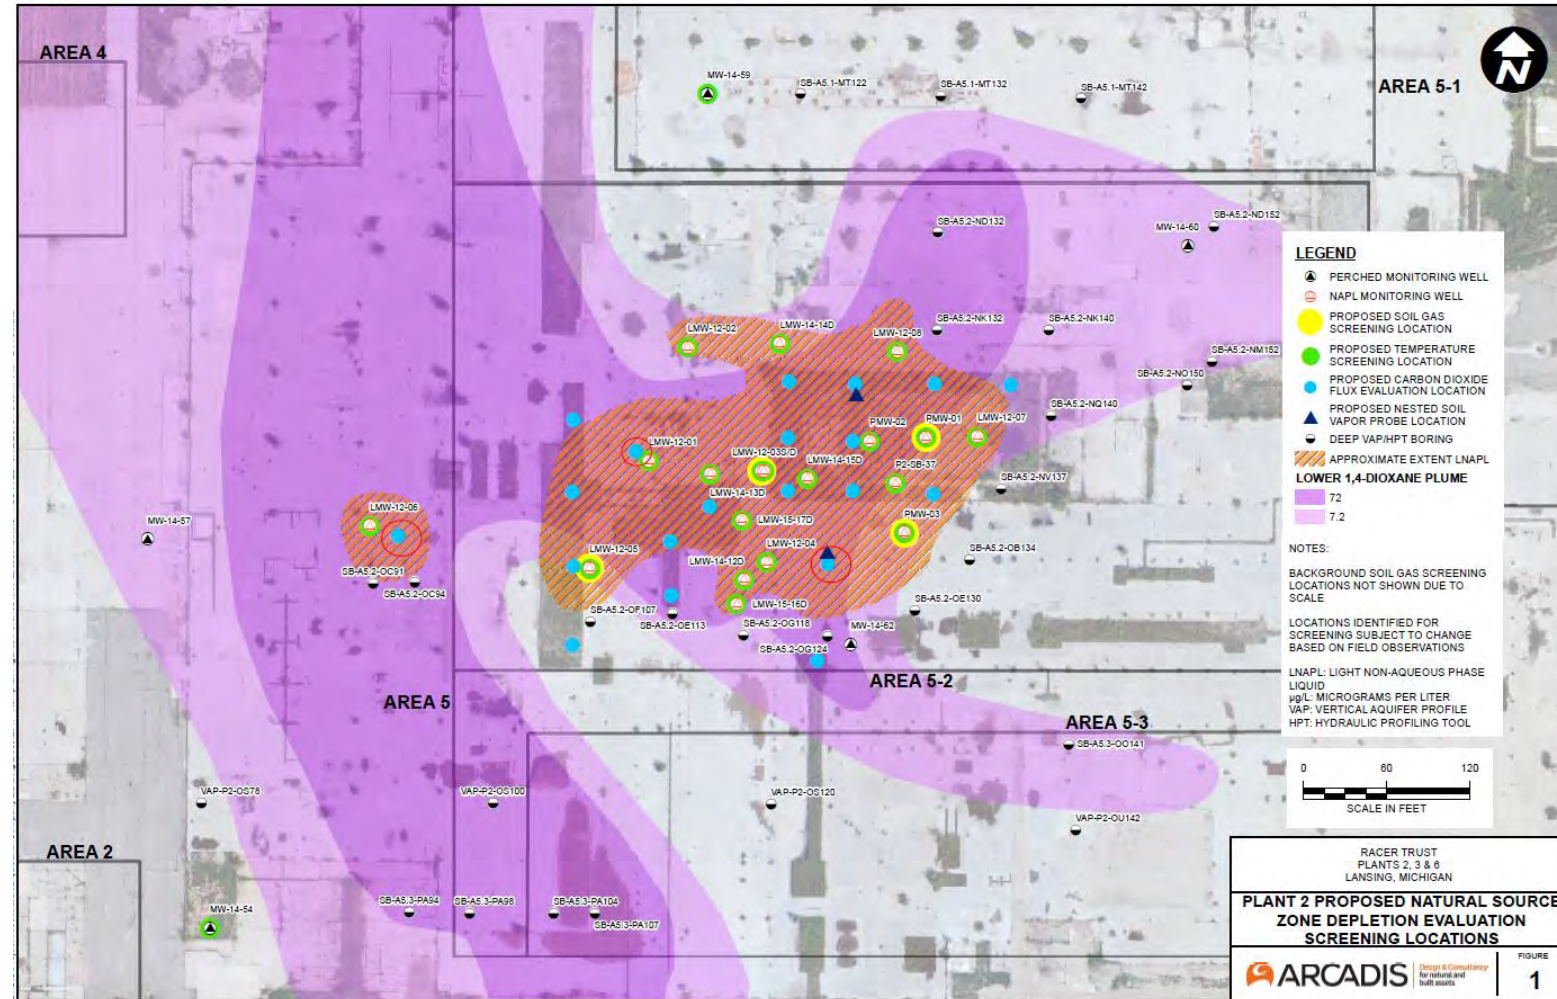
Natural Source Zone Depletion

- Soil vapor screening from existing wells screened across the water table
 - evaluate the extent to which hydrocarbons and/or respiration and biogenic gases are present in the vadose zone
- Temperature profiling (one-time snapshot and long-term)
 - measure the heat released during the biologically-mediated NSZD processes
- CO2 flux evaluation to estimate time-averaged NSZD rates associated with volatilization and biodegradation of hydrocarbons in the vadose zone.

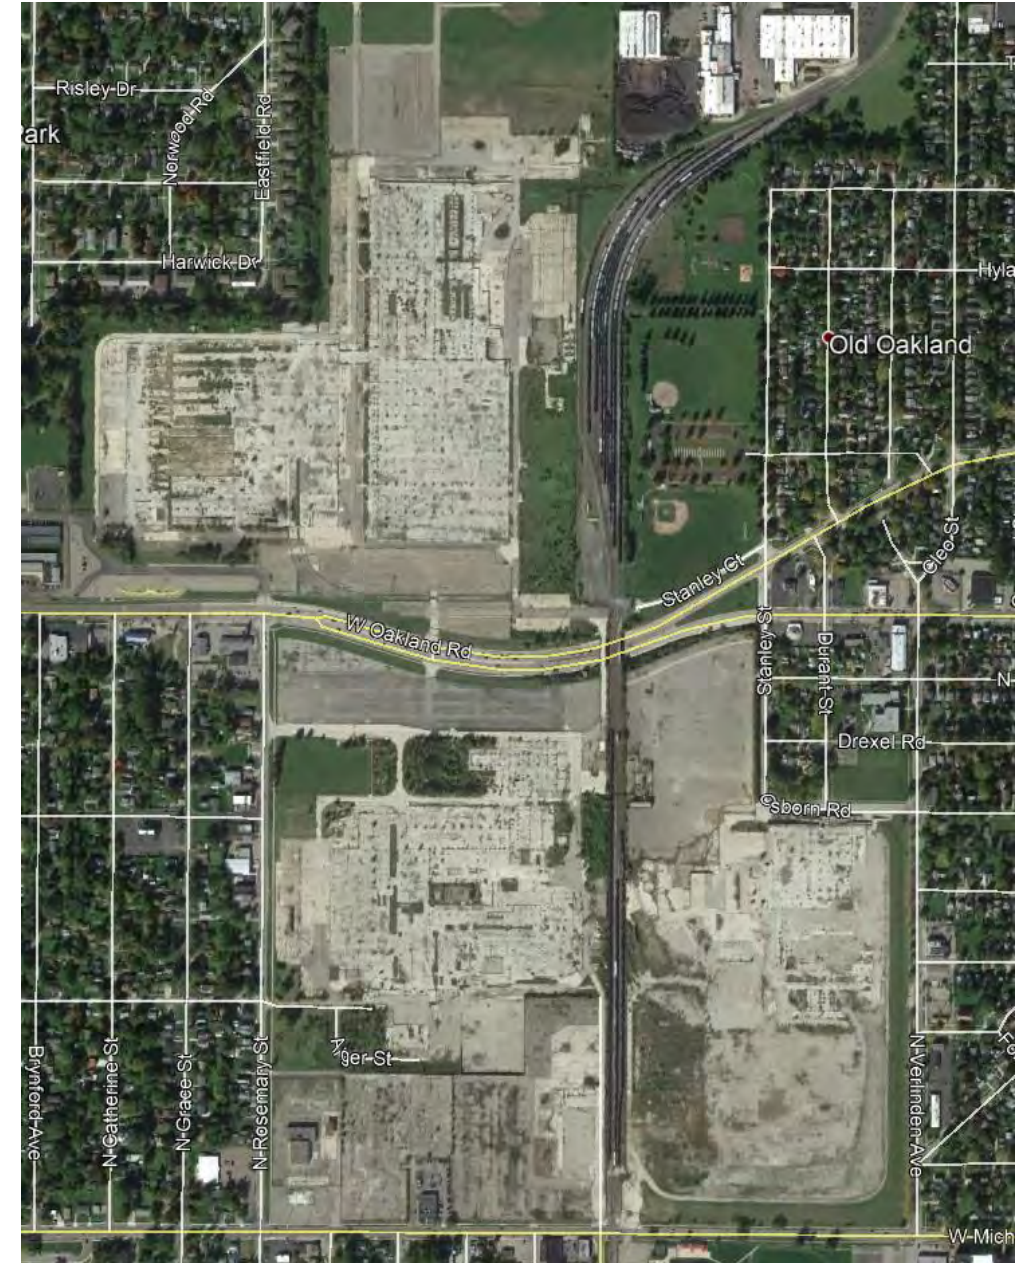
Vapor Intrusion Assessment

Currently evaluating vapor intrusion based on the latest guidance

- Building at Rosemary and W. Michigan
- Property Boundaries
