# 2<sup>ND</sup> QUARTER PROGRESS REPORT

RACER Trust Plants 2, 3 & 6, Lansing, Michigan

July 15, 2019

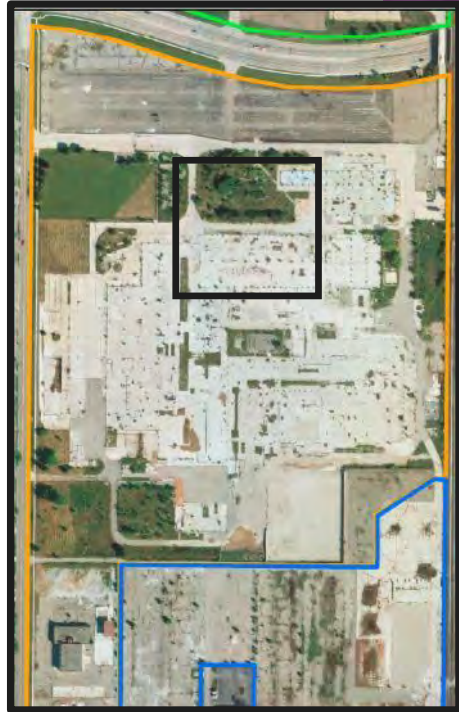
# NSZD Evaluation Locations

- Soil gas readings were taken at five locations
- The presence of VOCs in soil vapor, methane and/or carbon dioxide above atmospheric conditions, and oxygen below atmospheric concentrations can indicate NSZD is active and depleting LNAPL mass

- Initial data provides three lines of evidence that NSZD is active: vapor screening, temperature profiles, and CO<sub>2</sub> / Methane flux
- LNAPL is being degraded at a rate ranging from approximately 1,200 to 3,500 gallons/acres/year
- CO<sub>2</sub> flux method does not account for naturally-occurring CO<sub>2</sub> flux, likely an over estimate
- Using the minimum of the range, this equates to approximately 1,400 gallons of LNAPL depleted per year at the Site, based on a LNAPL footprint of 1.2 acres
  - For reference, manual LNAPL recovery efforts removed 57.8 gallons of LNAPL in 2017

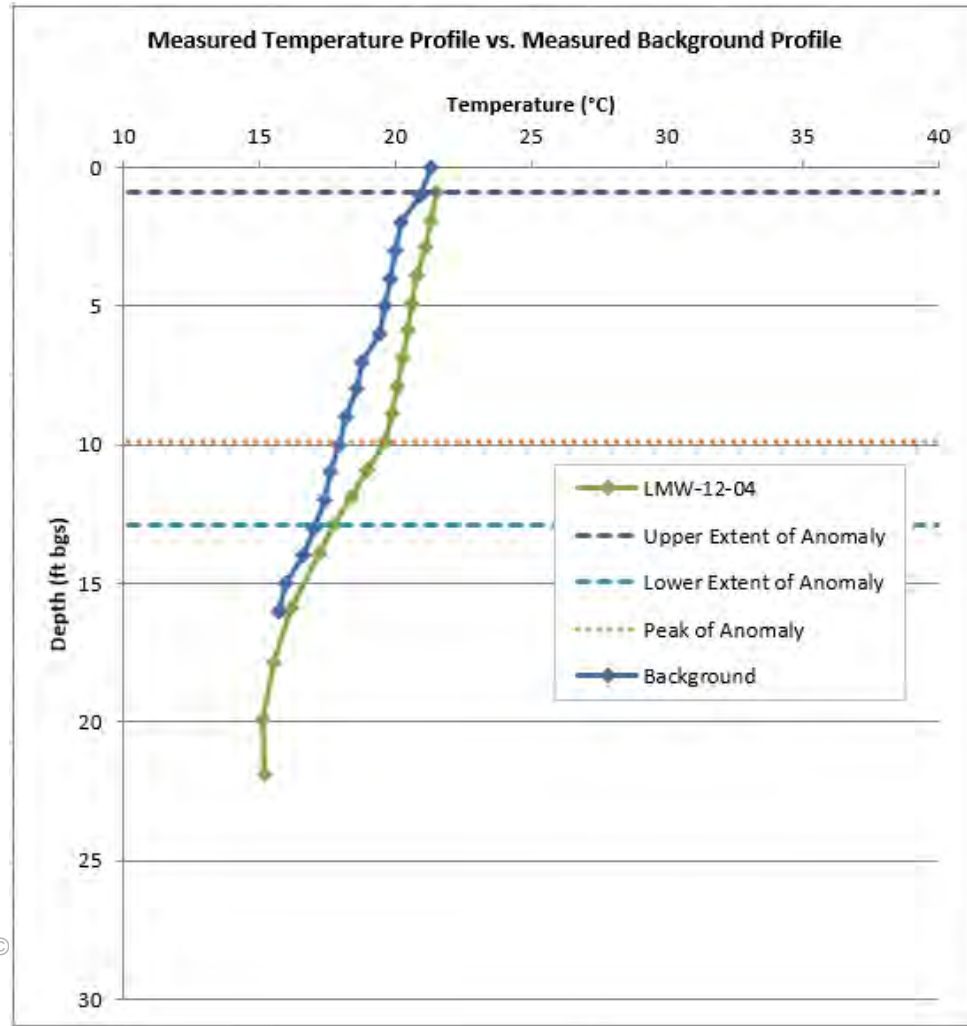
- “Snapshot” temperature profiles collected at 18 MWs in 8/18.

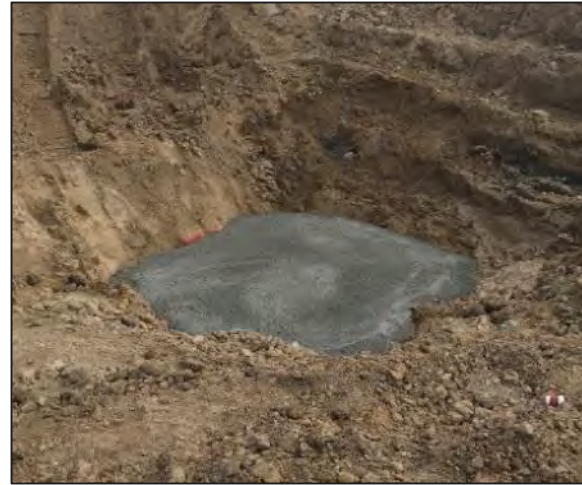
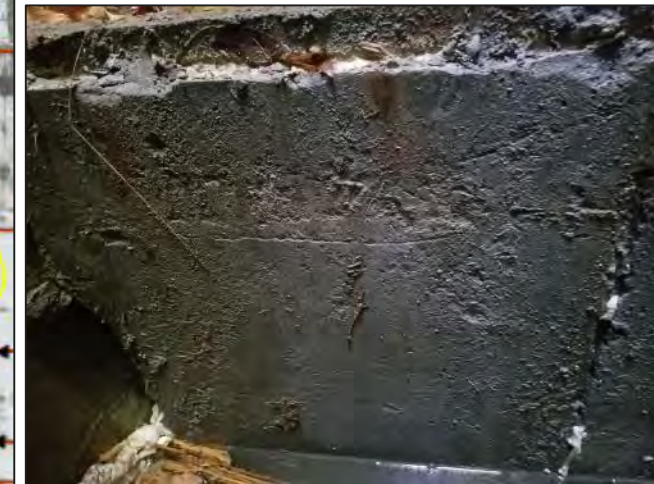
# 2018 Storm Sewer Modifications – Plant 3

- Previously observed PFAS impacts in storm sewers discharging from site at the Plant 3 outfall
- Modifications made to the storm sewer aimed at mitigating flow out of the eastern and western mains at the Plant 3 outfall
- 2 CLSM monoliths installed away from northern property boundary
- Excavations to install monoliths were ~27 feet deep, no groundwater was encountered in the excavations
- About 150 catch basins capped to minimize flow into the storm system
- Two mains to the southwest bulkheaded to mitigate potential backflow of impacted water
- Completed in October 2018

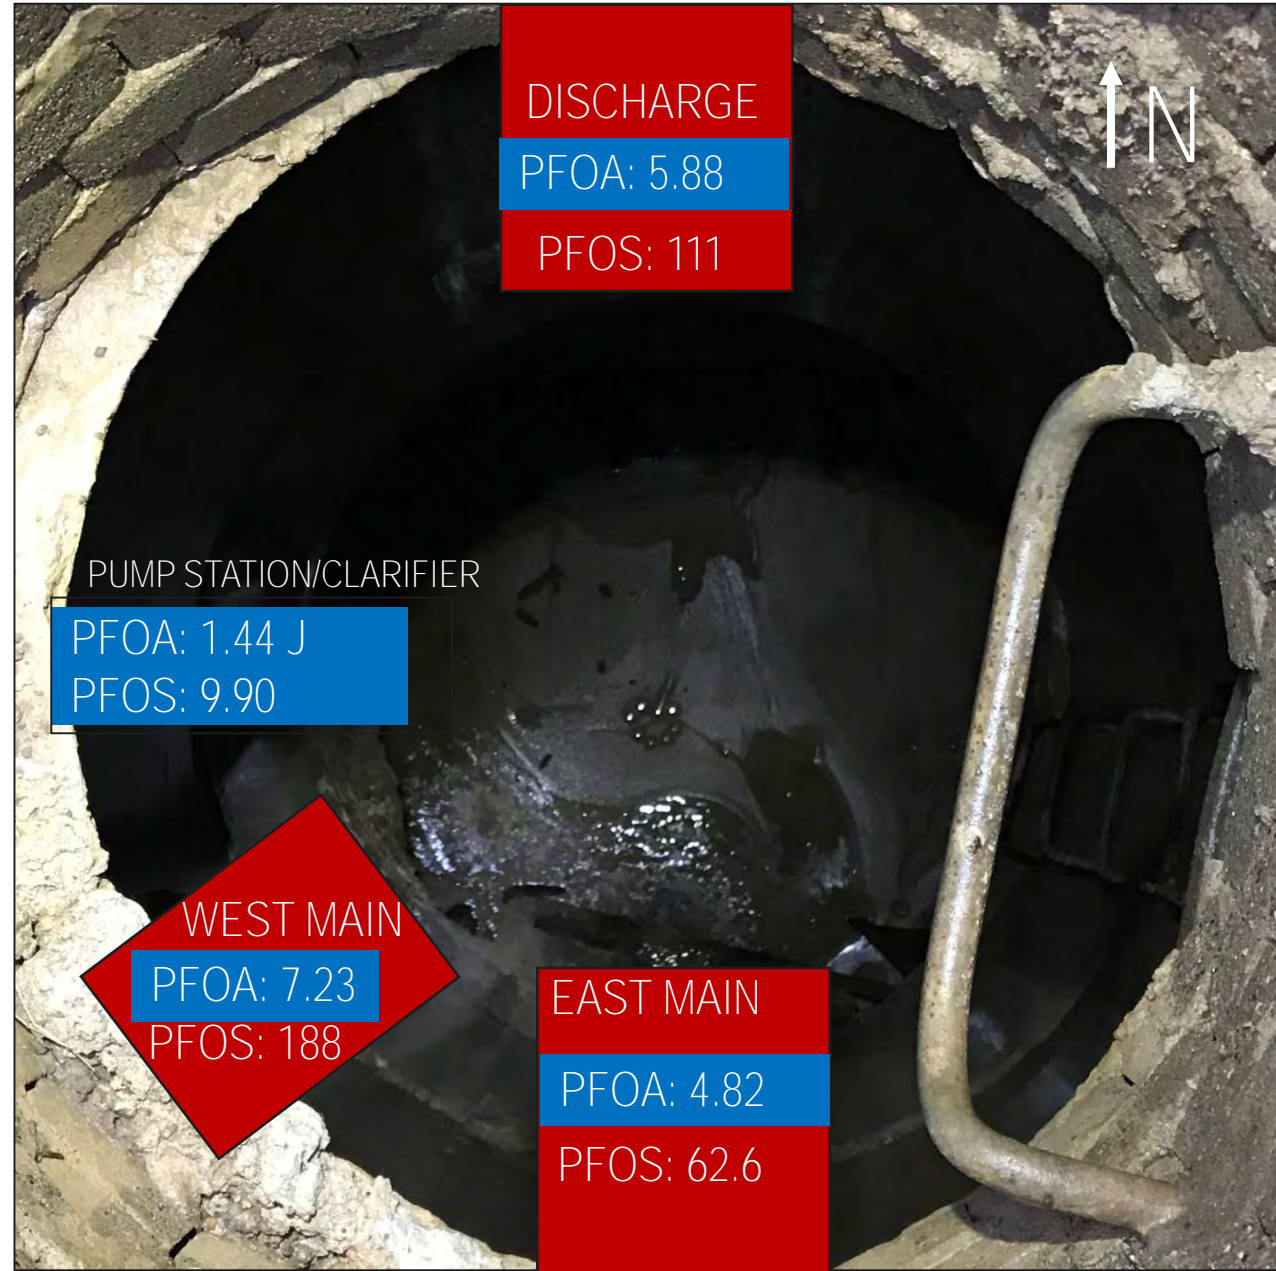
# March 2019 Invert Sampling

- All pipes contributing flow into the manhole at the northern property boundary were sampled individually with grab sampler
- Samples from the pipes showed concentrations above surface water criteria
- Flow from east main is apparent
- Standing water in west main backing up into sump

Sample taken 3/19/2019

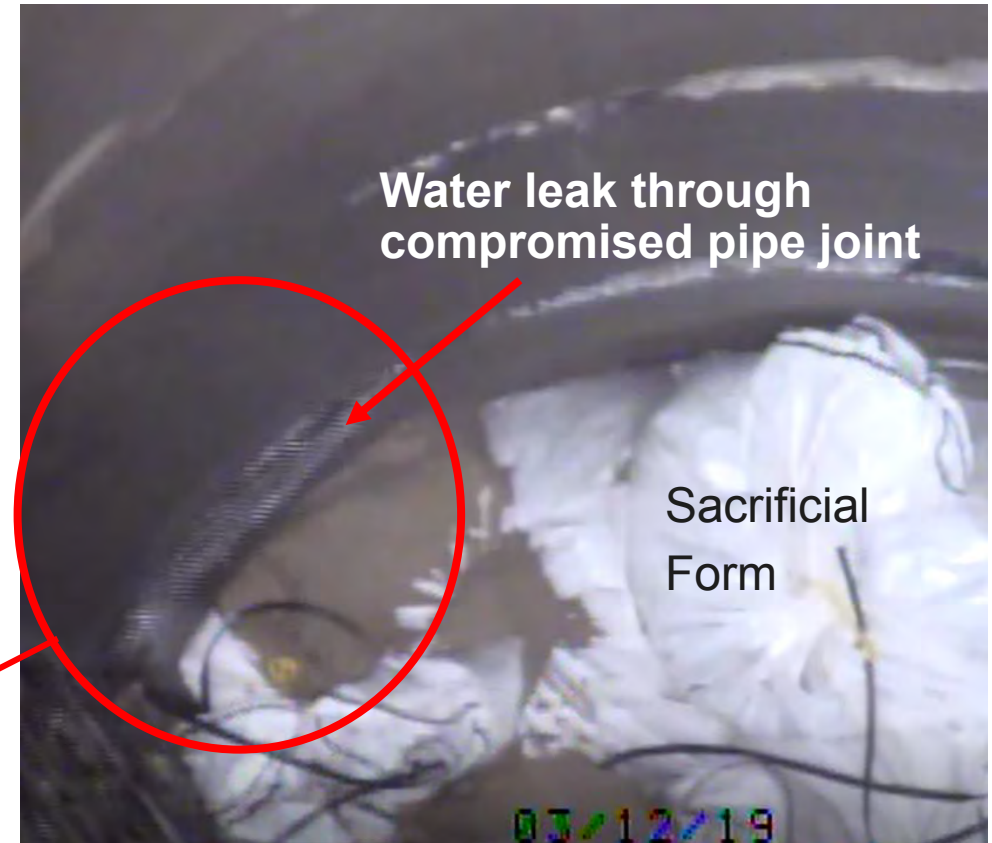
# March 2019 Camera Survey

- Sewer camera crew dispatched to collect video on E and W mains
- East Monolith is effectively blocking water in sewer pipe
- Infiltration into the first concrete pipe joint downstream of monolith was observed
- Sediment buildup prevented inspection of west main

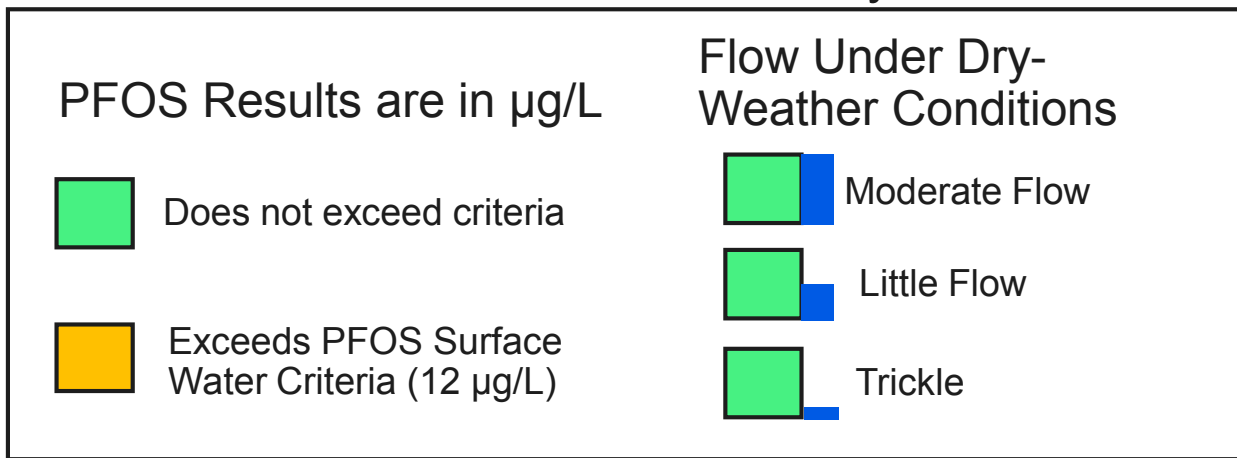
# Identify - Plant 2 PFOS Results Summary

- Initial round of sampling in January 2019 (9 structures)
  - 7 structures above PFOS criteria, including northern property outfalls
  - Southwestern outfall below criteria
- Confirmatory sampling and structure investigation took place in March 2019
  - Results consistent with January event
