RE: Windiate Park/Dixieland Subdivision Landfill, Pengelly Road Site, Genesee County, Michigan  
(Site ID No. 25000689)

FILE: 1088190/1940103639 - Soil Cover Inspection Report

## WINDIATE PARK SOIL COVER MAINTENANCE CHECKLIST

## WINDIATE PARK FLINT, MICHIGAN

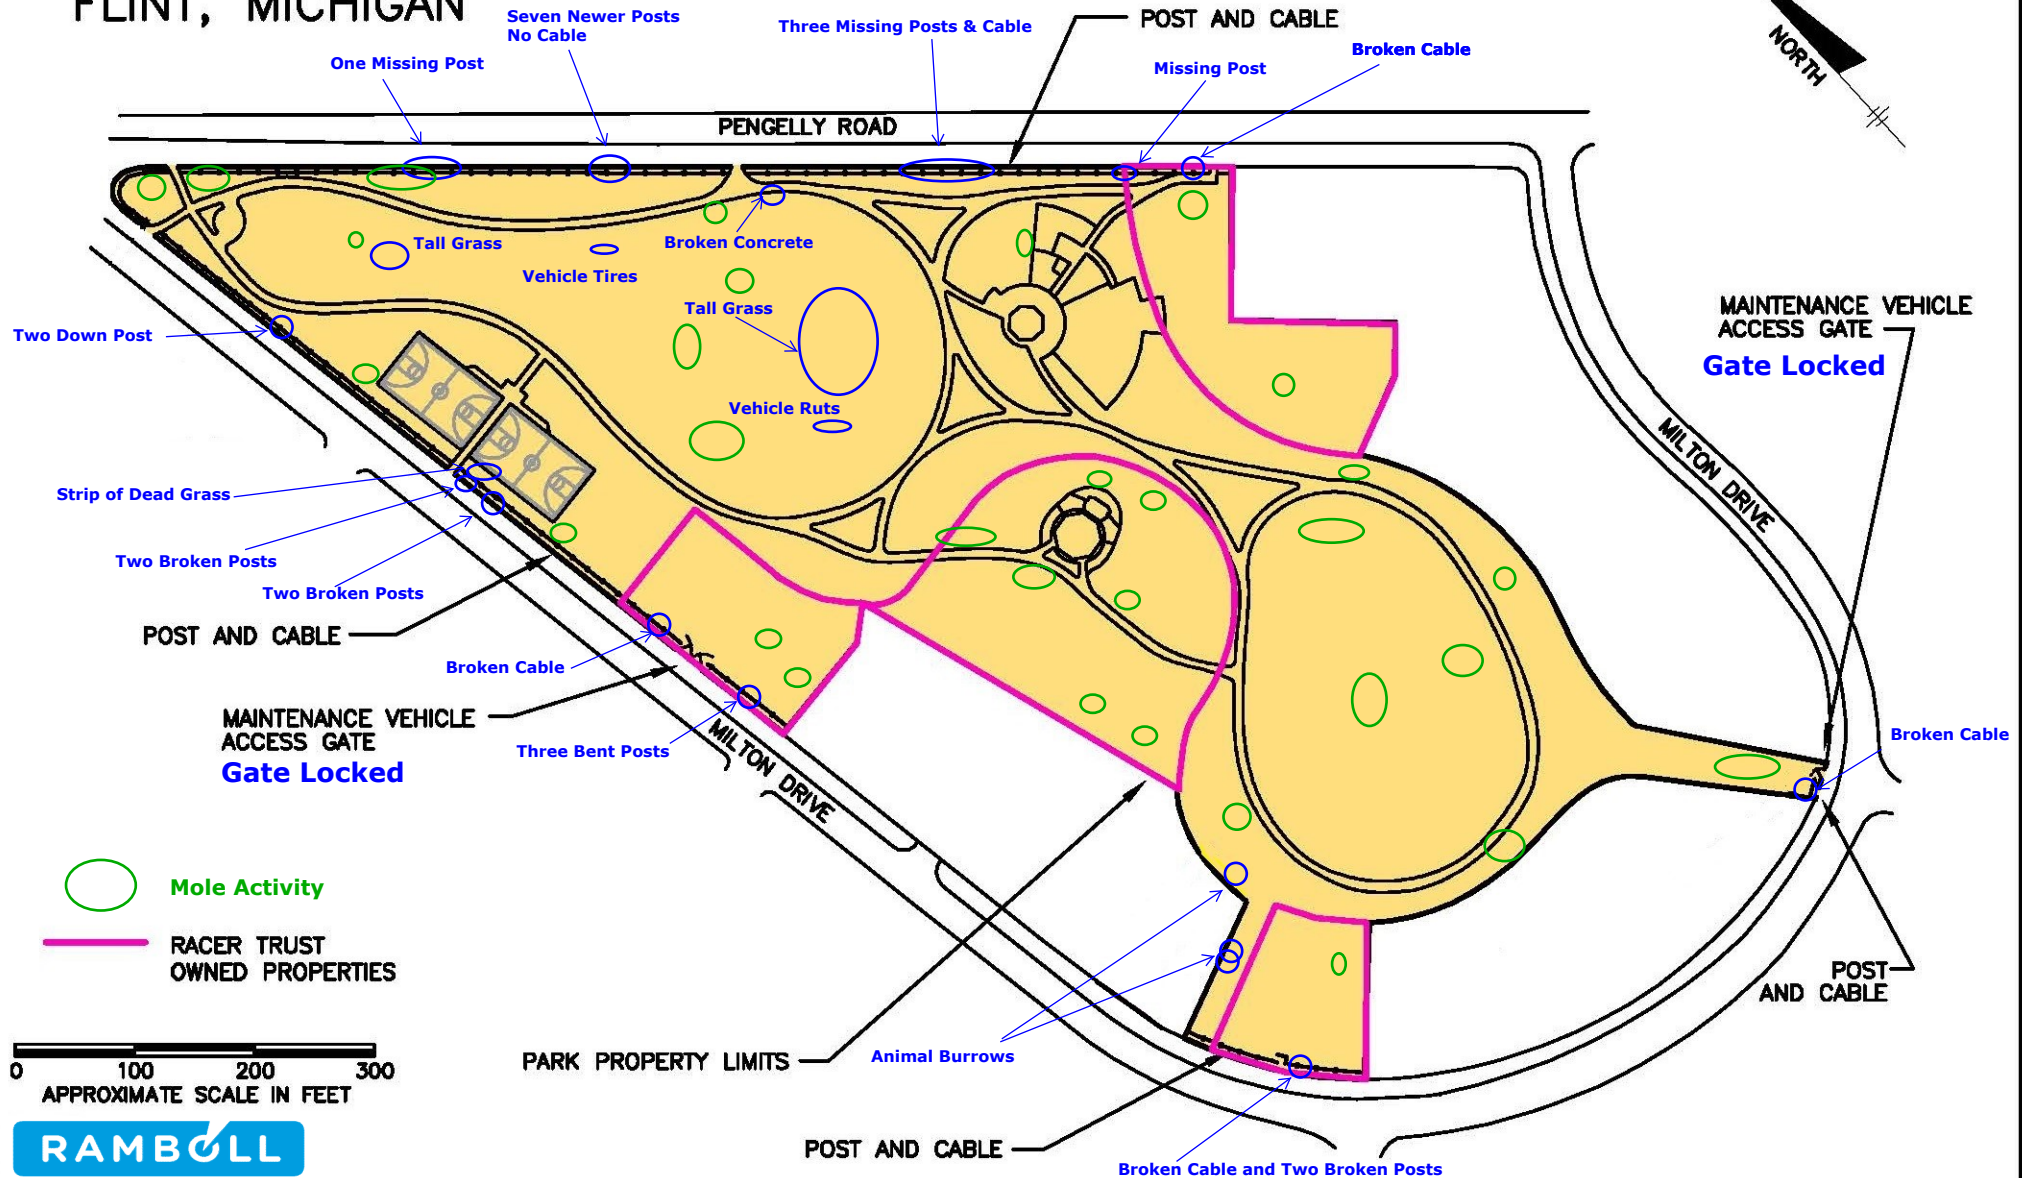
# INSPECTION MAP

| Inspected Item: | Comments: |
|---|---|
| SOIL COVER | Some small areas of exposed soil throughout site due to mole activity (mole mounds/trails). |
| GRASS/VEGETATIVE LAYER | Acceptable. No maintenance required at this time. On the City of Flint property: Two areas were observed with tall grass and tall woody plants. One area was observed with dead grass. |
| POST & CABLE / VEHICLE GATES | Approximately ten damaged posts were observed during the site inspection (either partially down or completely down). Approximately five posts were missing. Approximately five sections of down cable were observed. The south and west maintenance vehicle access gates were locked. |
| OTHER OBSERVATIONS | A number of mole mounds and/or trails were observed. Unable to determine if the mounds are from recent activity or from older activity. Two animal burrows were observed. At one burrow an entry and exit were observed and at the other burrow only an entry was observed. Efforts will be needed to remove the animals from the burrows. No signs of waste were observed in the animal burrow spoils. On the City of Flint property, one section of concrete was observed where the concrete collapsed around manhole on the sidewalk along Pengelly Road. Vehicle ruts were observed near the area with tall vegetation. |

Grass has been mowed

Cut down tall vegetation areas and add topsoil to grade.  
Manage animal burrows and mole activities.  
Replace cable and posts that are missing or damaged.
