RE: *Quarterly Status Report –October 2015 – December 2015*  
*Coldwater Road Landfill*  
*1245 East Coldwater Road, Flint, MI*  
*MID 005 356 860*

**4TH QUARTER 2015  
BURROW LOCATION  
MAP**

4<sup>TH</sup> QRT - PHOTOGRAPHIC LOG

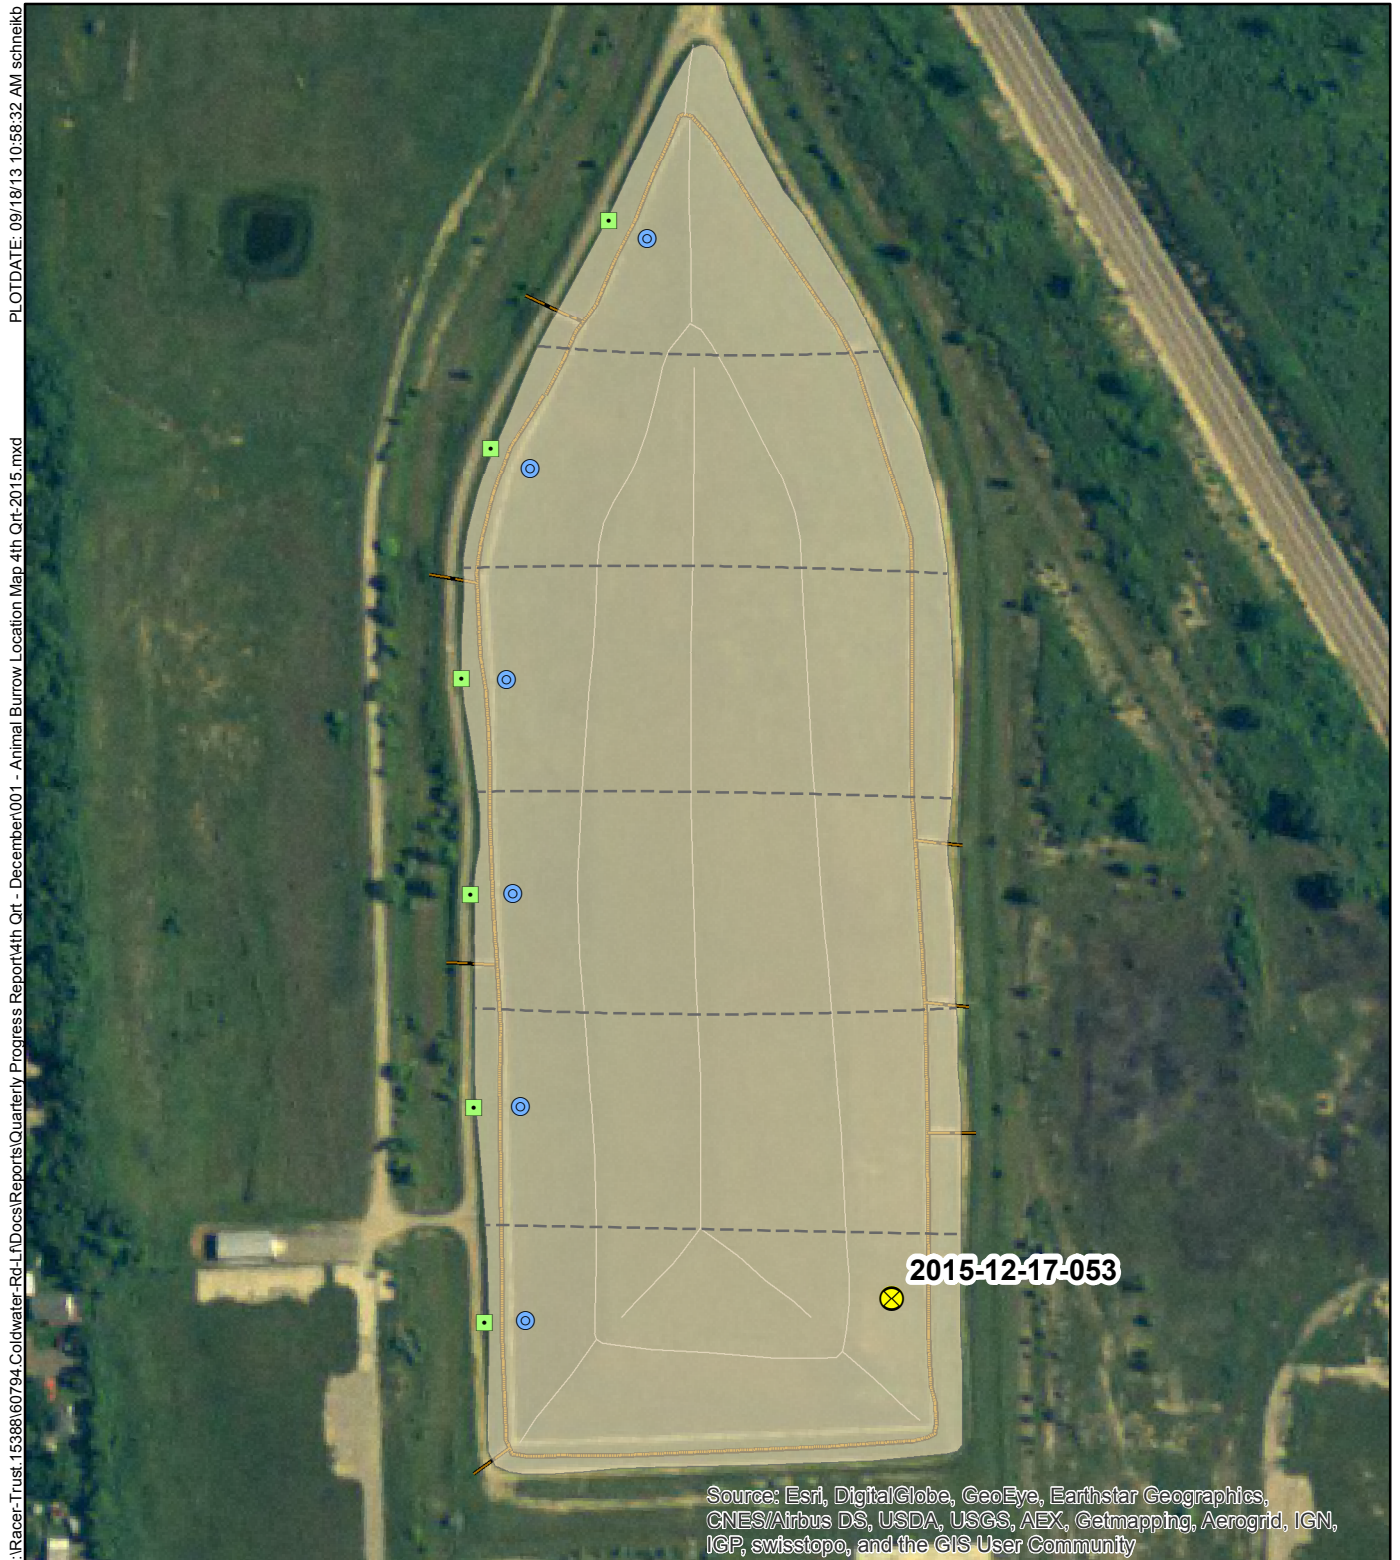
- » Observed one potentially active animal burrow on December 15, 2015 and set trap. There was no activity at burrow and on December 17, 2015 the burrow was filled in and closed out. On December 15, 2015 a number of mole mounds were observed at Cell F3 and Cell F4. Mole traps were set on December 30, 2015 and will be monitored during the first quarter 2016. See attached figure for animal burrow location and photo log for detailed information concerning animal burrow activities for this quarter.

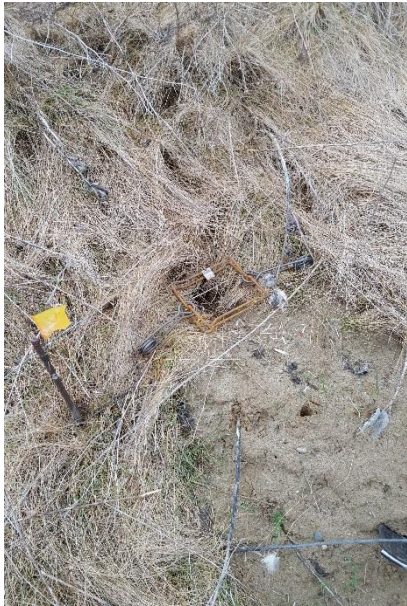
LOCATION:		APPROX. LENGTH:	APPROX. DEPTH:	APPROX. DIAMETER:
Cell F3 – Middle of slope		4+ feet	1 foot	4 inches
DATE FOUND:	DATE CLOSED:

12/15/15	12/17/15			
<b>NOTES:</b> <b>ID: 2015-12-17-053</b>  PRE repair photo of burrow.  Trap set up for 2 days. No activity.  No signs of liner damage.

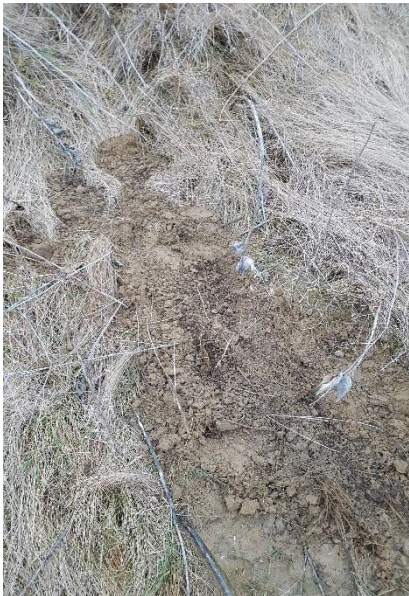
<b>LOCATION:</b>  Cell F3 – Middle of slope		<b>APPROX. LENGTH:</b>  4+ feet	<b>APPROX. DEPTH:</b>  1 foot	<b>APPROX. DIAMETER:</b>  4 inches
<b>DATE FOUND:</b>  12/15/15	<b>DATE CLOSED:</b>  12/17/15

<b>NOTES:</b>  <b>ID: 2015-12-17-053</b>  POST repair photo.  Filled in burrow.
