MEMO

Fiero Monitoring Well Abandonment Summary
Pontiac North Campus

Figure 1 Well Abandonment Locations Former Fiero Property

RACER TRUST
 PONTIAC NORTH CAMPUS
 PONTIAC, MICHIGAN

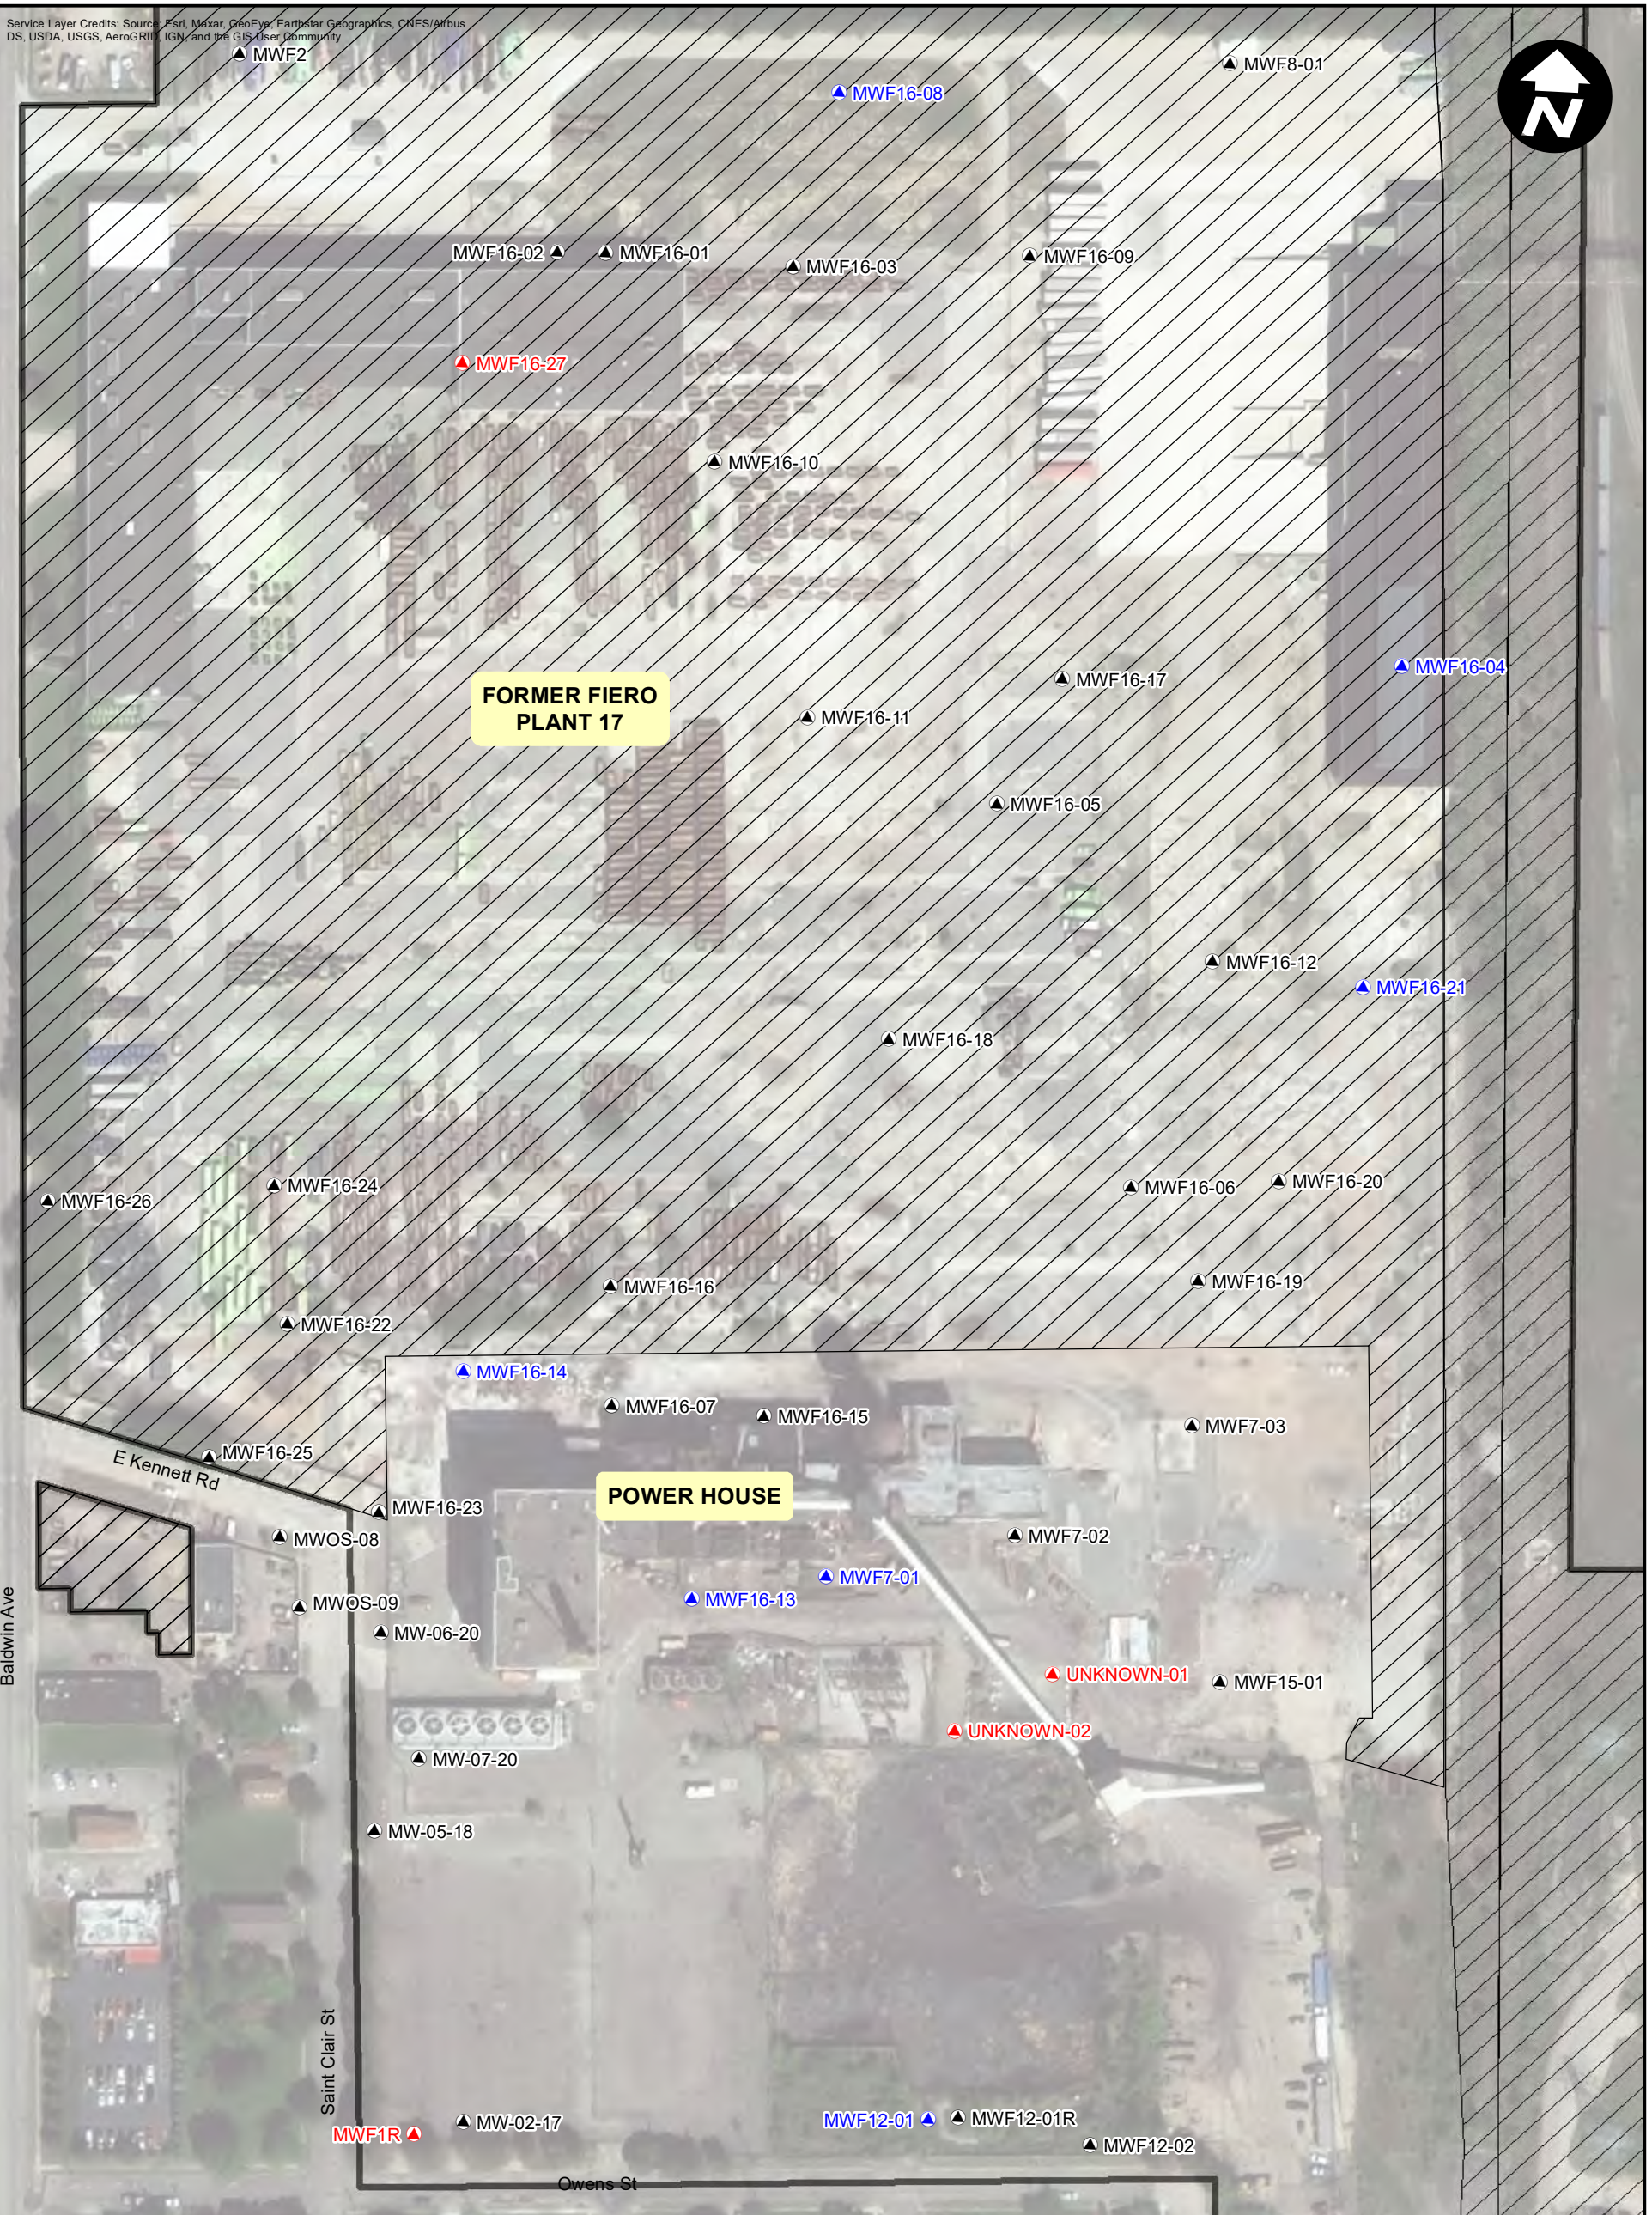
This memorandum summarizes monitoring well abandonment activities conducted at the Former Fiero Assembly and Powerhouse properties of the Revitalizing Auto Communities Environmental Response Trust (RACER) Pontiac North Campus Site (Site) located in Pontiac, Michigan (**Figure 1**). The well abandonment scope of work was performed in accordance with the United States Environmental Protection Agency's (USEPA's) August 11, 2020 limited approval of the *Fiero Property Well Abandonment Request* (Arcadis, July 2020).

**WELL ABANDONMENT LOCATIONS
 FORMER FIERO PROPERTY**

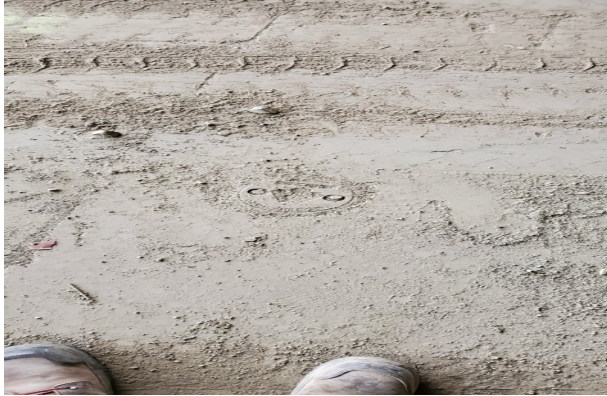
Well ID: MWF16-27

Well before Abandonment

Well Depth: 25 ft

2in Annulus Grouted: Yes No from 25 ft to 1 ft Grout Type: Bentonite

Casing: Pulled Cut Depth BGS: 3 Well Grouted? Yes No

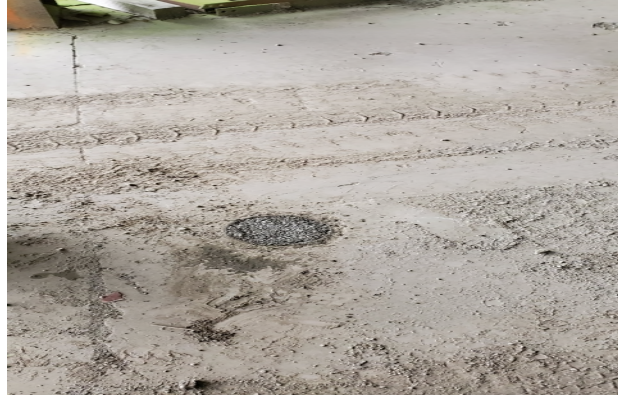
Well after Abandonment

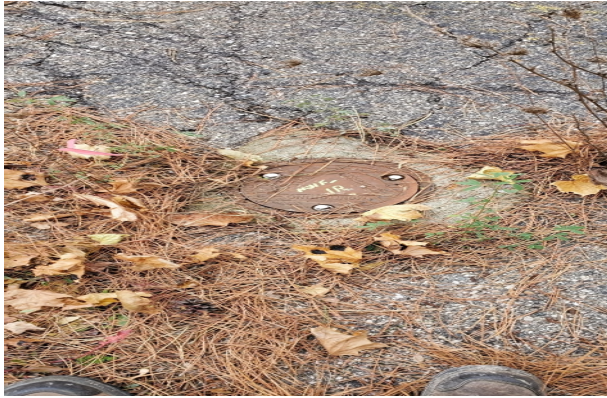
Well ID: MWF1R

Well before Abandonment

Well Depth: 24 ft

2in Annulus Grouted: Yes No from 24 ft to 1 ft Grout Type: Bentonite

Casing: Pulled Cut Depth BGS: 3 Well Grouted? Yes No

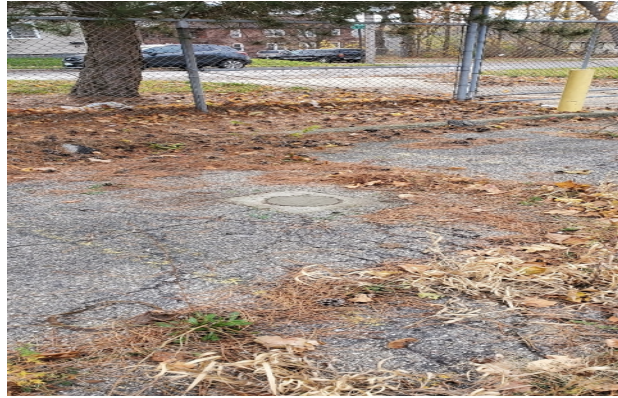
Well after Abandonment

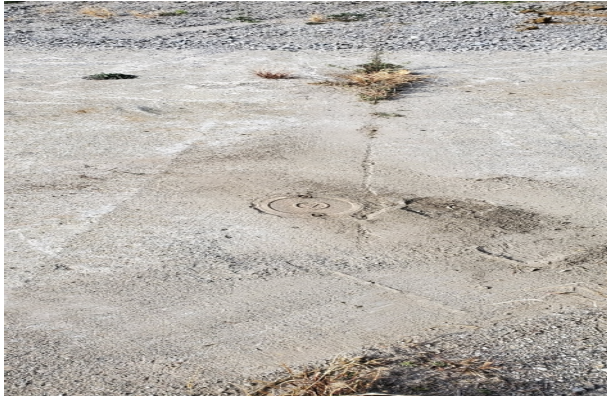
Well ID: UNKNOWN-01

Well before Abandonment

Well Depth: 24.11 ft

2in Annulus Grouted: Yes No from 24.11 ft to 2 ft Grout Type: Bentonite

Casing: Pulled Cut Depth BGS: 3 Well Grouted? Yes No

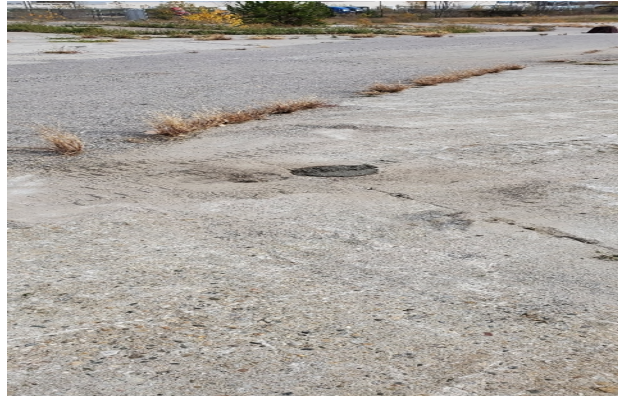
Well after Abandonment

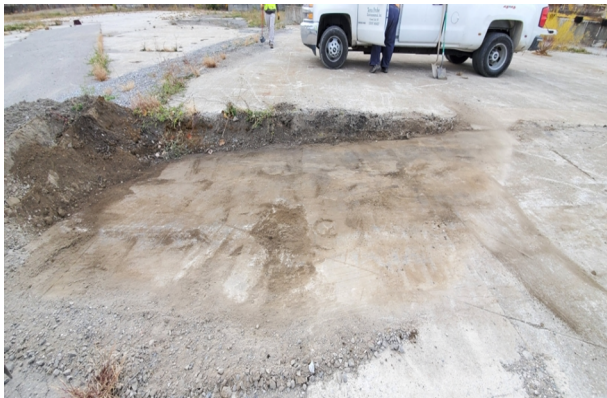
Additional Photos

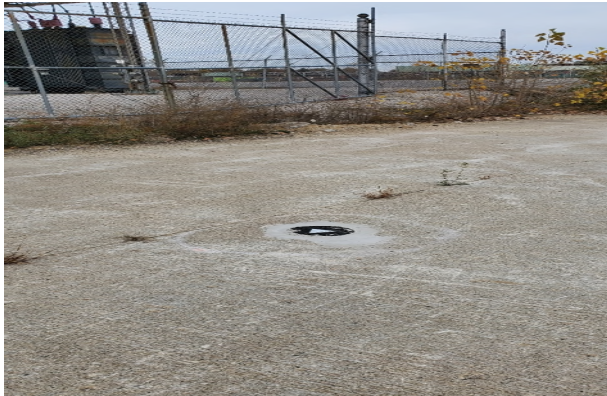
Well ID: UNKNOWN-02

Well before Abandonment

Well Depth: 39.1 ft

2in Annulus Grouted: Yes No from 39.1 ft to 1 ft Grout Type: Bentonite

Casing: Pulled Cut Depth BGS: 3 Well Grouted? Yes No

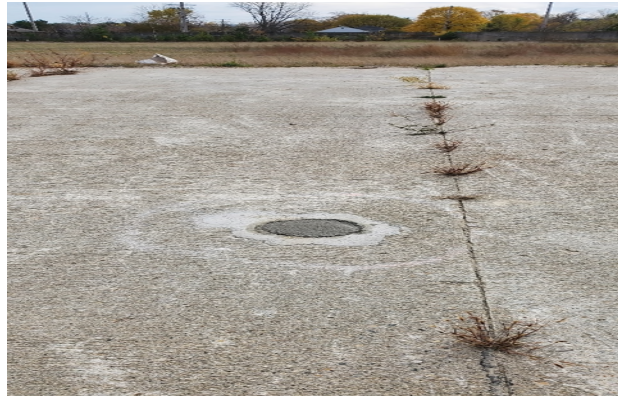
Well after Abandonment
