Subject: Plant 2 Area 2 Excavation and Plants 2 and 3 Exposure Barrier

Placement Completion Report

Plants 2 & 3 MID 980 700 827

Lansing, Michigan

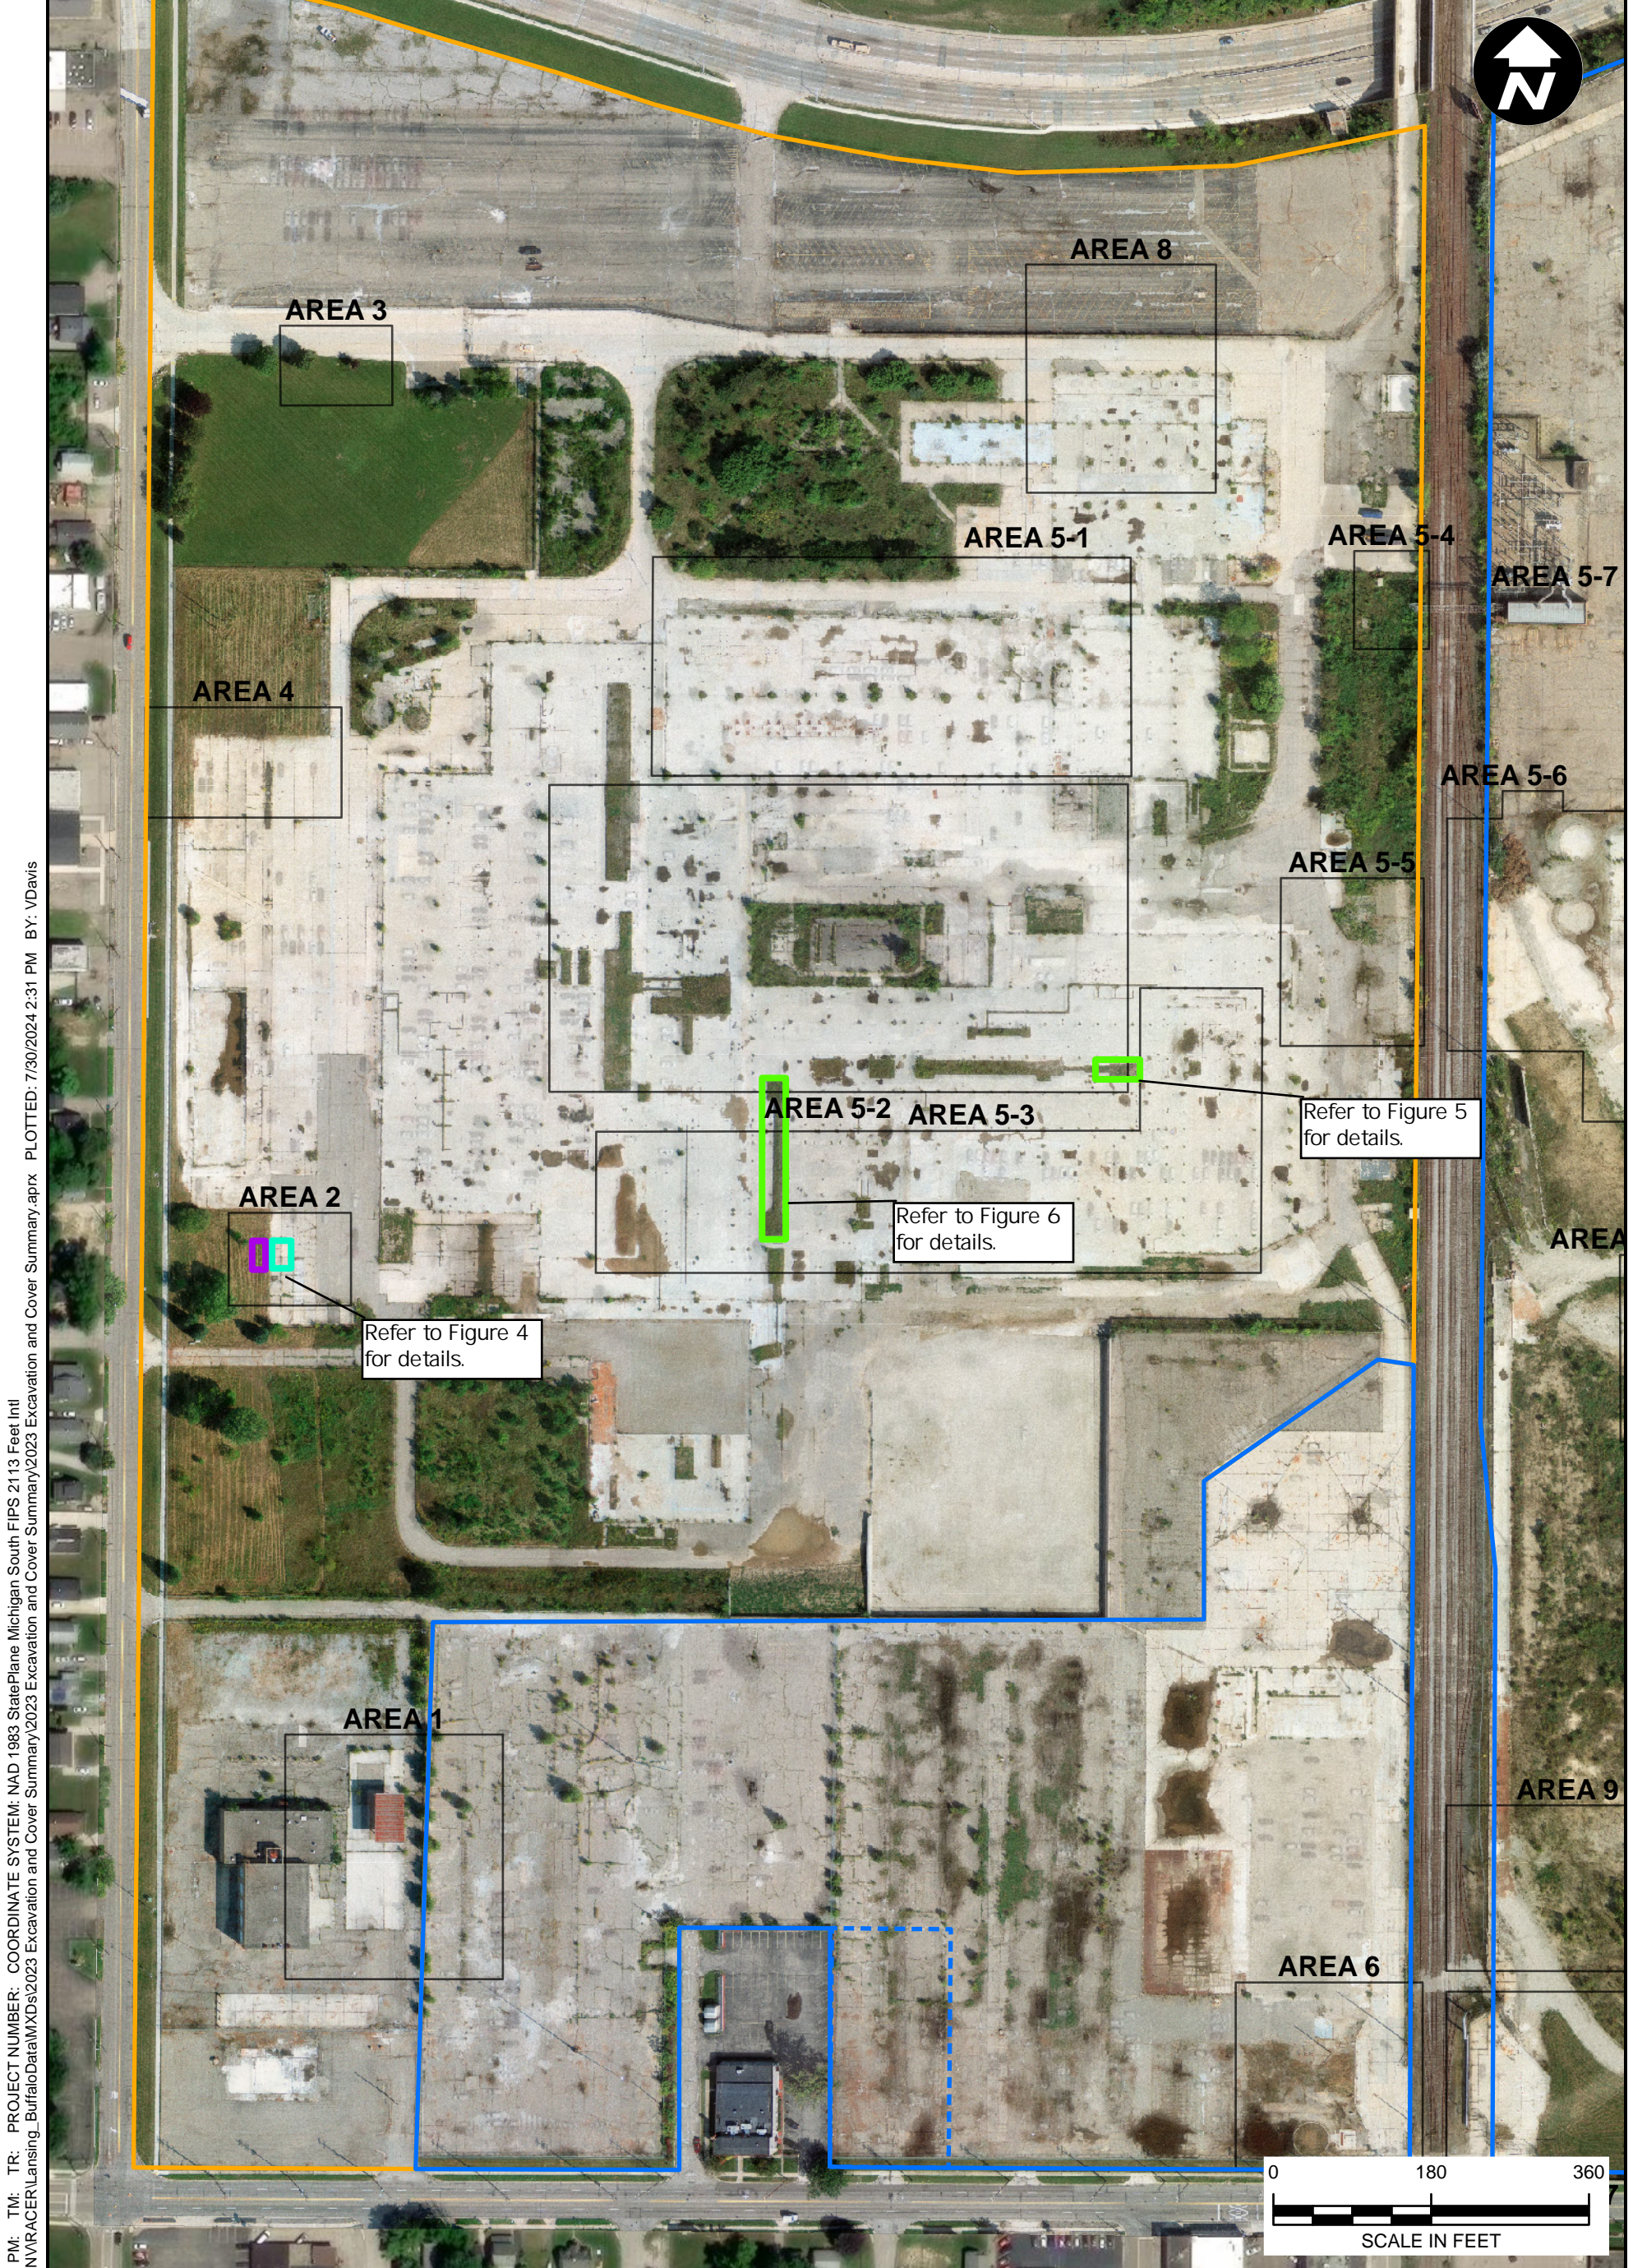
**PLANT 2 SOIL CORRECTIVE MEASURES**

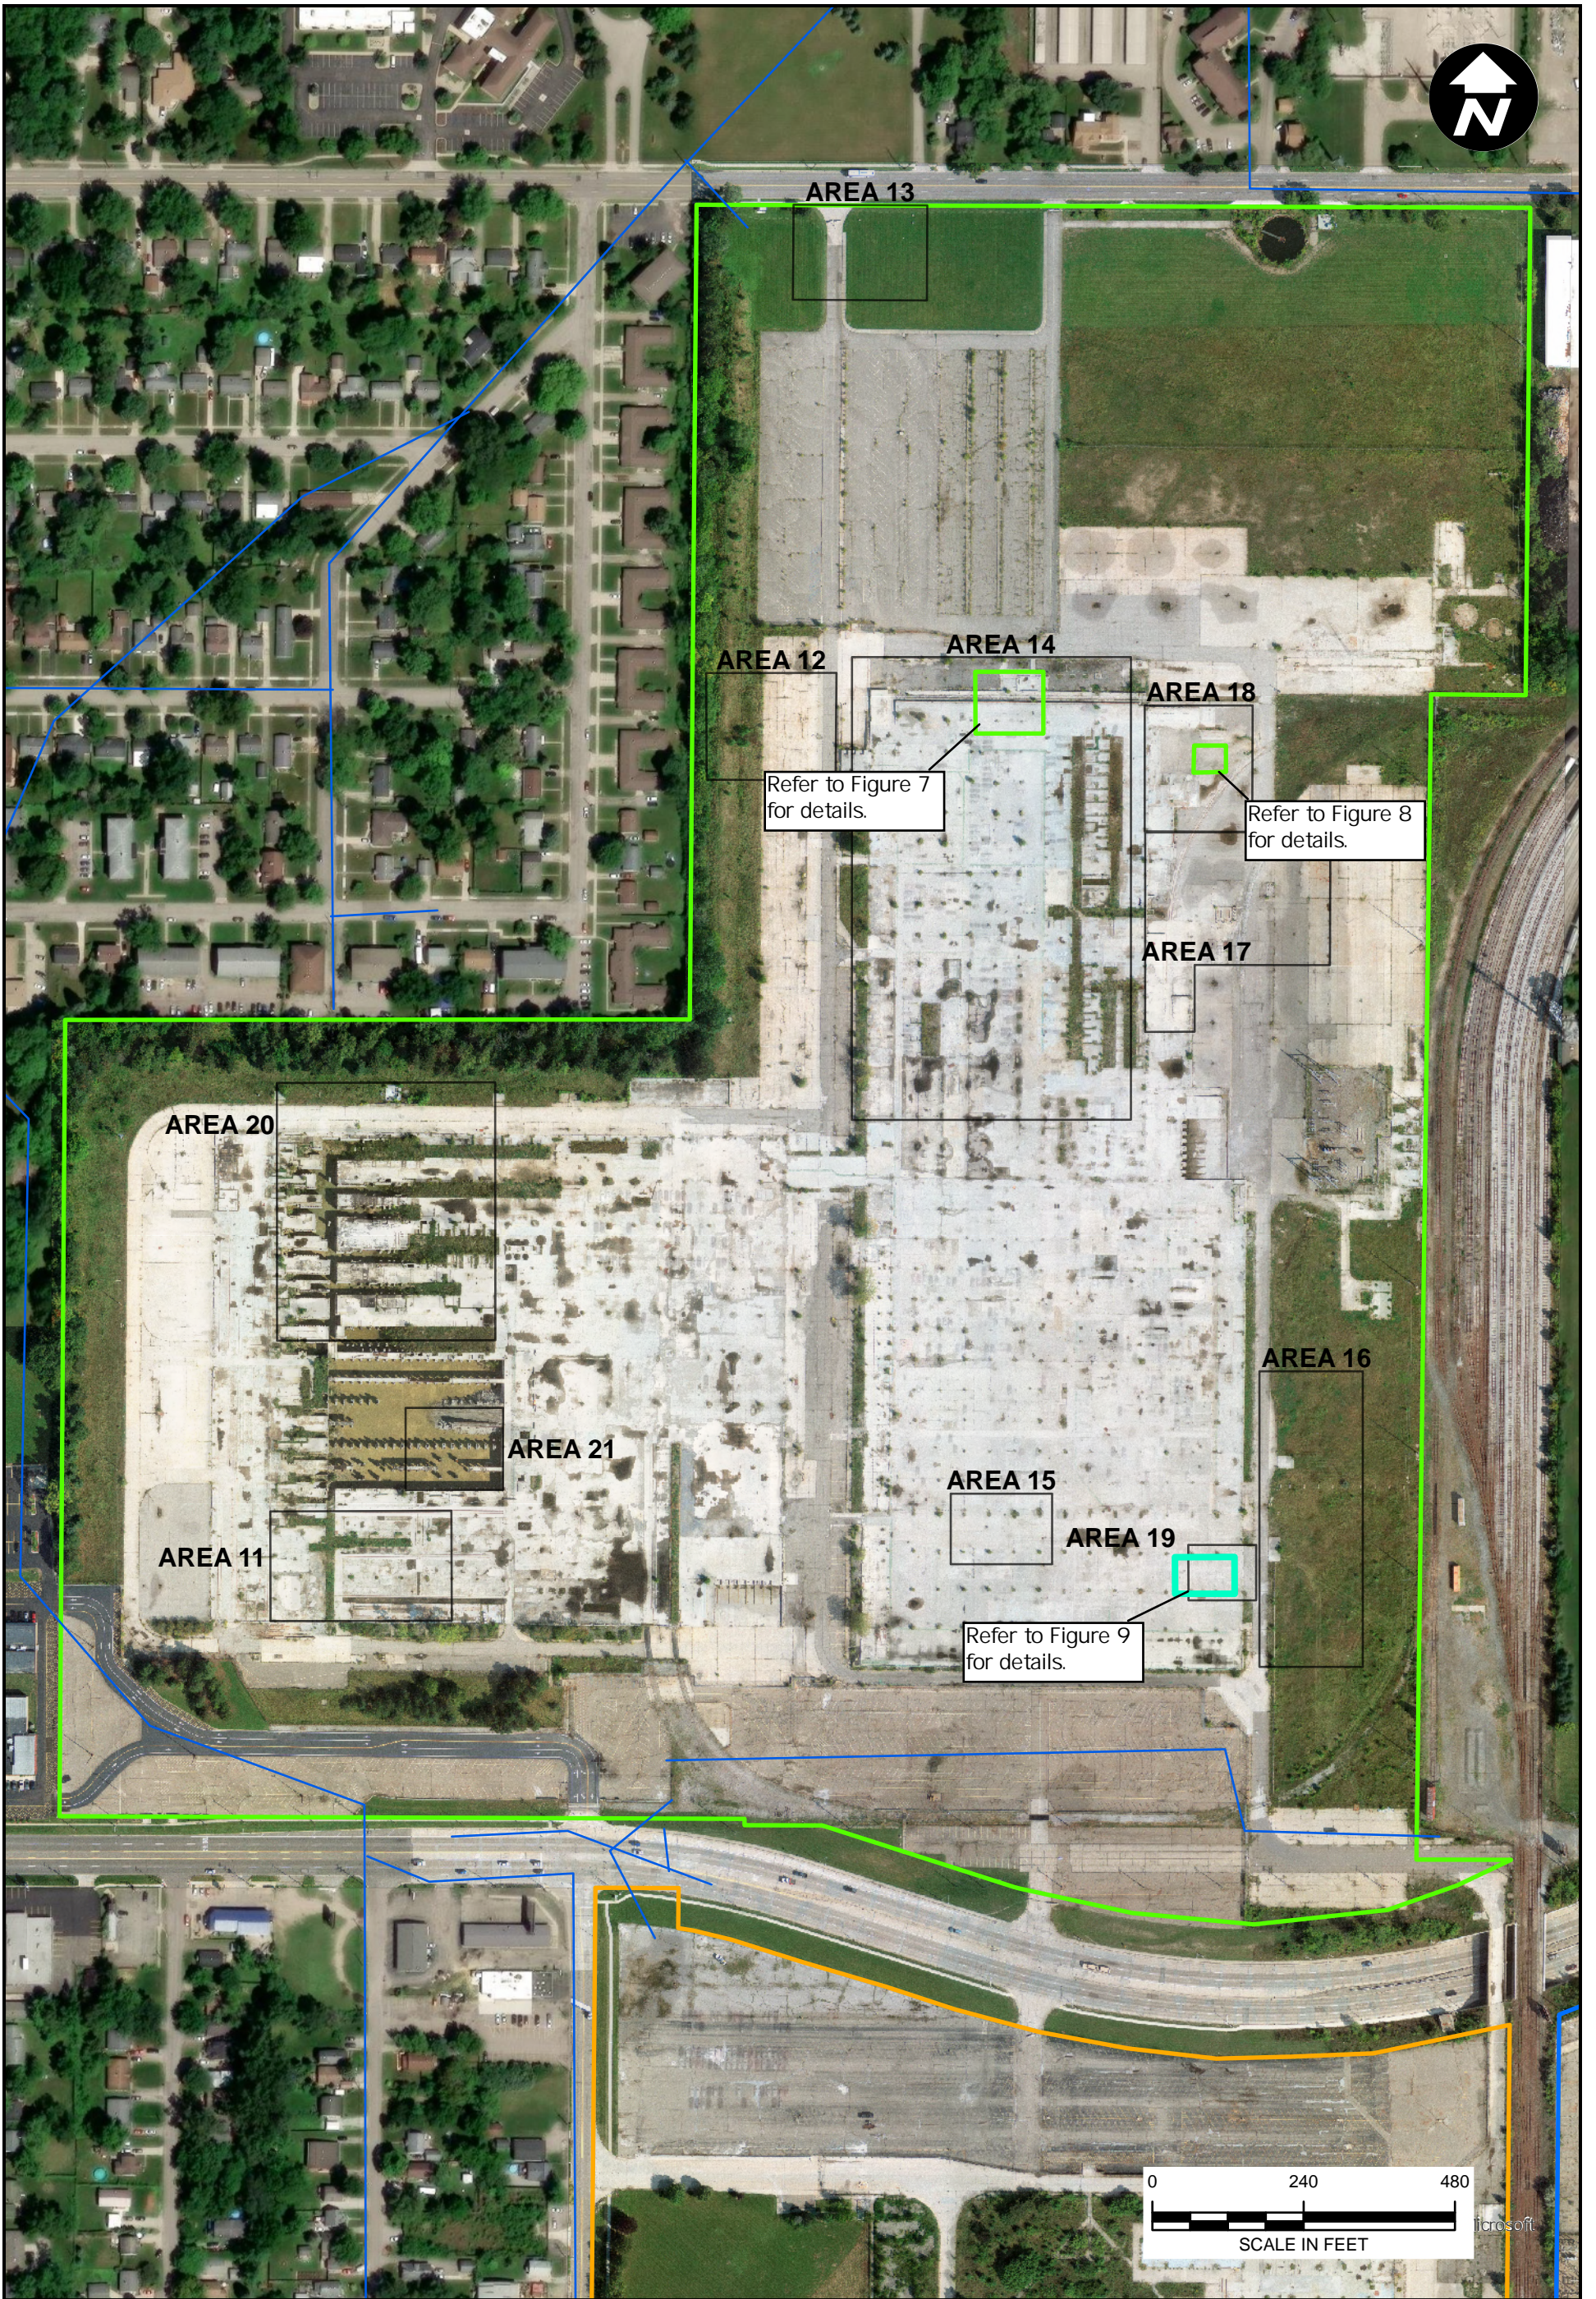
FIGURE  
**3**

**PLANT 3 SOIL CORRECTIVE MEASURES**

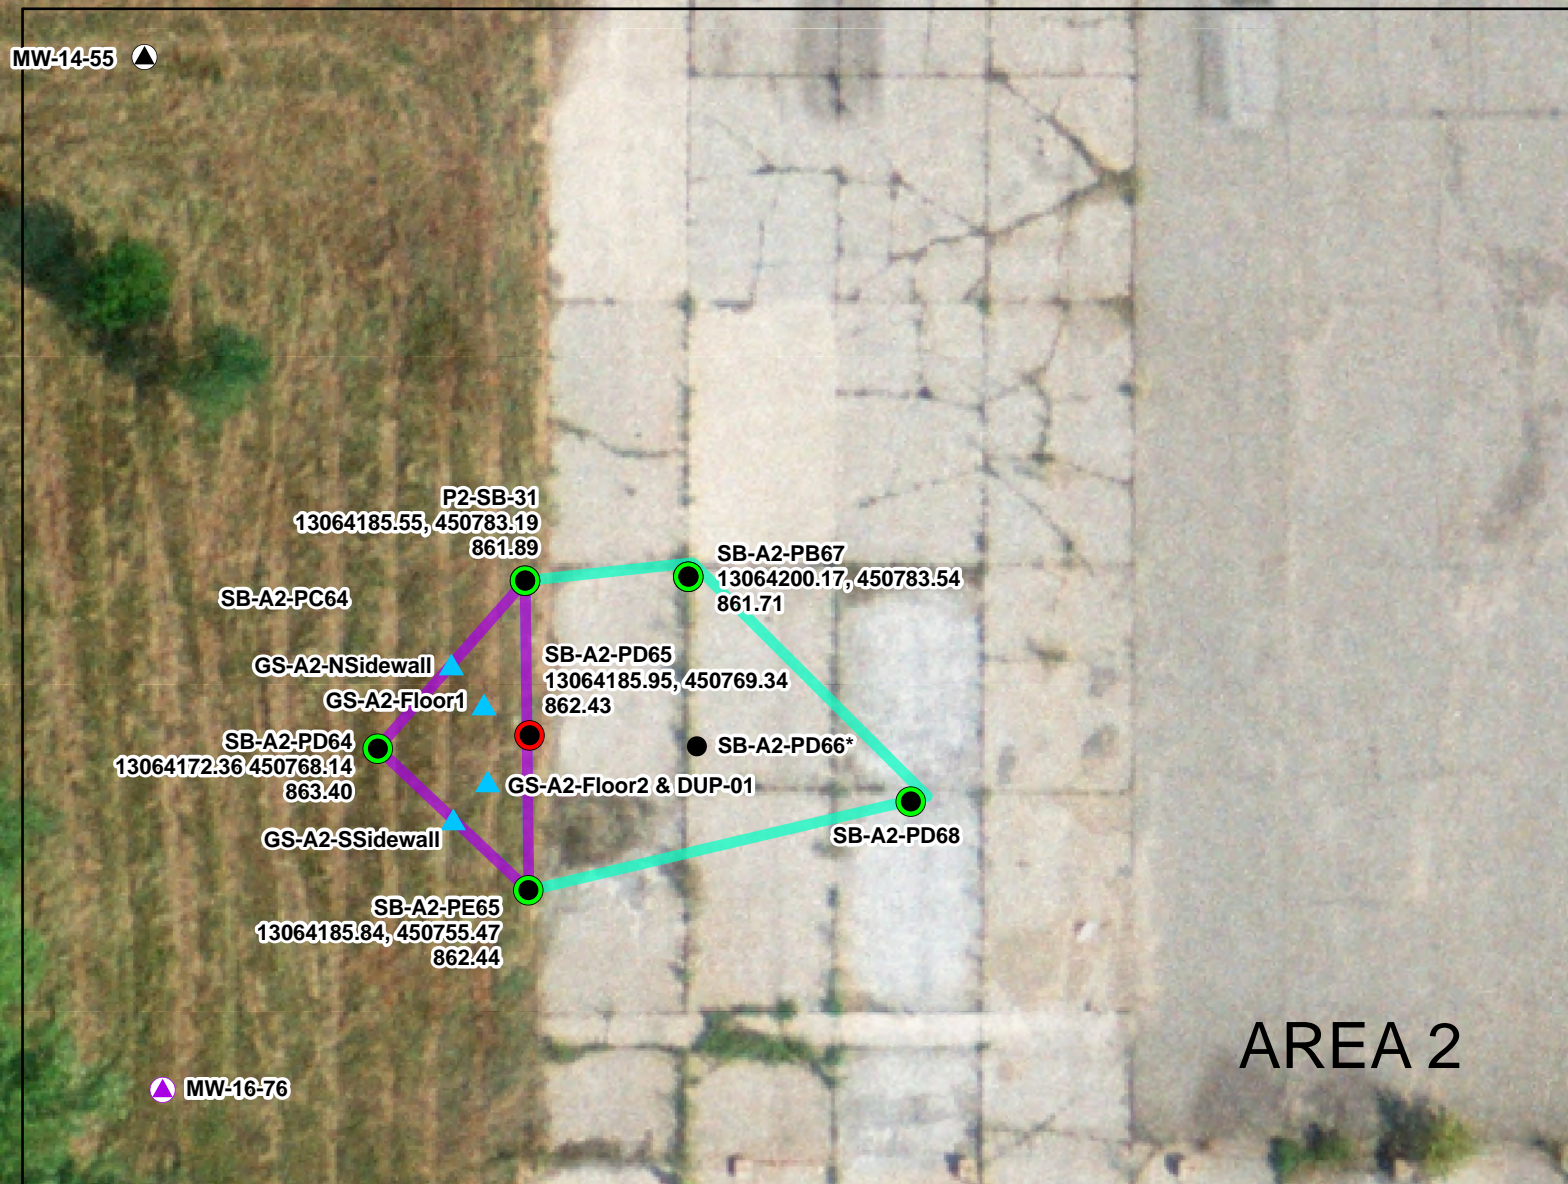
NOTE: SIDEWALL SAMPLES COLLECTED APPROXIMATELY 1.5' BELOW GROUND SURFACE IN THE APPROXIMATE CENTER OF THE NORTHERN AND SOUTHERN SIDEWALLS.

**AREA 2  
 EXCAVATION, CONFIRMATION SOIL SAMPLING,  
 AND EXISTING EXPOSURE BARRIER**

Location SB-A2-PD65 required a corrective measure as outlined in the Work Plan to address the NRDCC exceedance of arsenic (**Figure 4**). The corrective measure for Area 2 included excavation of the impacted location within the portion of the area with no impervious ground cover and the utilization of the existing concrete surface as an exposure barrier for the portion of the area with concrete cover (**Figure 4**).

Excavation of soil boring SB-A2-PD65 began at the location and moved westward towards soil boring SB-A2-PD64 which is below EGLE NRDCC for arsenic. The portion of soil boring location SB-A2-PD65 that is underneath the existing concrete surface to the east of the location was not excavated and the existing concrete is retained as an exposure barrier in this area.

Excavation soil verification sampling was conducted as described in the following section. Existing concrete with a thickness of at least 6-inches is present to the east of impacted soil boring SB-A2-PD65 and will remain as an exposure barrier.

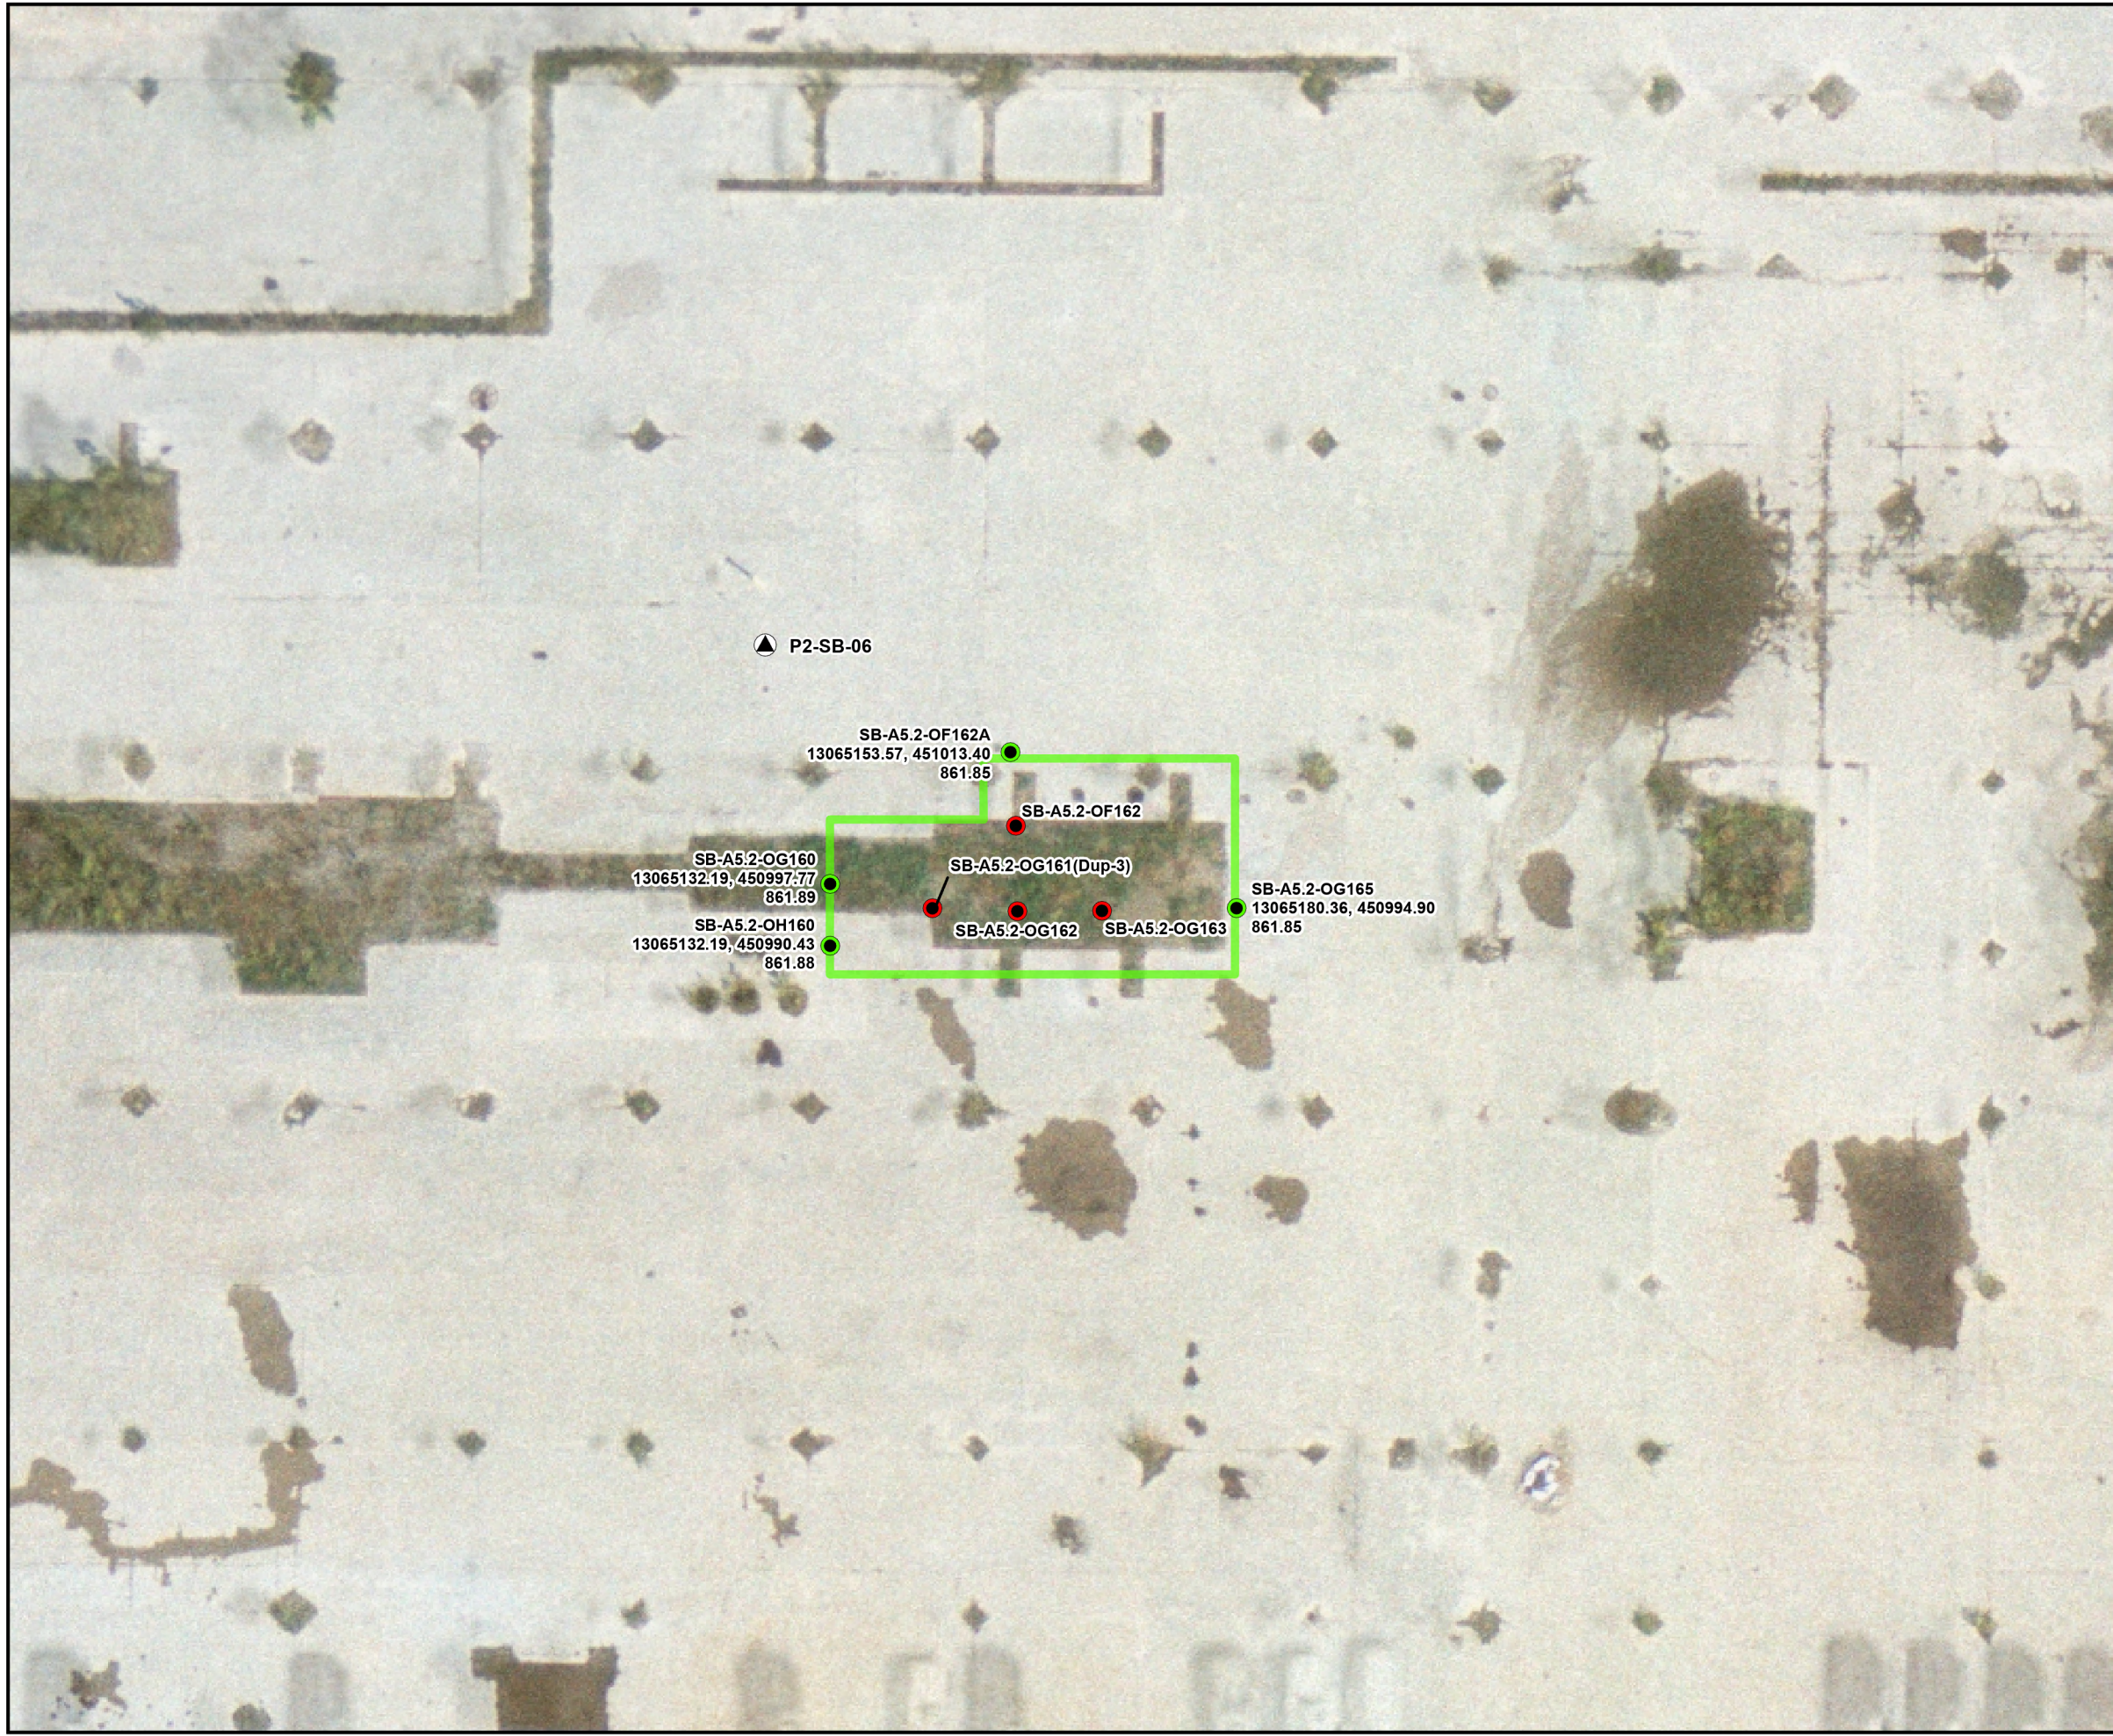
**ARCADIS** | FIGURE 5

**AREA 5-2  
EXPOSURE BARRIER PLACEMENT**

Exceedances of benzo(a)pyrene were identified within several samples in Areas 5-2 and 5-3 at Plant 2 and at three locations (SB-A18-CJ150, SB-A18-CJ149, and SB-A18-CK149) within Plant 3 Area 18 above EGLE NRDC (**Figures 5, 6, and 7**) which required corrective action as outlined in the Work Plan. The corrective action completed in these areas included the placement of an exposure barrier, consisting of a geotextile layer and gravel cover, placed over the delineated exceedances in Areas 5-2 and 5-3 at Plant 2 and Area 18 at Plant 3. The estimated extents of the completed exposure barrier areas are presented in **Figures 5, 6, and 7**.

Exposure barrier placement activities were conducted from December 11-14, 2023. Once the planned location of the exposure barriers for Areas 5-2, 5-3 and 18 for placement were surveyed and marked out, geotextile fabric was first placed over the existing ground surface to act as a demarcation layer beneath the gravel barrier. Overtop the geotextile fabric, a 6-inch to 1-foot layer of 22A road gravel was placed as the exposure barrier and graded to promote drainage and prevent ponding. Gravel utilized for the cover material was obtained from an MDOT Prequalified Supplier, and per the supplier was virgin, freshly quarried material (**Attachment 3**). Following completion of barrier placement, each of the areas was measured by JSS with a laser level to verify exposure barrier thickness met or exceeded the 6 inch approved thickness in all areas of the barrier placement. Photographs of the exposure barrier placement areas in Areas 5-2 and 5-3 at Plant 2 and Area 18 at Plant 3 are provided in **Attachment 4**.

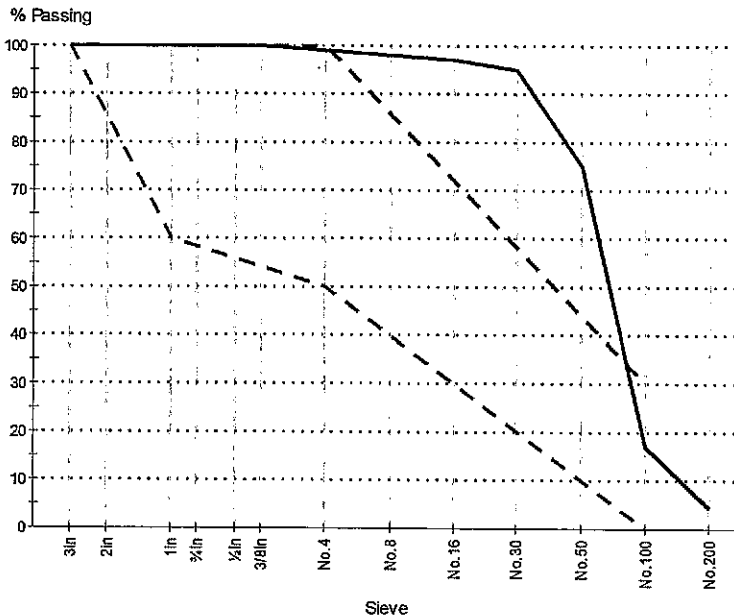
Method: ASTM C 136, ASTM C 117

Sieve Size	% Passing	Limits
3in	100	100
2in	100	100
1in	100	60 - 100
3/4in	100	60 - 100
1/2in	100	60 - 100
3/8in	100	60 - 100
No. 4	99	50 - 100
No. 8	98	50 - 100
No. 16	97	50 - 100
No. 30	95	50 - 100
No. 50	75	50 - 100
No. 100	17	0 - 30
No. 200	4.5	0 - 30
Finer No. 200 (75µm)	4	0 - 7
