Subject: Phase I Environmental Site Assessment  
MLC ID 1309  
No Etkin Ground Lease Parcels 85 and 92  
Martin Luther King Boulevard South  
Pontiac, Michigan

**Phase I Environmental Site Assessment  
MLC ID 1309  
No Etkin Ground Lease Parcels 85 and 92  
Martin Luther King Blvd South  
Pontiac, Michigan**

**January 5, 2010  
ARCADIS Project No. 010-15317-04**

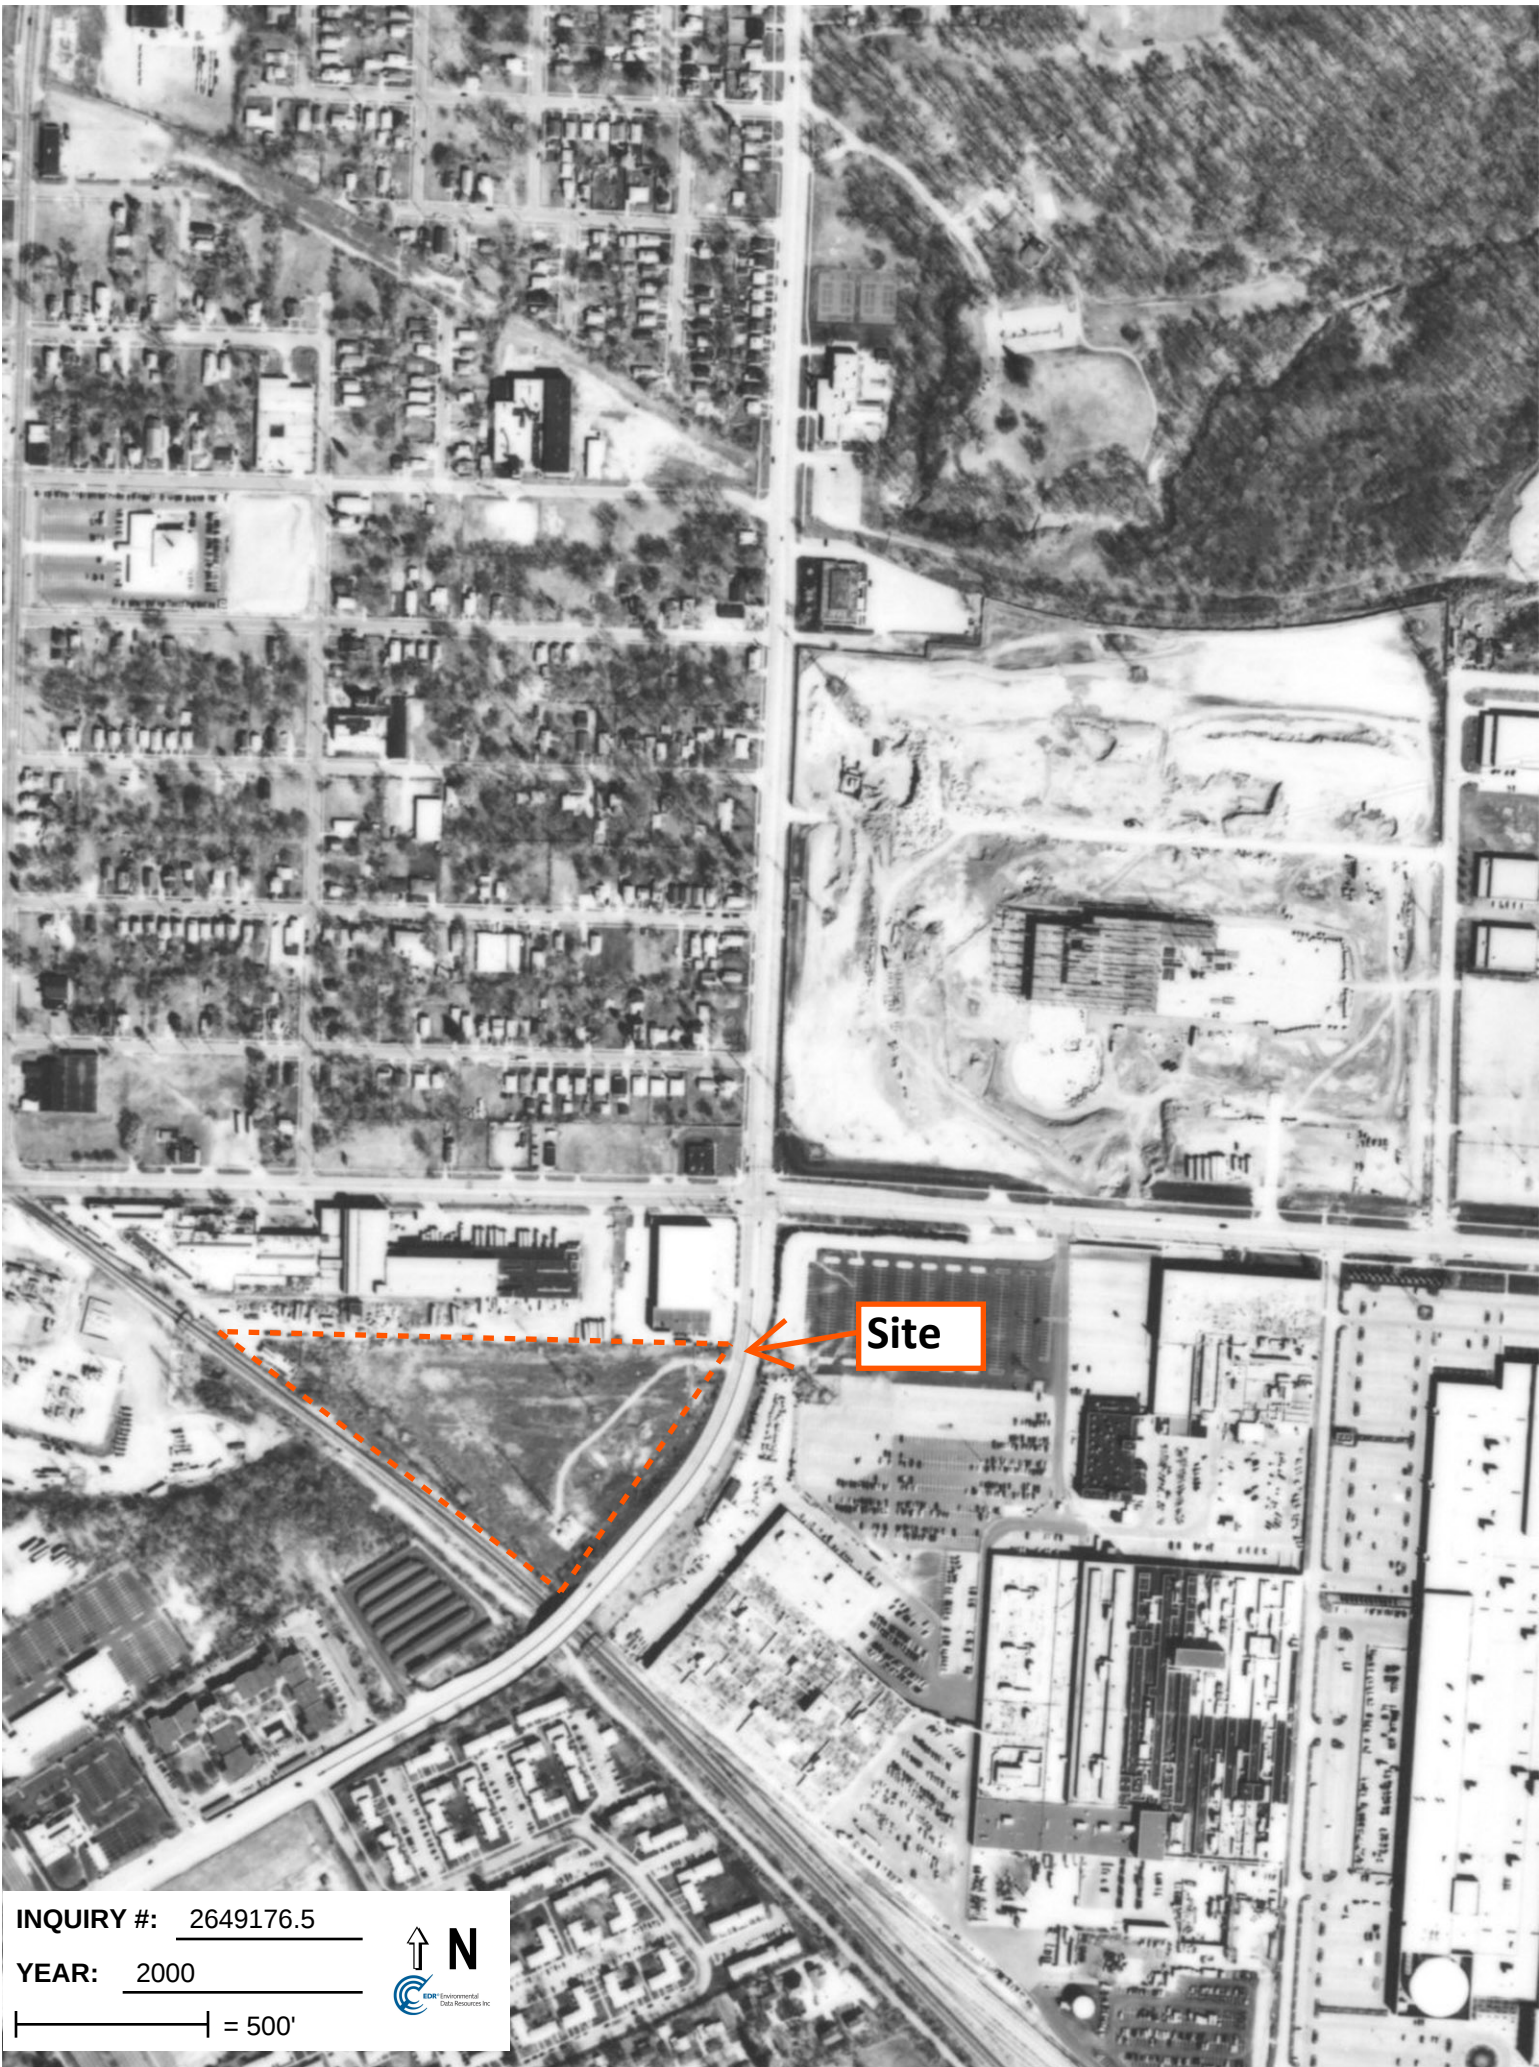
YEAR: 2000

The 2000 photograph depicts the Site as a grassy area with an access road from Martin Luther Boulevard South. The access road extends to a small building and a cell phone communication tower located at the southern portion of the Site. The property to the east across Martin Luther King Boulevard has expanded a large building and removed the building noted in the 1993 photograph. Asphalt parking areas have been constructed at the northeast portion of the property to the east of the Site. The adjacent property to the southwest of the Site has been developed with several small commercial units (self storage units). The remaining surrounding areas are essentially unchanged from the 1972 photograph.
