Site Vicinity
Former Delphi Thermal (Harrison Radiator) Facility
MLC-1317

Moraine, Ohio

Phase I Environmental Site Assessment Questionnaire

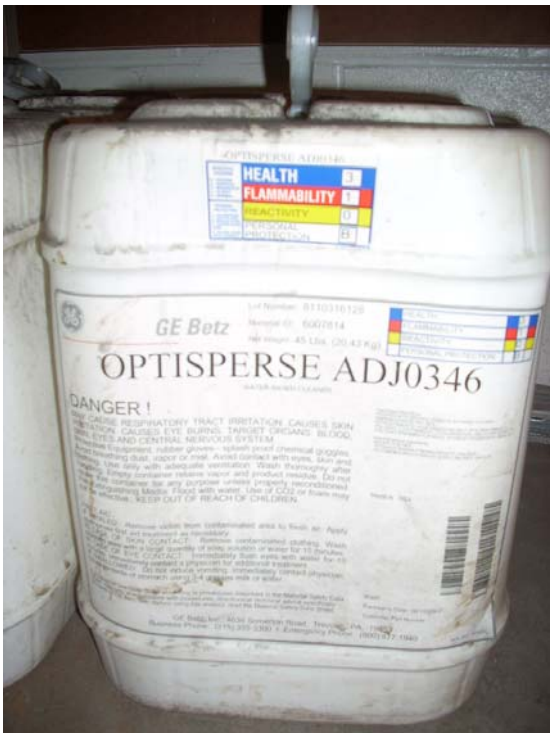
Photograph #12

Description of Photograph:
Administration Building boiler, which is currently operational, and the associated boiler water chemical tank.

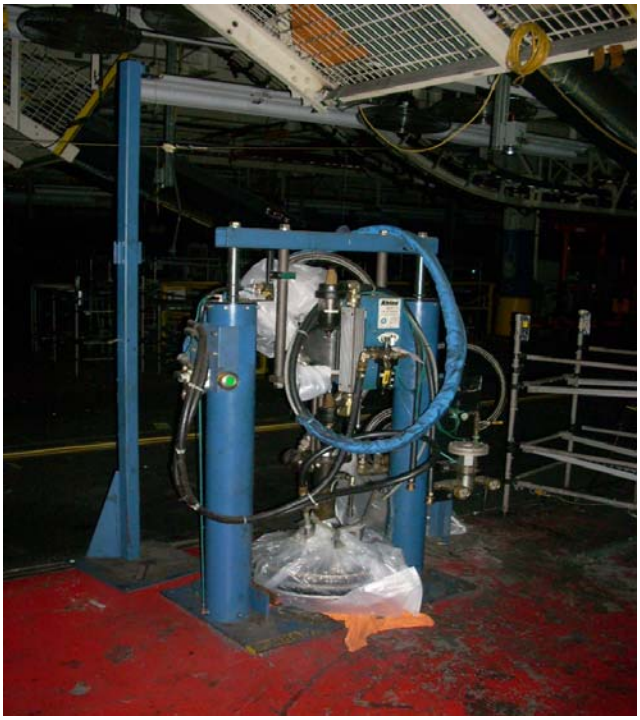
Photograph #99

Description of Photograph:
General Assembly area—leak collector system in the area where fluids were added to the new vehicle located in the middle of the Assembly building.
