2021 Annual Inspection Report

Linden Road Landfill
FILE: 1088190/1940100784

APPENDIX A
August 9, 2021
Inspection Report

RACER Trust - Linden Road
Operation and Maintenance Periodic Inspection Report
Flint, MI

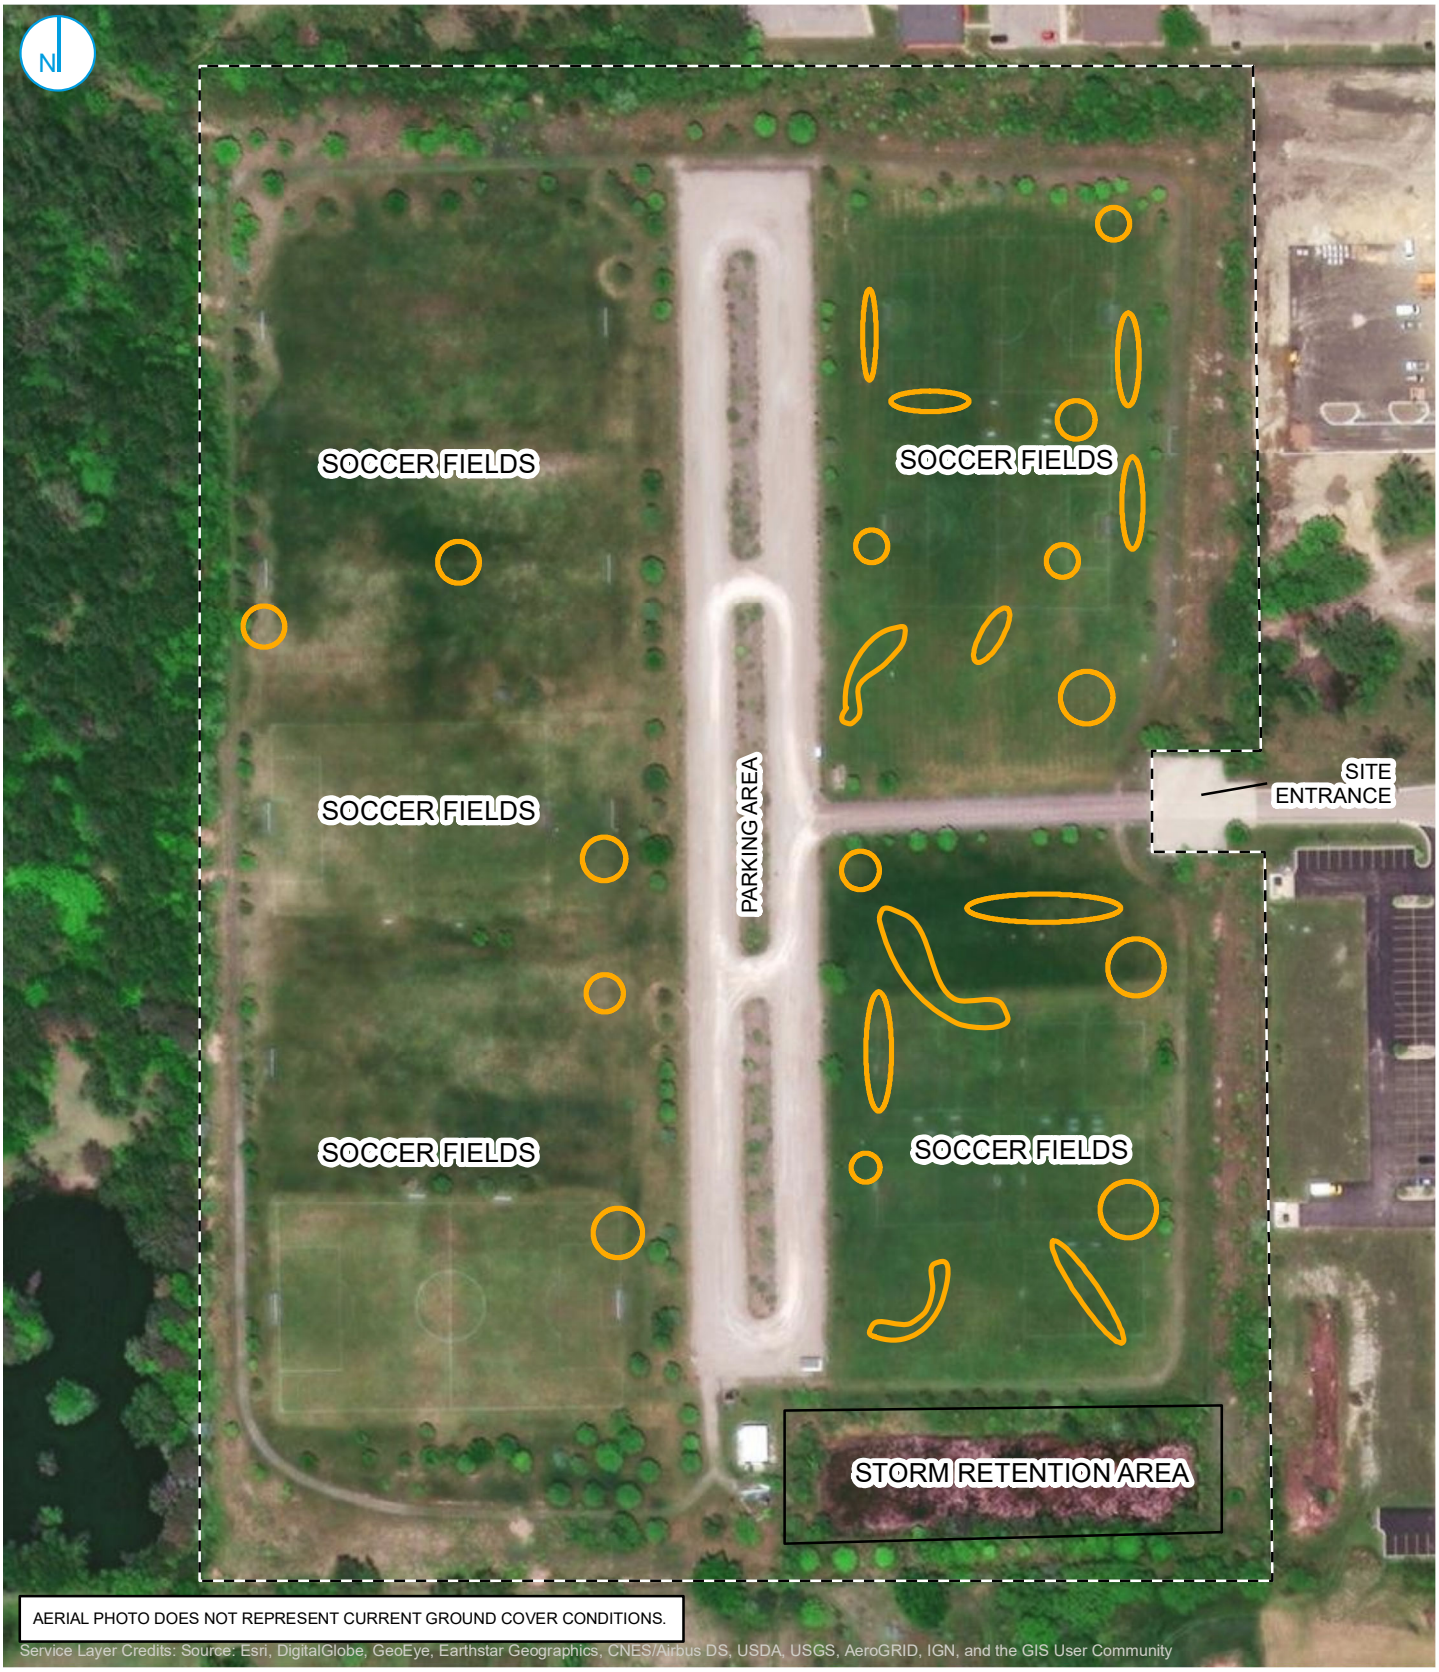
FIGURE 01

As noted in the report, moles have made tunnels and mounds in several areas. The mole activity appeared to be just below the surface and no signs of damage to the final cover or evidence of waste were observed during the inspection.

MOLE ACTIVITY

During the inspection Ramboll placed poisonous mole peanuts in several tunnels to eliminate the moles and prevent further damage. Ramboll plans to continue working with the AYSO to control the moles and burrowing animals. Otherwise, the landfill cap is in good condition.

Summary of Deficiencies and/or Corrective Actions: Mole trails observed were treated with posion mole peanuts.
