PHASE I ENVIRONMENTAL SITE ASSESSMENT REPORT

PARCELS 59-10-100-031 AND 59-10-100-030
DAVISON ROAD
BURTON, MICHIGAN

SME Project Number: 100047.00
August 27, 2025

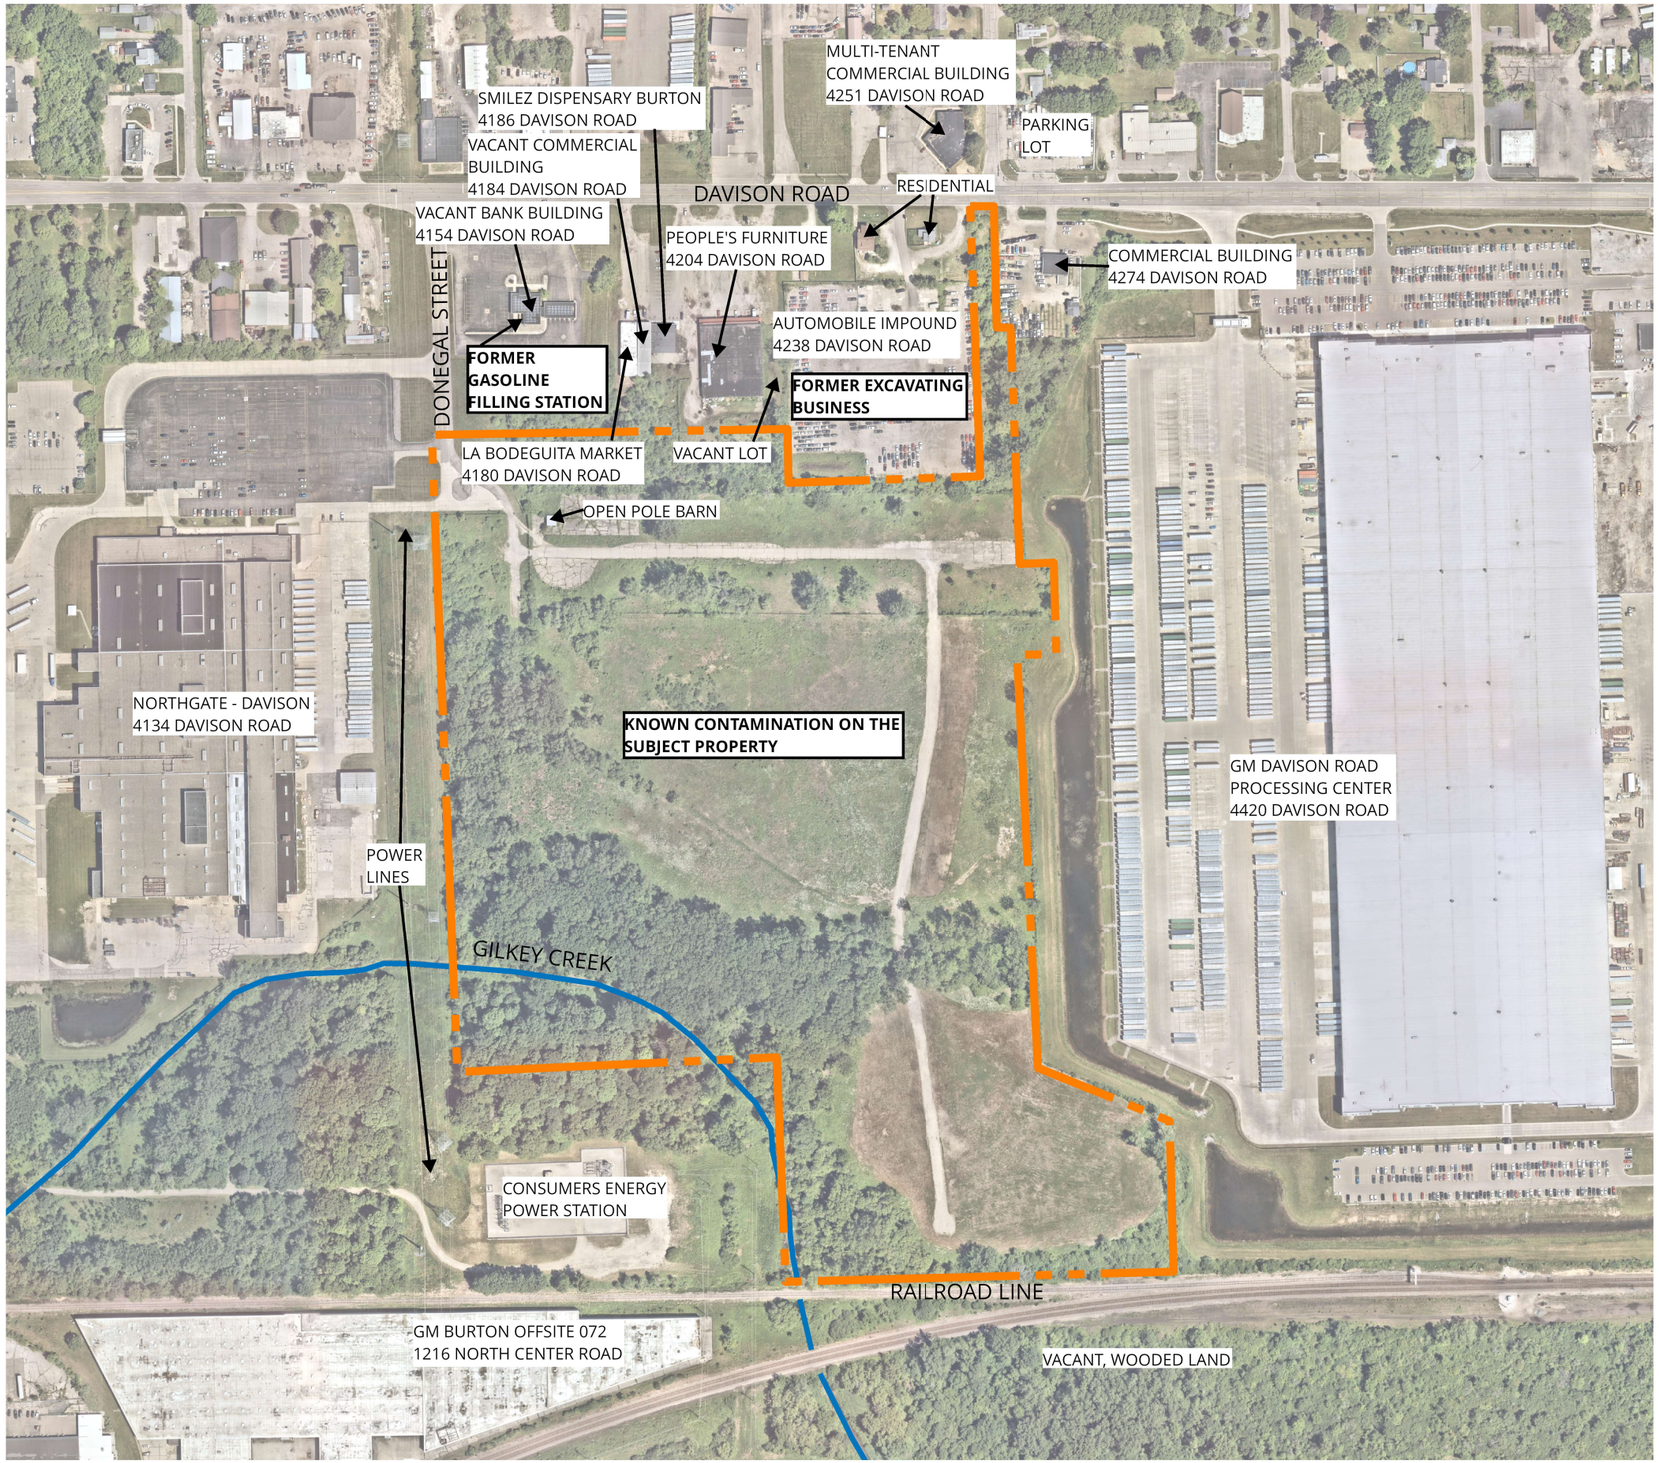
FIGURE 1: PROPERTY LOCATION MAP
FIGURE 2: PROPERTY FEATURES DIAGRAM

- The Subject Property was used for dumping of construction debris, foundry sand, and other solid waste from nearby industrial sites in the southeastern portion. Multiple investigations were completed on the Subject Property and PAHs and VOCs were measured above Part 201 criteria in soil and metals in soil and groundwater. The known contamination on the Subject Property represents a REC.
- An RC was recorded on the Subject Property in 2017, which implemented land use restrictions. A No Further Action Report was also filed In 2017 and approved by MDEQ, which requires the land use restrictions to be followed. The land use restriction on the Subject Property represents a CREC.

- A gasoline filling station was present to the north of the Subject Property from at least 1957 until 1967. The potential for migration of contamination from unknown or unreported releases associated with the former gasoline filling station to the north onto the Subject Property represents a REC.
- An excavating business was to the north of the Subject Property from at least 1975 until 2014 when it was replaced by an automobile impound yard. The potential for migration of contamination from unknown or unreported releases associated with the former excavating business to the north onto the Subject Property represents a REC.
