# RACER TRUST LANSING PLANTS 2, 3, & 6

#### **2021 Fourth Quarter Progress Report | January 15, 2022**

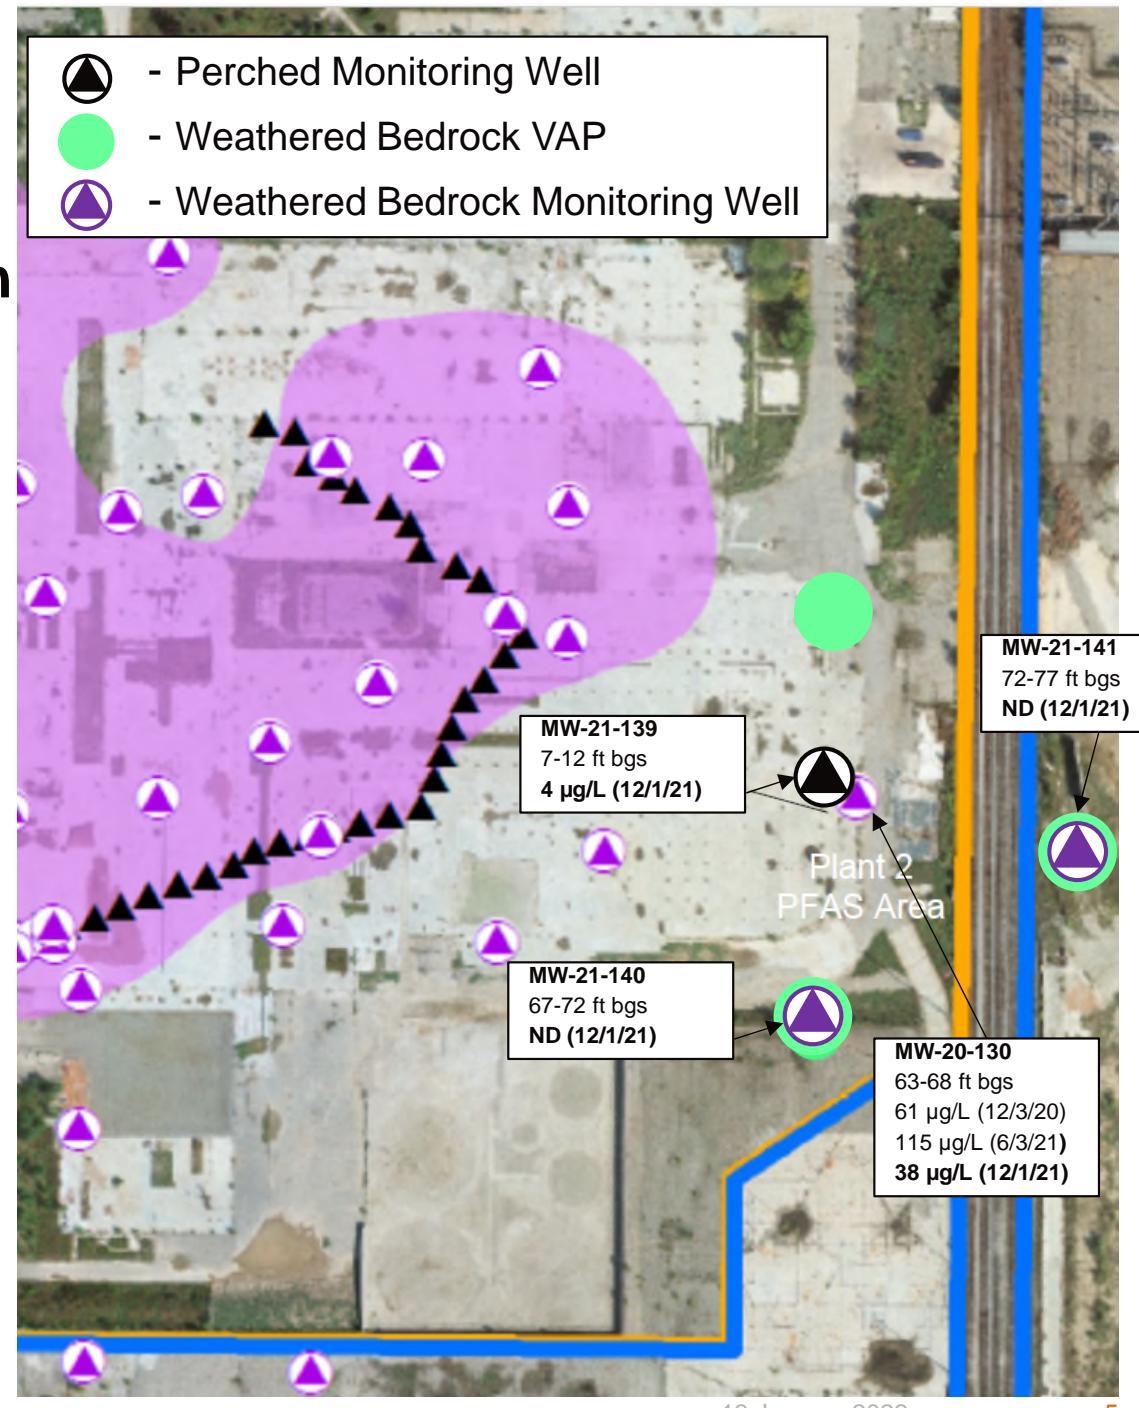
Investigation into 1,4-dioxane detected in weathered bedrock (WB) well MW-20-130

- One shallow monitoring well installed within the southeastern portion of Plant 2 (MW-21-139)
  - Sampled for 1,4-dioxane and PFAS during the Fourth Quarter groundwater monitoring event.
  - 1,4-Dioxane: 4 μg/L, PFAS results pending
- Completed three deep vertical aquifer profile (VAP) borings and collection of groundwater samples to delineate 1,4-dioxane in WB
  - 1,4-dioxane was not detected in the VAP samples
- Converted two VAP borings into WB monitoring wells to act as a sentinel monitoring locations (MW-21-140, MW-21-141)
  - Sampled during Fourth Quarter groundwater monitoring event
  - 1,4-dioxane was not detected in the samples

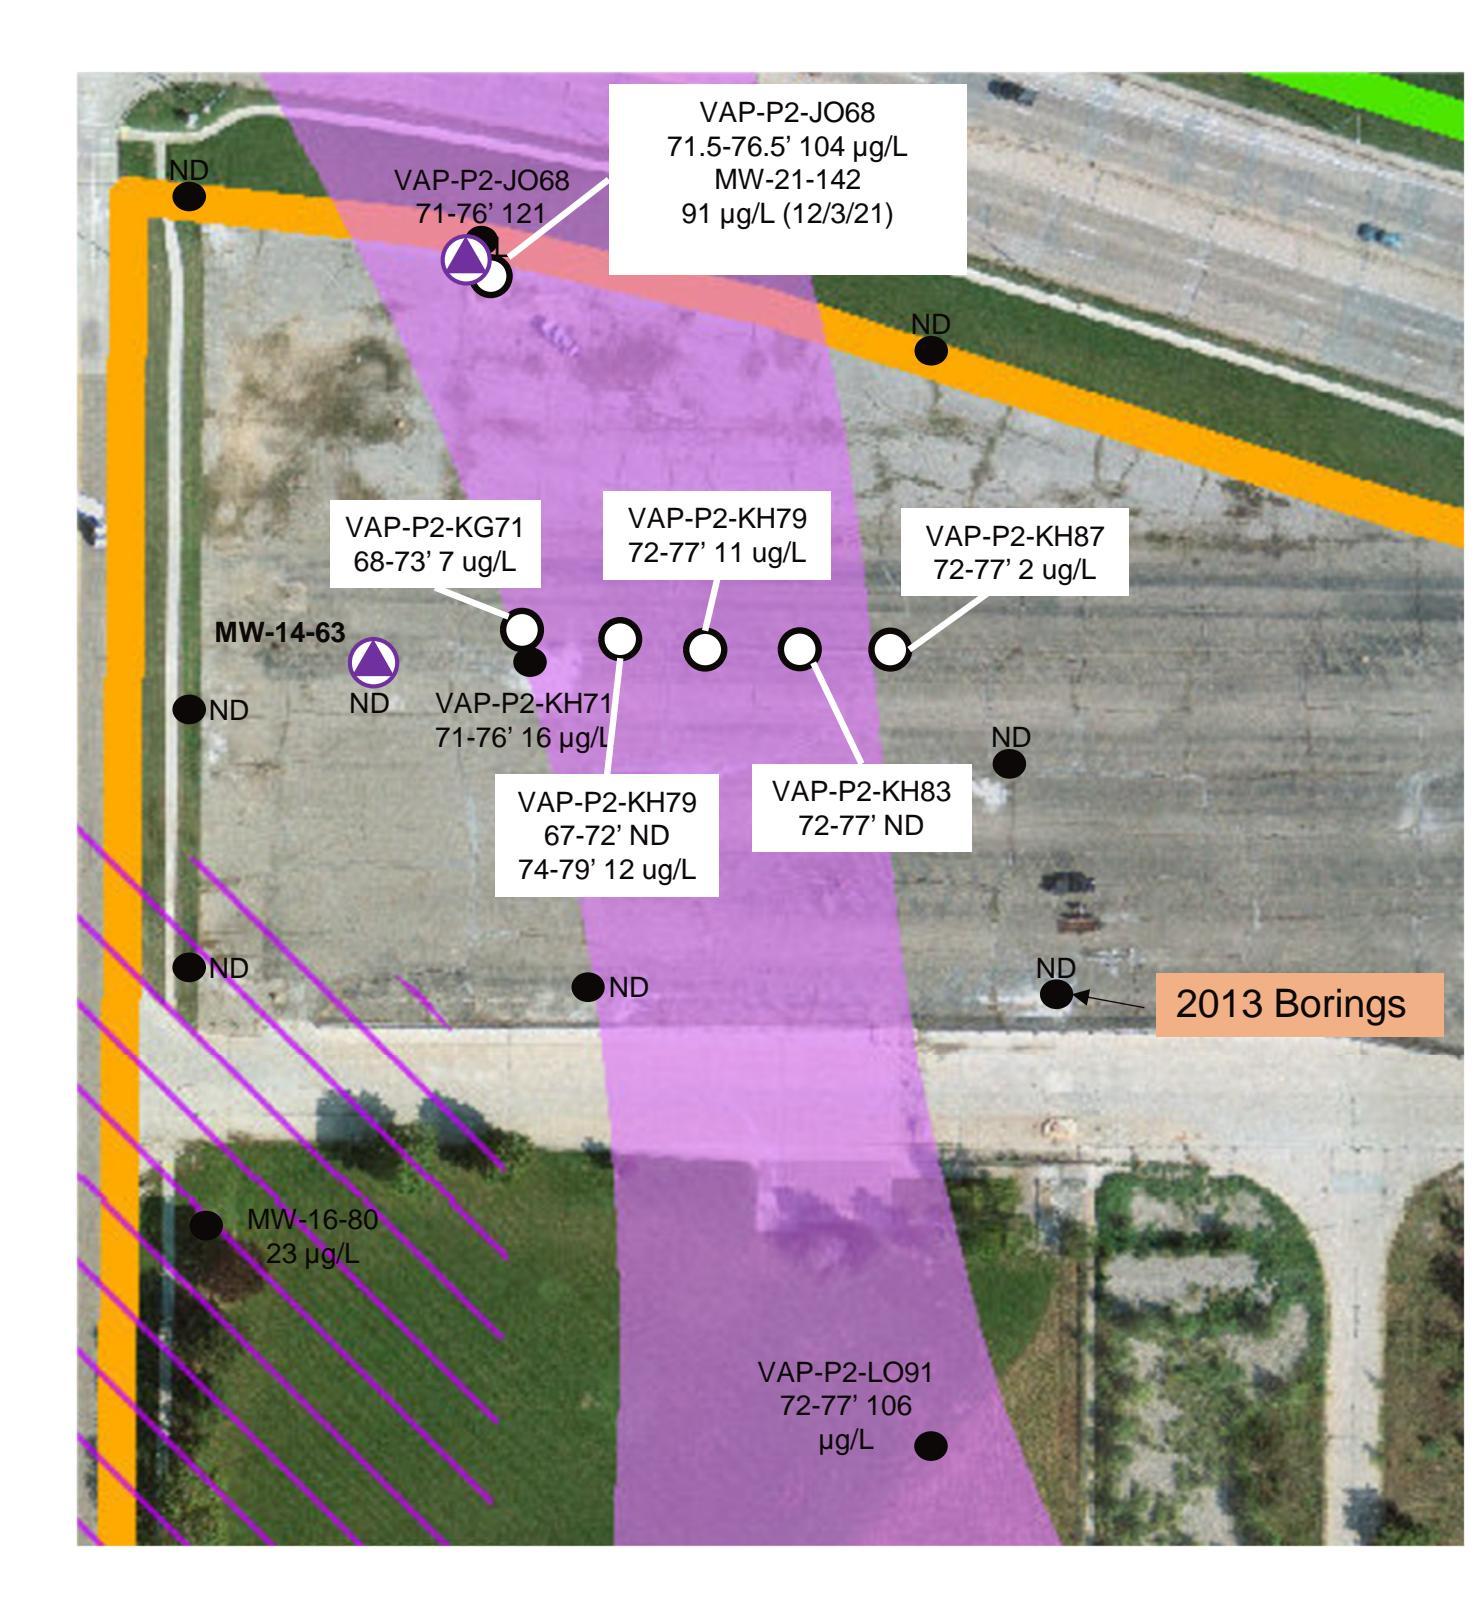
Investigation to (re)characterize the lower 1,4dioxane plume in the northwestern portion of Plant 2 and install a performance monitoring well for biosparge system

- Completed a total of 6 VAP borings into the weathered bedrock
- Collected 1 to 2 groundwater samples from the weathered bedrock at each location
  - Five locations to the east to MW-14-63 contained low concentrations of 1,4-dioxane (non-detect - 12 µg/L)
- 1 VAP boring and groundwater samples collected (SB-P2-JO68) replicated historical VAP intervals and results
  - Converted VAP-P2-JO68 to a performance monitoring well for biosparge (MW-21-142)
- Also abandoned 10 test wells not included in the current groundwater monitoring program or used for biosparge performance monitoring

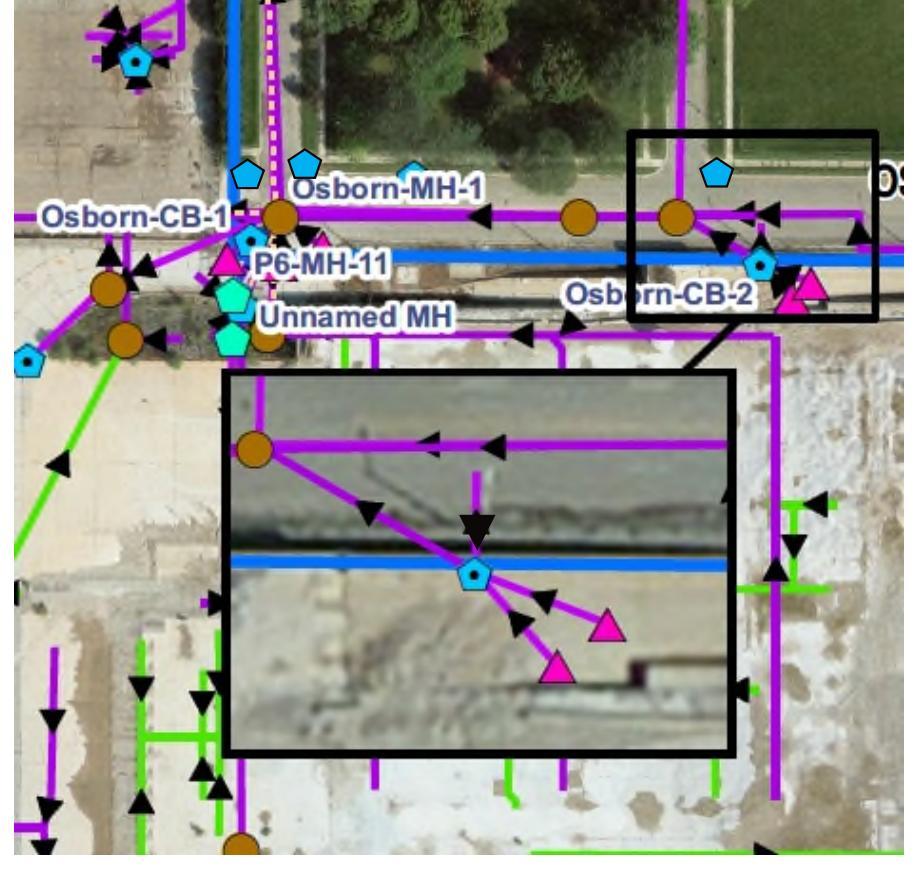
- Osborn Street catch basin was replaced in November 2021 as part of sewer modifications completed during fourth quarter 2021 to prevent infiltration of groundwater containing Perfluorooctanesulfonic acid (PFOS) into the sewer system
- Old brick catch basin wall had numerous leaking cracks that would be difficult to repair
- Replaced entire catch basin structure to mitigate leaks
- Structure replacement preserves stormwater drainage in Osborn Street with no connections to the RACER site

New catch basin structure

Catch Basin ▲ Plugged Pipe Filled Structure

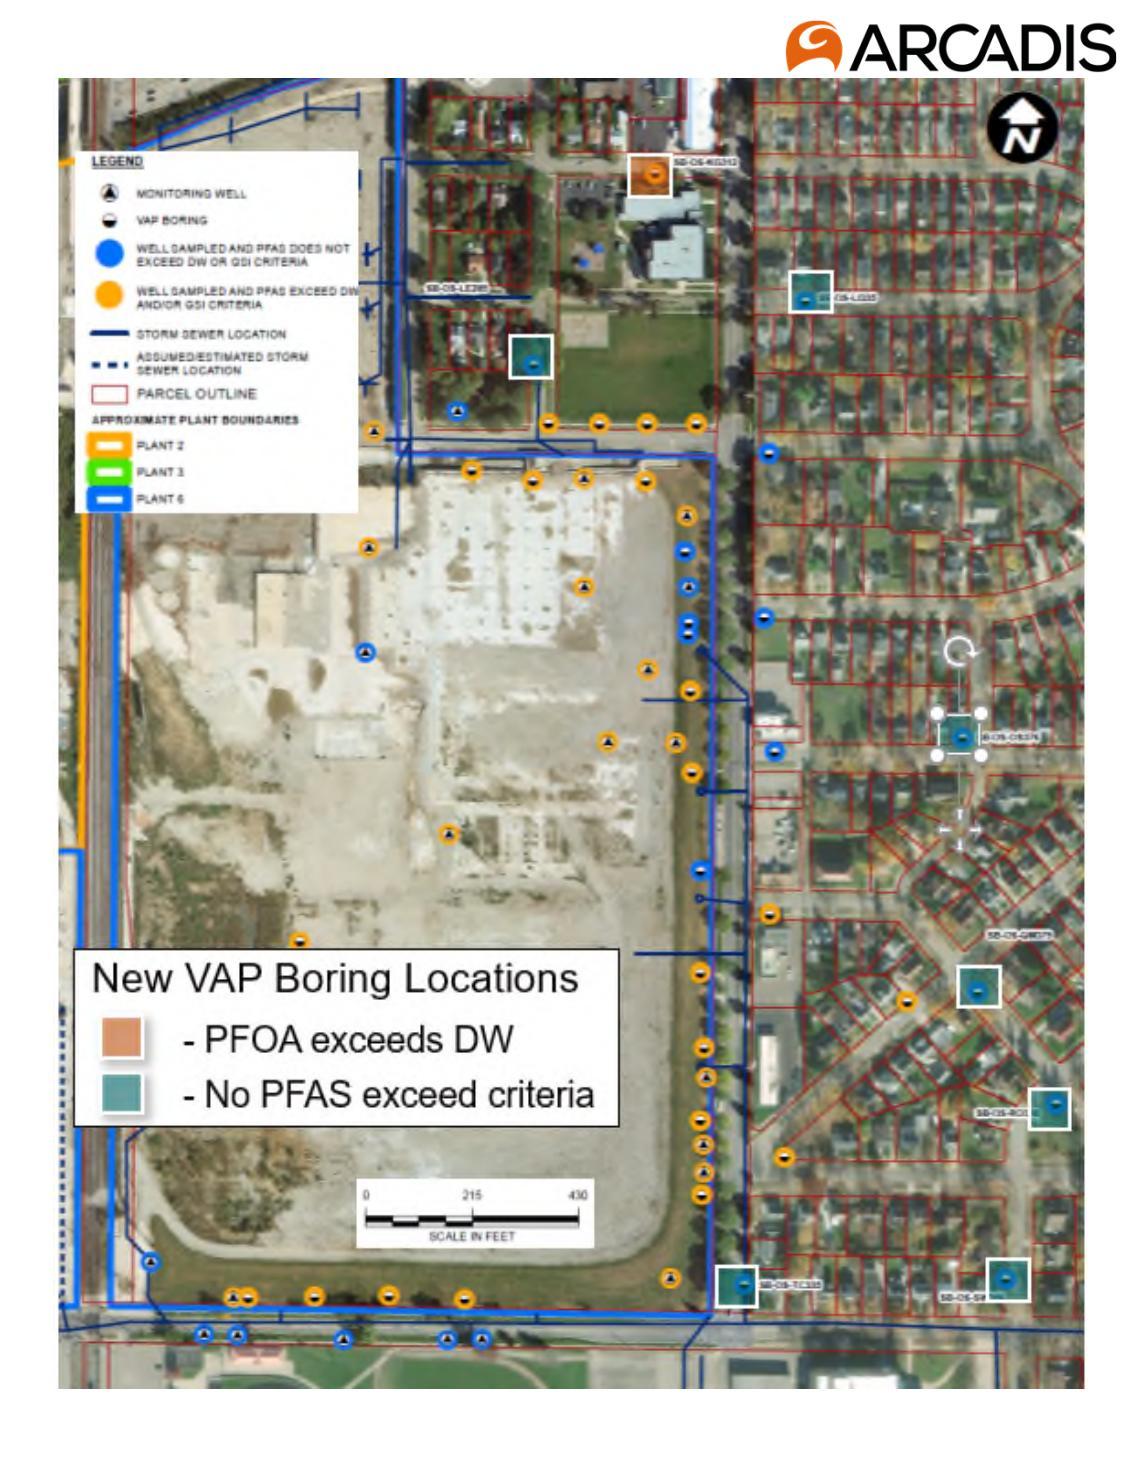
- One groundwater sample collected from 11-15 ft below the ground surface (bgs) at the northernmost boring (SB-OS-KG312) contained Perfluorooctanoic acid (PFOA), the specific PFAS of concern in off-site groundwater, at a concentration of 11 ng/L exceeding Drinking Water criteria
- PFOA detected at low concentrations in four other shallow samples but not detected in any samples collected from deeper intervals
- There are no known complete exposure pathways to PFOA in the groundwater for residents and therefore PFOA present in shallow groundwater is not expected to pose a risk to residents

Based on the results it is anticipated monitoring wells will be installed in Spring of 2022 to establish a monitoring network for PFOA impacts. A draft summary report including proposed monitoring well locations will be submitted to EGLE in January 2022.

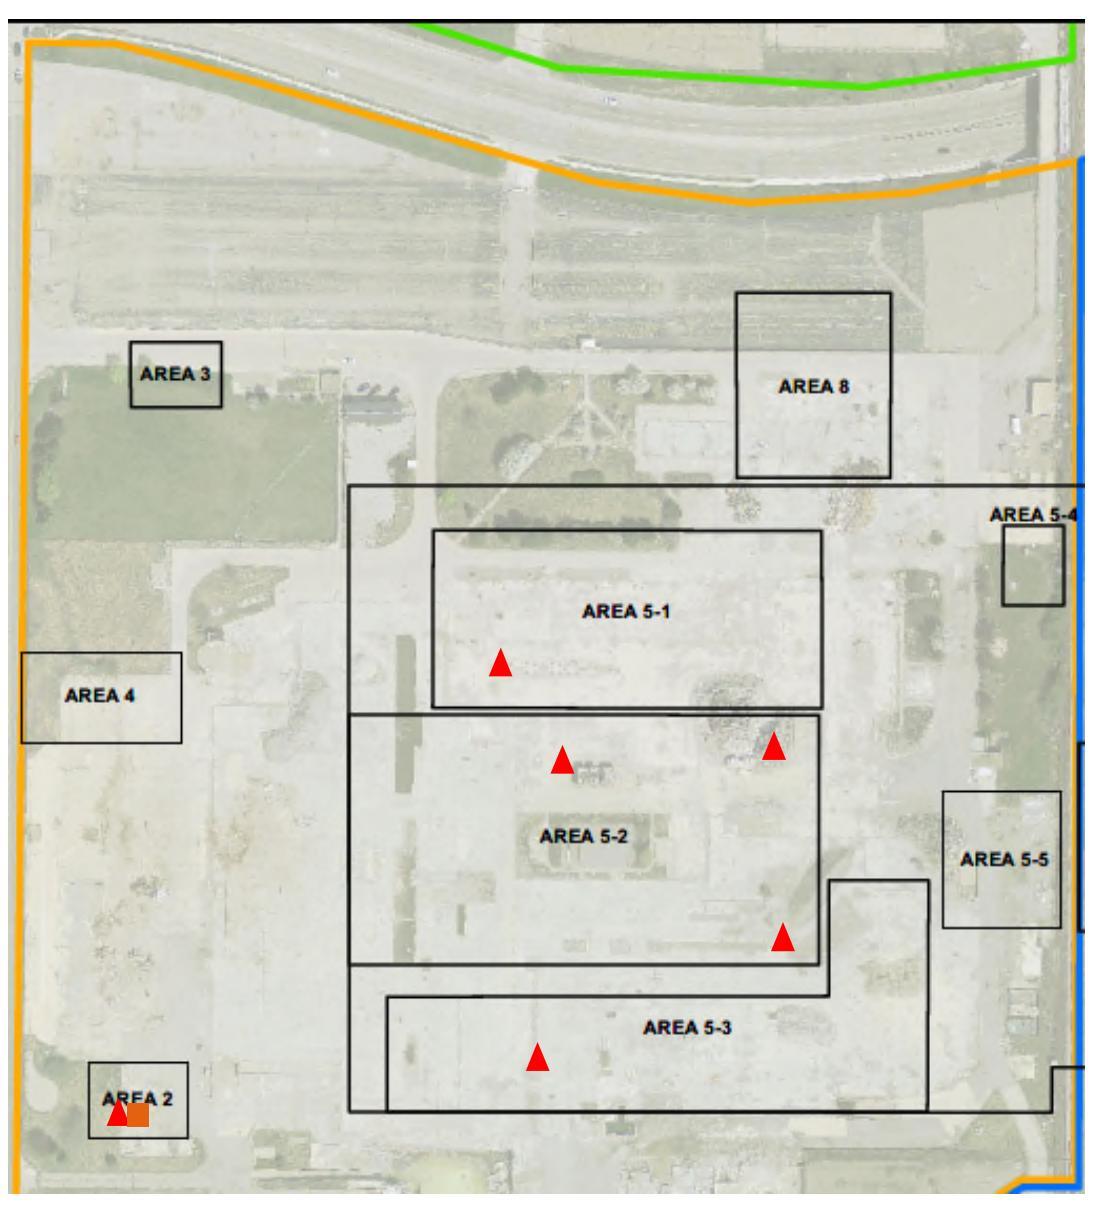
# Plant 2 – Locations that require an exposure barrier or notification in the Amended DRC

- Plant 2 Areas 2 (criteria exceedance of manganese), 5-1 (criteria exceedance of benzo(a)anthracene, benzo(a)pyrene, benzo(b)fluoranthene and dibenzo(a,h)anthracene), 5-2 (criteria exceedance of manganese and benzo(a)pyrene), and 5-3 (criteria exceedance of manganese and benzo(a)pyrene)

- Portions of the following areas will require an exposure barrier:
  - Plant 2 Area 2 (excavation and existing barrier) (criteria exceedance of arsenic)

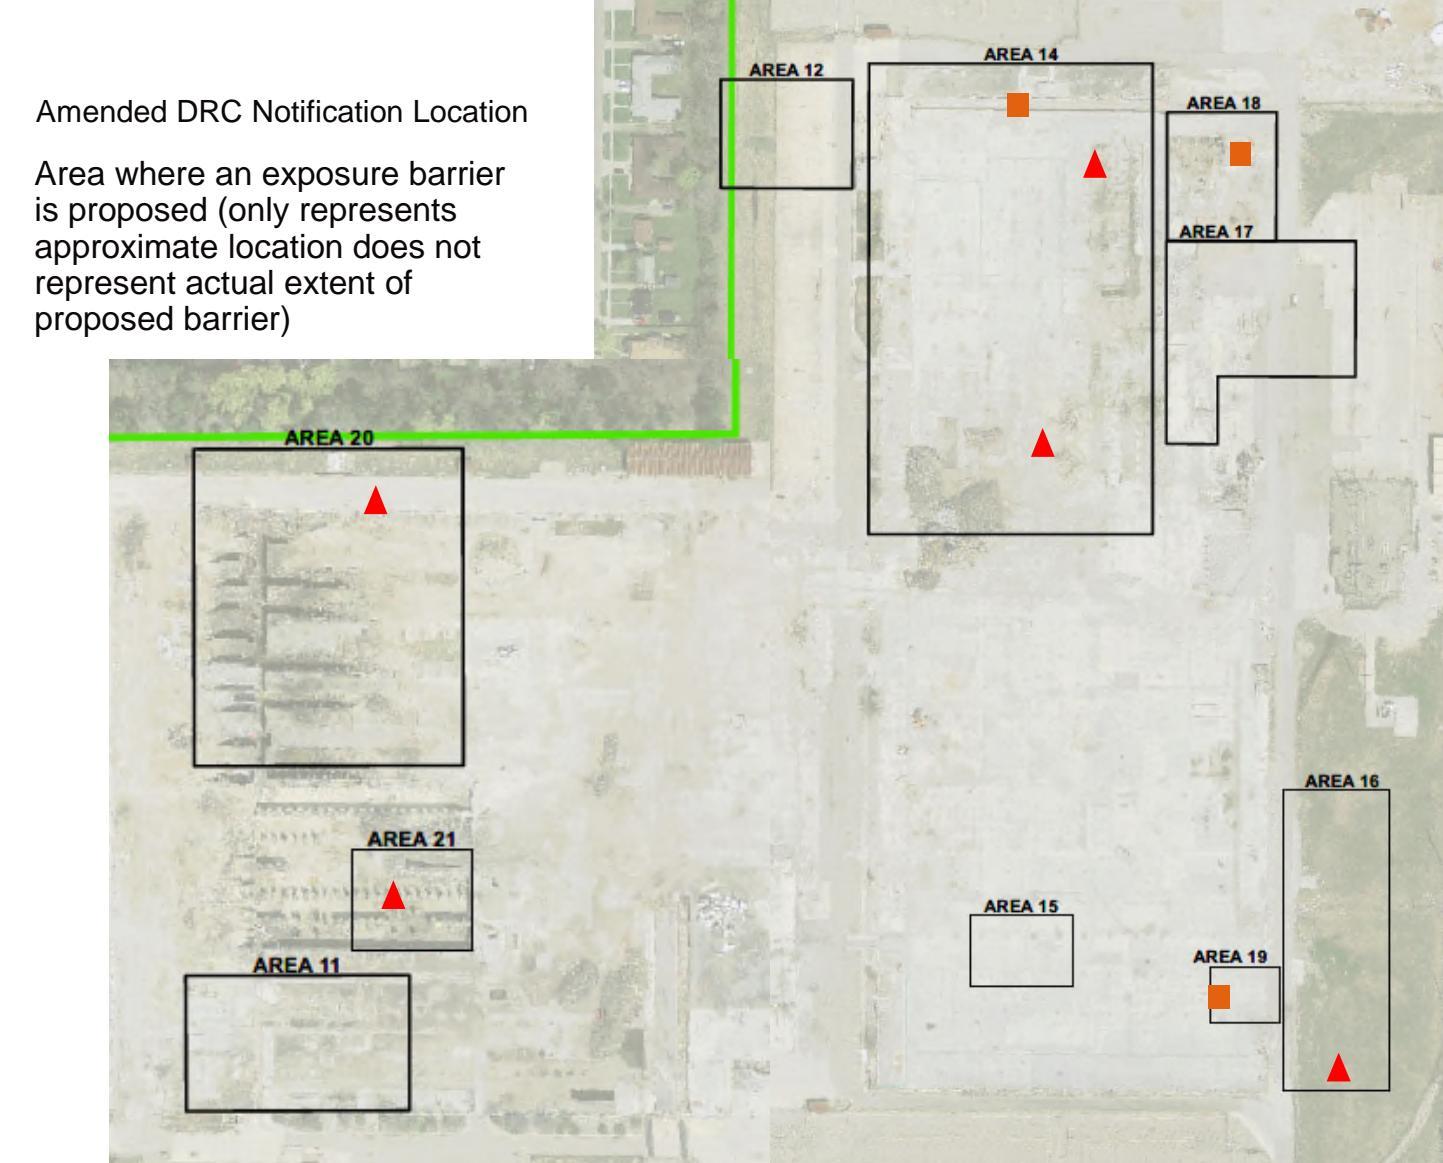
Plant 3 – Locations that require an exposure barrier or notification in the Amended DRC

- Plant 3 Areas 14 (criteria exceedance of arsenic and nickel), 16 (criteria exceedance of lead), 20 (criteria exceedance of manganese) and 21 (criteria exceedance of arsenic)

- Plant 3 Area 14 (existing barrier) (criteria exceedance of cyanide)
  - Plant 3 Area 18 (barrier placement) (criteria exceedance of benzo(a)pyrene)
  - Plant 3 Area 19 (existing barrier) (criteria exceedance of arsenic)
