**Landfill Inspection Report  
Coldwater Road Landfill  
Flint, Michigan  
MID 005 356 860**

**RACER TRUST  
Detroit, Michigan**

February 2019

RE: 2018 Annual Landfill Inspection Report  
Coldwater Road Landfill, Flint, Michigan  
MID 005 356 860

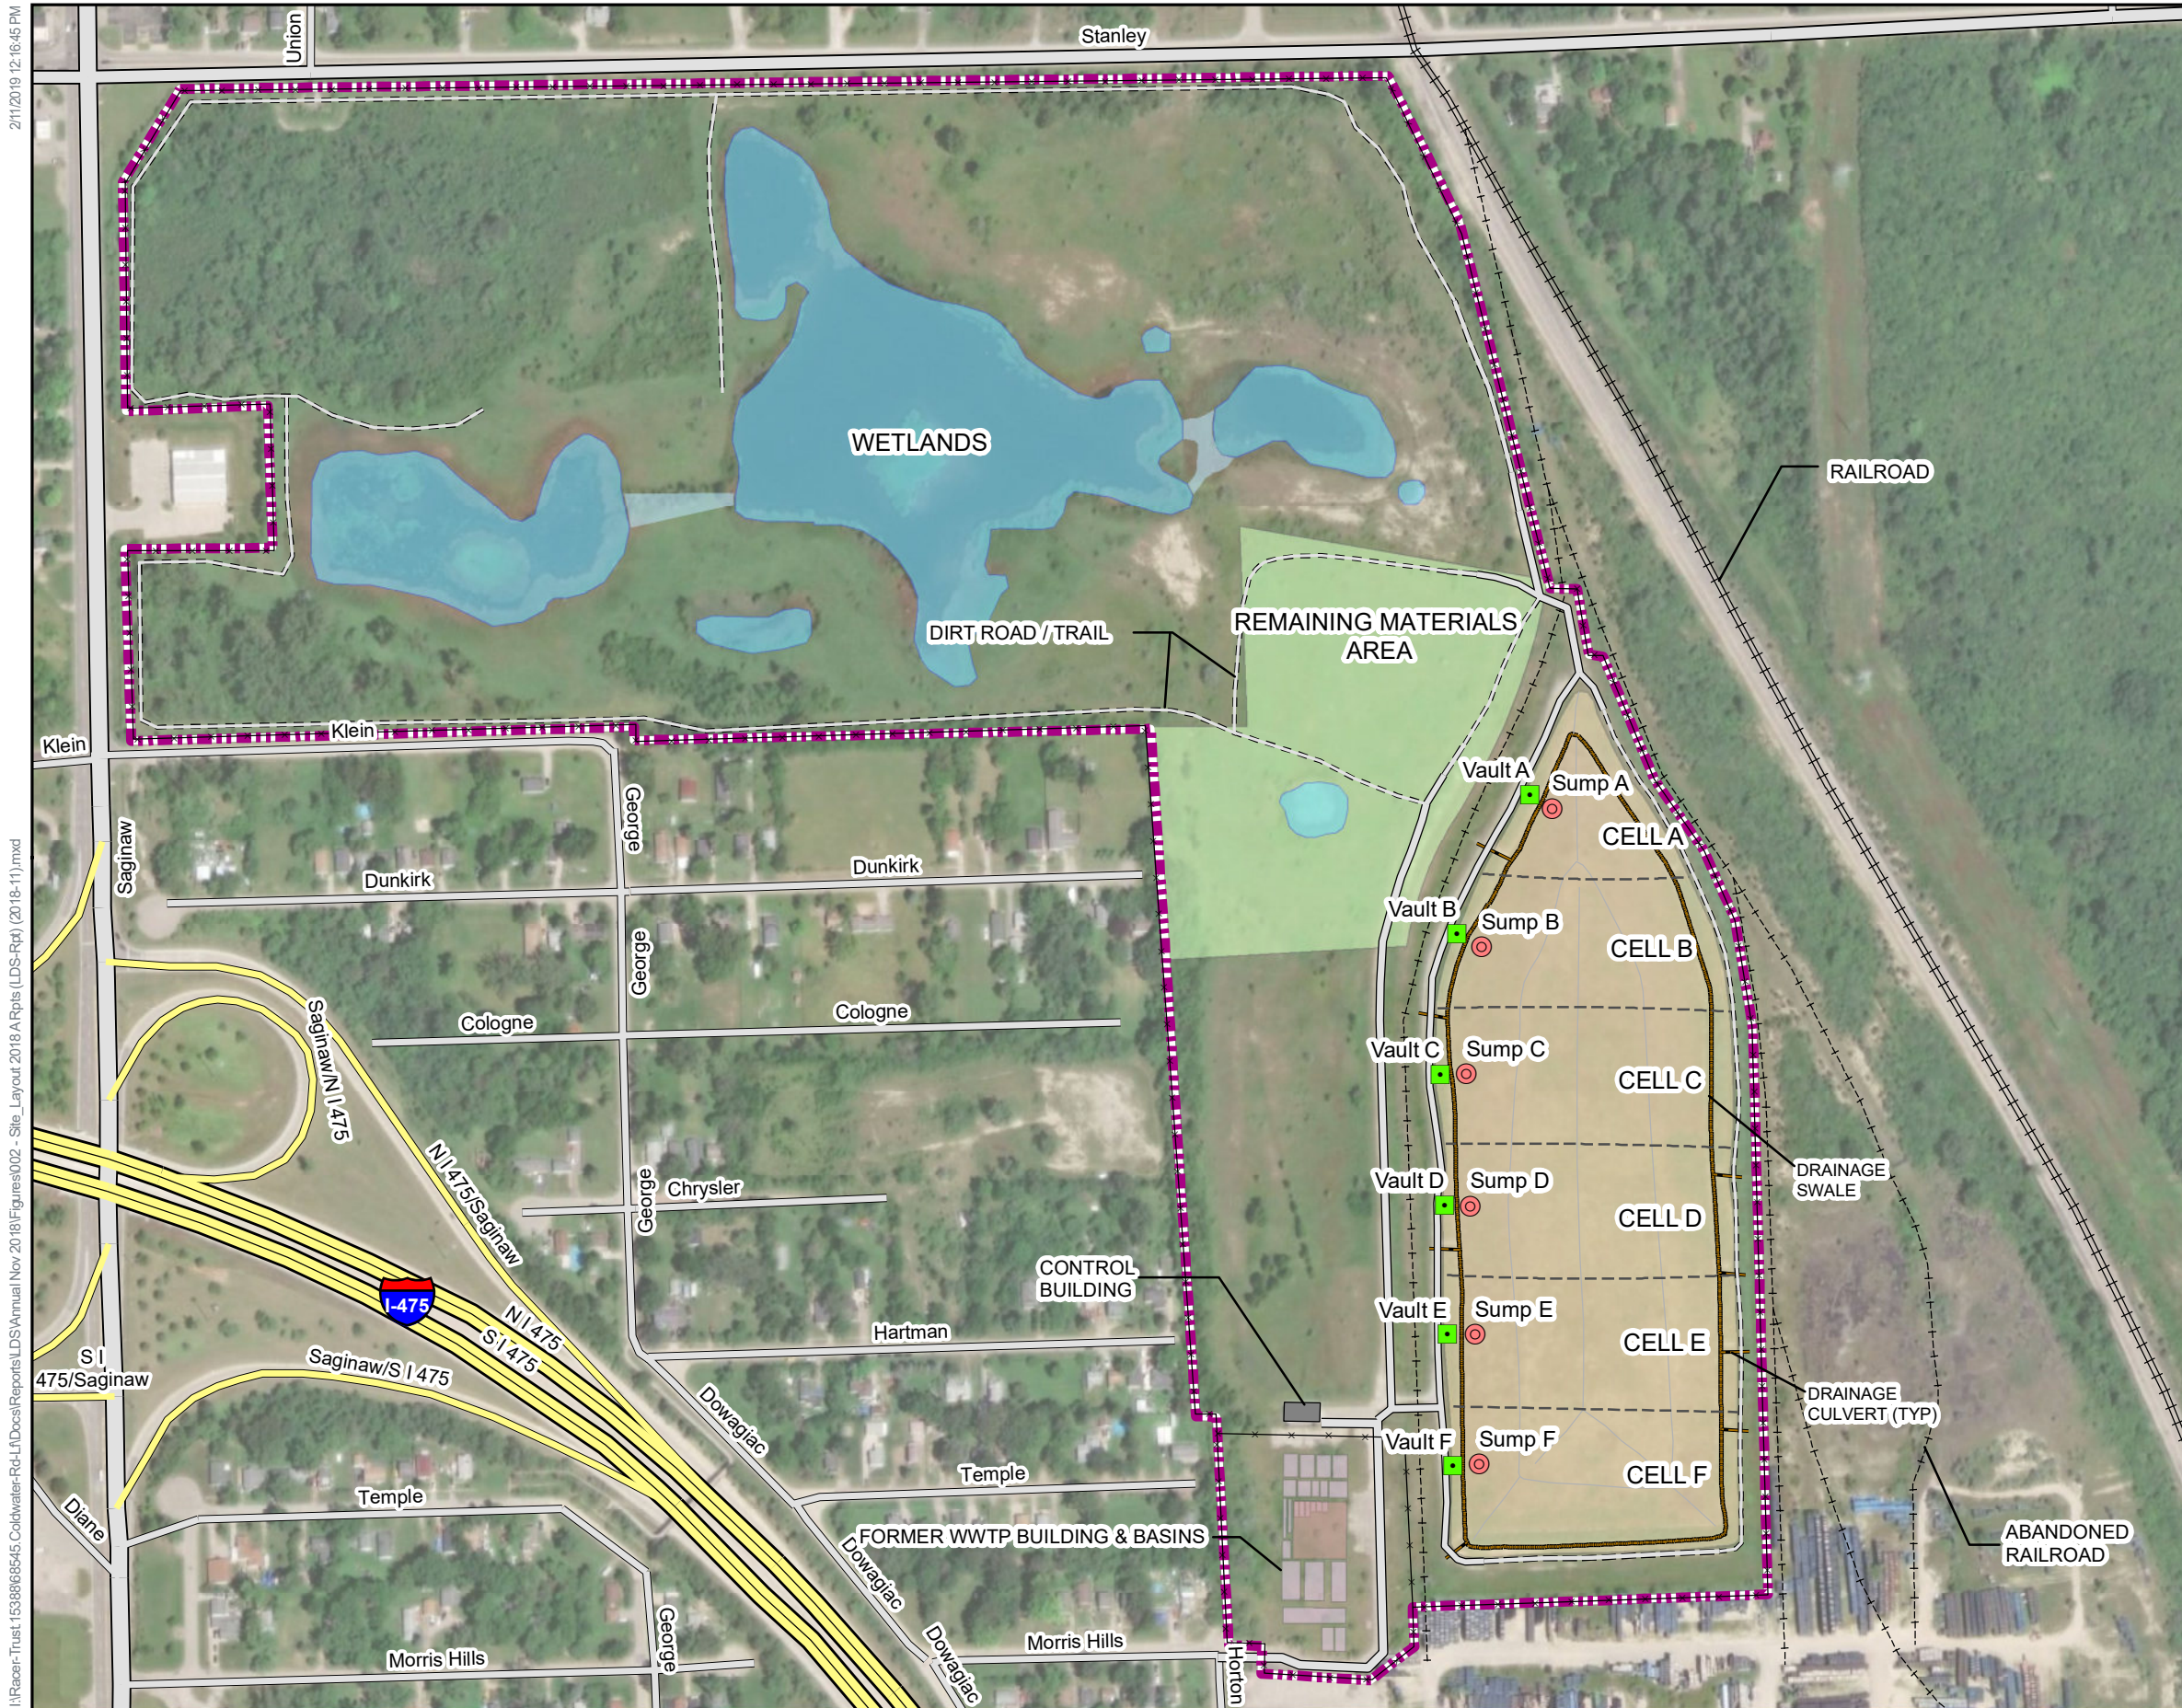
During the 2<sup>nd</sup> quarter and 4<sup>th</sup> quarter, one previously repaired hole along the west perimeter fence had been reopened. The hole was repaired during the site inspections [Figure 3](#).

-   LEACHATE COLLECTION SUMP
-   ACCESS PORT FOR LEAK DETECTION VAULT
-   FENCE REPAIR
-   ANIMAL BURROW LOCATION (4th Quarter 2018)
-   MOLE ACTIVITY
-   PONDED WATER
-   ROAD REPAIR
-   PROPERTY BOUNDARY
