Re: Ley Creek PCB Dredgings Site (Registry # 7-34-044)
NYSDEC Order on Consent Index # D-7-0008-97-06
2004 Annual OM&M Inspection Report

Re: Ley Creek PCB Dredgings Site
August 2004 OM&M Inspection

**AUGUST 2004
OM&M INSPECTION
PARTIAL SITE PLAN**

Re: Ley Creek PCB Dredgings Site
2004 OM&M Wetland Evaluation

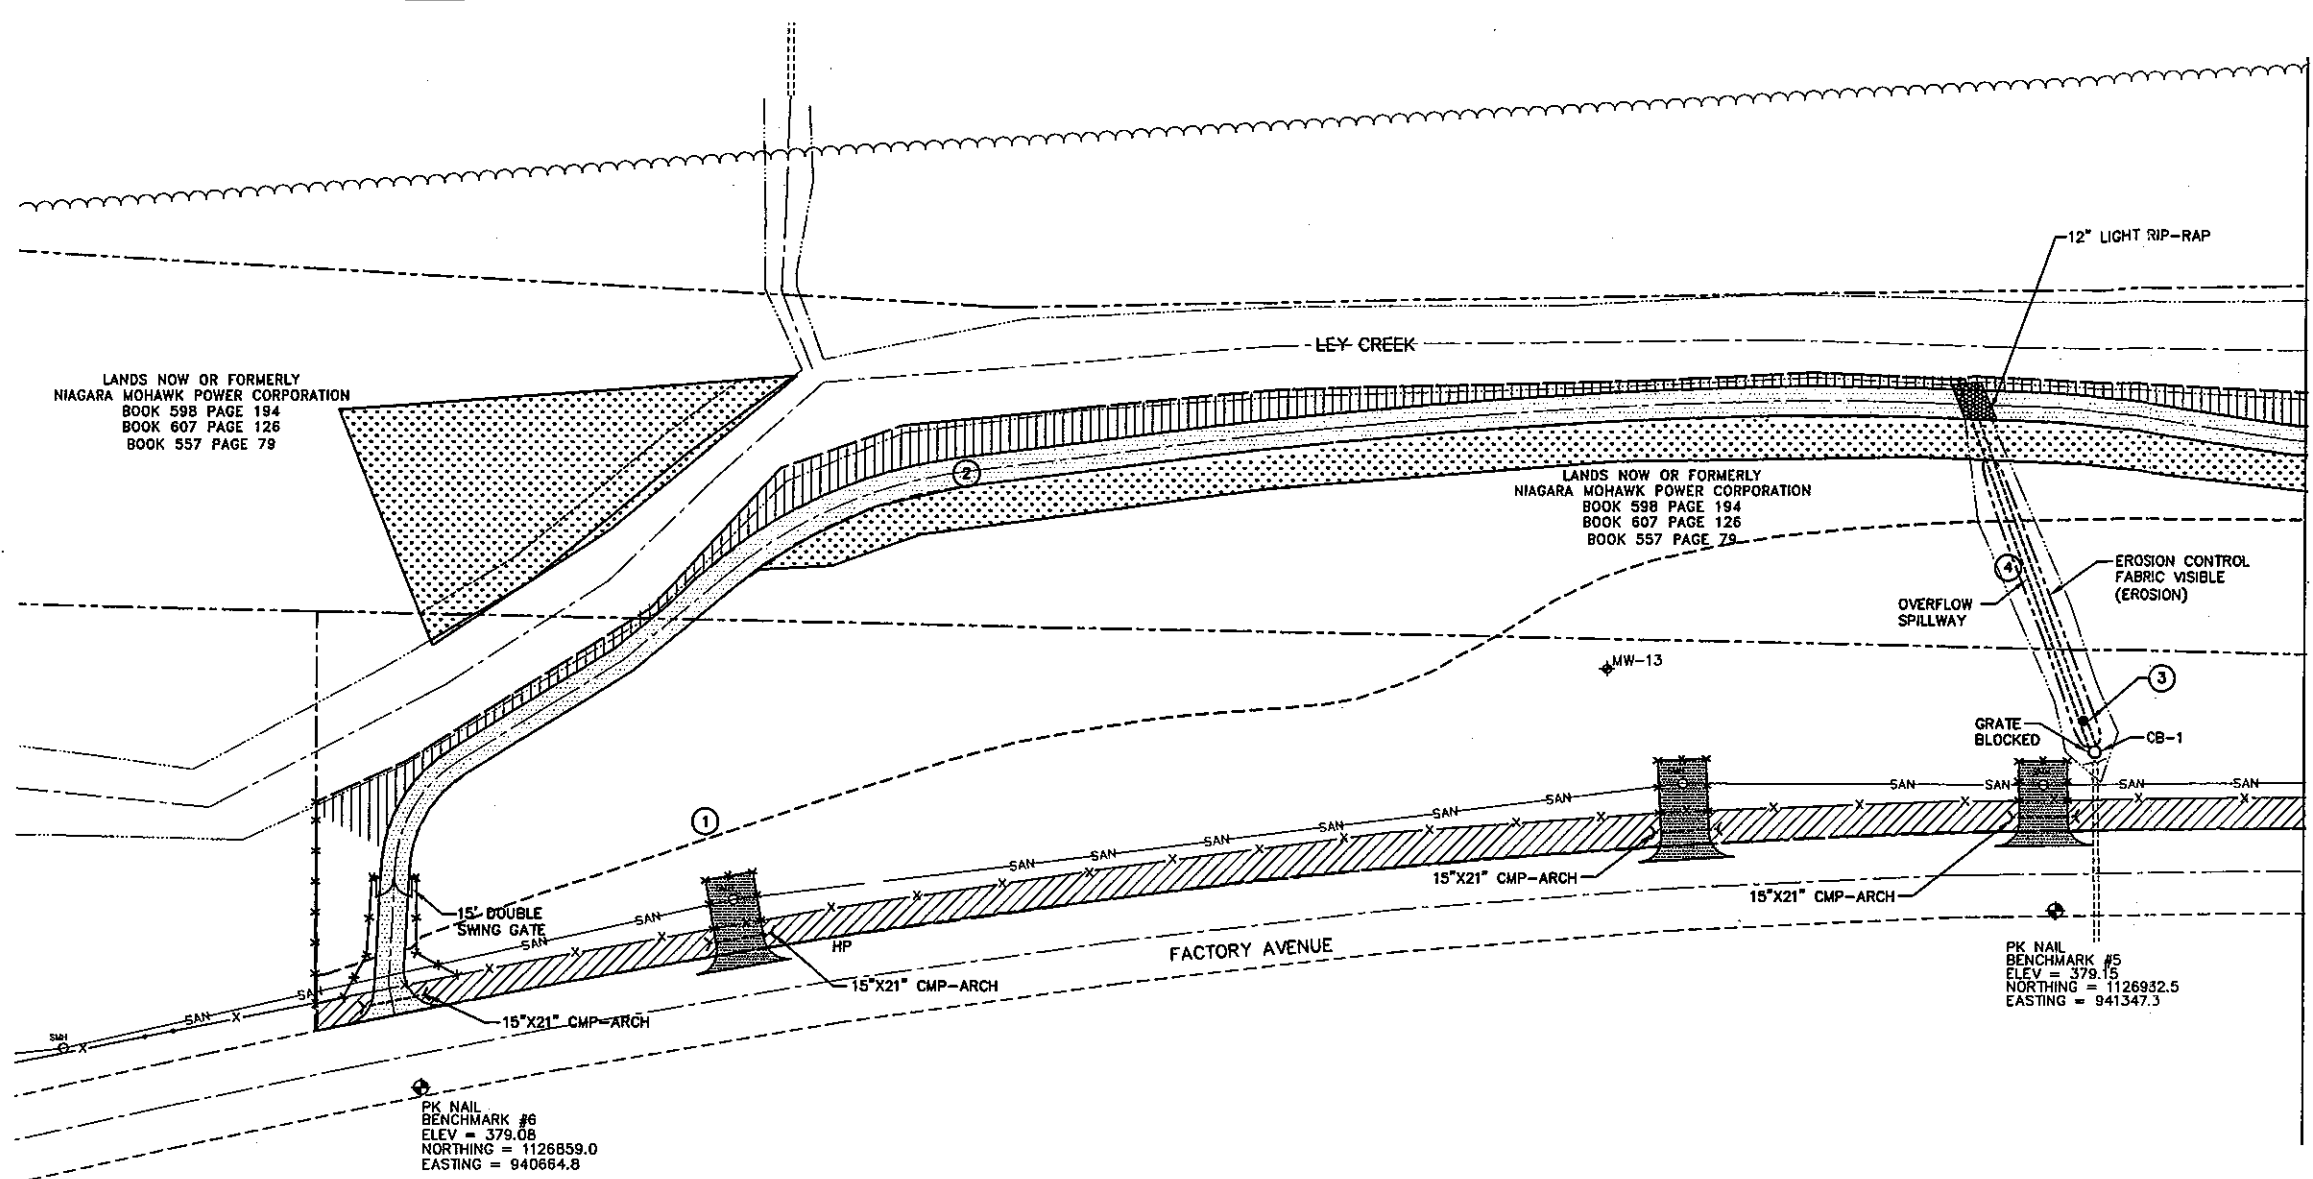
FIGURE 1

- Vegetative cover erosion: (Photograph 10, Figures 1 and 3). Two areas of erosion were observed within the CB-1 and CB-3 overflow spillways, which require repair.

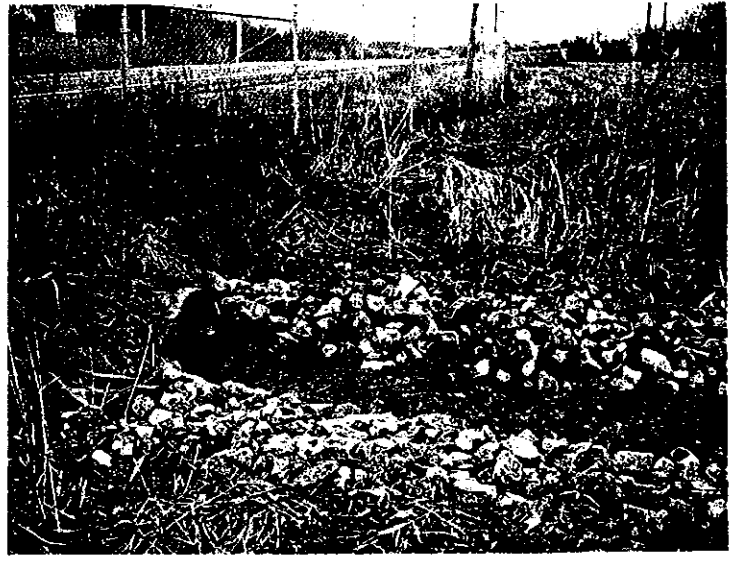
1. Signs intact?	X		
	2. Fence breached?		X	
	3. Access gates locked?	X		
	4. Areas of damage?	X		Refer to Figures 4 and 5 and Photograph 3
Note any additional comments:				
Vegetation is established in the stone access road.				
Erosion previously noted at CB-3 and CB-5 were addressed by adding rip-rap in the eroded areas.				
Observations (erosion at CB-1 overflow spillway, vegetative growth in western fence, ruts west of CB-3, and animal holes) made by O'Brien & Gere and				
NYSDEC on November 17, 2004 were addressed prior to the December OM&M site inspection.				
Repairs to the site fence remain to be done.

Photograph 6-View of area near CB-3

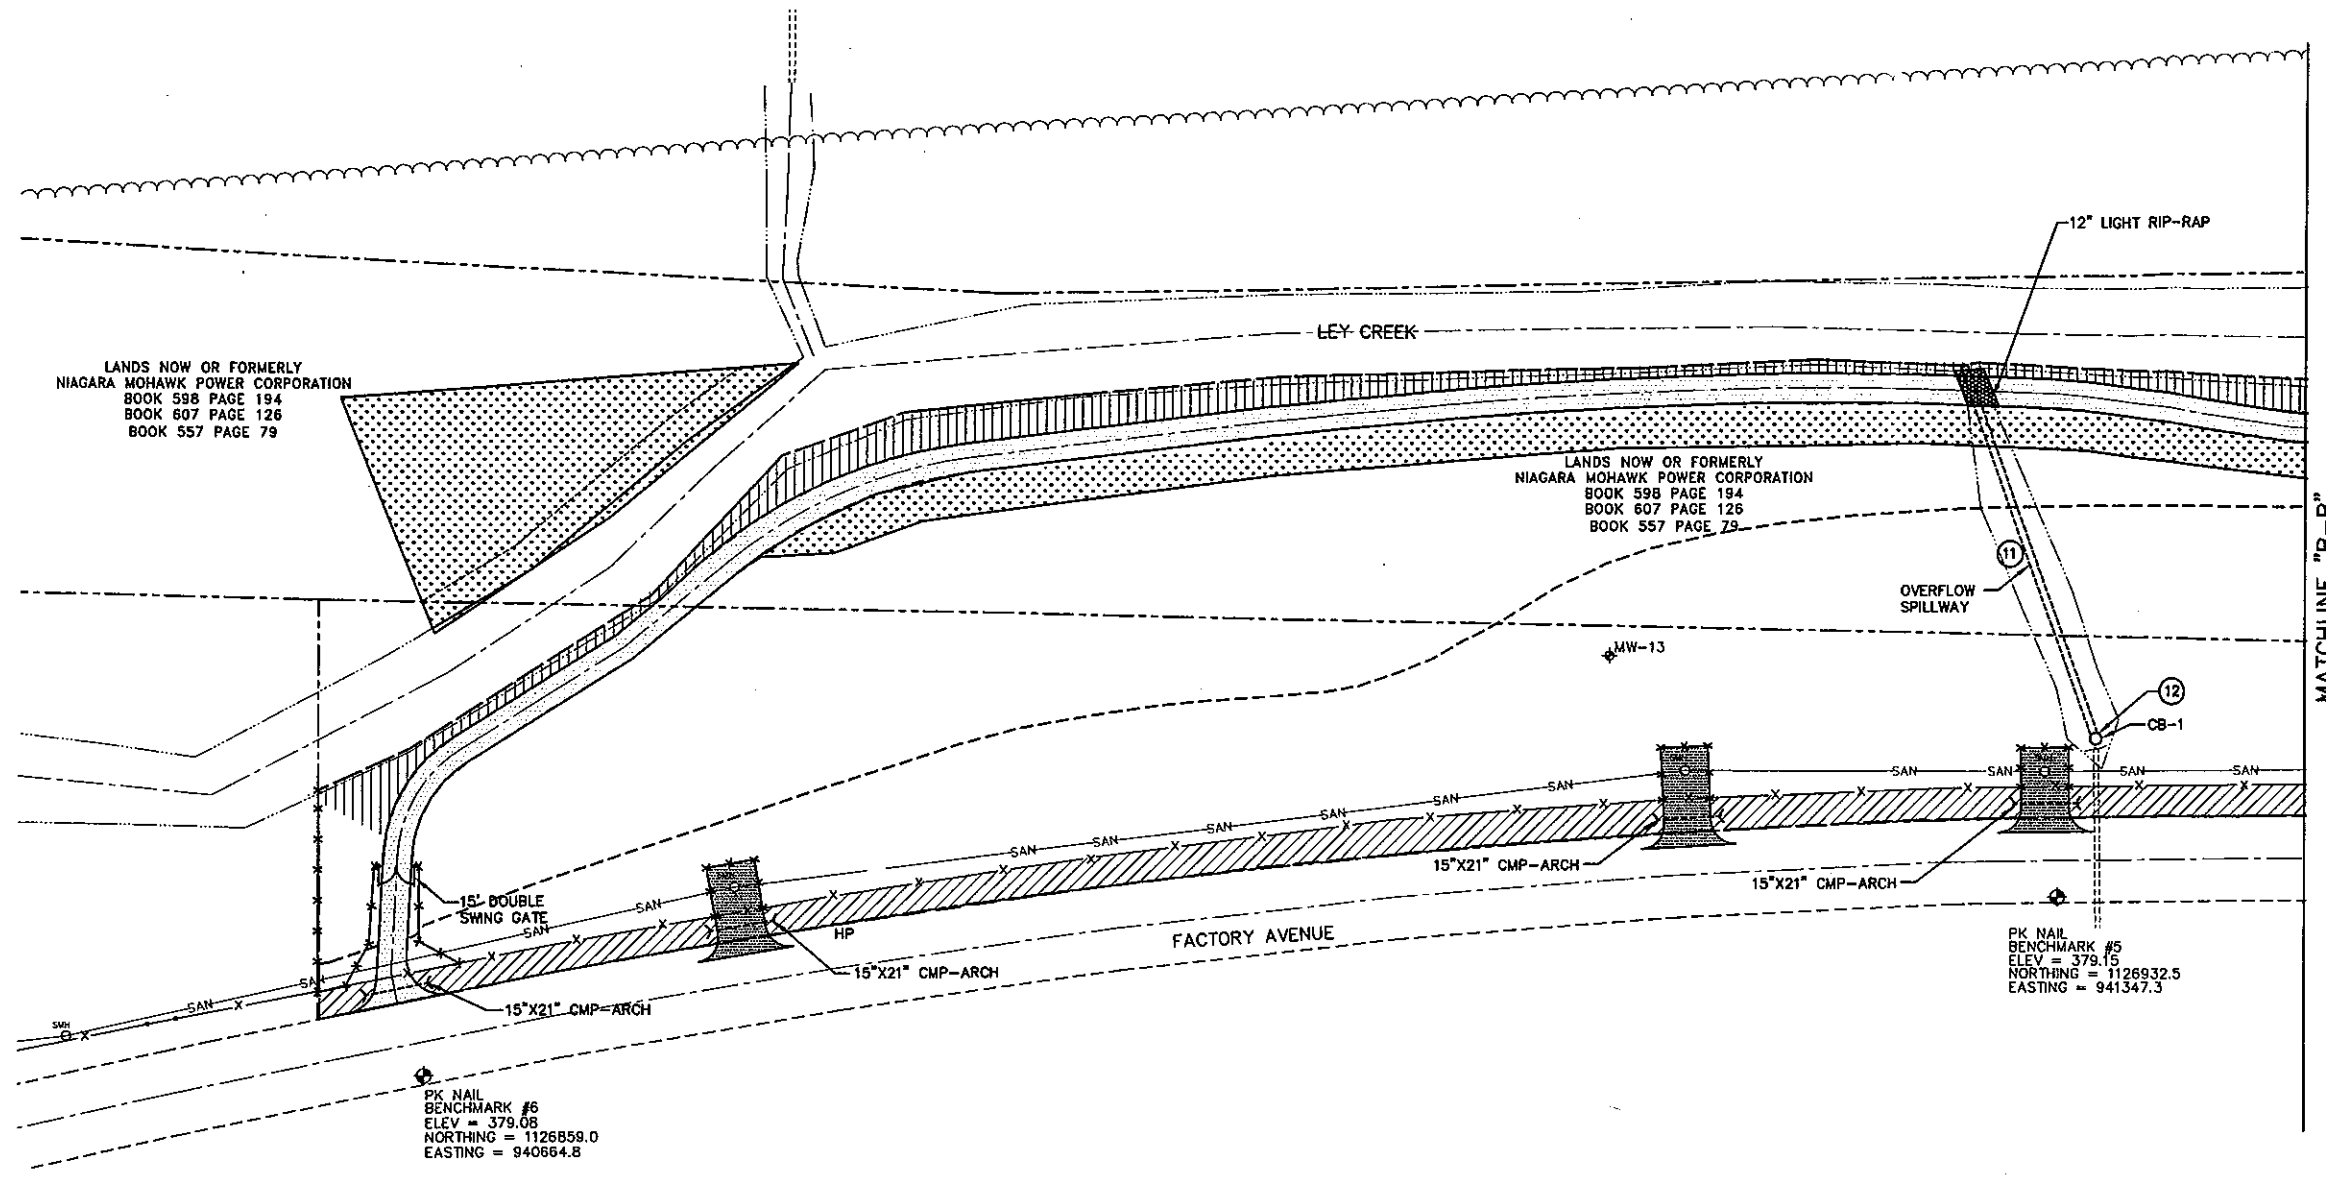
FIGURE 1

- Stone access road drainage: (Photograph 10. Figure 2.) One area of the stone access road, observed to have rutting and poor drainage characterized by ponded water being visible within the stone access road.
- Debris accumulation: (Photograph 12. Figure 1.) Debris was accumulated over the catch basin CB-1 grate, thus restricting flow.
- Vegetation within stone access road: A significant amount of vegetation was observed within the stone access road throughout the Site and the stone access road turnaround at the eastern end of the Site.
- Tree establishment: (Figure 2.) An approximate 2-inch diameter tree was observed along the fence line.

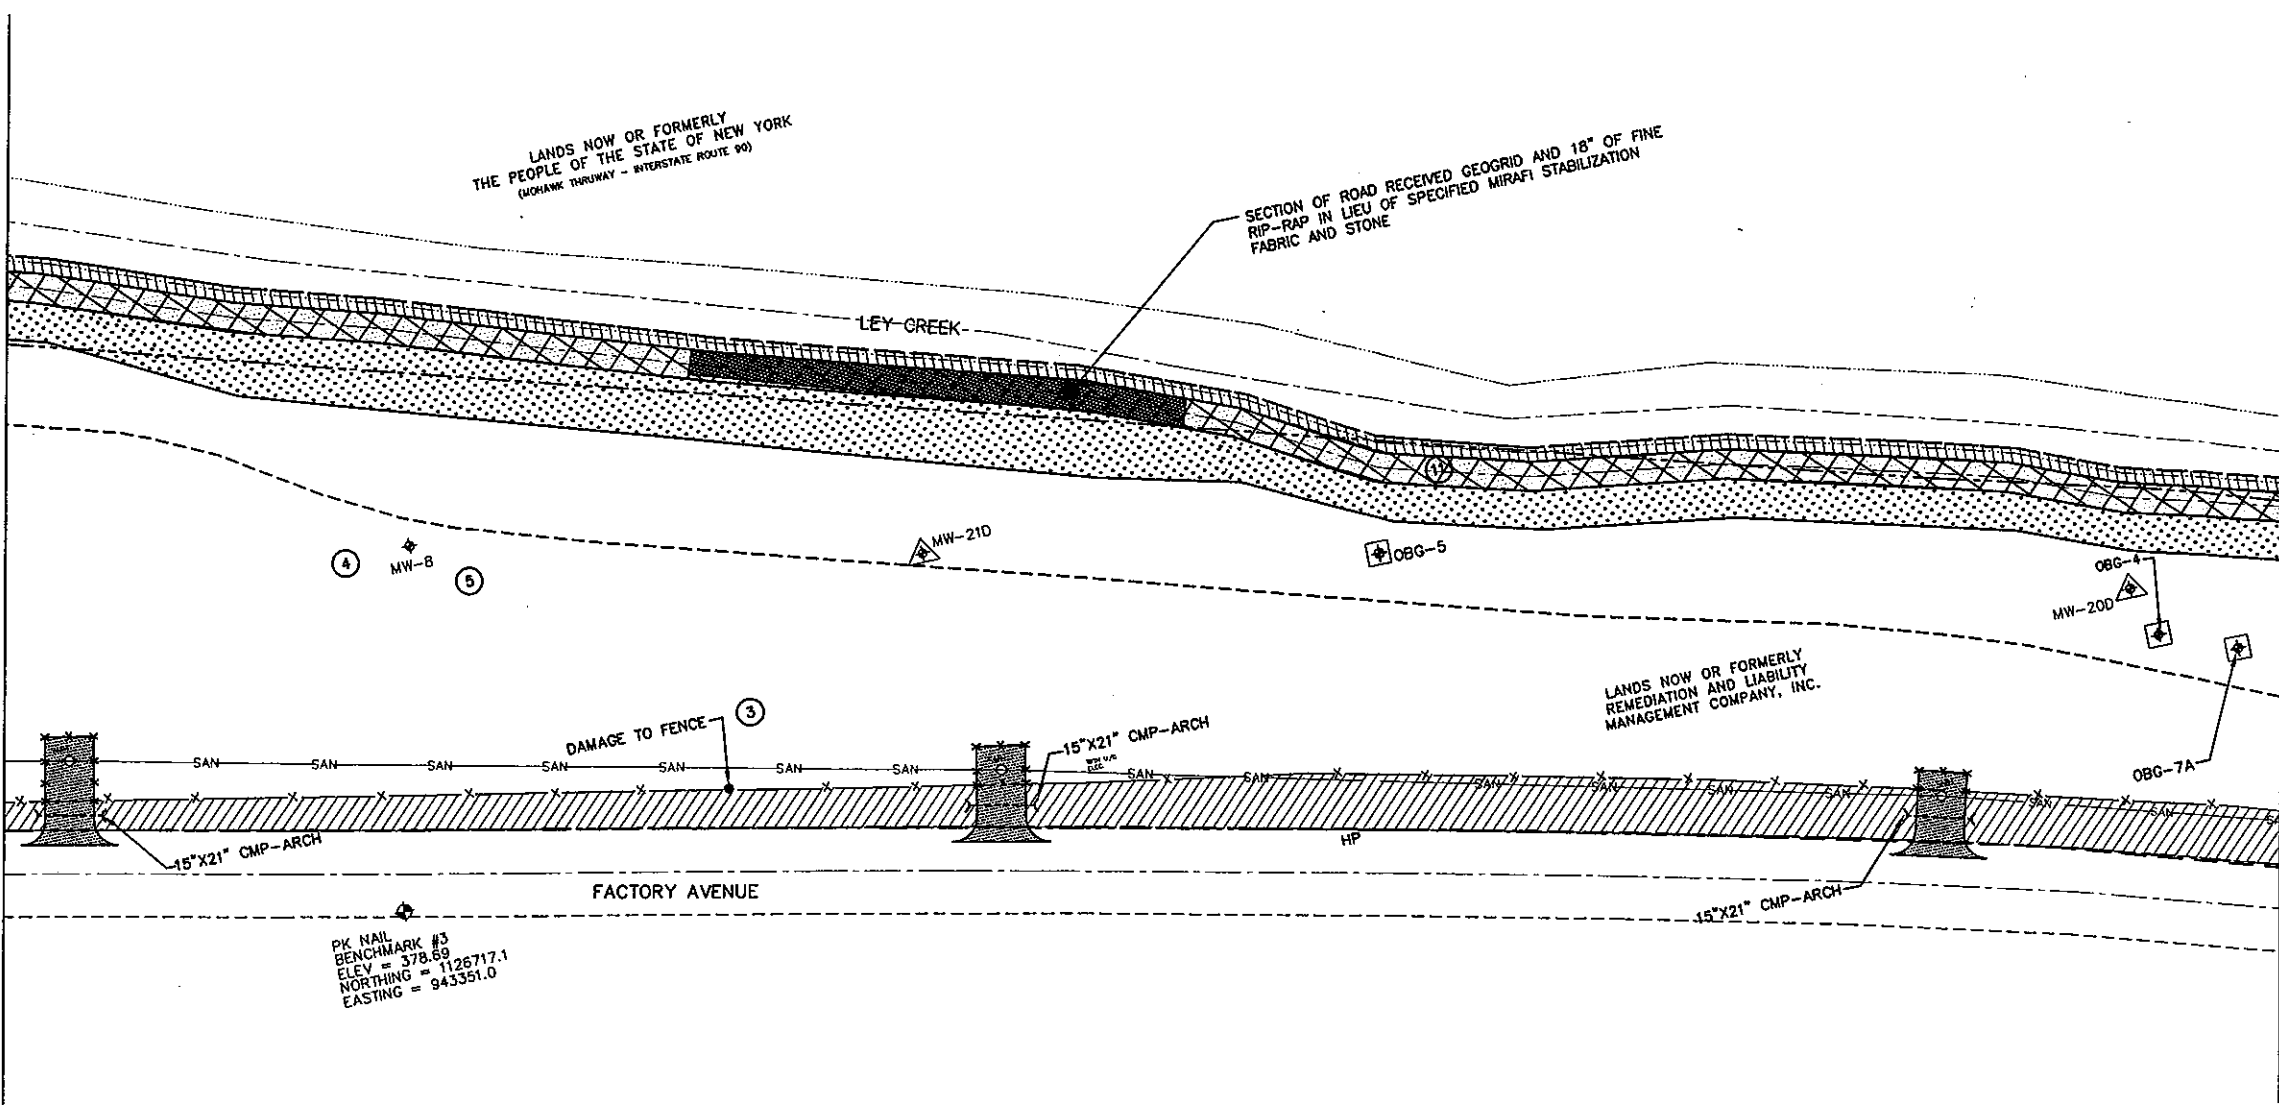
FIGURE 4

The two areas of the site security fence that were observed to be damaged during the site inspection (Figures 4 and 5) have not been repaired and should be repaired as soon as practicable.
