30214041.00006

RACER Pontiac North Campus – 2023 Property Inspection Report

IC/EC Inspection Report for Pontiac North, MI at Pontiac North Campus Industrial Land (#11970) on October 10, 2023

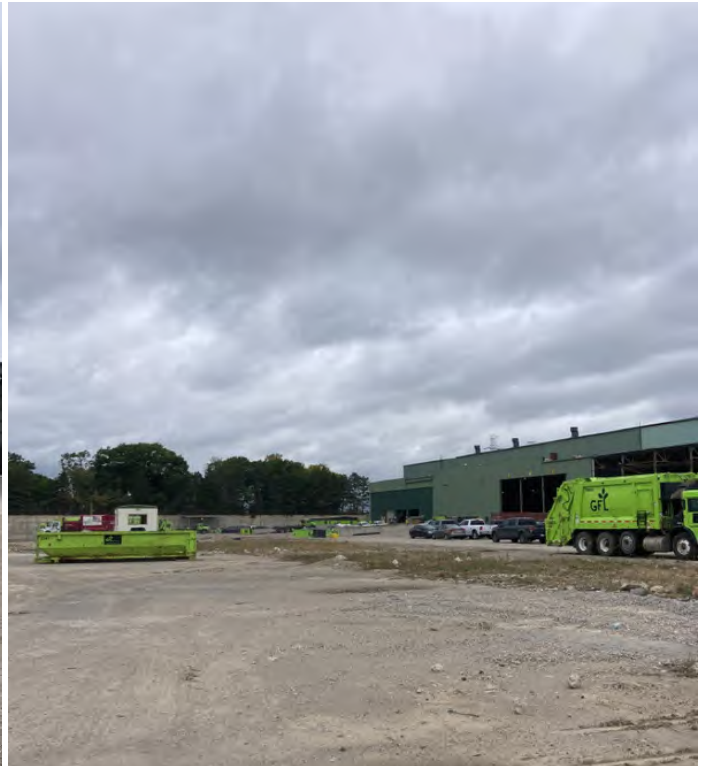
Building addition to existing assembly plant that was constructed last year in use located in northern portion of property

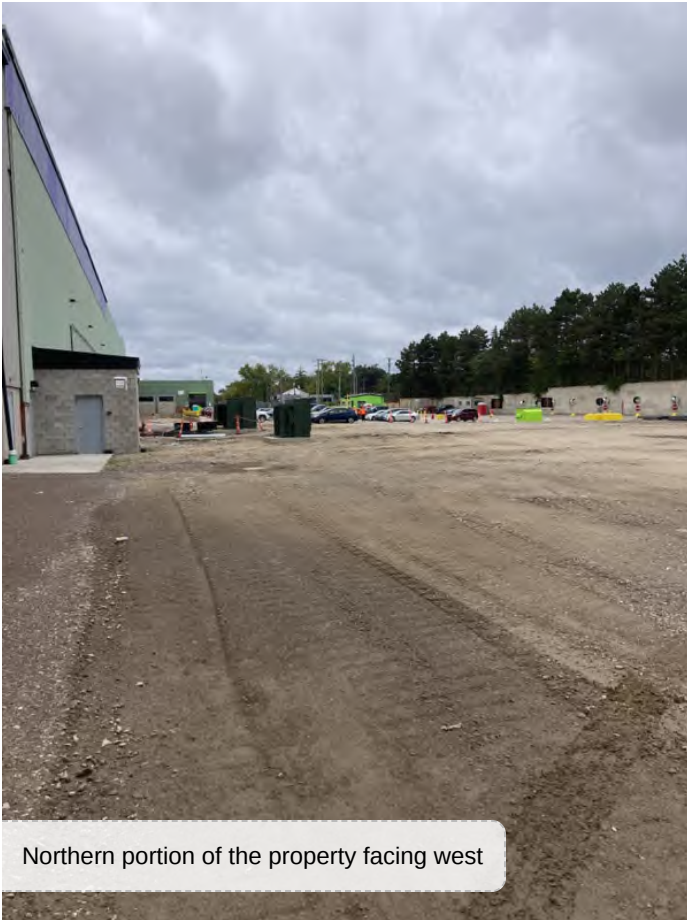
Name of the IC	Annual DRC inspection- Former Fiero Assembly Plant - GFL
Characterize restricted activities and uses	Other Restrictions
Characterize other restriction(s)	No water wells observed on property; no evidence of staining in areas visually observed; no evidence of soil relocation or excavation (three small piles of dirt, gravel and broken concrete observed); property is non residential use
Do site use and activities comply with other restrictions	Yes
Other comments or notes about the IC?	Newer fence installed along property southern border between GFL and powerhouse property; some refuse seen on ground near new building addition; barrels seen marking some monitoring wells especially in high traffic areas

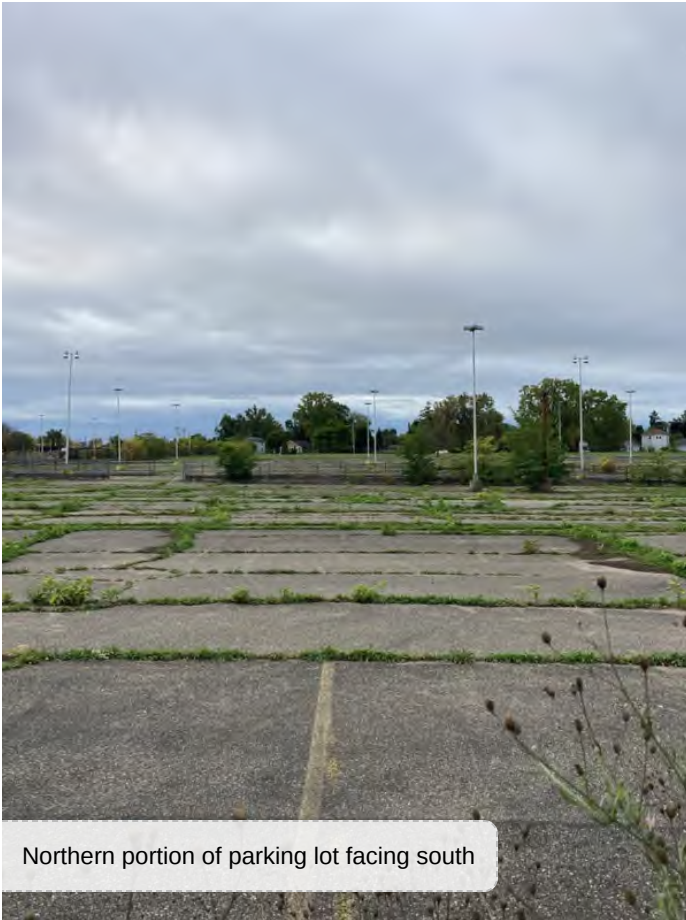
Name of the IC	Annual DRC inspection Fiero Parking Lot
Characterize restricted activities and uses	Other Restrictions
Characterize other restriction(s)	No water wells installed observed; no evidence of soil relocation or excavation; no buildings currently vacant lot; no observation of subsurface feature installation; property vacant non residential use; no staining where visually observed.
Do site use and activities comply with other restrictions	Yes
Other comments or notes about the IC?	Notes: quite a bit of vegetation growth; construction barrels or cones have been placed at PZ wells.

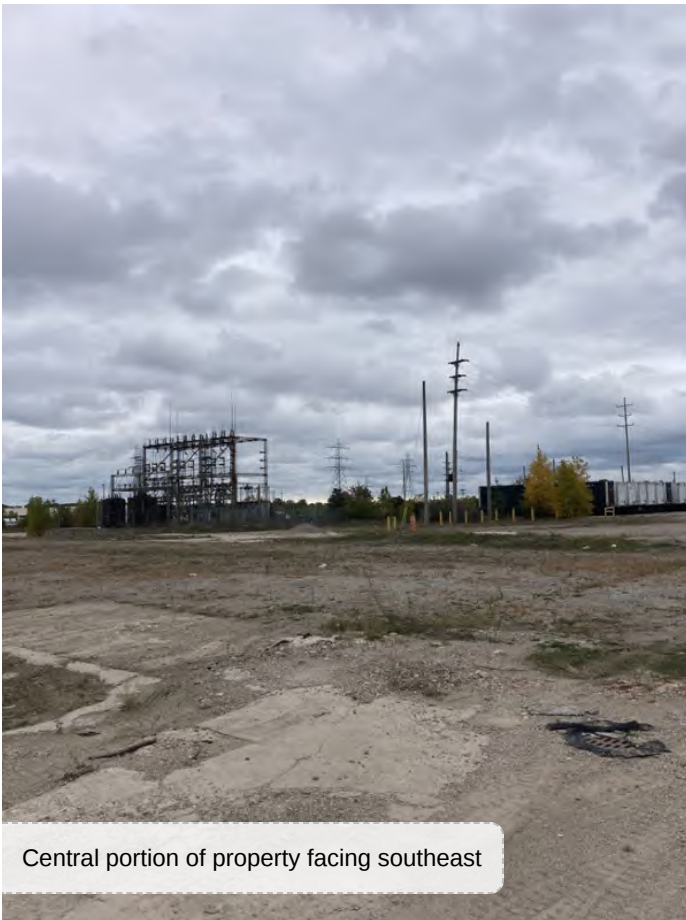
Name of the IC	Annual DRC inspection Fiero Powerhouse
Characterize restricted activities and uses	Other Restrictions
Characterize other restriction(s)	No water wells installed; no evidence of soil excavation or relocation activities; no buildings constructed currently vacant other than old powerhouse portion left; no evidence of subsurface utility installation; property is non residential use currently leased to park truck trailers.
Do site use and activities comply with other restrictions	Yes
Other comments or notes about the IC?	Some barrels in place marking wells some had been moved away from wells.

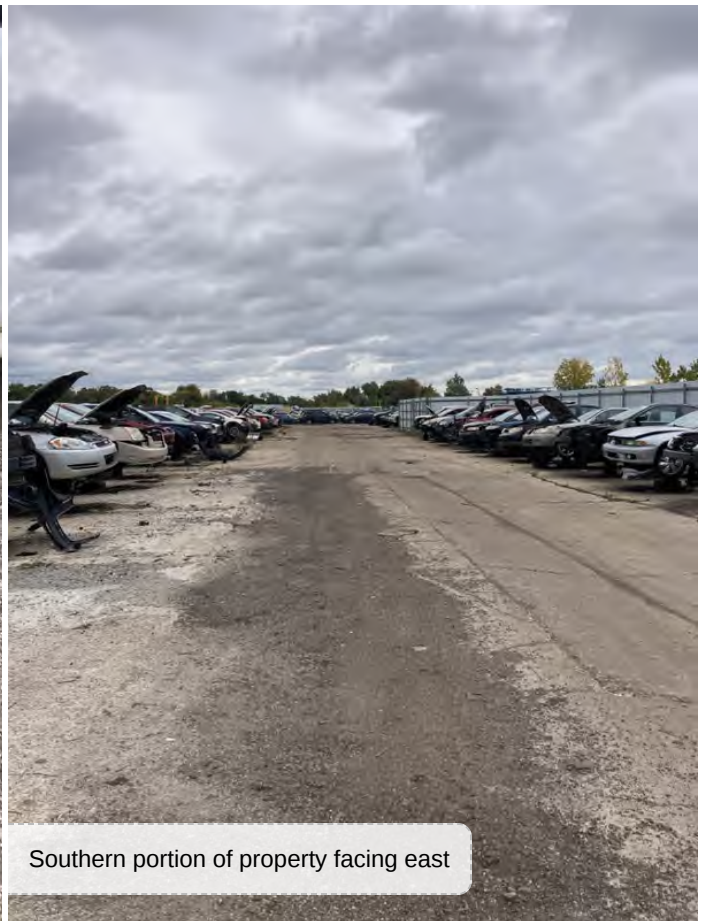
Staining with water puddle seen under a vehicle- several vehicles with staining underneath

Name of the IC	Annual DRC inspection- U pull and save auto parts
Characterize restricted activities and uses	Other Restrictions
Characterize other restriction(s)	No water wells observed at property; no evidence of excavation or soil relocation; no evidence of subsurface utility installation; no new buildings have been constructed; property is being used for non residential purposes.
Do site use and activities comply with other restrictions	Yes
Other comments or notes about the IC?	Staining observed beneath most vehicles stored at property

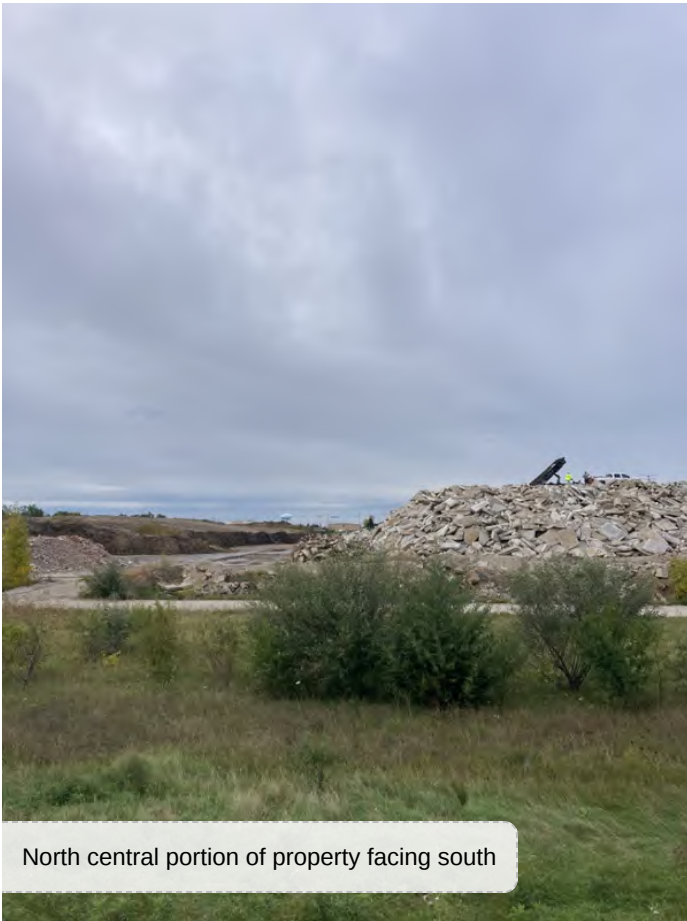
North central portion of property facing south

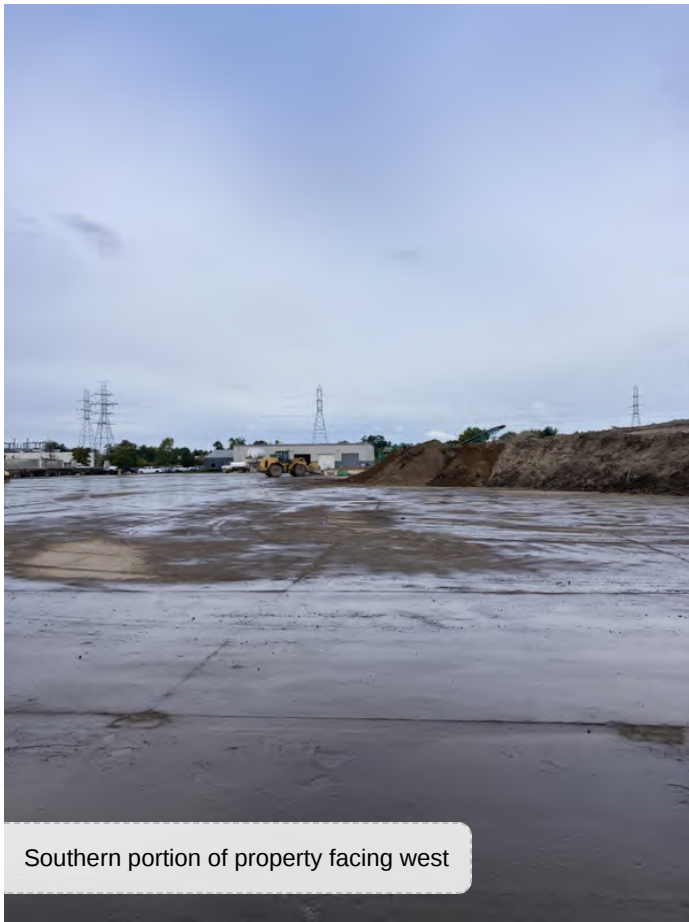
Southern portion of property facing west

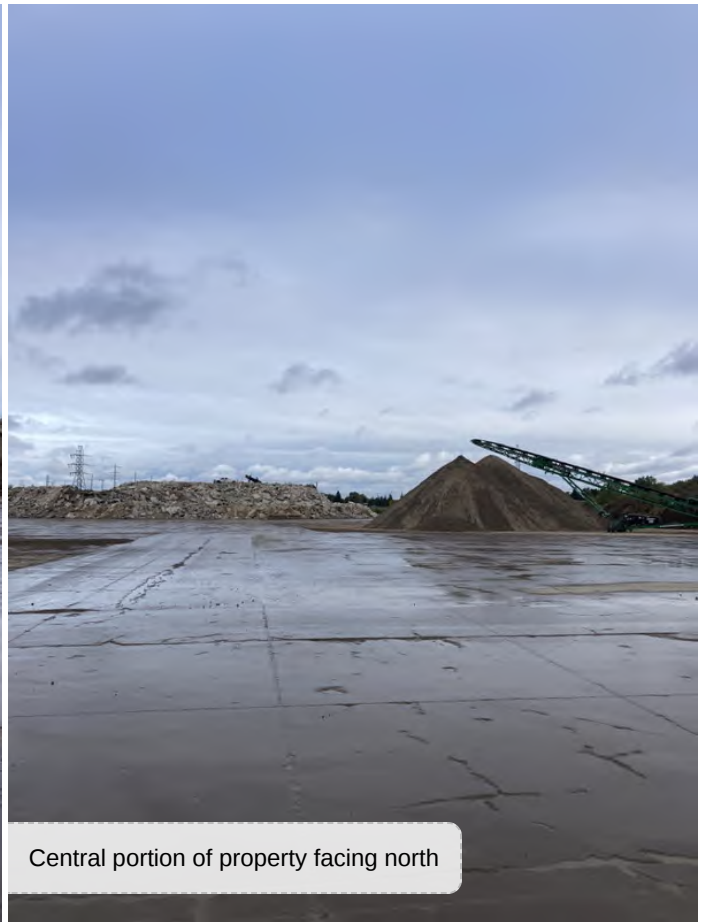
Central portion of property facing north

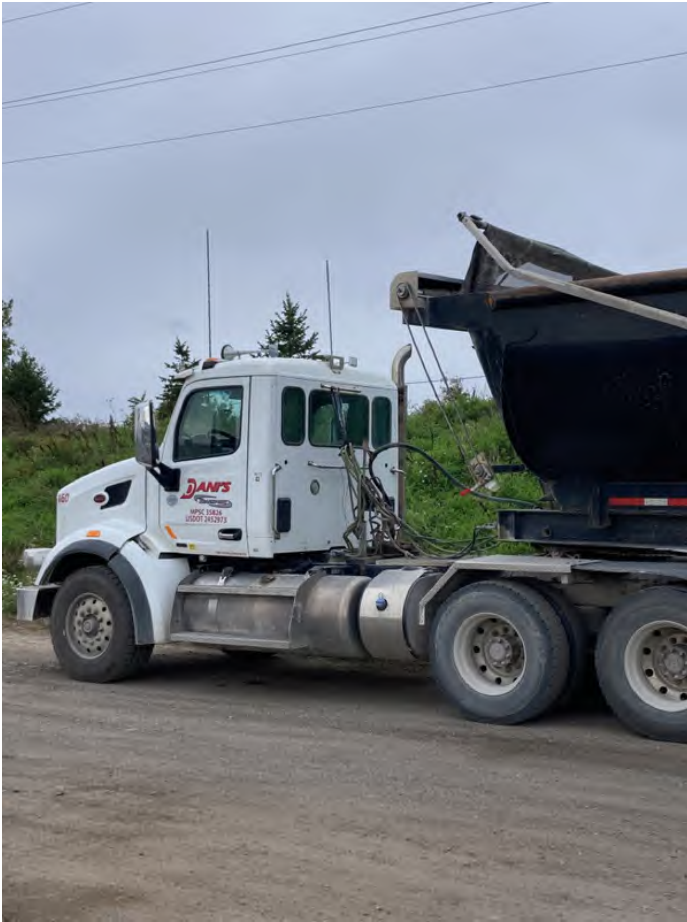
Name of the IC	Annual DRC inspection- Dani's Transport
Characterize restricted activities and uses	Other Restrictions
Characterize other restriction(s)	No water wells observed; no visual evidence of excavation or soil relocation (other than rubble storage piles that are part of business); no new buildings constructed; no evidence of subsurface feature installation; land is non residential use; no evidence of staining where visually evaluated during inspection other than some sheen in parking lot area where it was wet.
Do site use and activities comply with other restrictions	Yes
Other comments or notes about the IC?	Notes: types of materials stored included bricks; concrete; soil; truck trailers. Large soil pile that encompasses most of the central portion of the property is new for this years inspection. Construction barrels placed were seen smashed and not over monitoring wells.

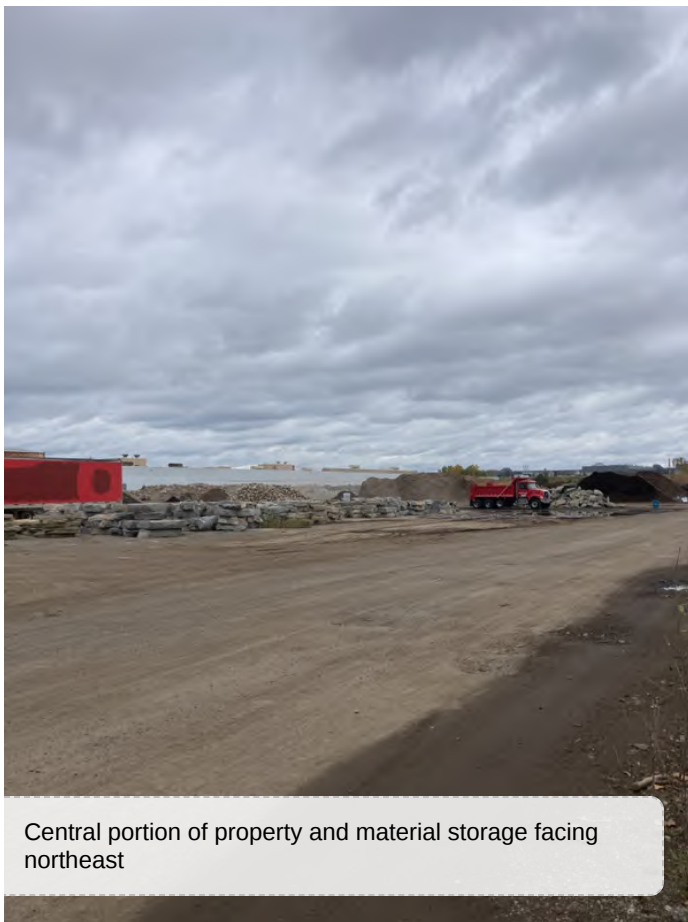
Name of the IC	Annual DRC inspection of former plant 14 currently bedrock
Characterize restricted activities and uses	Other Restrictions
Characterize other restriction(s)	Non residential use; no water wells installed; no soil excavation or relocation observed (other than soil piles stored onsite as part of business); no evidence of utility installation; no areas of staining observed where visually evaluated.
Do site use and activities comply with other restrictions	Yes
Other comments or notes about the IC?	Materials stored include wood chips; soil; tree debris; concrete; mulch; low occupancy areas are intact and area in central portion is being used for mulch storage.

Central portion of property and material storage facing northeast

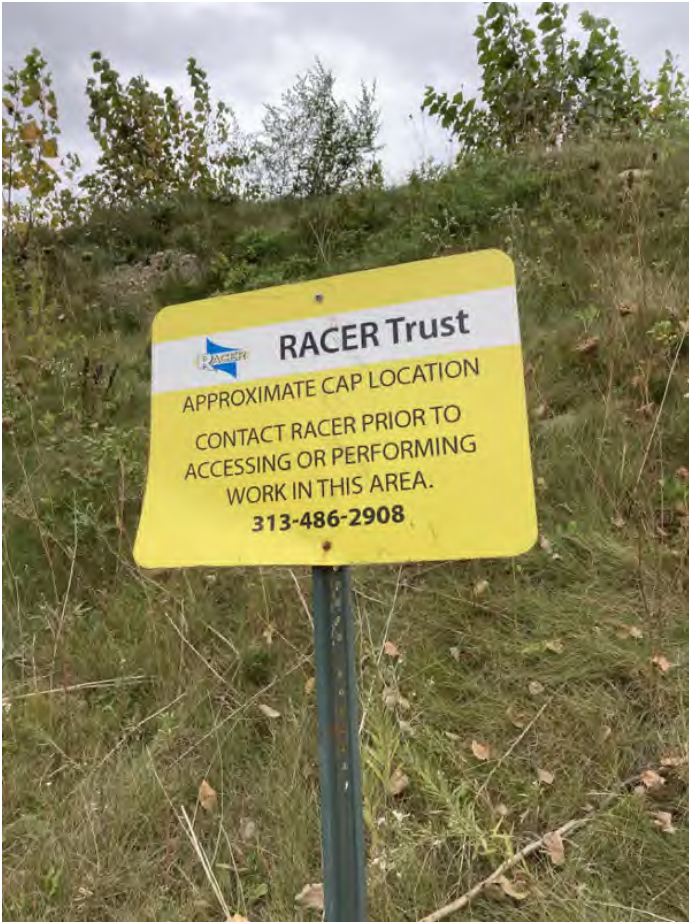
One of several markers installed around cap area

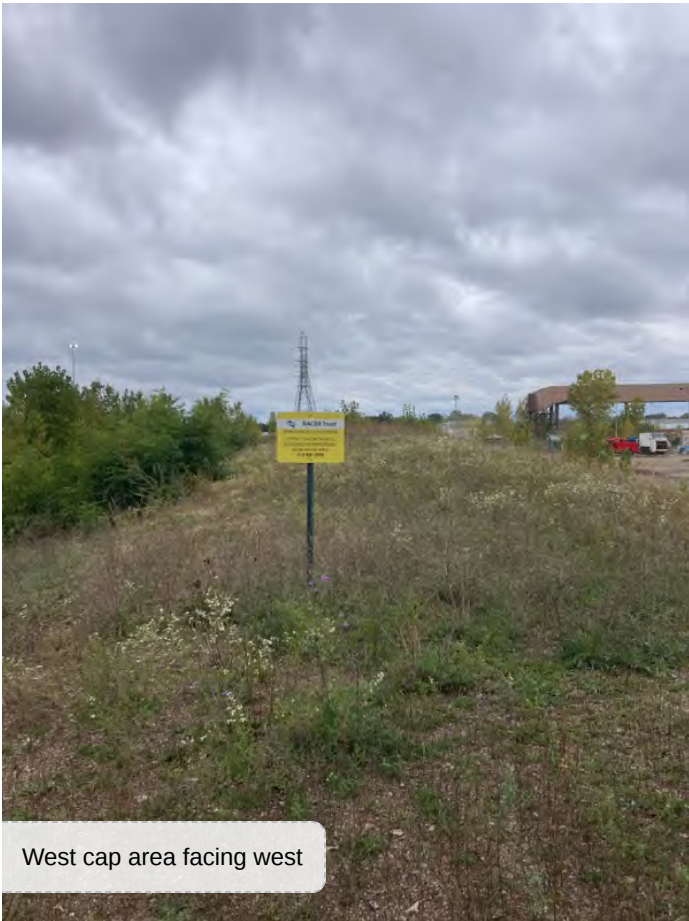
West cap area facing west

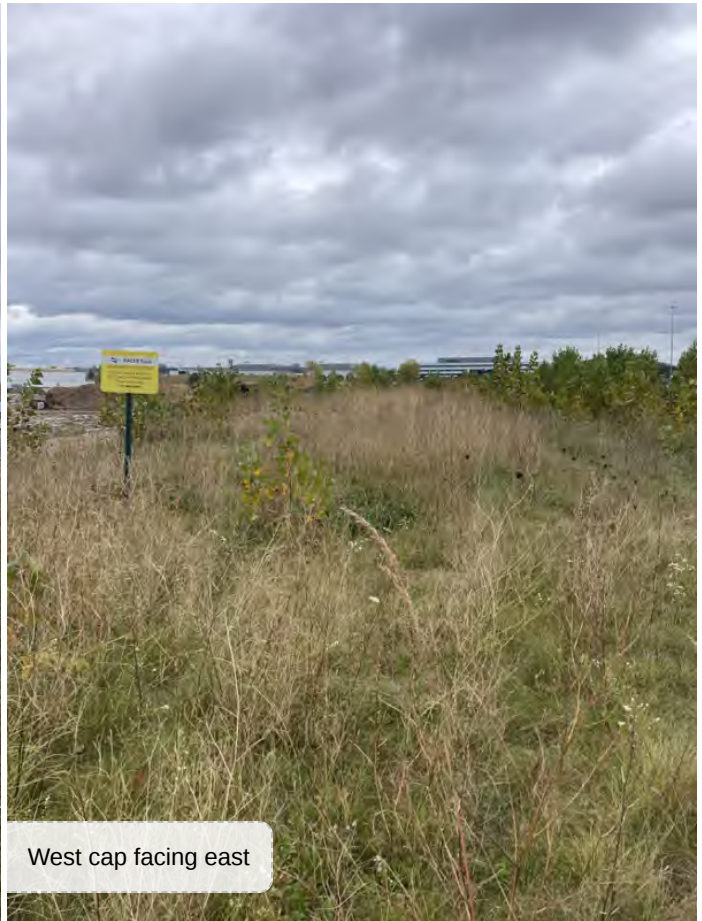
West cap facing east

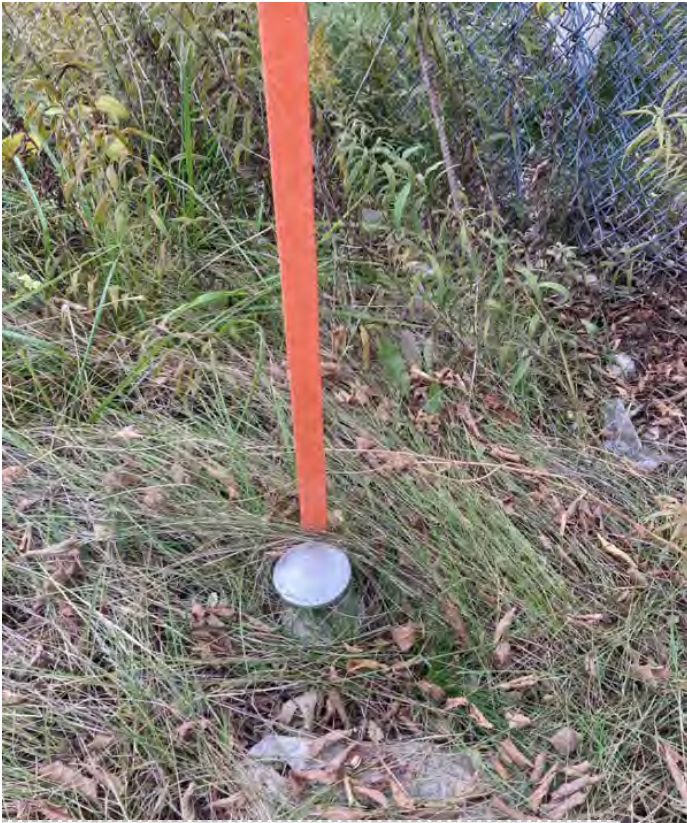
One of several markers present to demarcate cap area

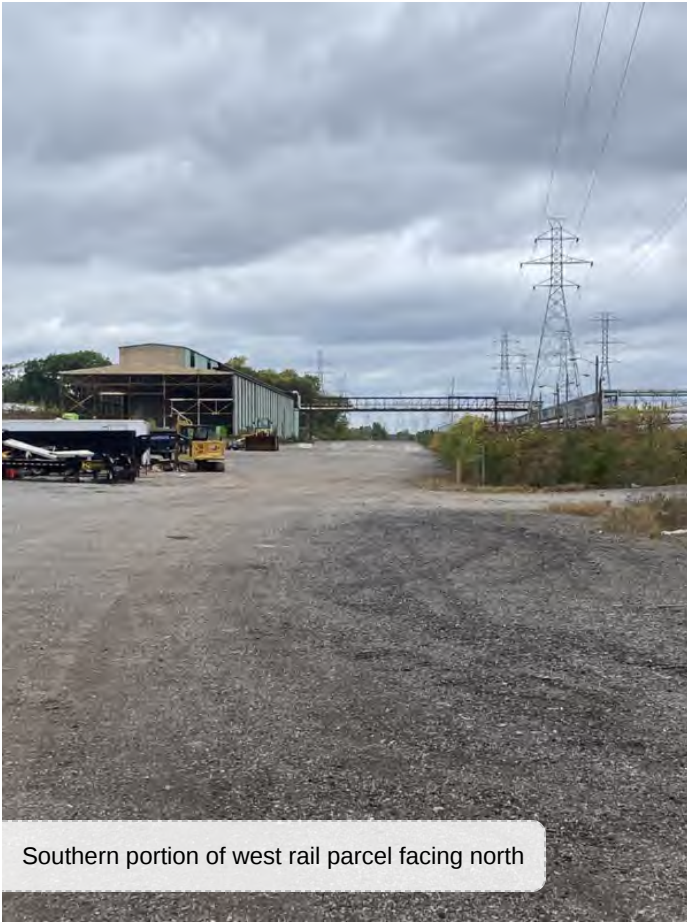
Southern portion of west rail parcel facing north

Name of the IC	Annual DRC inspection of rail parcels
Characterize restricted activities and uses	Other Restrictions
Characterize other restriction(s)	No water wells observed; no evidence of soil relocation or excavation; no buildings present; no evidence of subsurface utility installation; property is vacant non residential use; no areas of staining seen where visually inspected (with exception of one small area in southern portion of west rail parcel)
Do site use and activities comply with other restrictions	Yes
Other comments or notes about the IC?	Notes: heavier vegetation growth observed this year on rail parcels compared to the previous year. Equipment stored on southern portion of west rail parcel.

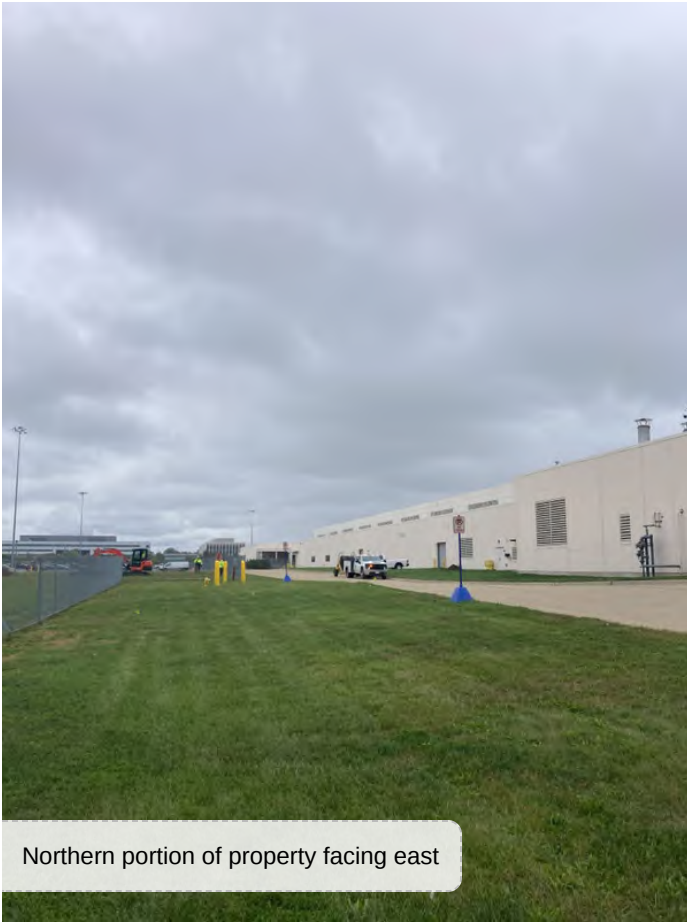
Northern portion of property facing east

Name of the IC	Annual DRC inspection of USPS property
Characterize restricted activities and uses	Other Restrictions
Characterize other restriction(s)	No water wells installed; no soil excavation or soil relocation observed; no new buildings constructed; no evidence of utility installation; land is being used for non residential purposes; no staining observed in areas visually evaluated.
Do site use and activities comply with other restrictions	Yes
Other comments or notes about the IC?	Fencing observed in northern portion of property that was not observed last year.

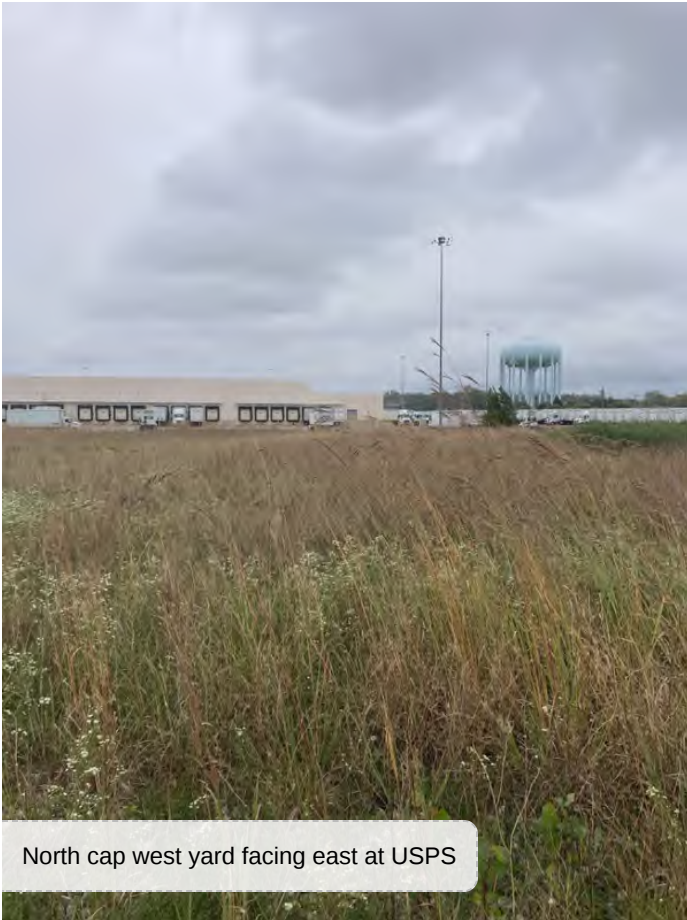
Name of the IC	USPS west yard north PCB cap
Characterize restricted activities and uses	Other Restrictions
Characterize other restriction(s)	Low occupancy area and PCB cap in place to prevent exposure to soils
Do site use and activities comply with other restrictions	Yes
Other comments or notes about the IC?	Tall vegetation made some markers hard to find- possibly cut down vegetation and paint marker sticks bright orange

North cap west yard facing east at USPS

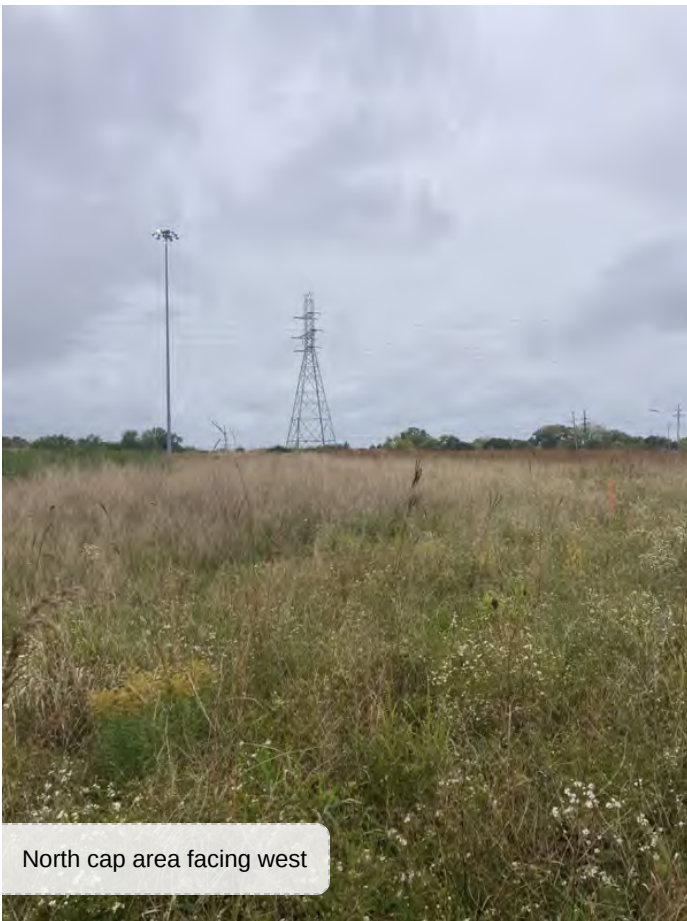
North cap area facing west

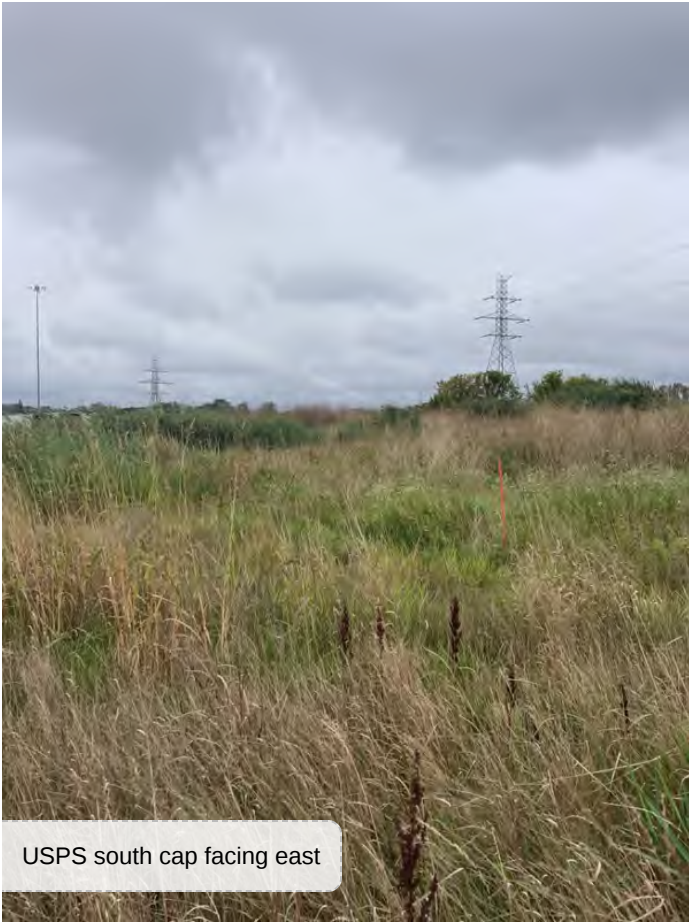
USPS south cap facing east

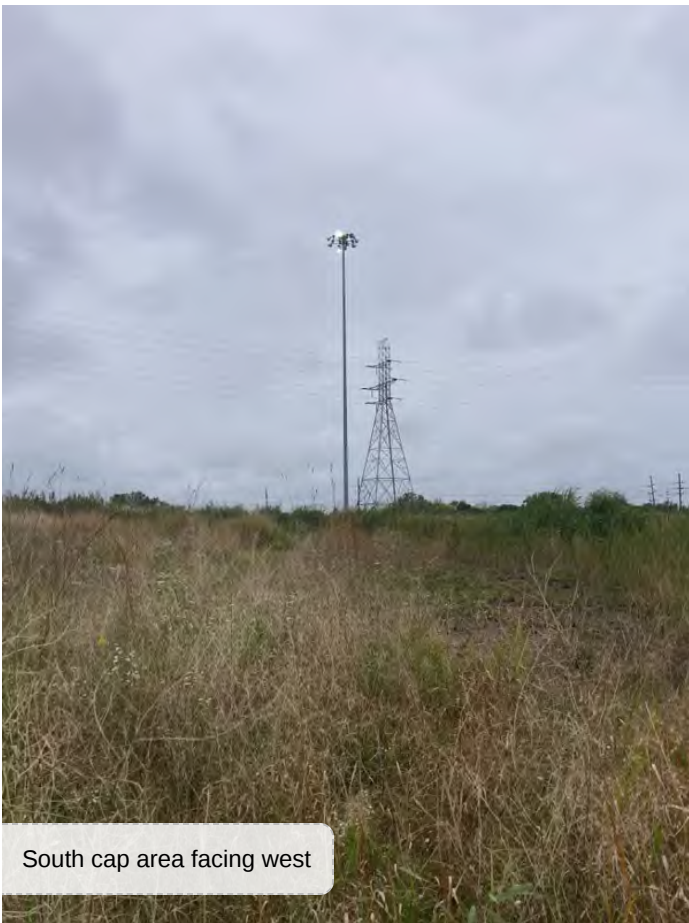
South cap area facing west

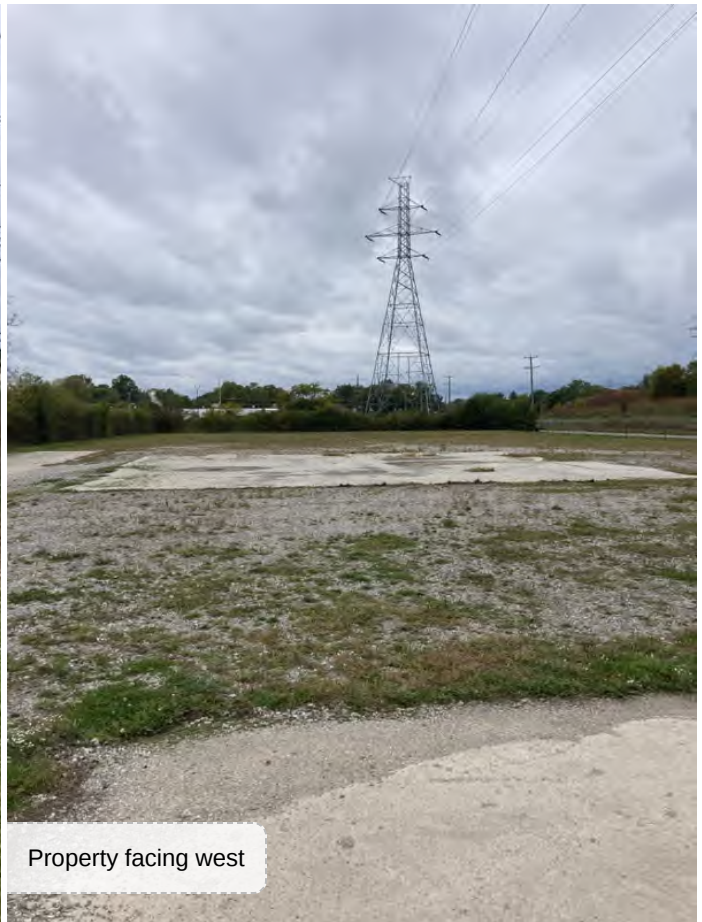
Property facing west

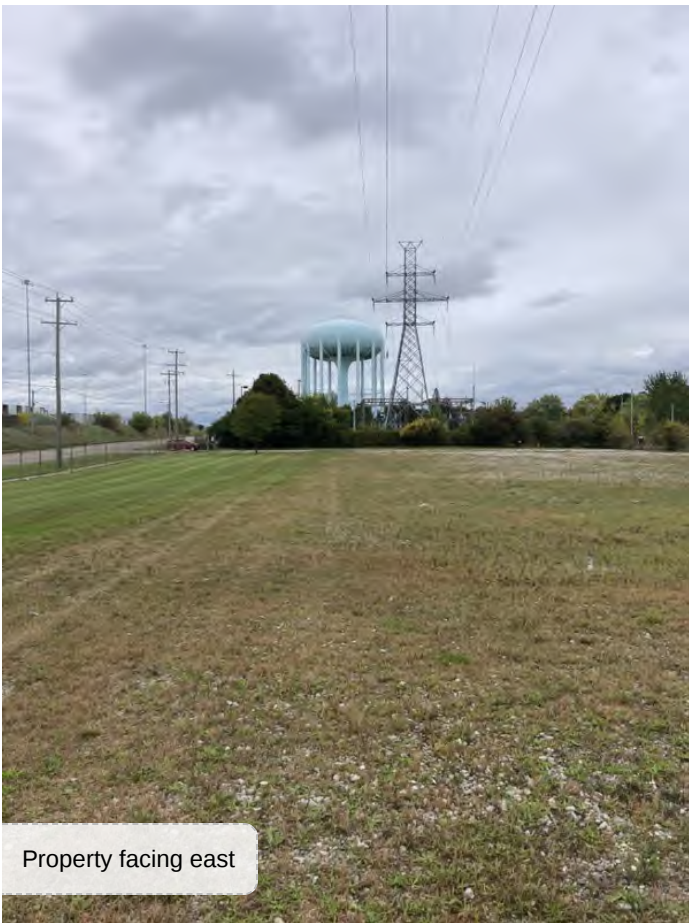
Property facing east

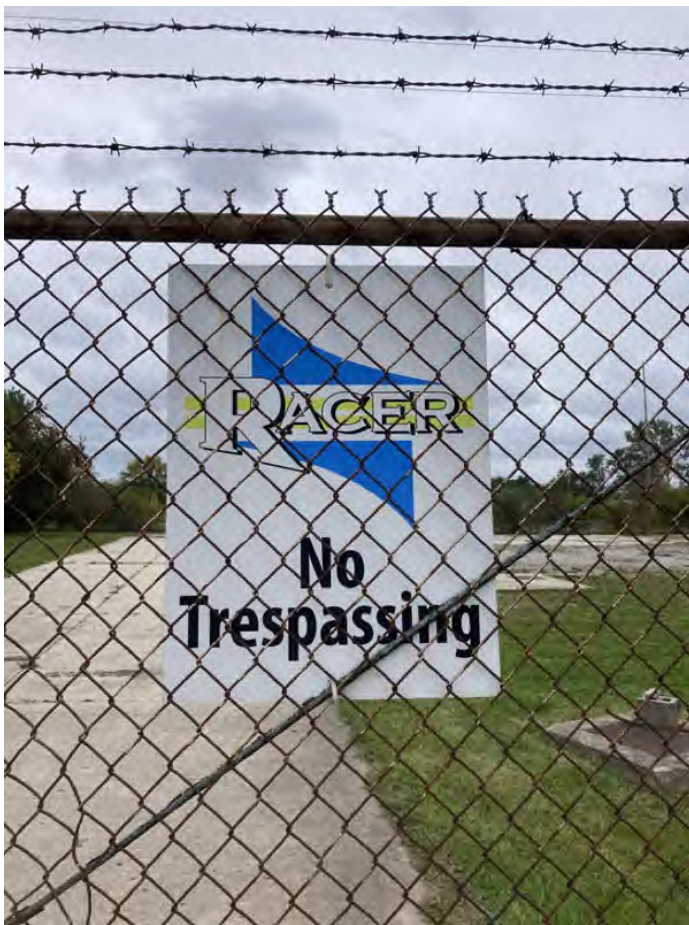
Name of the IC	Annual DRC inspection duck pond SWDF
Characterize restricted activities and uses	Other Restrictions
Characterize other restriction(s)	No water wells installed; no evidence of excavation or soil relocation; no buildings at property currently vacant; no evidence of subsurface utility installation; vacant non residential use. No visual evidence of staining in areas observed
Do site use and activities comply with other restrictions	Yes
Other comments or notes about the IC?	Property locked in fence ground cover is gravel and grass

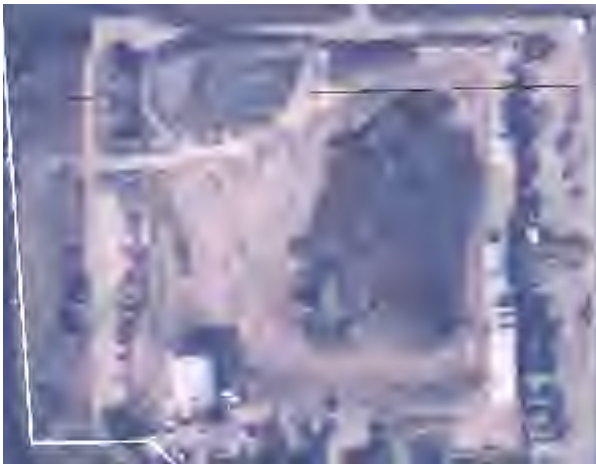
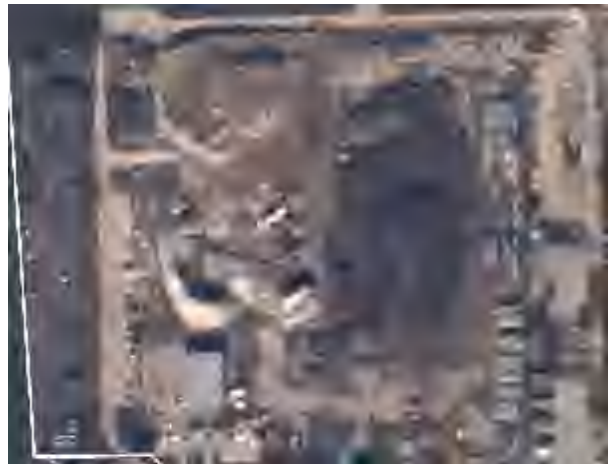
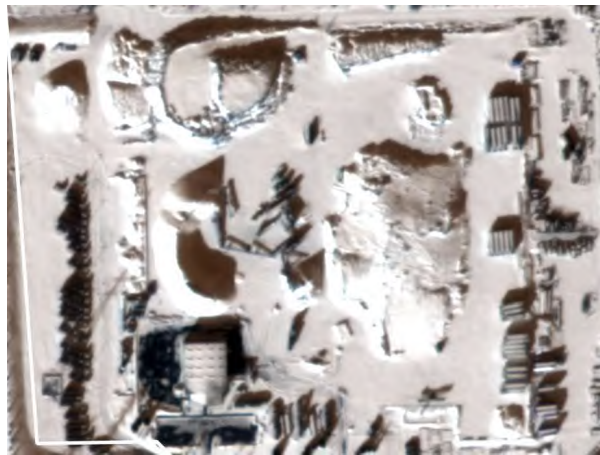
Change Item #1 - High Resolution Imagery

Change Detection Scope	AOI Sector	Commentary
Visible stockpiling of soil	1 - N Construction Site	Stockpiling of soil continues from the previous Change period.

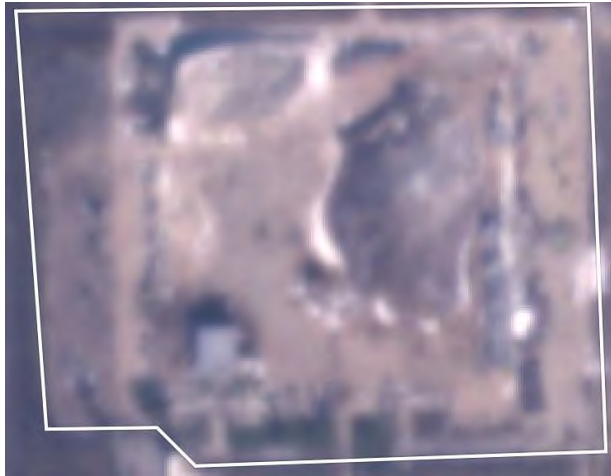
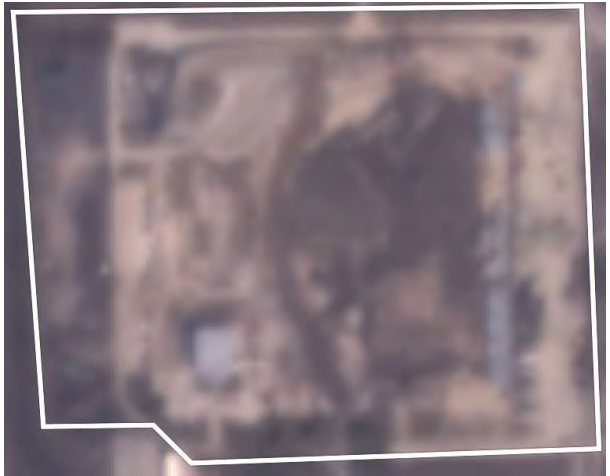
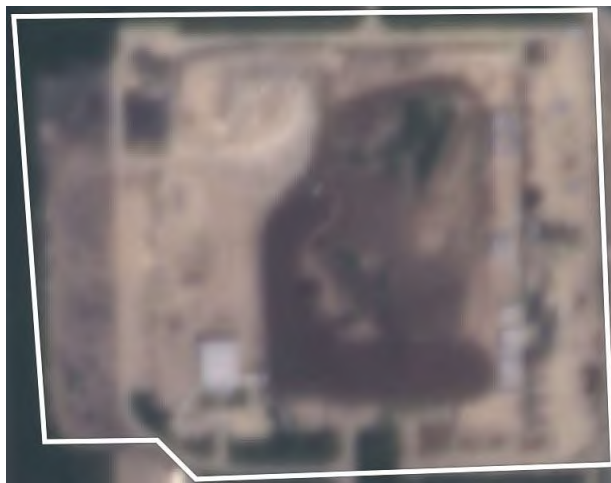
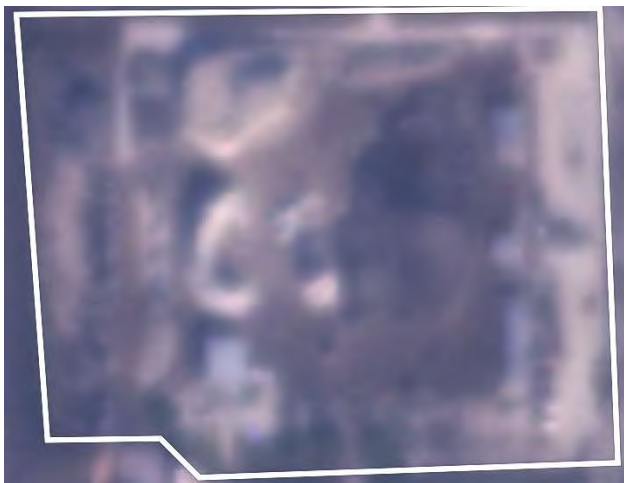
Change Detection Item #1 - Medium Resolution Imagery

Images 1-4 show an ongoing Stockpiling of soil in AOI Sector 1 which continues from the previous Change period. The extent and level of stockpiling changes during the Change period and at the end of 2023, new piles are visible in the left part of the AOI.

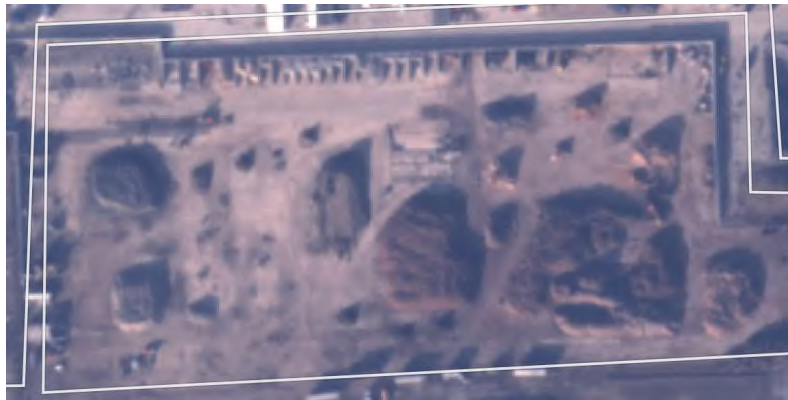
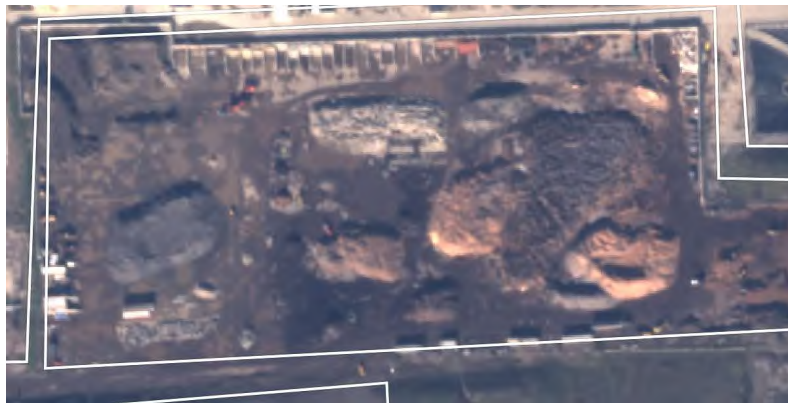
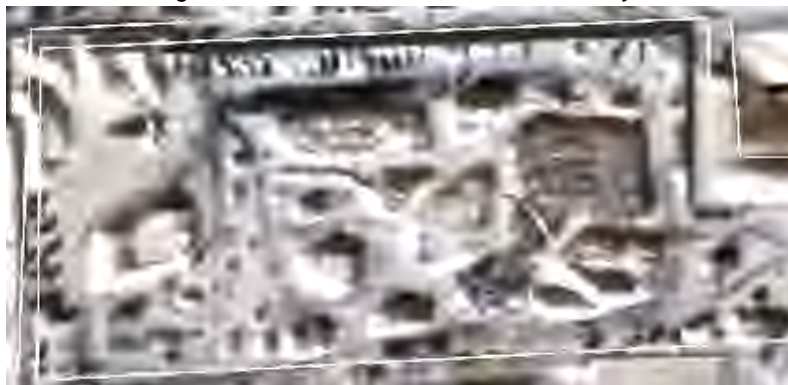
Change Item #2 - High Resolution Imagery

Change Detection Scope	AOI Sector	Commentary
Visible stockpiling of soil	3 - Middle Construction Site	Stockpiling of soil continued from the previous Change period in the whole AOI.

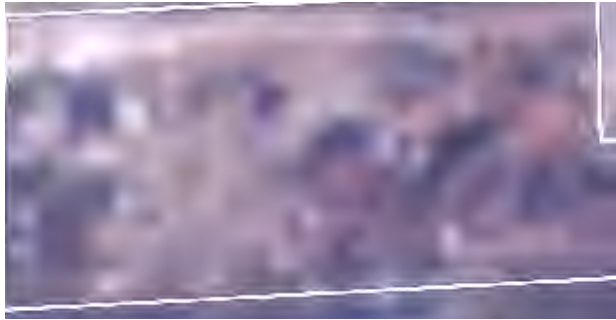
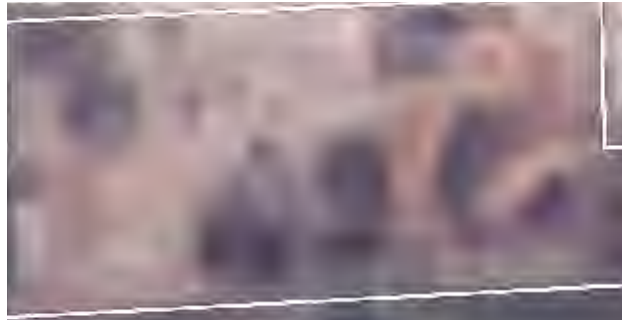
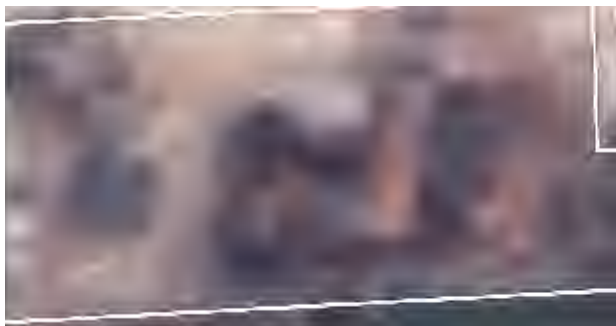
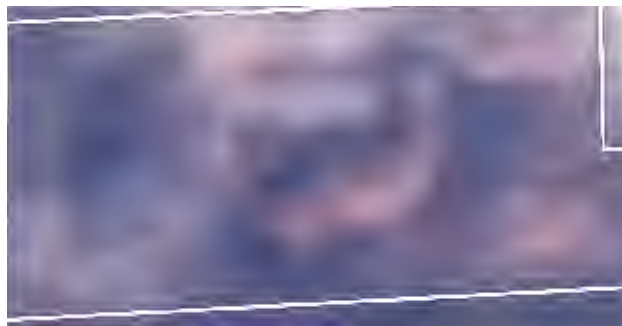
Change Detection Item #2 - Medium Resolution Imagery

Images 1-4 show an ongoing Stockpiling of soil in AOI Sector 3 which continues from the previous Change period. There is visible movement of piles and change in the amount of soil during the Change period.

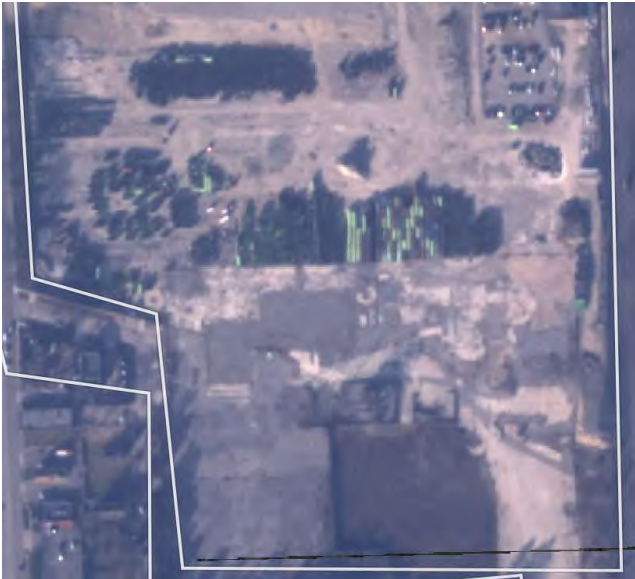
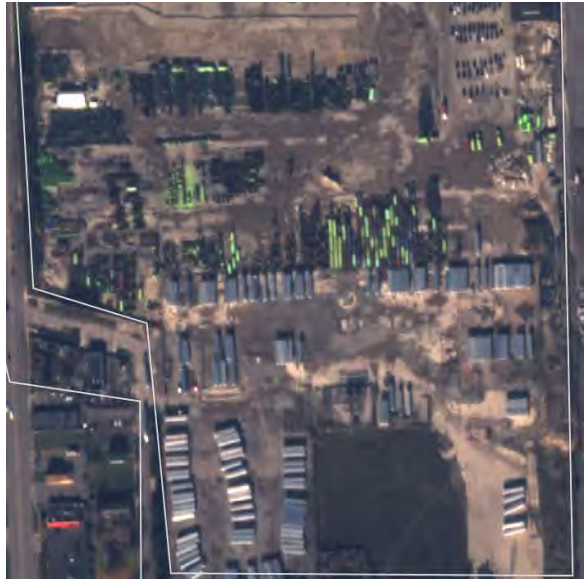
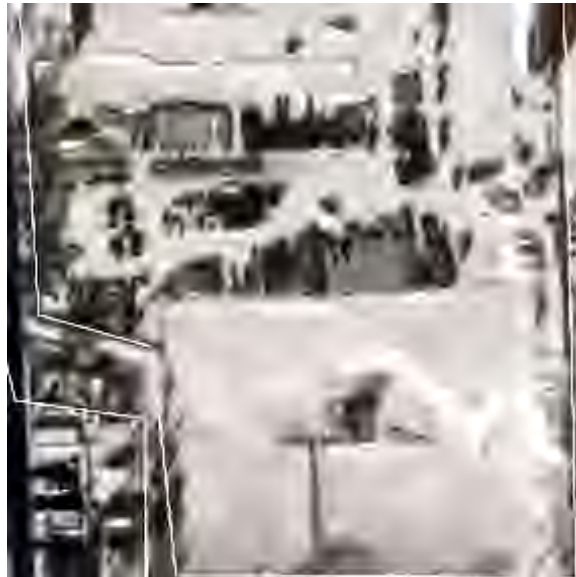
Observation A - High Resolution Imagery

Observation	AOI Sector	Commentary
Displacement of logistic storages	2 - W Construction Site	Change in the amount and position of logistic storages during the Change period.

Image 1 shows the southern part of the AOI Sector 2 at the beginning of the Change period. We can observe that the logistic storages were placed in the upper part of the AOI. During the Change period, the logistic storages were relocated mainly into the middle and southern parts of the AOI (**Image 2**), at the end of the Change period in **Image 3** the logistic storages were back in the upper part of the AOI.

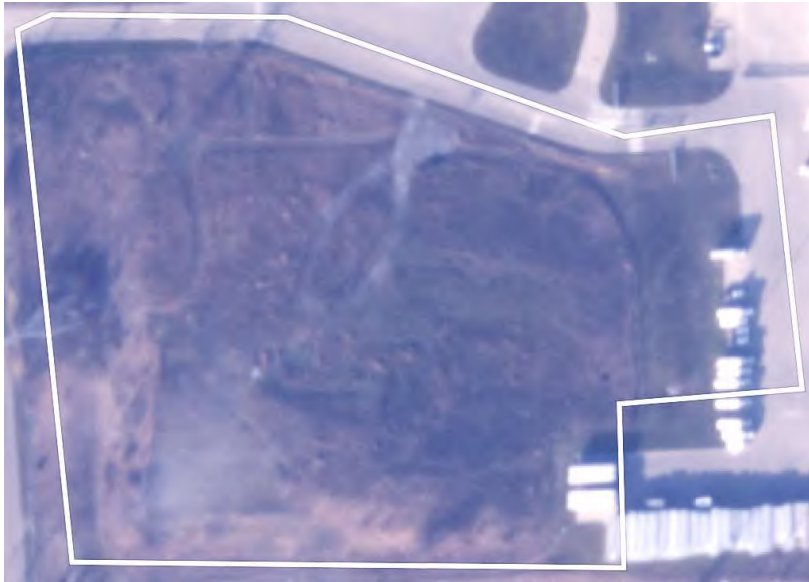
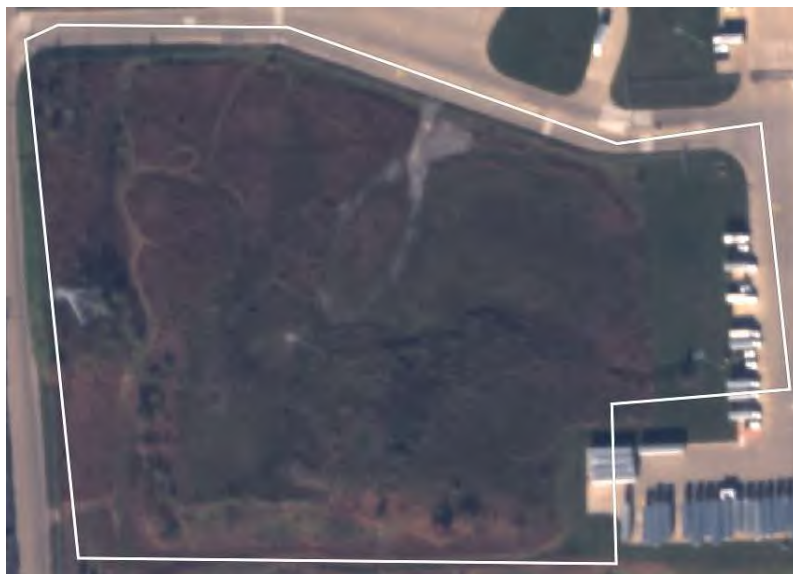
Observation B - High Resolution Imagery

Observation	AOI Sector	Commentary
Vegetation development	4 - Vegetation	Vegetation growth is observed according to the development in previous years. The values are consistently below average.

Image 1 shows relatively lush vegetation at the beginning of the monitoring in the context of the vegetation period. The vegetation seems to be sparser at the end of the Change period (**Image 2**).
