30214041.00006

RACER Pontiac North Campus – 2023 Property Inspection Report

IC/EC Inspection Report for Pontiac North, MI at Pontiac North Campus Industrial Land (#11970) on October 10, 2023

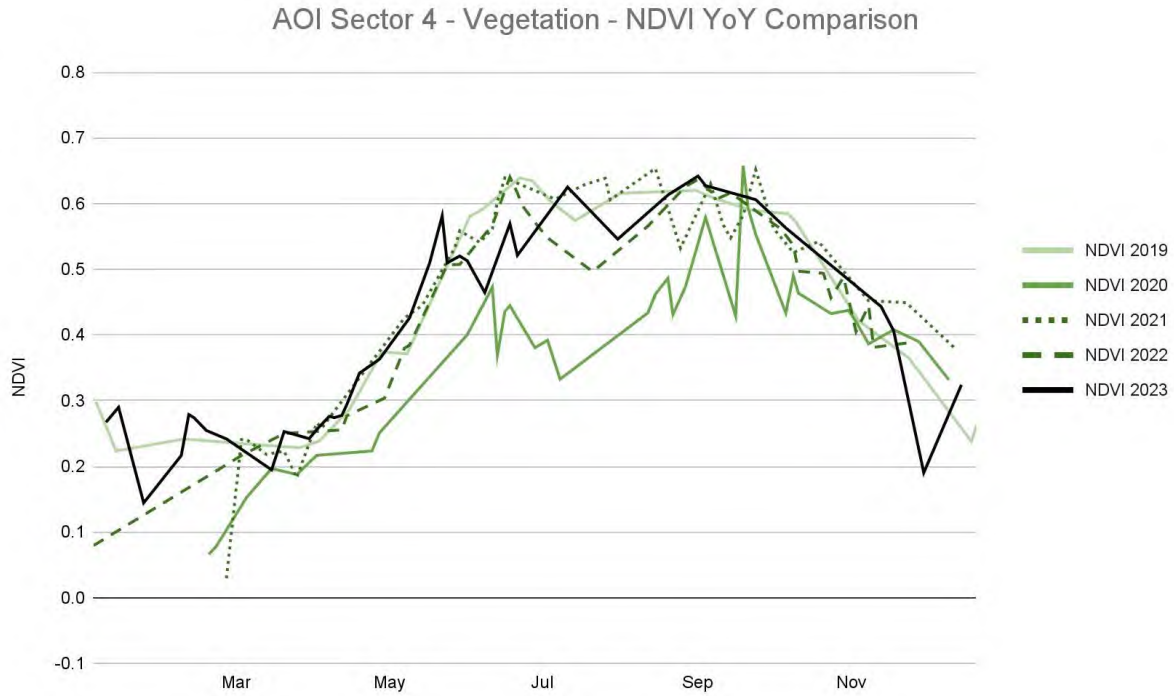
Observation B - Time series

NDVI (Normalized Difference Vegetation Index - defined on pg. 4) time series shows that this monitoring period development of vegetation around the AOI Sector 4. The values are comparable to previous years, suggesting normal vegetation health. The values align with the vegetation period, with peak values occurring in the summer and lower values in the winter. Values are similar to the previous Change period. The local peaks are caused by the atmospheric conditions at the given time (snow, clouds, etc.).

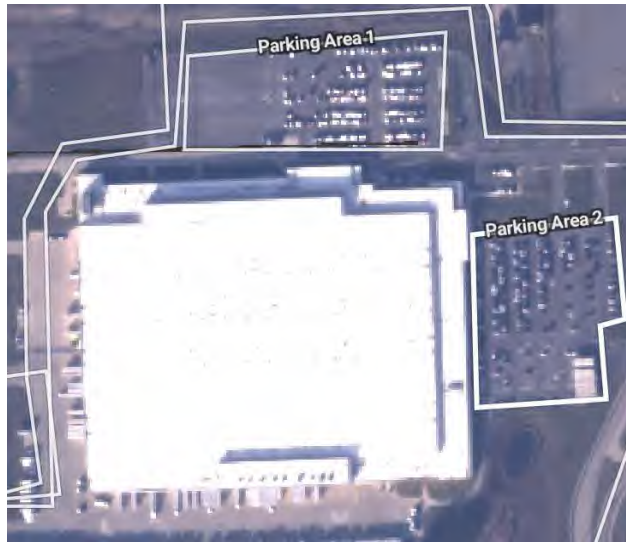
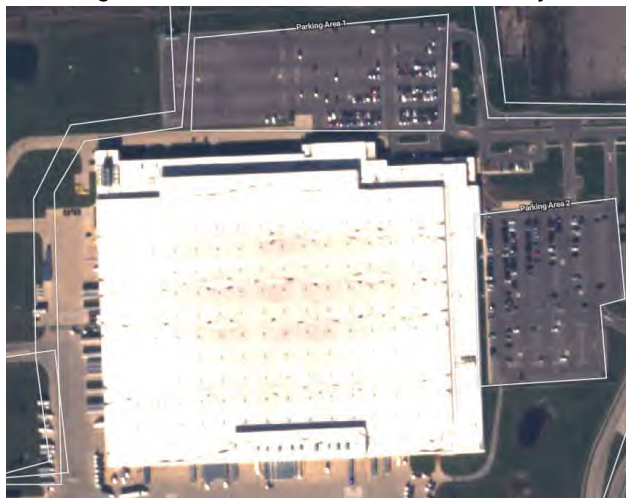
Observation C - High Resolution Imagery

Observation	AOI Sector	Commentary
Occupancy of Parking Areas 1 and 2	5 - Facility	The values of occupancy differ throughout the Change period in both Parking Areas.

Images 1 and **2** show the similar occupancy of Parking Area 1 in both available high-resolution imagery. On the contrary, we can observe a decrease in occupancy in parking areas at the end of the Change period. Detection of occupancy within the Change period is shown through the time series on the next page.

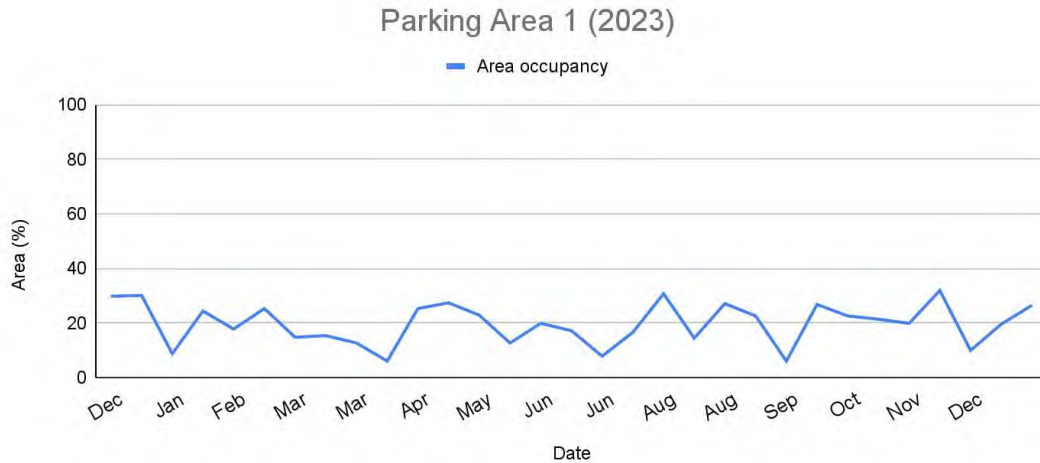
Observation C - Time Series

The time series of Parking Area 1 shows irregular car activity in 2023. We can observe irregular increases and decreases with no structure. Occupancy values are quite similar at the beginning of the Change period as at the end of the Change period. Optical imagery with the high resolution on the previous page confirms that the occupancy is lower in November 2023 than in December 2022.

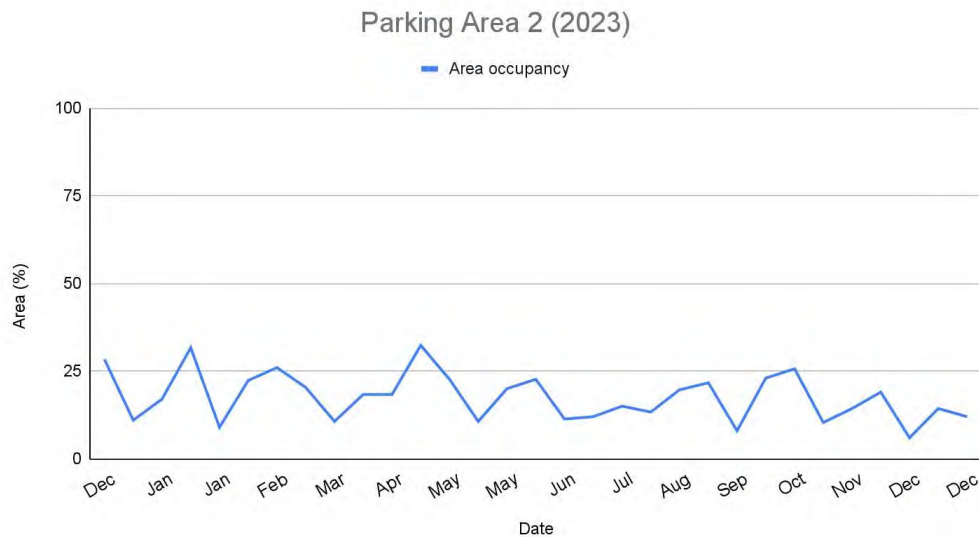
In Parking Area 2, we can observe that the occupancy was constantly changing throughout the Change period. Overall the occupancy is lower than in the previous Change period.
