RE: *Quarterly Status Report –July 2019 – September 2019*  
*Coldwater Road Landfill*  
*1245 East Coldwater Road, Flint, MI*  
*MID 005 356 860*  
FILE: 15388/72202/Docs

**3RD QUARTER 2019  
BURROW LOCATION  
MAP**

# COLDWATER RD LANDFILL | ANIMAL BURROW PHOTO LOG

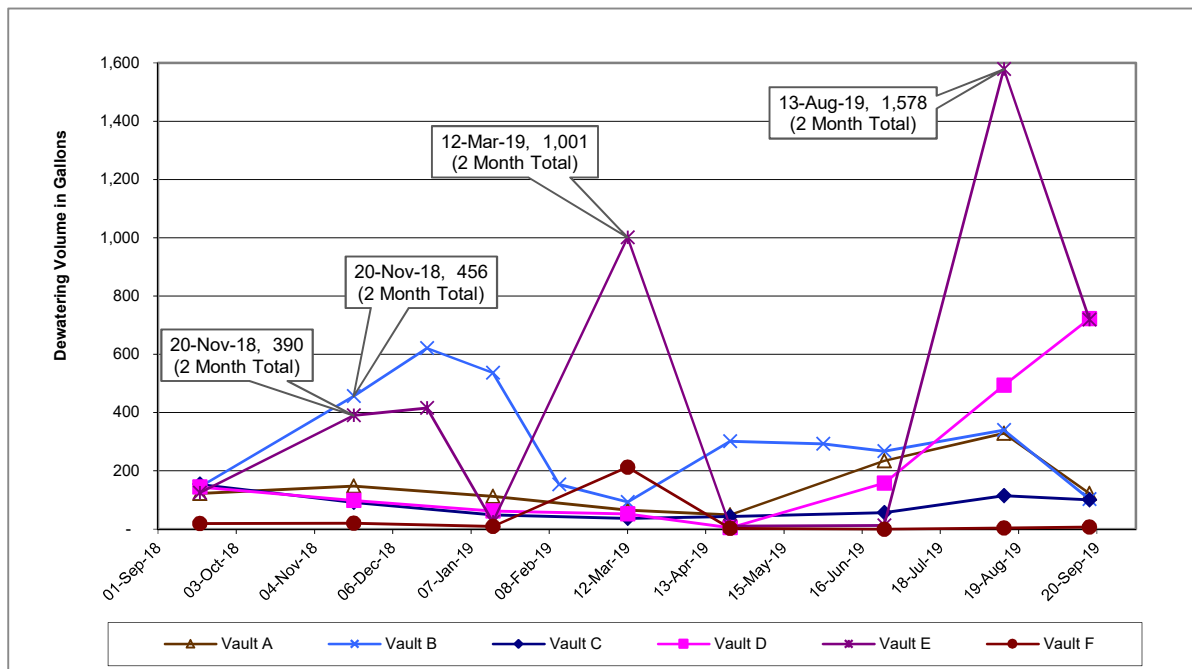
Total volume of water removed from the vaults during the third quarter was 4,635 gallons. According to the master flow meter and discharge records, a total of 2,464 gallons were pumped from the sumps during the third quarter.

The following graph presents the vault dewatering data in graphical format for the past year:
