RE: *Quarterly Status Report –July 2016 – September 2016*  
*Coldwater Road Landfill*  
*1245 East Coldwater Road, Flint, MI*  
*MID 005 356 860*  
FILE: 15388/62658/Docs

# COLDWATER RD LANDFILL | ANIMAL BURROW PHOTO LOG

**3RD QUARTER 2016  
 BURROW LOCATION  
 MAP**

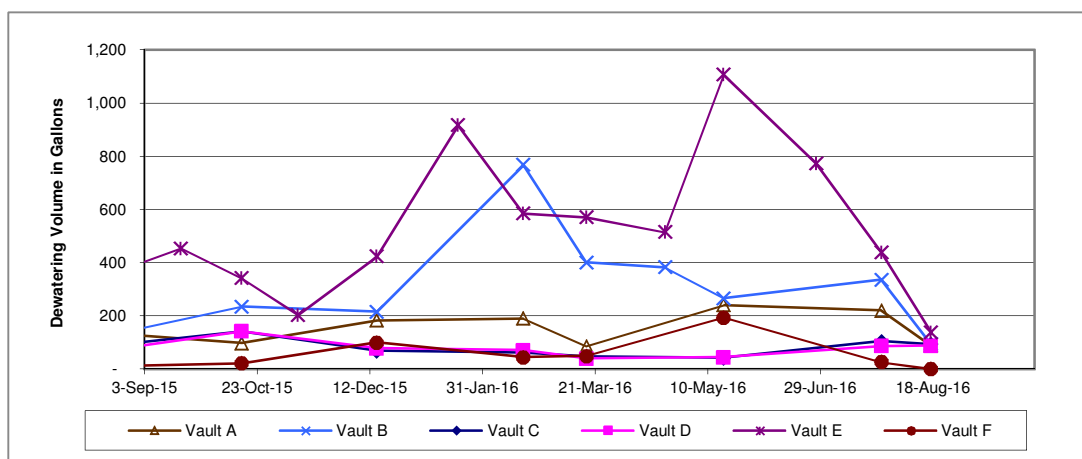
Total volume of water removed from the vaults during the third quarter was 1,715 gallons. According to the master flow meter and discharge records, a total of 1,680 gallons were pumped from the sumps during the third quarter.
