Re: Ley Creek PCB Dredgings Site (Registry # 7-34-044)
NYSDEC Order on Consent Index # D-7-0008-97-06
2005 Annual OM&M Inspection Report

Re: Ley Creek PCB Dredgings Site
2005 OM&M Wetland Evaluation

LEY CREEK PCB DREDGINGS SITE
SYRACUSE, NEW YORK
SITE REMEDIATION PROJECT

OM&M PARTIAL
SITE PLAN
WETLAND
EVALUATION

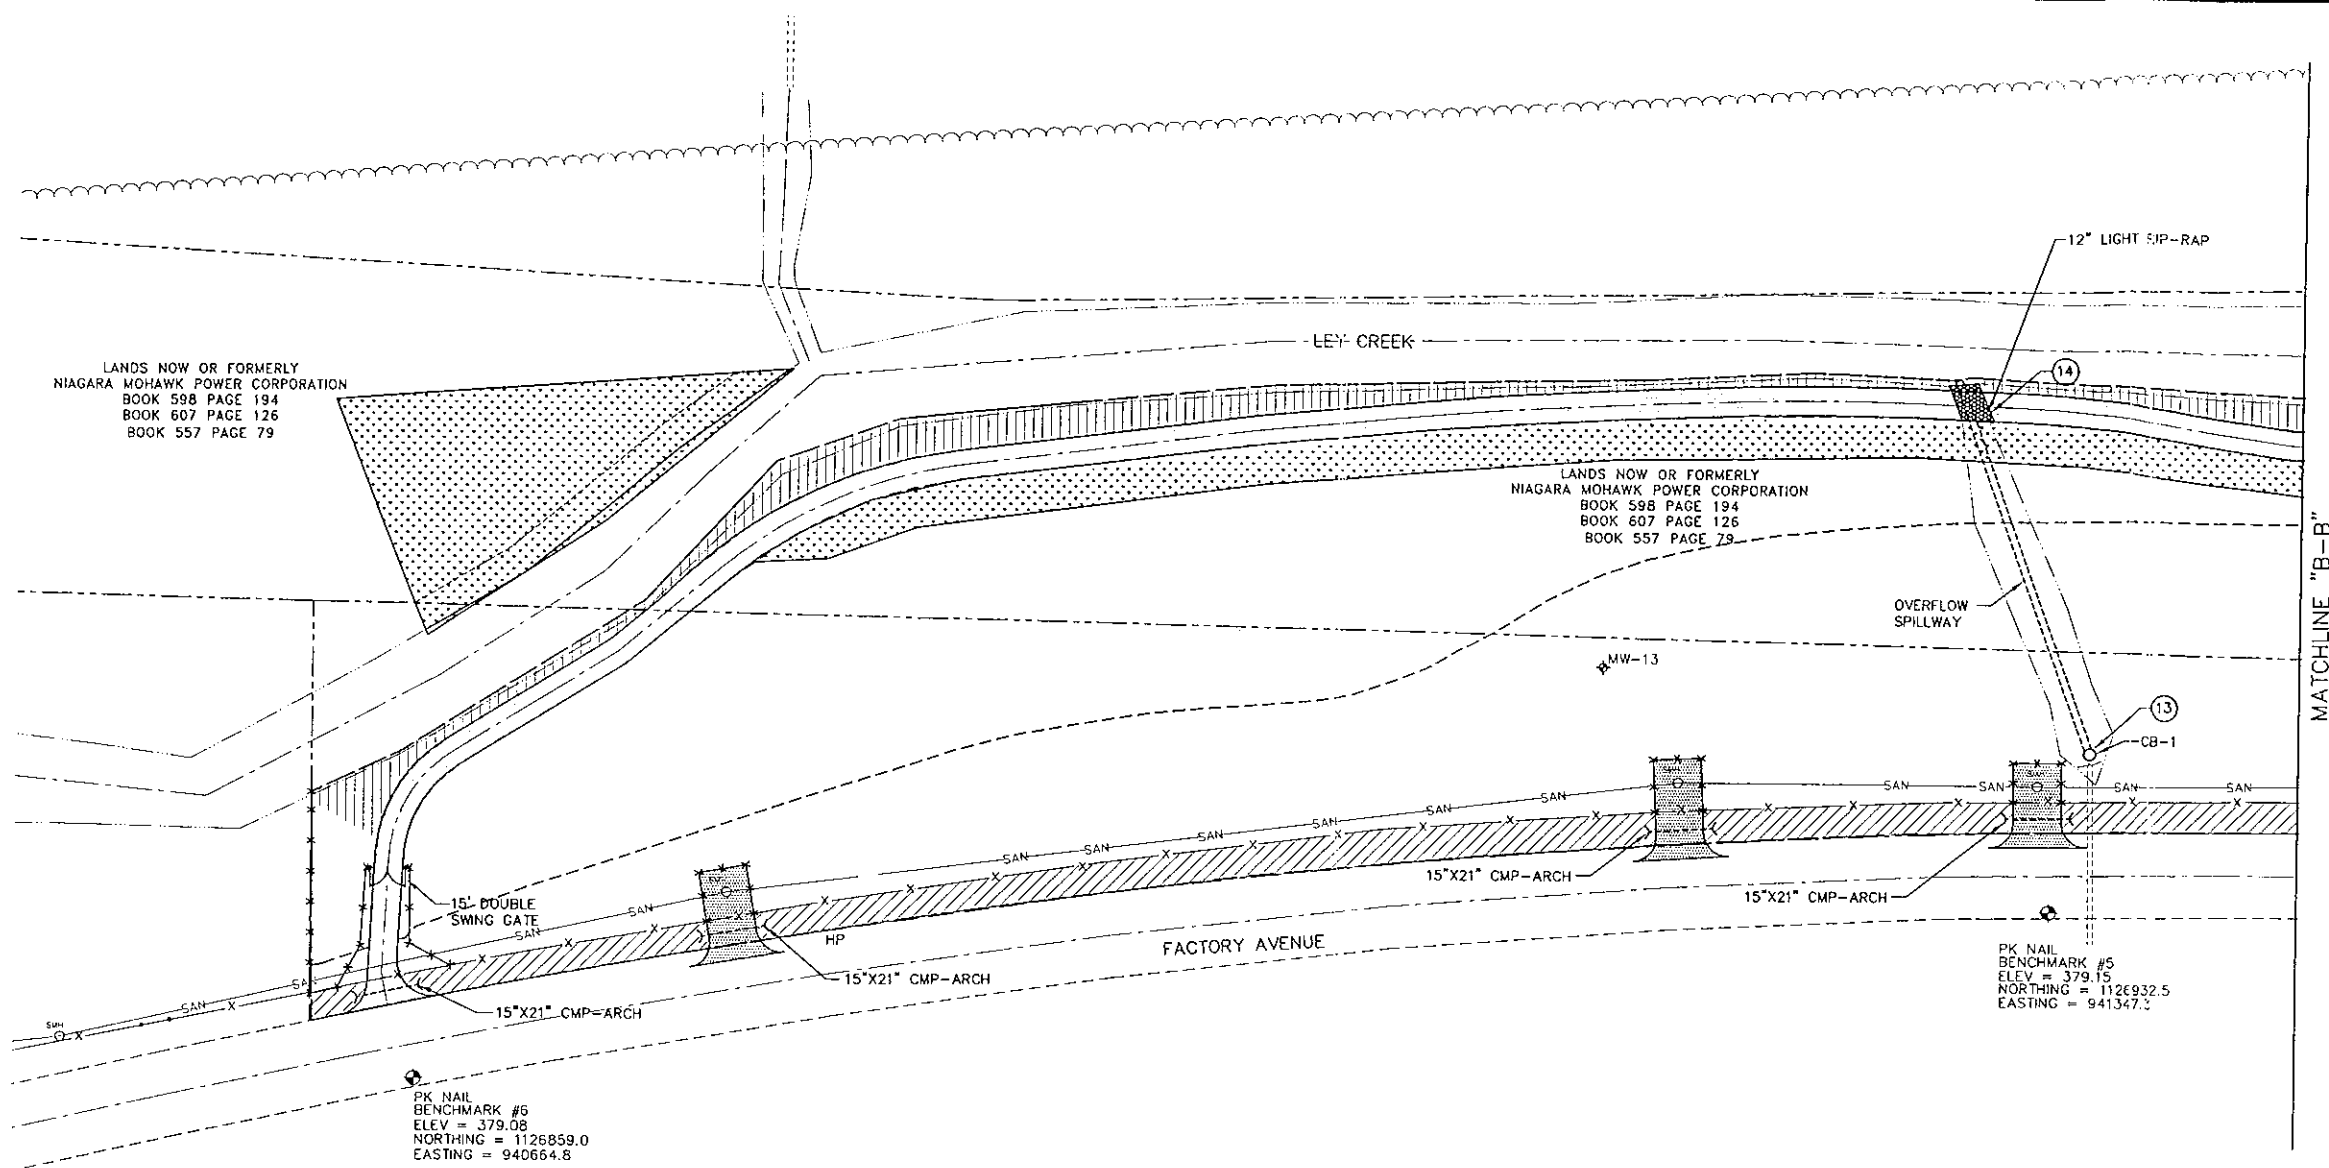
FIGURE 1

- Burrowing animal in vegetative cover (Photograph 4-Figure 5)
- Excessive bank scour due to clogged catch basin (Photograph 14-Figure 1)
- Exposed erosion control fabric (Photograph 1-Figure 5)
- Pavement depression (Photograph 9-Figure 3)
- Clogged catch basins (Photograph 12-Figure 3, and Photograph 13-Figure 1)
- Mowing/trimming around catch basins (Photographs 12-Figure 3, and Photograph 13-Figure 1).

2. Excessive scouring?	X		Refer to Photograph 14-Figure 1
	3. Areas of damage?		X	
Ground Water Wells	Visually inspect conditions.			
	1. Casings secure and locked?	X

- Remove vegetation from the stone access road and the stone access road turnaround
- Remove trees from fence line
- Unclog and replace grates in catch basins with trash racks to minimize clogging
- Place topsoil and seed over scoured areas
- Remove excessive vegetation around catch basins
- Repair pavement depression with like asphalt.

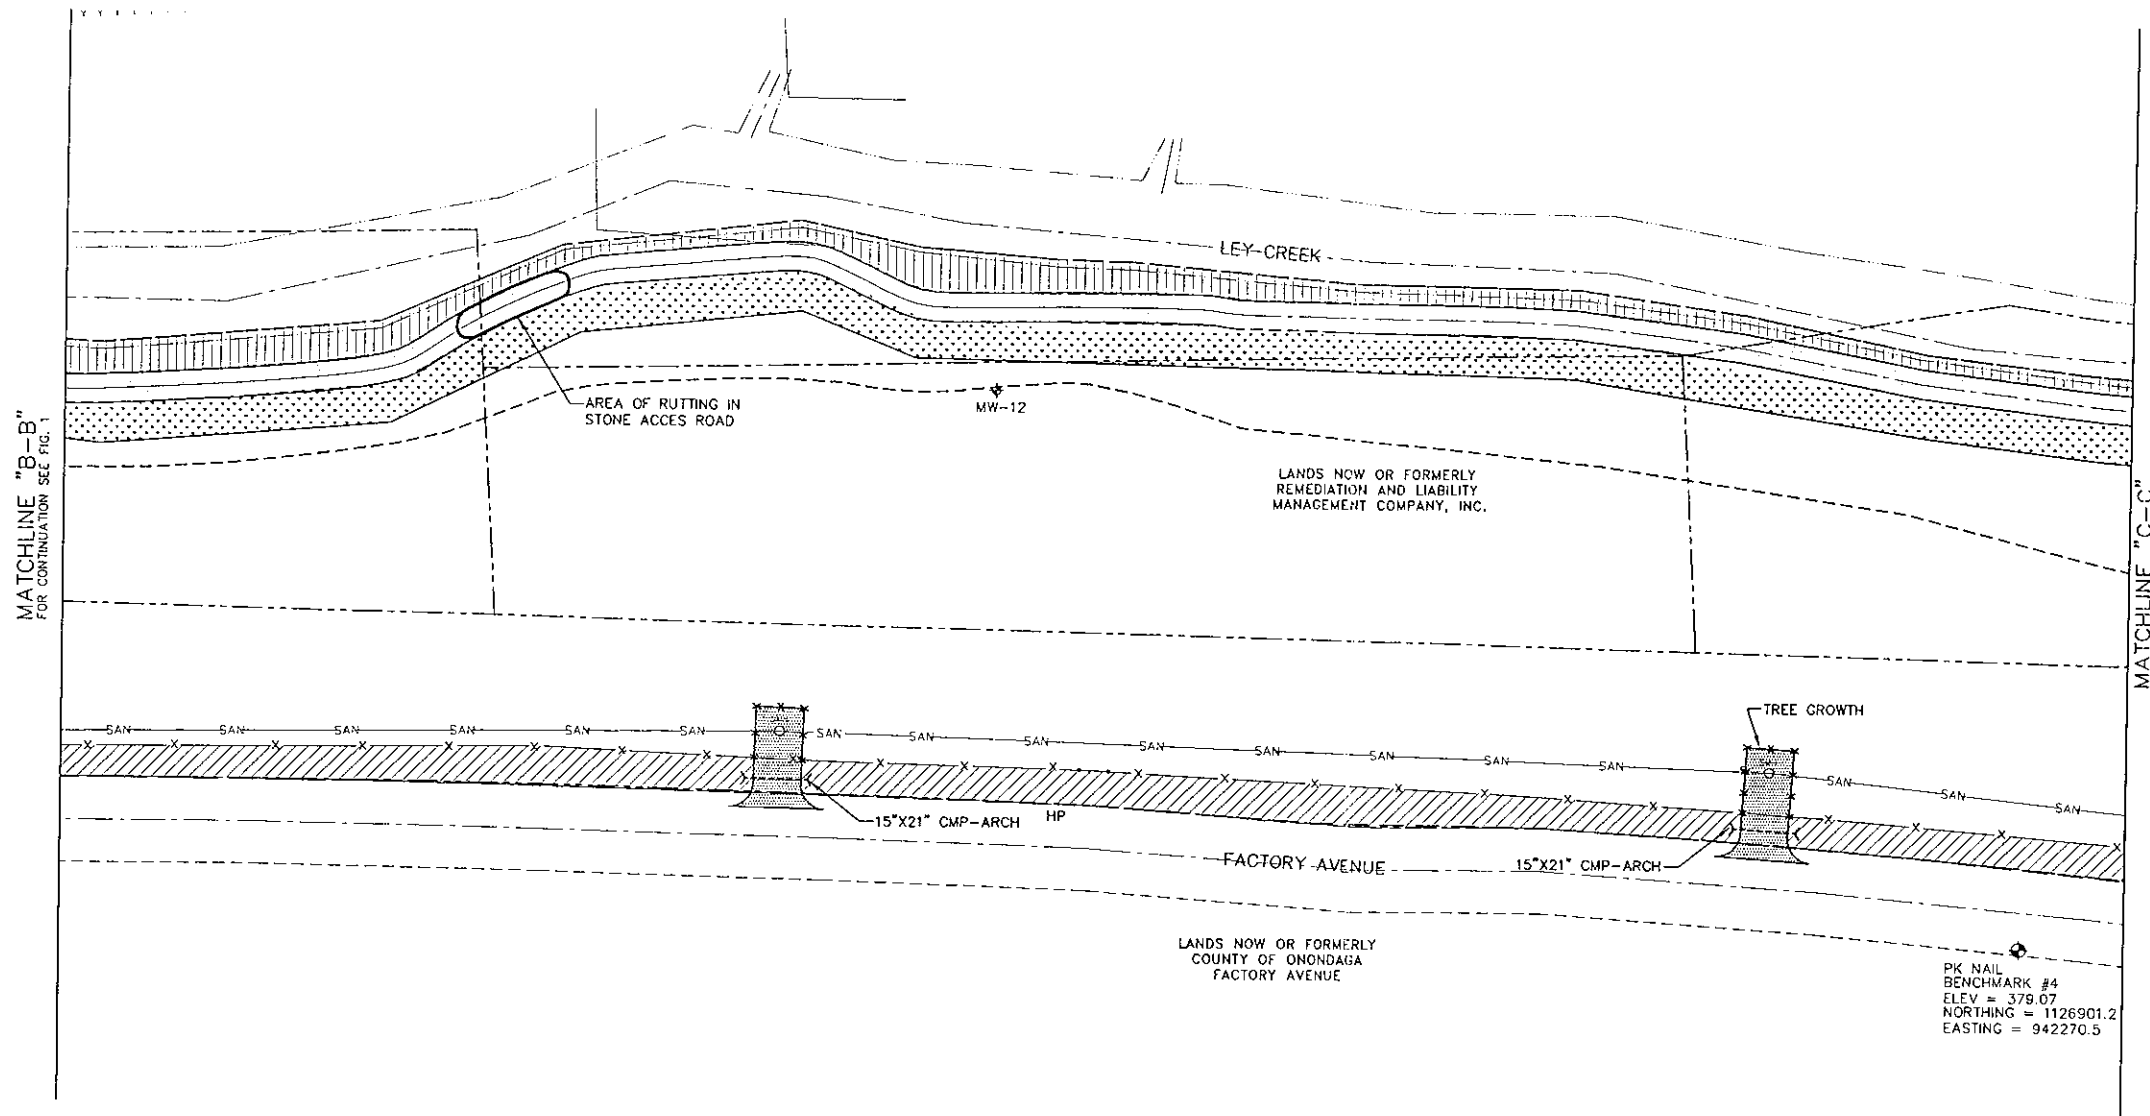
FIGURE 2

- Rutting of the stone access road (Figure 2)
- Delineation of the wetland area with signage
- Damage to the site security fence (Figures 4 and 5)
- Exposed erosion control fabric (Figure 3)
- Evidence of the presence of burrowing animals

- Repair the area of rutting of the stone access road by placement of additional crushed stone, and improve drainage of the stone access road by constructing small drainage channels to convey ponded water from the stone access road to Ley Creek. This could be performed by removal of less than 1 foot of vegetative cover material with subsequent replacement of crushed stone.
- Delineate wetland area with signage to discourage mowing of this area
- Repair the damaged site security fence
- Place topsoil over exposed erosion control fabric with subsequent seeding/fertilization and placement of erosion control fabric
- Remove burrowing animal(s) from the Site; place topsoil in the hole; and apply seed and fertilizer
- Remove vegetation from asphalt and repair cracks

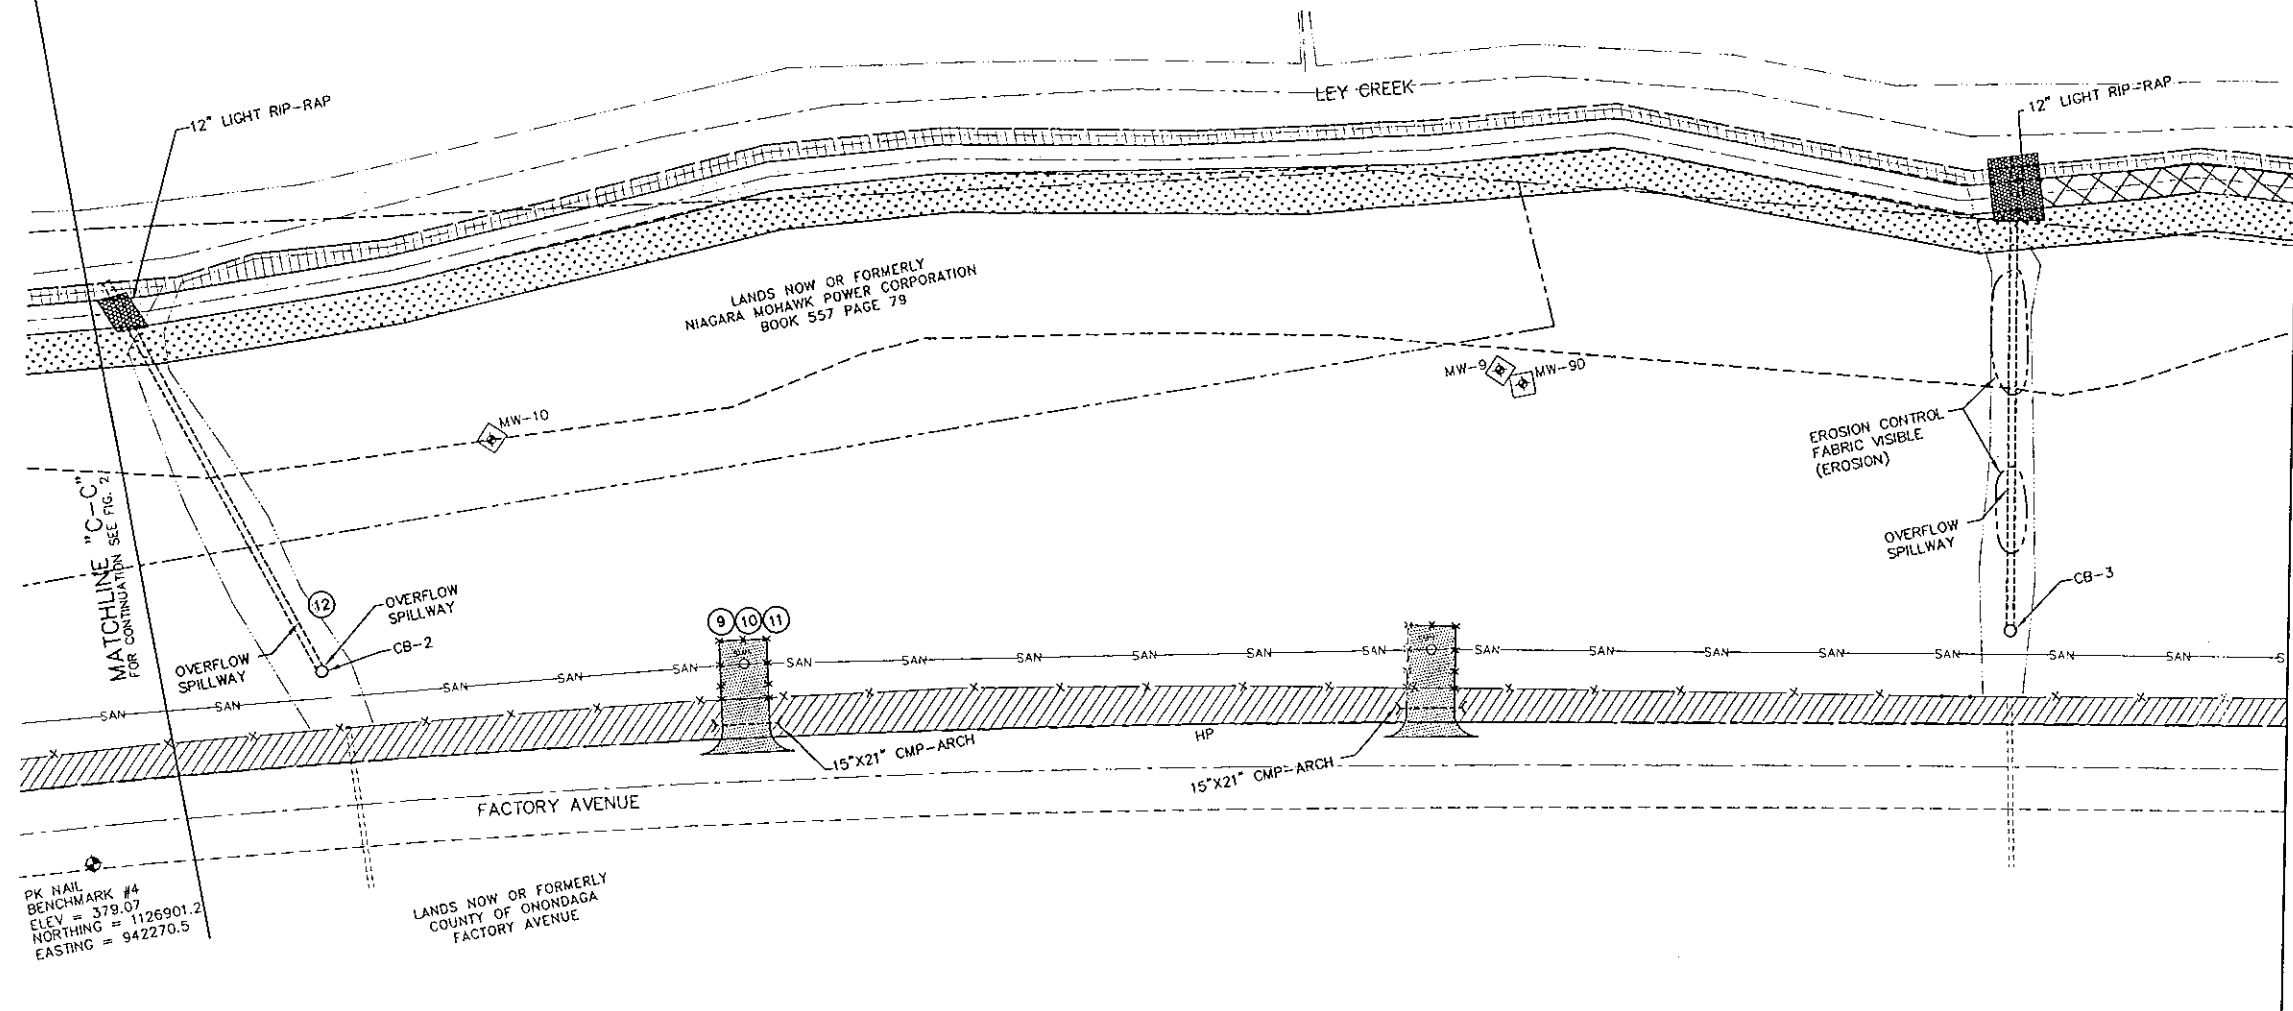
FIGURE 3

- Vegetation through pavement/cracks in asphalt (Photographs 9 and 11 - Figure 3)
- A significant amount of vegetation within the stone access road throughout the Site and the stone access road turnaround at the eastern end of the Site (Photograph 3-Figure 5)
- Tree establishment along the fence line (Photograph 5-Figure 4 and Photograph 10-Figure 3).

2. Areas of damage?		X	
Sanitary sewer access paths	Visually inspect conditions.			
	1. Cracks in asphalt?	X		Plant growth through asphalt. Refer to Figure 3 and Photographs 9 and 11.

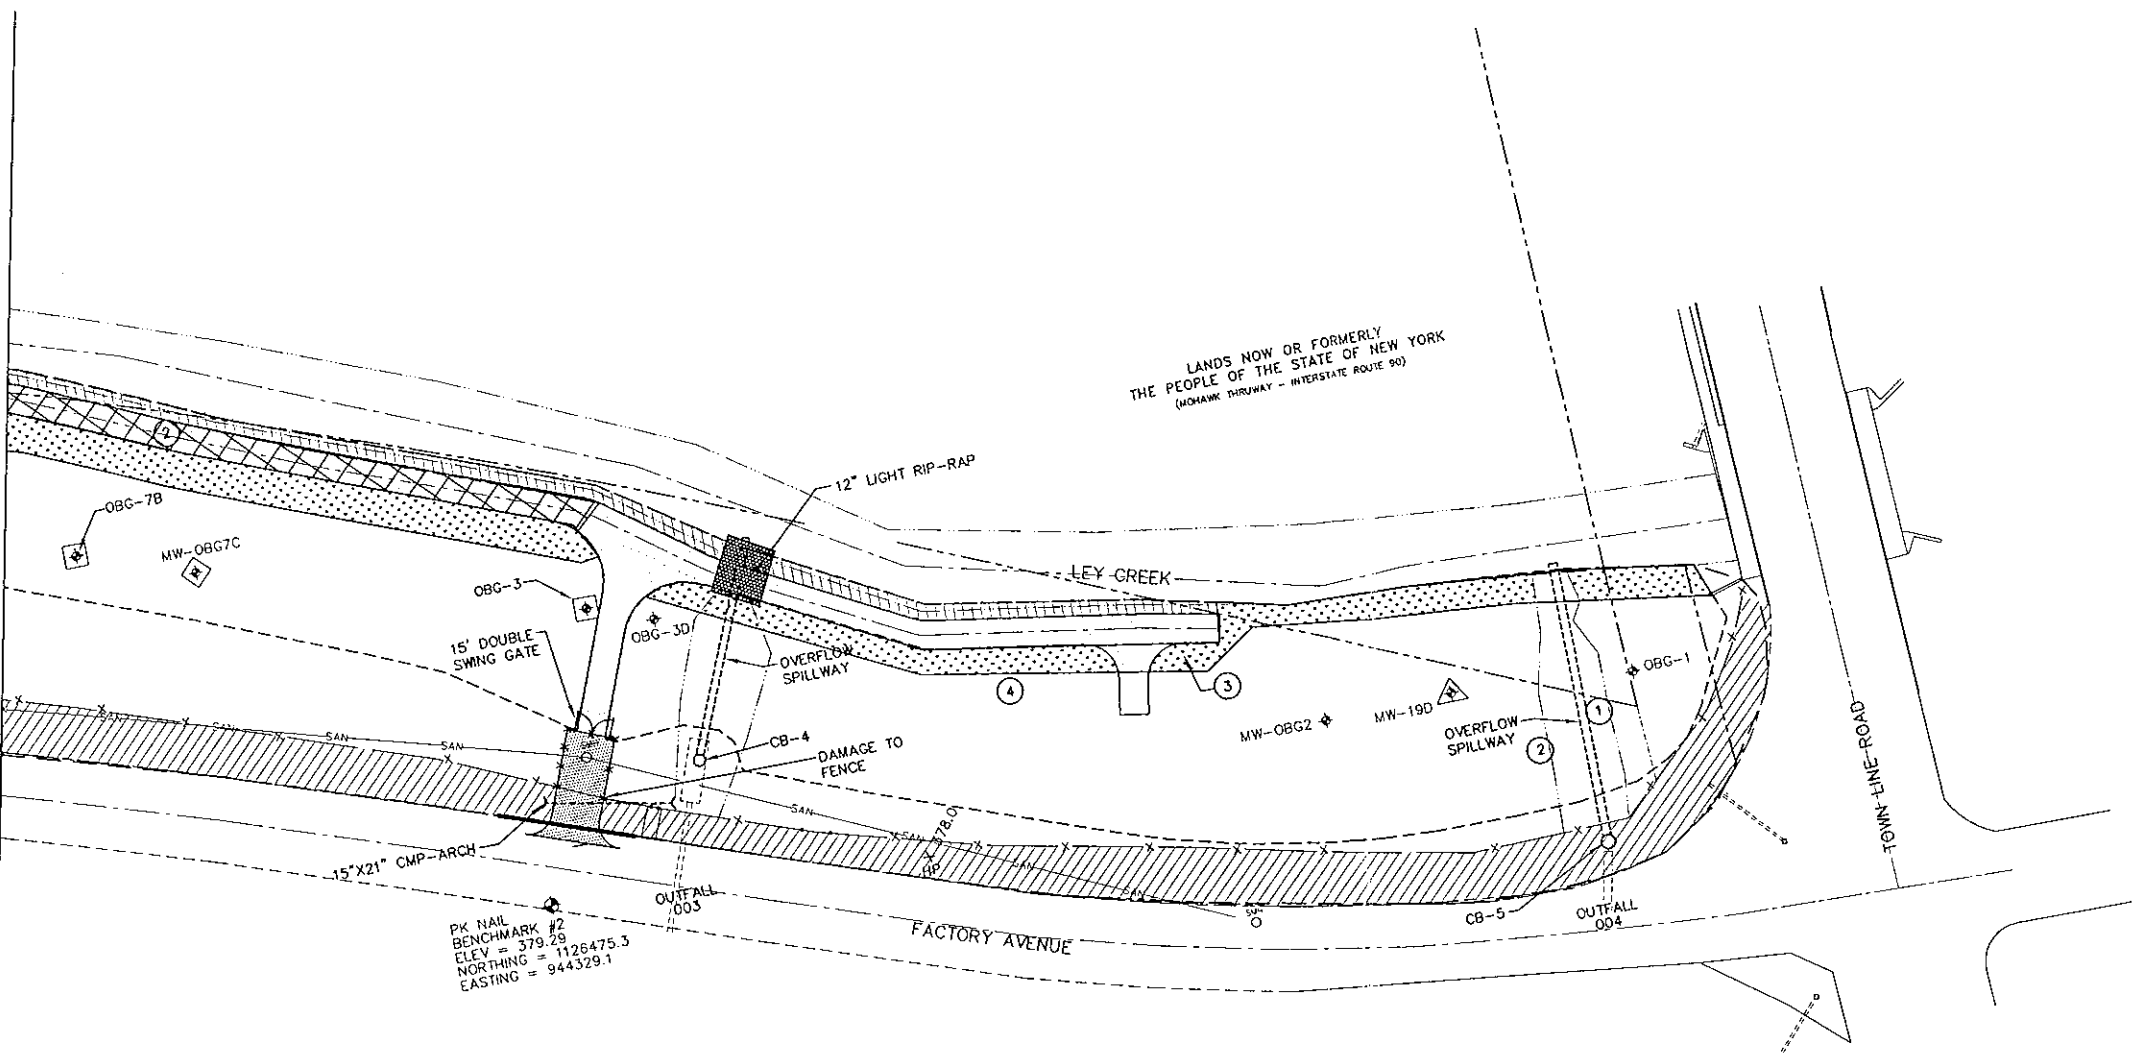
FIGURE 5

Item	Task	Response		Comments
		Yes	No	
Sanitary sewer access paths	3. Debris accumulating in access paths?		X	
Physical Site Security	Visually inspect fences and gates			
	1. Signs intact?	X		
	2. Fence breached?		X	
	3. Access gates locked?	X		
	4. Areas of damage?	X		Refer to Figures 4 and 5.

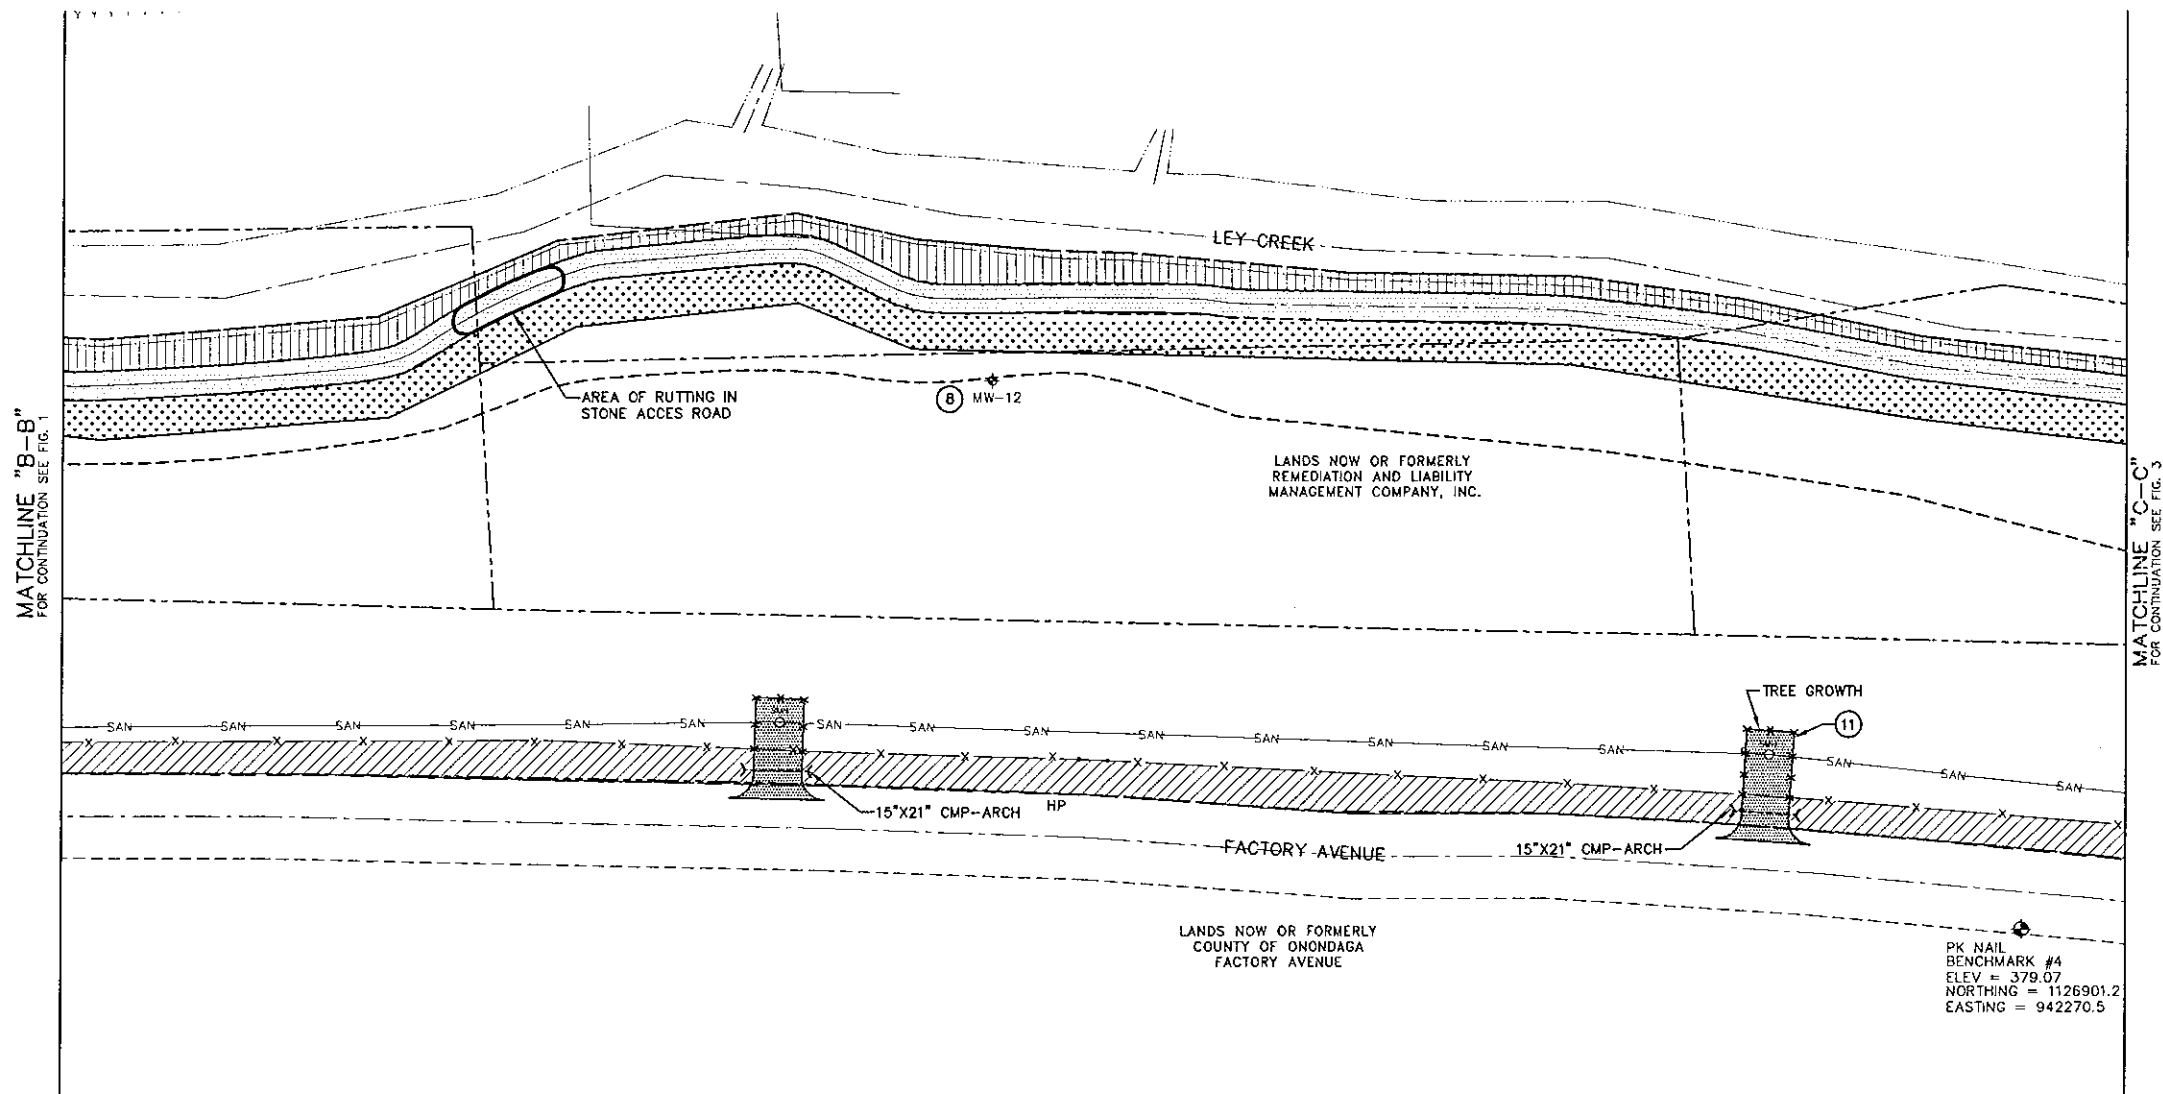
FIGURE 2

- Rutting of the stone access road (Figure 2)
- Delineation of wetland area with signage
- The two areas of the site security fence that were observed to be damaged during previous site inspections (Figures 4 and 5) have not been repaired and should be repaired as soon as practicable.

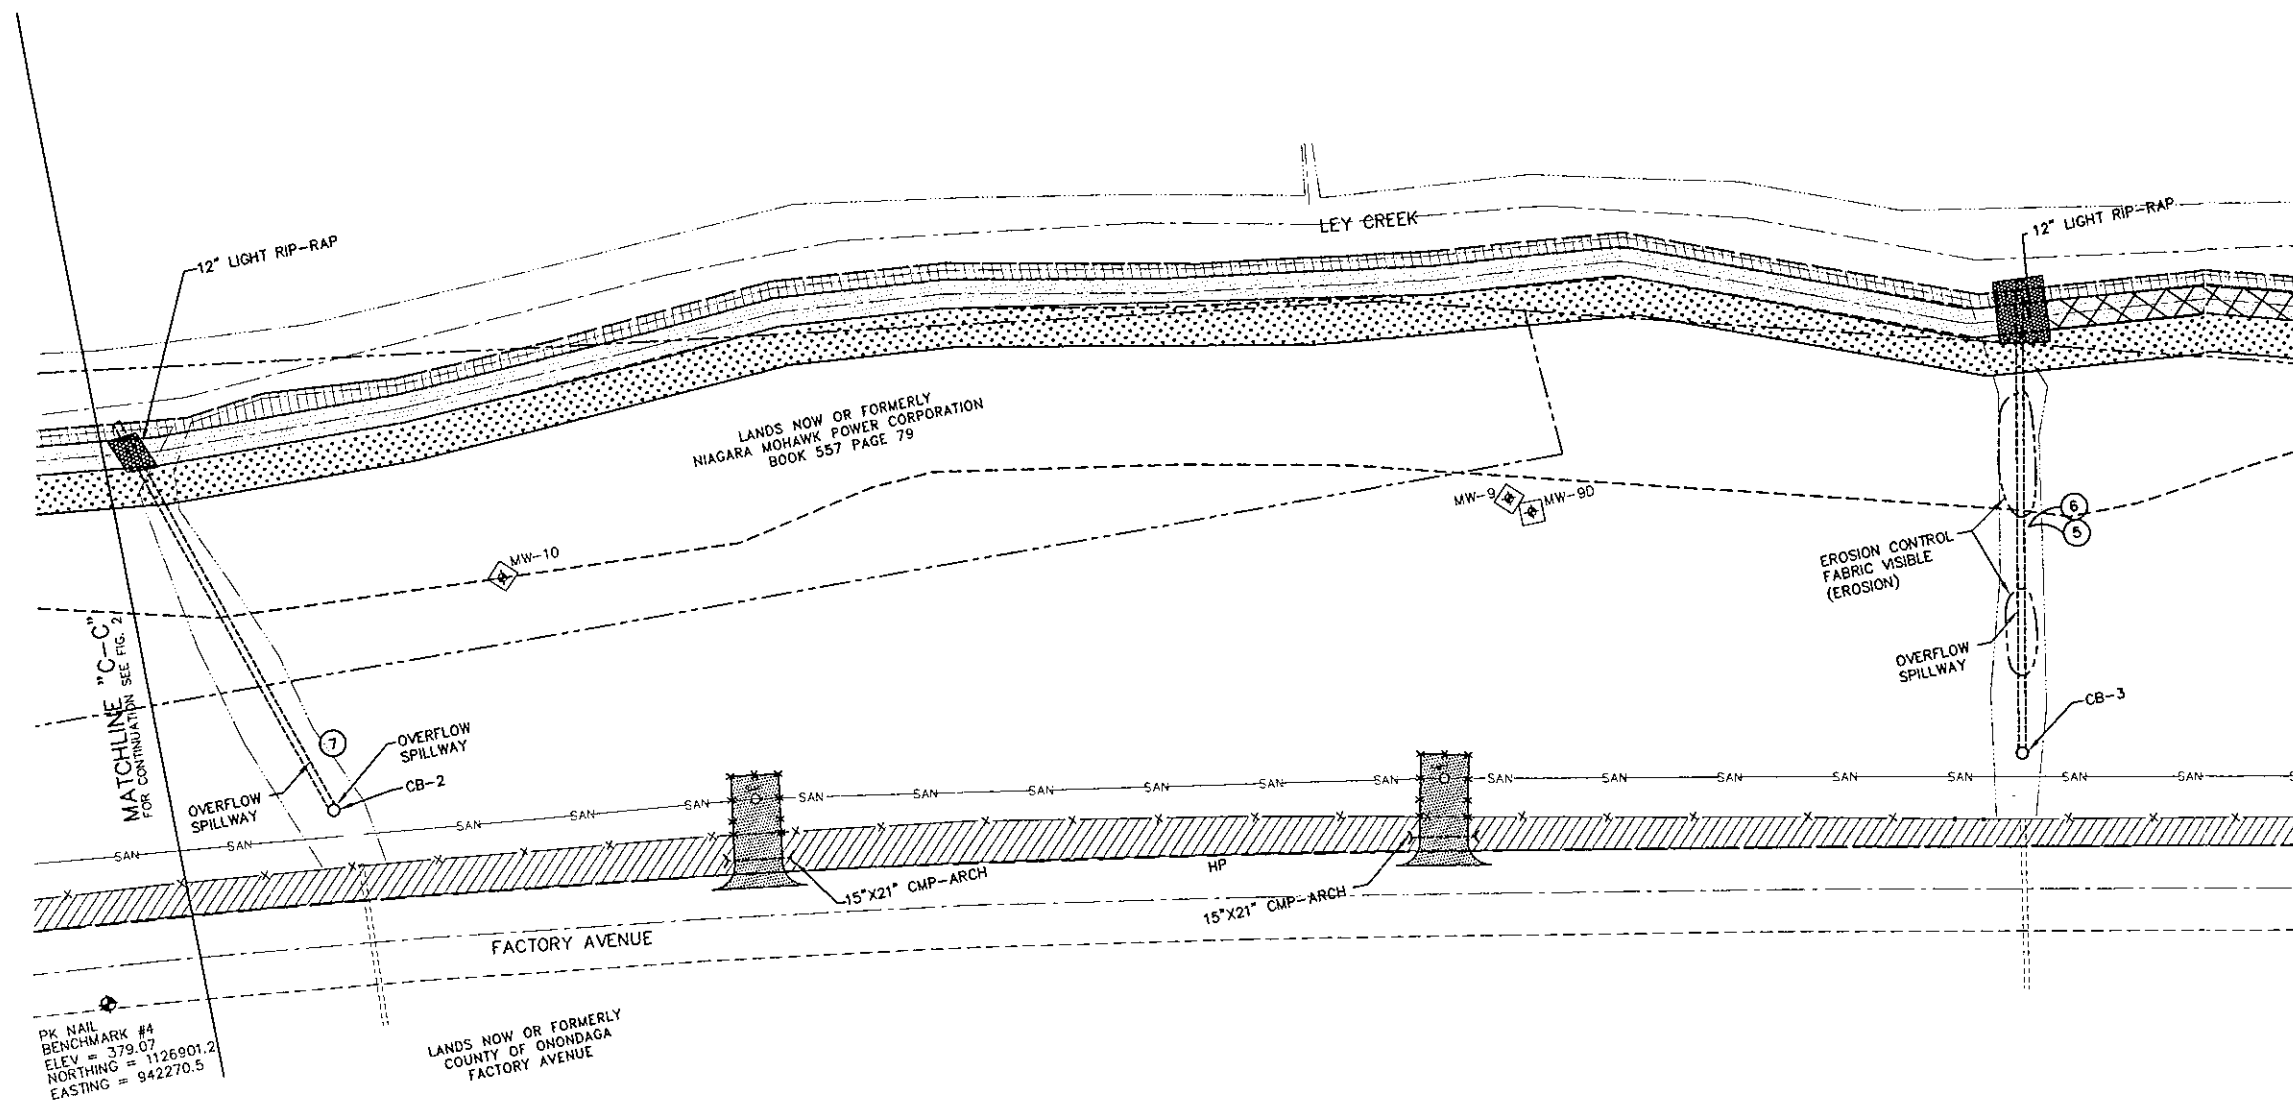
FIGURE 3

- Exposed Erosion Control Fabric: (Photograph 6, Figure 3) Topsoil has eroded away resulting in the exposure of erosion control fabric
- Presence of burrowing animals: (Photograph 8, Figure 2). A burrowing animal hole was observed near MW-12
- Vegetation through pavement/cracks in asphalt: (Photograph 11, Figure 3) Vegetation was observed growing through pavement
- Vegetation within stone access road: A significant amount of vegetation was observed within the stone access road throughout the Site and the stone access road turnaround at the eastern end of the Site
- Tree establishment: (Photograph 10 and 11, Figure 1 and Figure 3) Trees were observed along the fence line.

Item	Task	Response		Comments
		Yes	No	
Vegetative Cover	Visually inspect surface conditions.			
	1. Areas of settlement?		X	
	2. Areas of erosion?	X		Refer to Figure 3 and Photograph 6.
	3. Areas where geotextile visible due to erosion?		X	
	4. Areas of slope instability?		X	
	5. Lack or thinning vegetation?		X	
	6. Presence of burrowing animals?	X		Refer to Figure 2 and Photograph 8.
	7. Areas of damage?		X	
	8. Drainage problems?		X	
	9. Mowing required?	X		
Access Road	Visually inspect conditions.			
	1. Areas of settlement?		X
