## **APPENDIX I**

### **Test Pit Location Summary and Photo Logs**

## Leeds Site Investigation; TP-02 (Photo Log)

**Project** Former Leeds Manufacturing Plant; Northern Parcel  
**Location** Kansas City, Missouri

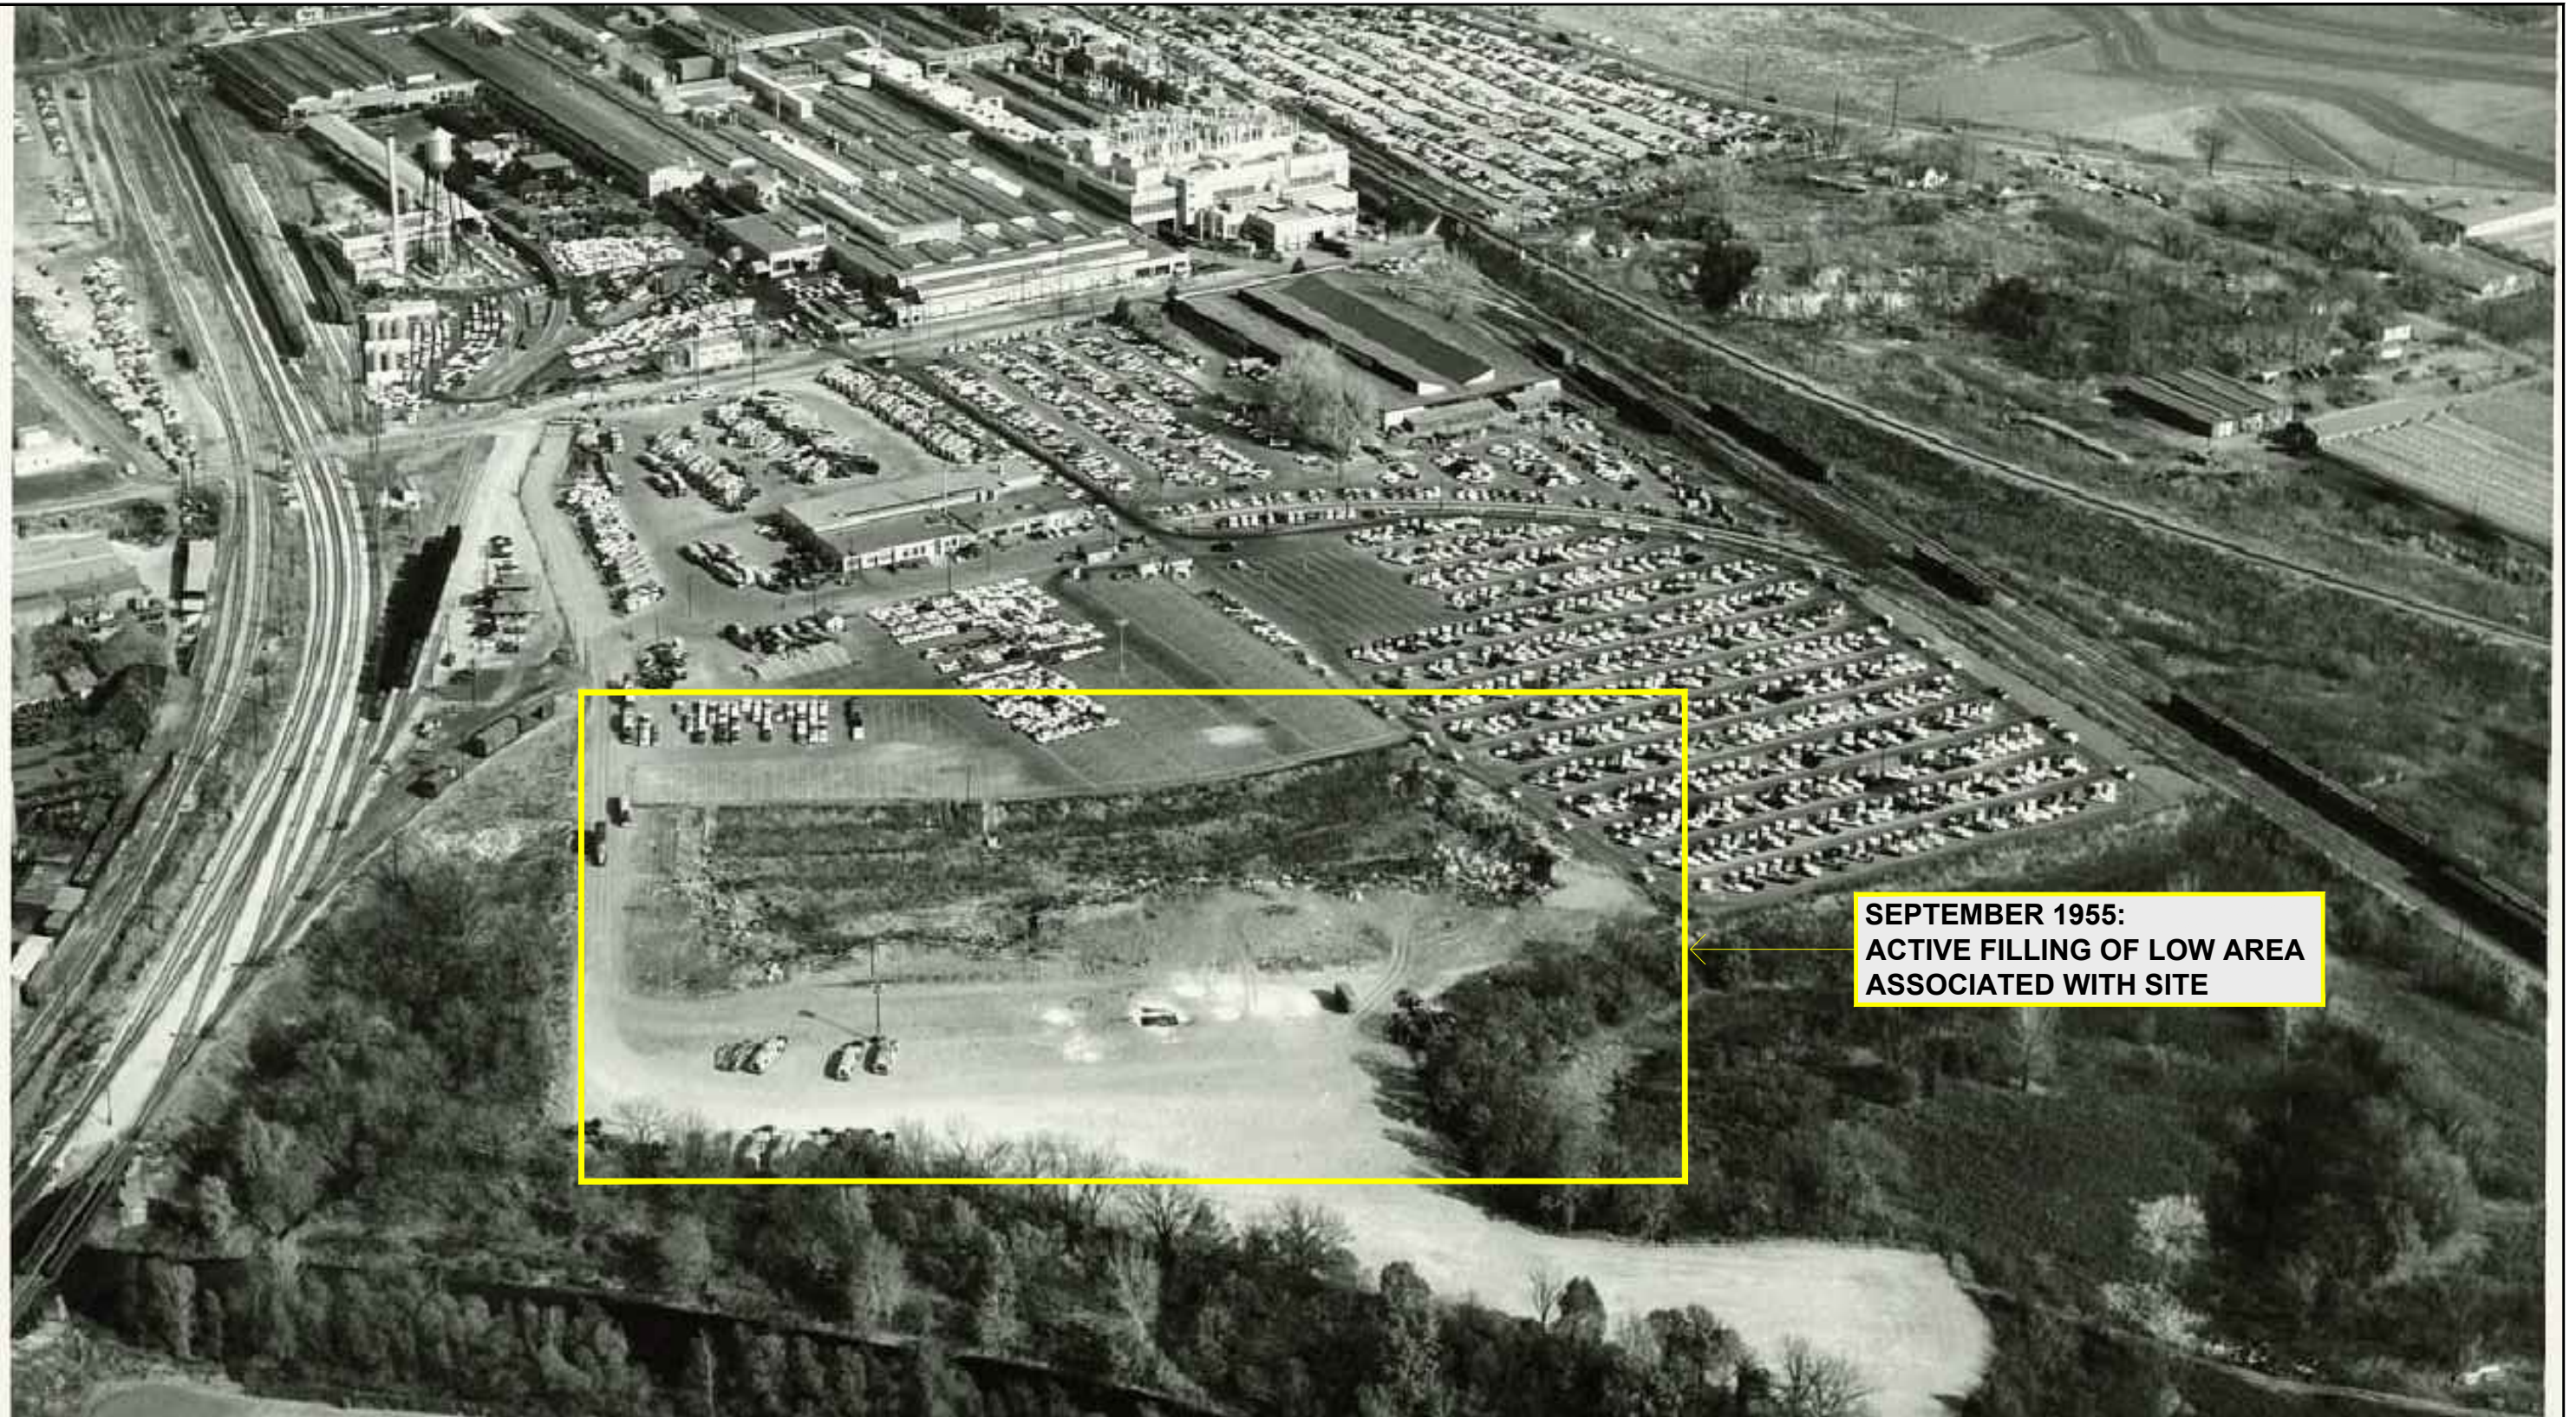
**FIGURE I-3**

**SEPTEMBER 1955:  
ACTIVE FILLING OF LOW AREA  
ASSOCIATED WITH SITE**

**SEPTEMBER 1955  
ACTIVE FILLING AREA**

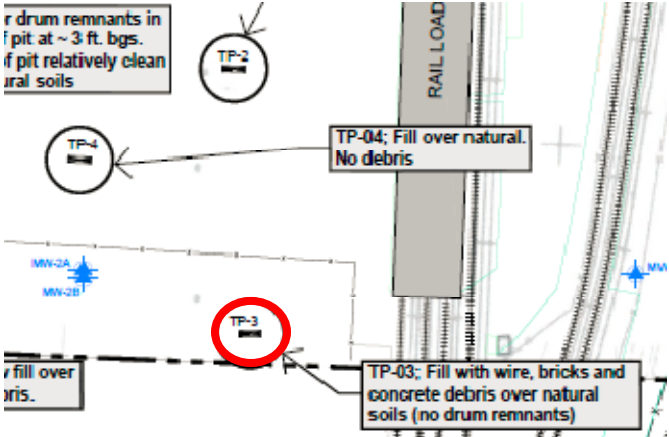
| Photo No. | Date | |
|---|---|---|
| <b>Description</b><br>TP-03 Location | | <p>The site map shows the location of TP-03 (circled in red) relative to other features. TP-03 is located near a 'RAIL LOAD' area. Other features include TP-04 (Fill over natural, No debris), TP-02, TP-01, MW-02, MW-01, and MW-03. A text box indicates 'drum remnants in pit at ~3 ft. bgs. if pit relatively clean natural soils'.</p> |

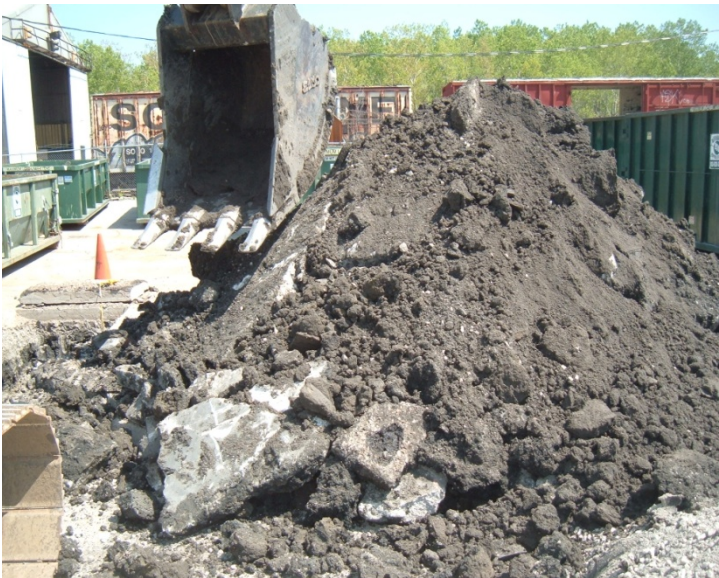
| Photo No. | Date | |
|---|---|---|
| 6 | 4/09/12 | |

| Photo No. | Date | |
|---|---|---|
| <b>Description</b><br>Test pit spoil pile. | | |

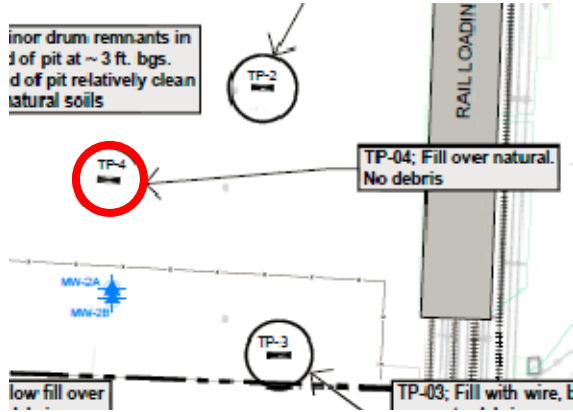
| Photo No. | Date | |
|---|---|---|
| 1 | 4/05/12 | |

| Photo No. | Date | |
|---|---|---|
| <b>Description</b><br>TP-04 Location | | |

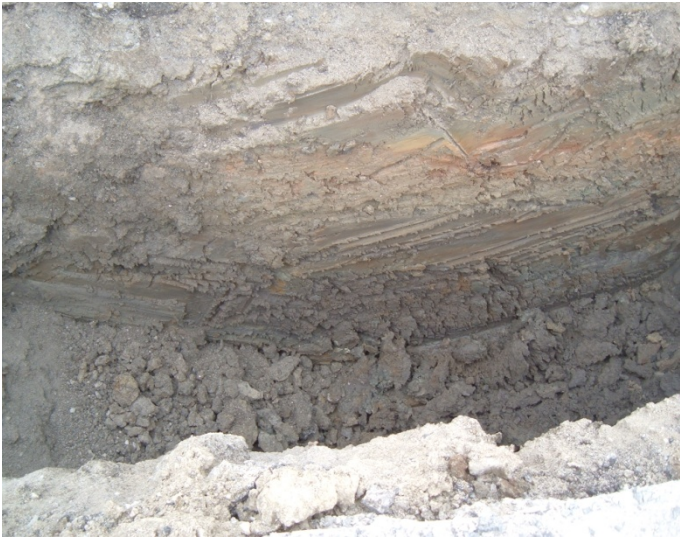
| Photo No. | Date | |
|---|---|---|
| 2 | 4/05/12 | |

| Photo No. | Date | |
|---|---|---|
| <b>Description</b><br>Fill in test pit sidewall.<br>Orange coloring is oxidized clay, not orange paint. | | |

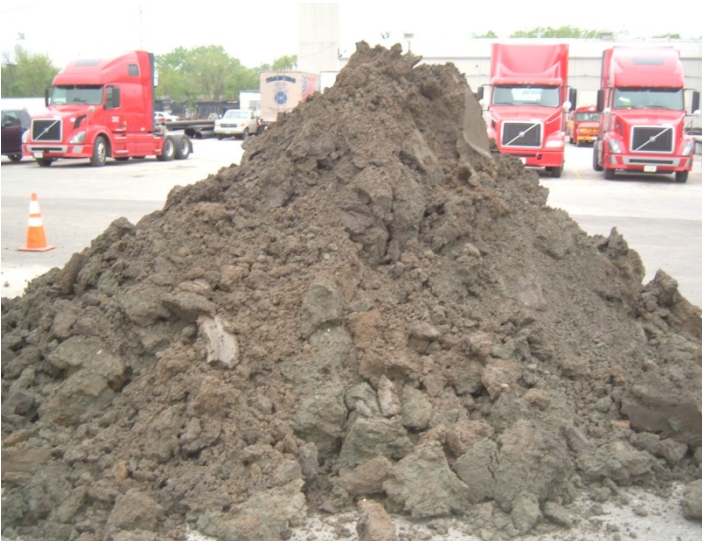
| Photo No. | Date | |
|---|---|---|
| 4 | 4/05/12 | |

| Photo No. | Date | |
|---|---|---|
| <b>Description</b><br>Test pit spoil pile. No debris. | | |

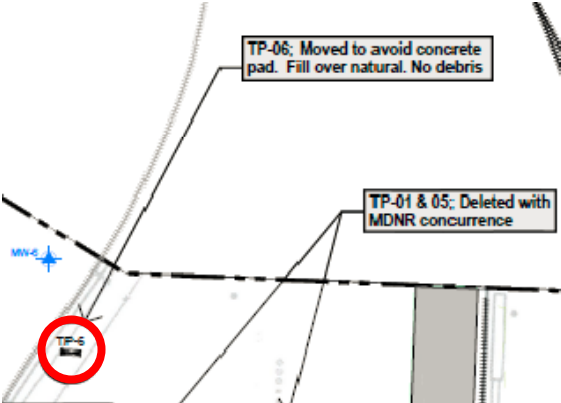
| Photo No. | Date | |
|---|---|---|
| 1 | 4/04/12 | |

| Photo No. | Date | |
|---|---|---|
| <b>Description</b><br>TP-06 Location | | |

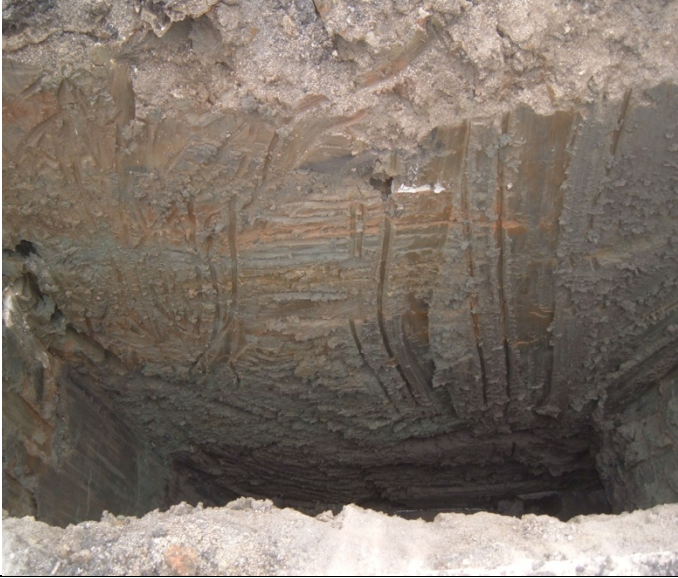
| Photo No. | Date | |
|---|---|---|
| 3 | 4/04/12 | |

| Photo No. | Date | |
|---|---|---|
| <b>Description</b><br>Fill over natural soil at depth (darker brown) | | |

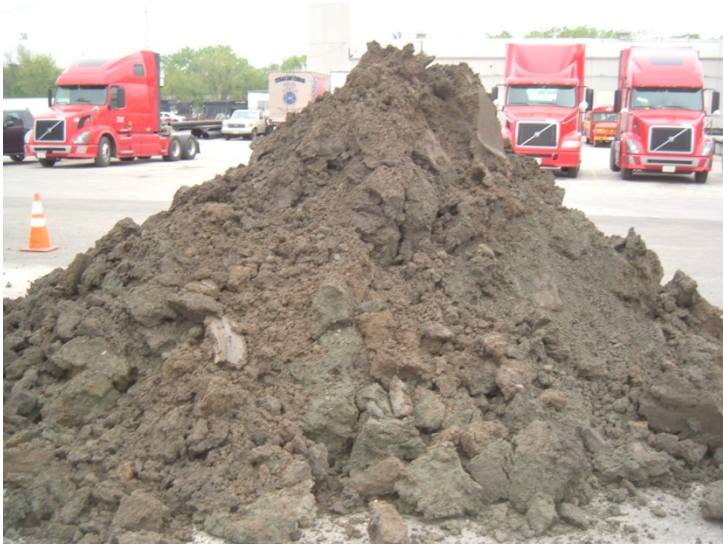
| Photo No. | Date | |
|---|---|---|
| 4 | 4/04/12 | |

| Photo No. | Date | |
|---|---|---|
| <b>Description</b><br>Test pit spoil pile. No debris. | | |

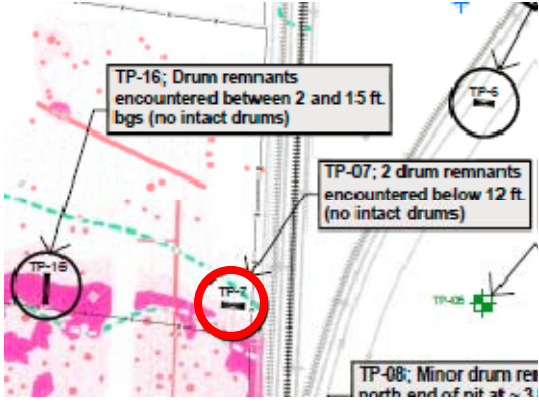
| Photo No. | Date | |
|---|---|---|
| <b>Description</b><br>TP-07 Location | | A site map showing the locations of drum remnants. TP-16 is marked with a black circle and 'I' in the lower left. TP-07 is marked with a red circle and 'II' in the center. TP-08 is marked with a green square and 'III' in the lower right. TP-05 is marked with a black circle and 'IV' in the upper right. Text boxes provide details: TP-16: Drum remnants encountered between 2 and 15 ft. bgs (no intact drums); TP-07: 2 drum remnants encountered below 12 ft. (no intact drums); TP-08: Minor drum rem north end of pit at ~3. A north arrow is in the top right. |

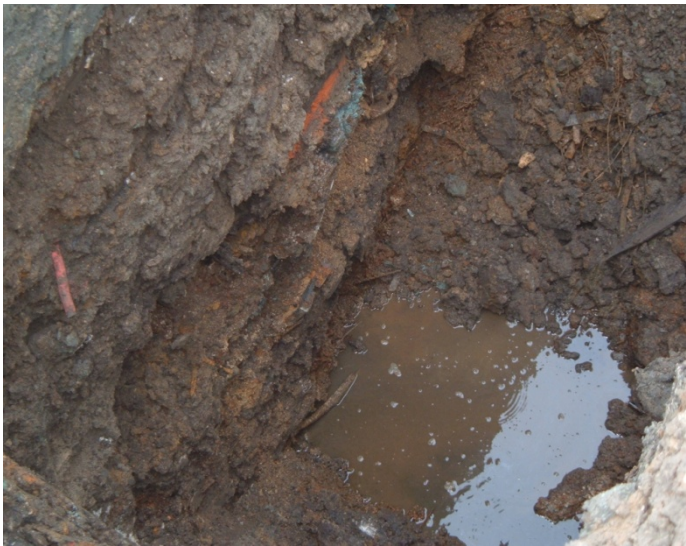
| Photo No. | Date | |
|---|---|---|
| 4 | 4/04/12 | |

| Photo No. | Date | |
|---|---|---|
| <b>Description</b><br>Deeper fills contain more paint and metal debris. Groundwater encountered at approx. 12 ft. bgs. | | |

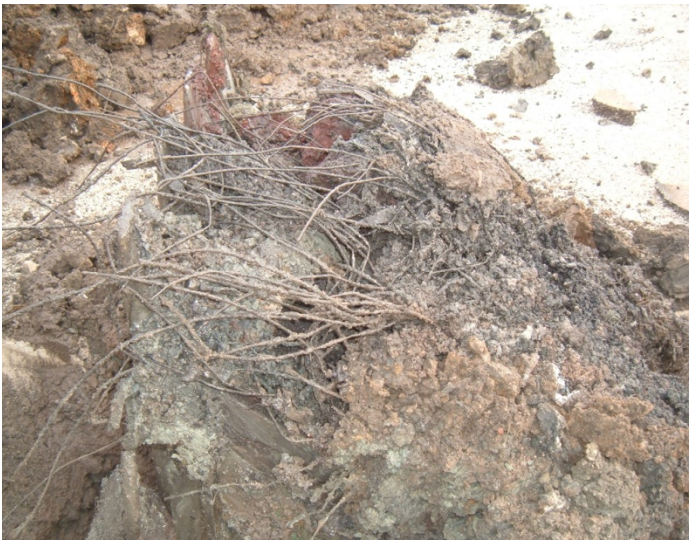
| Photo No. | Date | |
|---|---|---|
| 5 | 4/04/12 | |

| Photo No. | Date | |
|---|---|---|
| <b>Description</b><br>Wire debris from approx. 12 ft. bgs. | | |

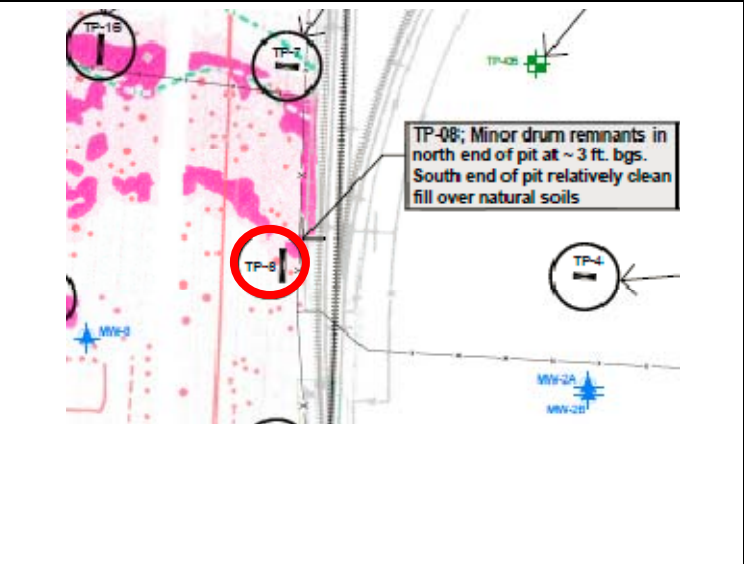
| Photo No. | Date | |
|---|---|---|
| 1 | 4/06/12 | |

| Photo No. | Date | |
|---|---|---|
| <b>Description</b><br>TP-08 Location | | |

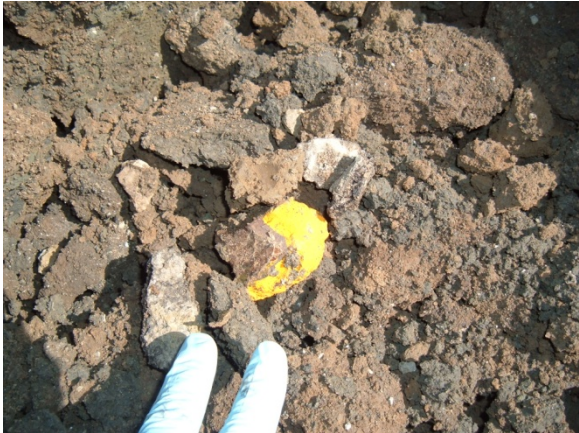
| Photo No. | Date | |
|---|---|---|
| 4 | 4/06/12 | |

| Photo No. | Date | |
|---|---|---|
| <b>Description</b><br>Minor amounts of paint debris encountered. | | |

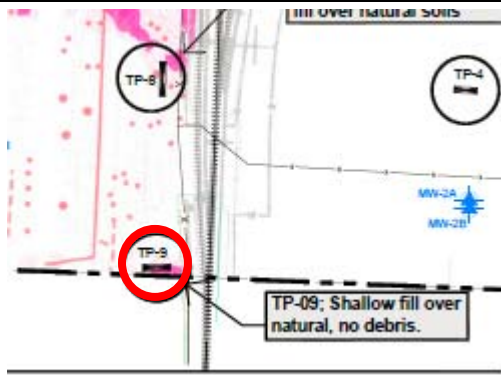
| Photo No. | Date | |
|---|---|---|
| <b>Description</b><br>TP-09 Location | | A site map showing the location of Test Pit 09 (TP-09) relative to other features. TP-09 is circled in red. Other features include TP-8, TP-4, MW-2A, and MW-2B. A legend indicates 'Till over natural soils'. A text box points to TP-09, stating 'TP-09; Shallow fill over natural, no debris.' |

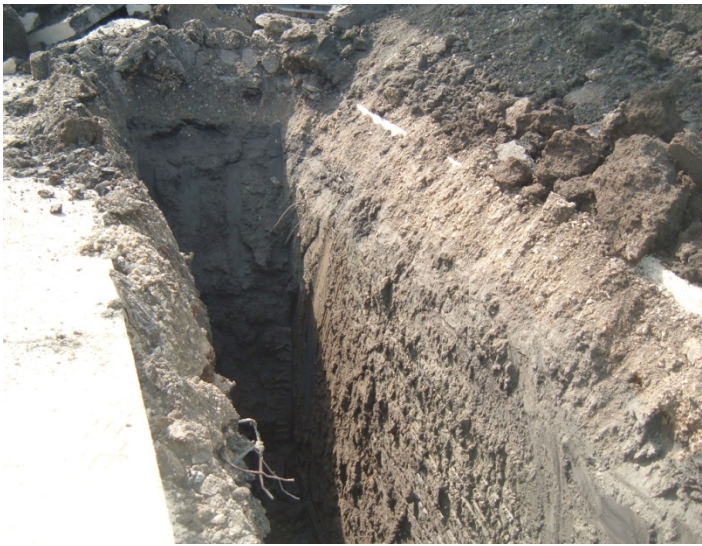
| Photo No. | Date | |
|---|---|---|
| <b>Description</b><br>Test pit sidewall, no debris | | A photograph showing the interior sidewall of a test pit. The soil is a light brown, silty material, appearing to be a shallow fill over natural soil. There is no visible debris on the sidewall. |

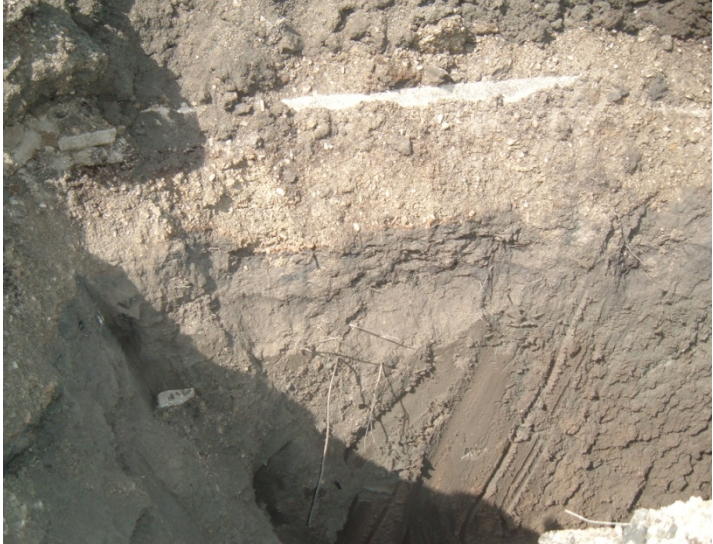
| Photo No. | Date | |
|---|---|---|
| 3 | 4/09/12 | |

| Photo No. | Date | |
|---|---|---|
| <b>Description</b><br>Fill over natural soils at shallow depth | | |

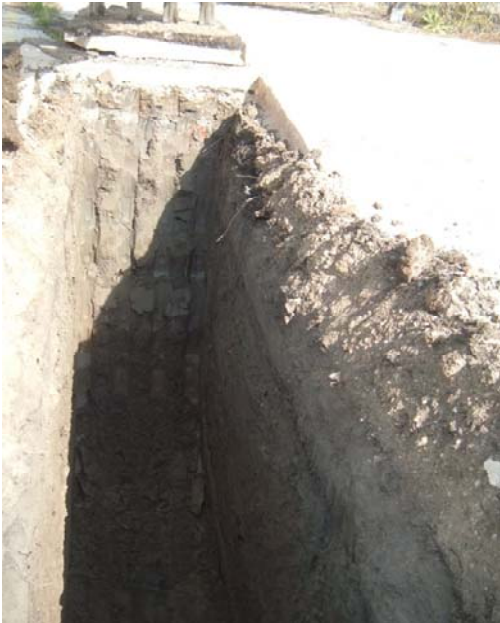
| Photo No. | Date | |
|---|---|---|
| 4 | 4/09/12 | |

| Photo No. | Date | |
|---|---|---|
| <b>Description</b><br>No debris. | | |

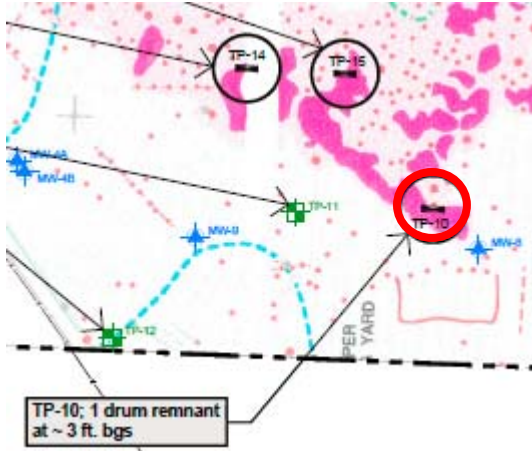
| Photo No. | Date | |
|---|---|---|
| 1 | 4/09/12 | |

| Photo No. | Date | |
|---|---|---|
| <b>Description</b><br>TP-10 Location | | |

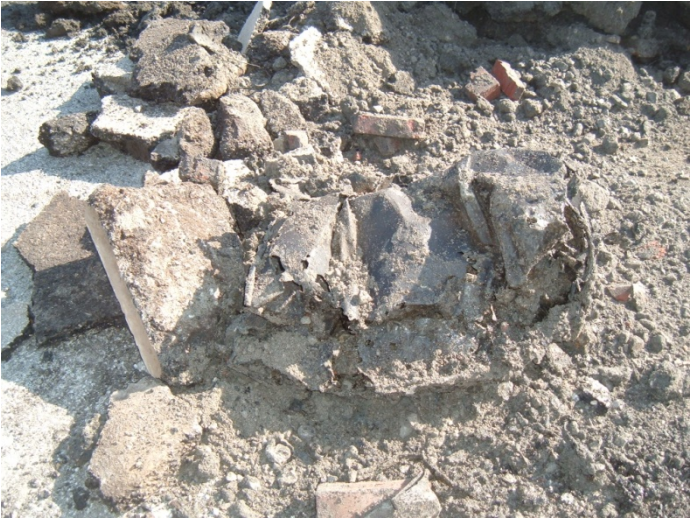
| Photo No. | Date | |
|---|---|---|
| 4 | 4/09/12 | |

| Photo No. | Date | |
|---|---|---|
| <b>Description</b><br>Drum remnant encountered at approx. 3 ft. bgs. | | |

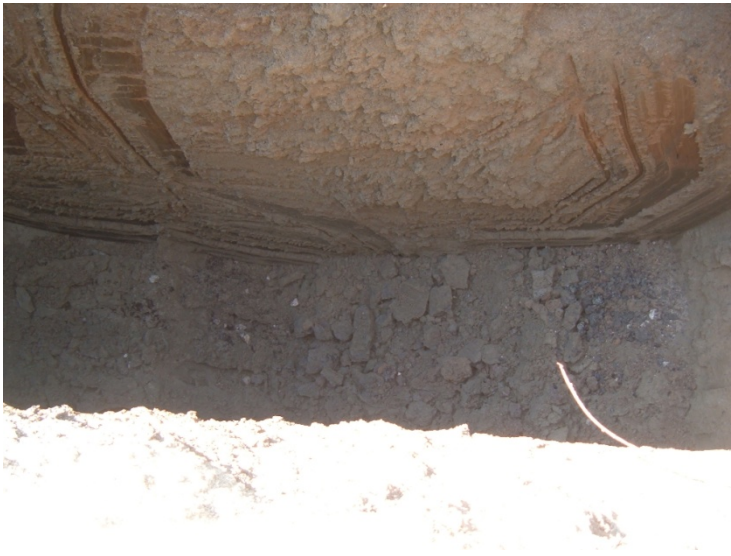
| Photo No. | Date | |
|---|---|---|
| 5 | 4/09/12 | |

| Photo No. | Date | |
|---|---|---|
| <b>Description</b><br>Natural material beneath fill at depth. | | |

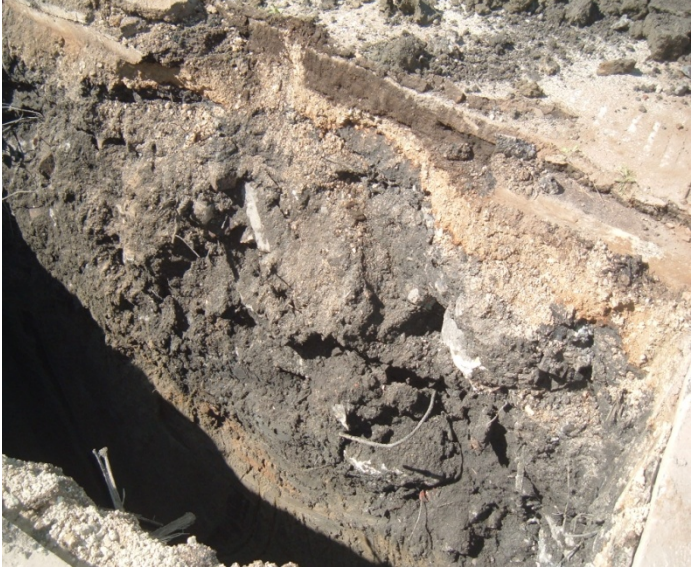
| Photo No. | Date | |
|---|---|---|
| 3 | 4/06/12 | |

| Photo No. | Date | |
|---|---|---|
| <b>Description</b><br>Fill in test pit sidewall. | | |

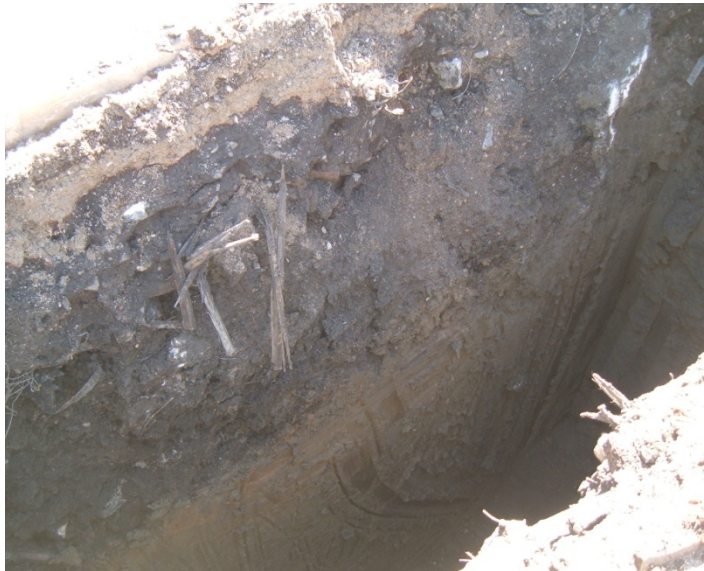
| Photo No. | Date | |
|---|---|---|
| 8 | 4/06/12 | |

| Photo No. | Date | |
|---|---|---|
| <b>Description</b><br>Fill over natural at approx. 6 ft. bgs. | | |

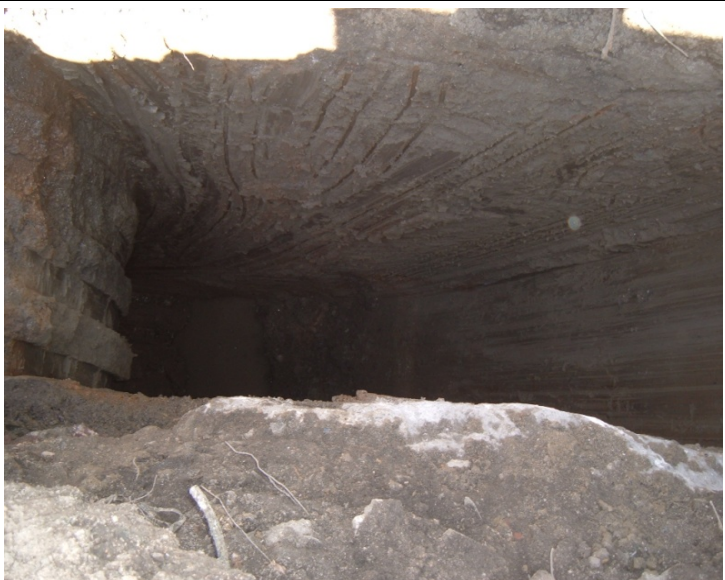
| Photo No. | Date | |
|---|---|---|
| 6 | 4/06/12 | |

| Photo No. | Date | |
|---|---|---|
| <b>Description</b><br>Natural soil beneath fill. Concrete piece at bottom of photo demarks bottom of fill. | | |

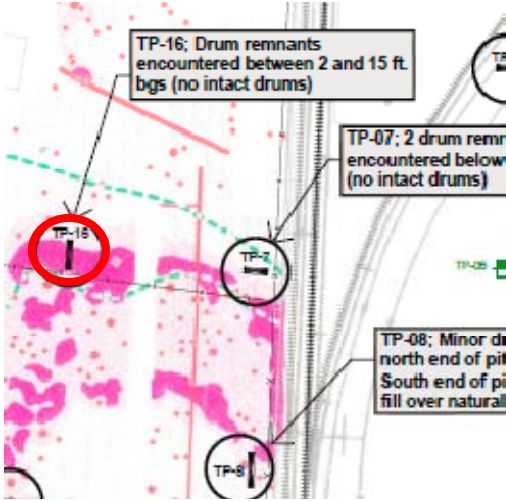
| Photo No. | Date | |
|---|---|--|
| 1 | 4/03/12 | |

| Photo No. | Date | |
|---|---|--|
| Description | Test Pit Location | |

- TP-16: Drum remnants encountered between 2 and 15 ft. bgs (no intact drums)
- TP-07: 2 drum remnants encountered below (no intact drums)
- TP-08: Minor drums north end of pit. South end of pit fill over natural ground.

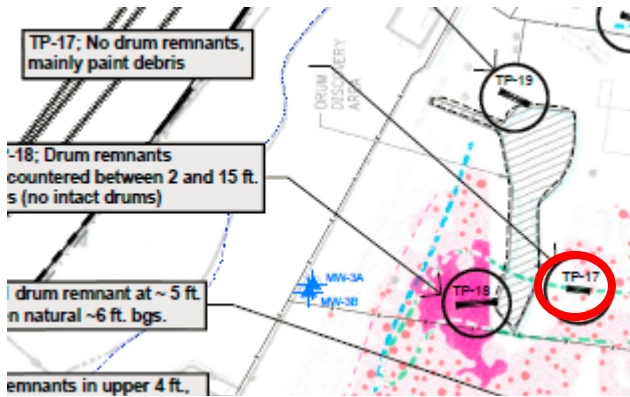
| Photo No. | Date | |
|---|---|---|
| <b>Description</b><br>TP-17 Location | | <p>TP-17: No drum remnants, mainly paint debris</p> <p>TP-18: Drum remnants countered between 2 and 15 ft. s (no intact drums)</p> <p>drum remnant at ~ 5 ft. n natural ~6 ft. bgs.</p> <p>remnants in upper 4 ft.</p> <p>DRUM DISCOVERY AREA</p> <p>MN-3A</p> <p>MN-3B</p> <p>TP-18</p> <p>TP-17</p> |

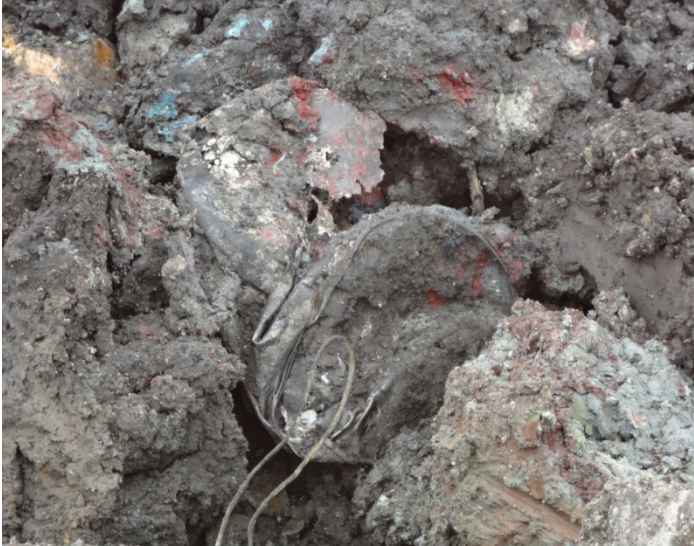
| Photo No. | Date | |
|---|---|---|
| 3 | 4/03/12 | |

| Photo No. | Date | |
|---|---|---|
| <b>Description</b><br>Crushed paint can | | |

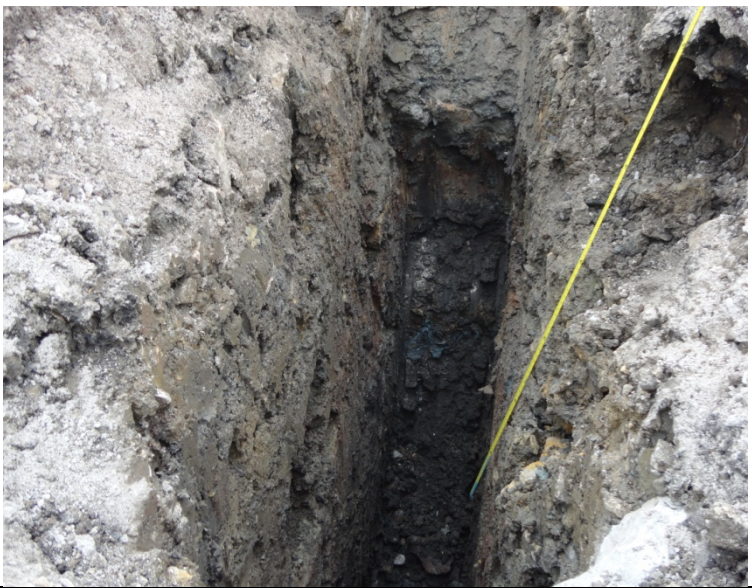
| Photo No. | Date | |
|---|---|---|
| 6 | 4/03/12 | |

| Photo No. | Date | |
|---|---|---|
| <b>Description</b><br>Test pit walls showing no drum remnants. | | |

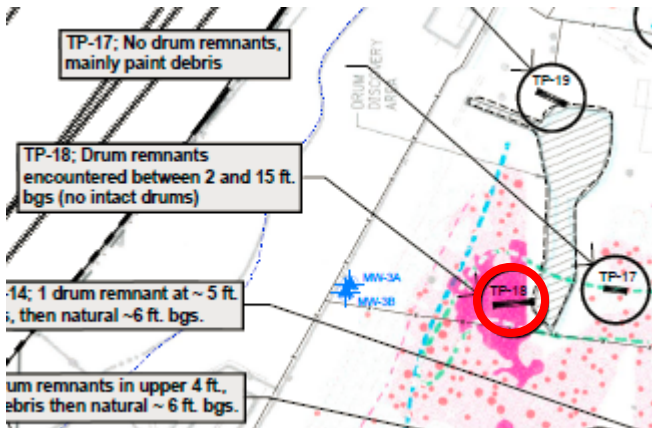
| Photo No. | Date | |
|---|---|---|
| 1 | 4/02/12 | |

| Photo No. | Date | |
|---|---|---|
| <b>Description</b><br>TP-18 Location | | |

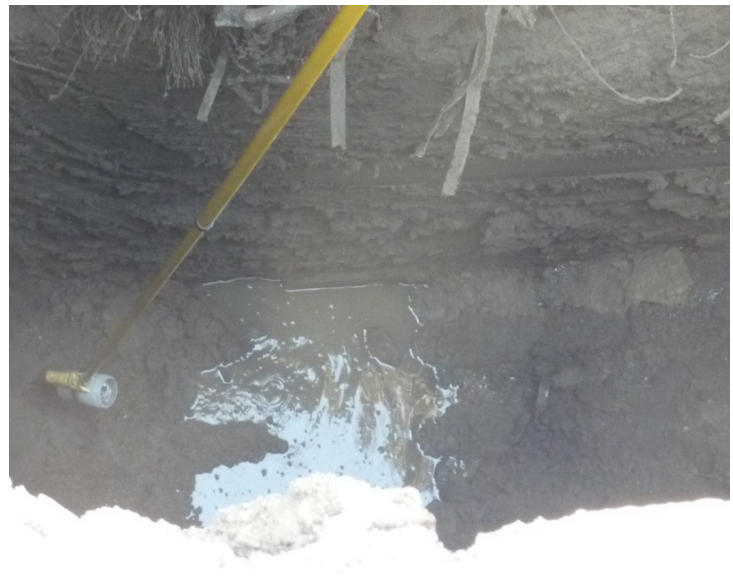
| Photo No. | Date | |
|---|---|---|
| 6 | 4/02/12 | |

| Photo No. | Date | |
|---|---|---|
| <b>Description</b><br>Bottom of test pit (~23 ft.) showing natural soil beneath depth of drums. | | |

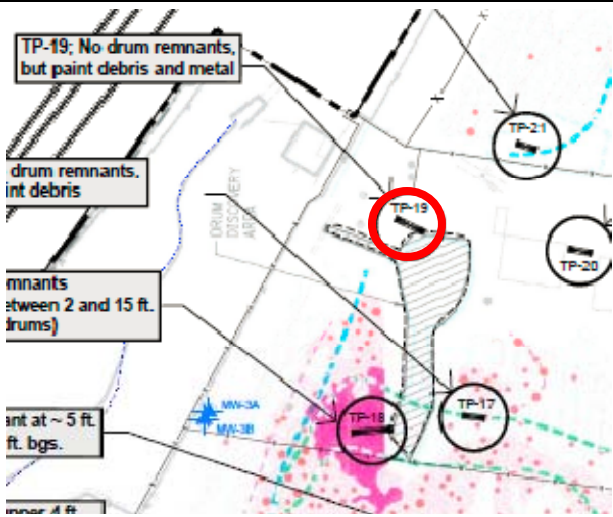
| Photo No. | Date | |
|---|---|---|
| <b>Description</b><br>TP-19 Location | | A site map showing the location of TP-19, which is circled in red. Other sampling points are marked with circles and labeled: TP-21, TP-20, TP-18, and TP-17. Text boxes on the map provide details: 'TP-19; No drum remnants, but paint debris and metal', 'drum remnants, paint debris', 'remnants between 2 and 15 ft. (drums)', and 'paint at ~ 5 ft. ft. bgs.'. A blue star indicates 'MW-3A' and 'MW-3B'. A dashed line is labeled 'DRUM DISCOVERY AREA'. The map also shows various colored dots (pink, blue, green) and lines representing different features or boundaries. |

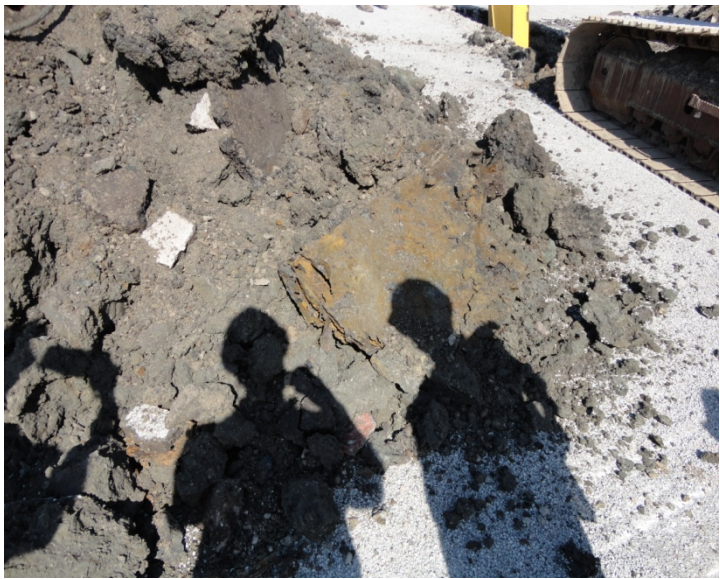
| Photo No. | Date | |
|---|---|---|
| 4 | 4/02/12 | |

| Photo No. | Date | |
|---|---|---|
| <b>Description</b><br>Buried metal object, not a drum. | | |

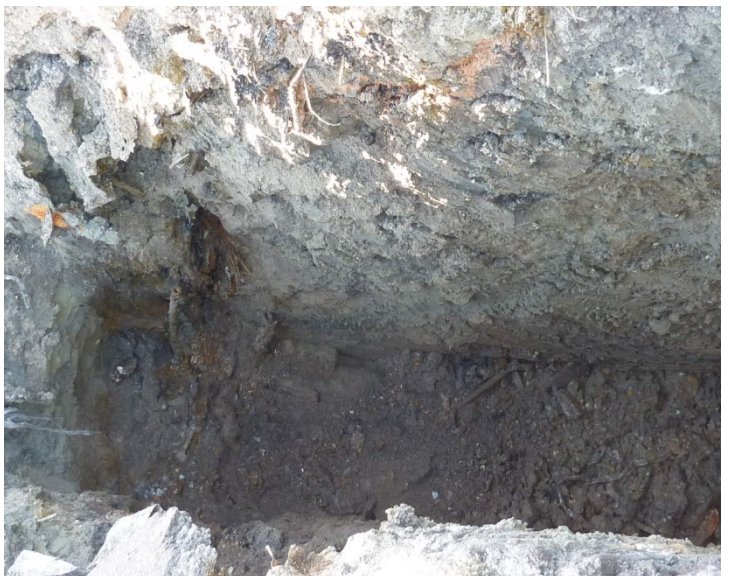
| Photo No. | Date | |
|---|---|---|
| 6 | 4/02/12 | |

| Photo No. | Date | |
|---|---|---|
| <b>Description</b><br>Test Pit sidewall, no drums. | | |

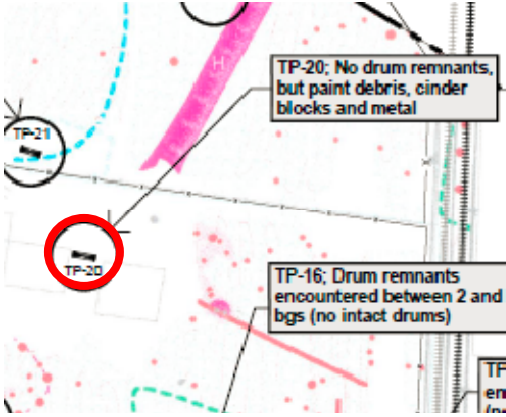
| Photo No. | Date | |
|---|---|---|
| 1 | 4/04/12 | |

| Photo No. | Date | |
|---|---|---|
| <b>Description</b><br>TP-20 Location | | |

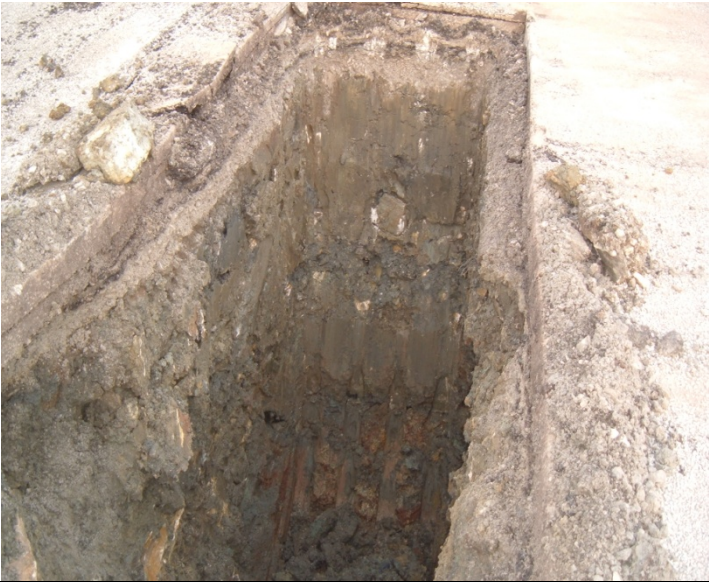
| Photo No. | Date | |
|---|---|---|
| 2 | 4/04/12 | |

| Photo No. | Date | |
|---|---|---|
| <b>Description</b><br>Fill in test pit sidewall. | | |

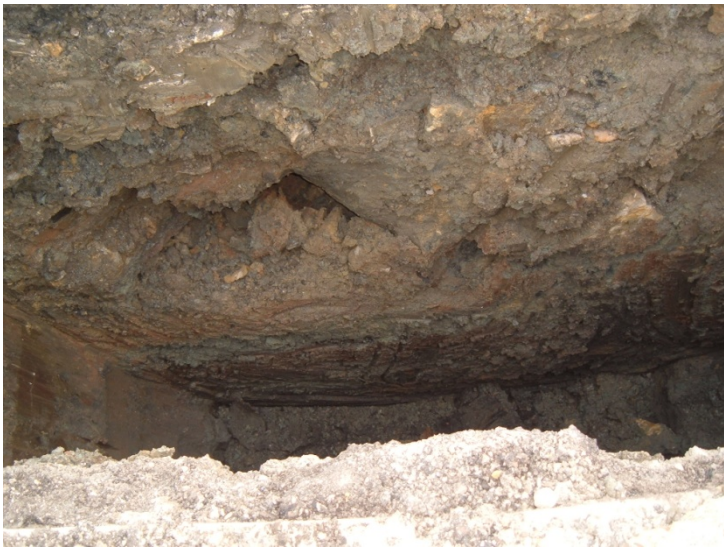
| Photo No. | Date | |
|---|---|---|
| 6 | 4/04/12 | |

| Photo No. | Date | |
|---|---|---|
| <b>Description</b><br>.Natural soil at depth (dark brown) beneath fill. | | |

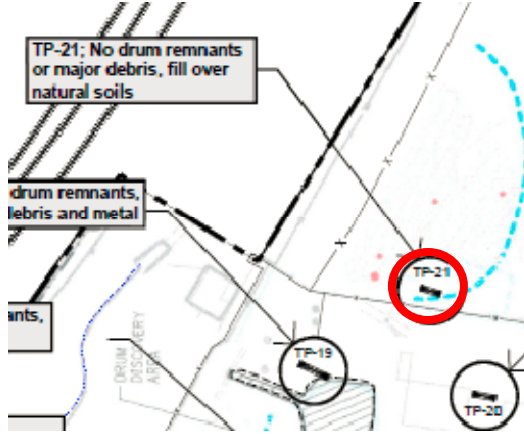
| Photo No. | Date | |
|---|---|---|
| <b>Description</b><br>TP-21 Location | | A site map showing the location of TP-21. A red circle highlights the area labeled 'TP-21'. A blue dashed line indicates a boundary. A black line points to a label 'TP-21; No drum remnants or major debris, fill over natural soils'. Another black line points to a label 'drum remnants, debris and metal'. A label 'DRUM DISCOVERY AREA' is also present. Other labels include 'TP-15' and 'TP-20'. |

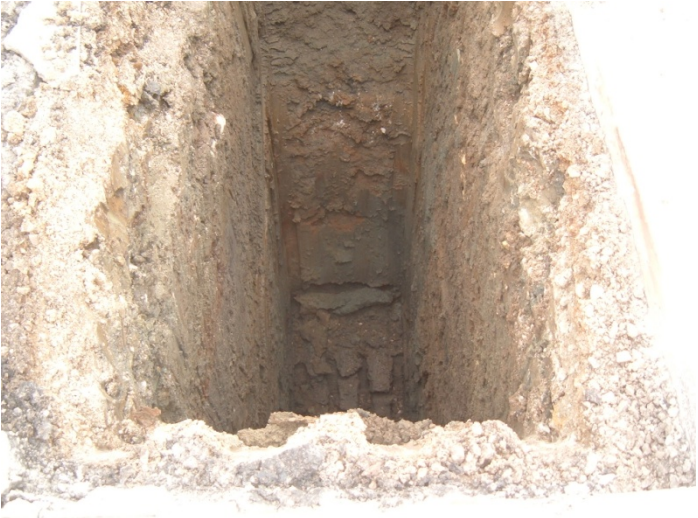
| Photo No. | Date | |
|---|---|---|
| 3 | 4/04/12 | |

| Photo No. | Date | |
|---|---|---|
| <b>Description</b><br>No debris in fill. | | |

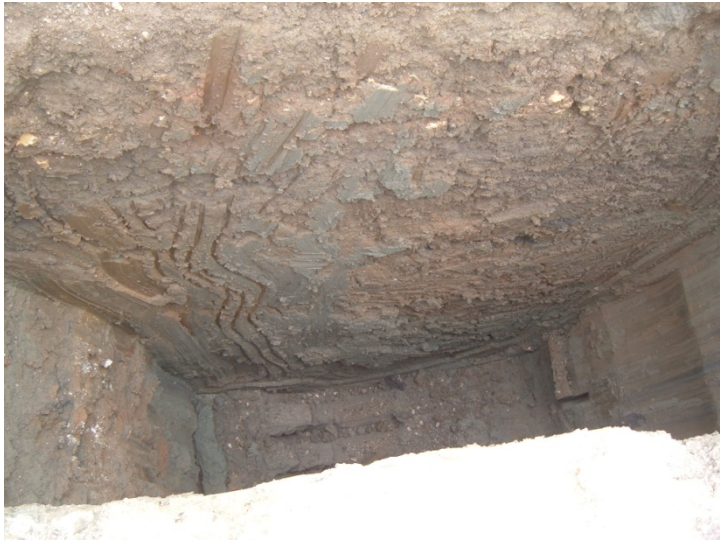
| Photo No. | Date | |
|---|---|---|
| 4 | 4/04/12 | |

| Photo No. | Date | |
|---|---|---|
| <b>Description</b><br>Fill over natural soil with no debris. | | |

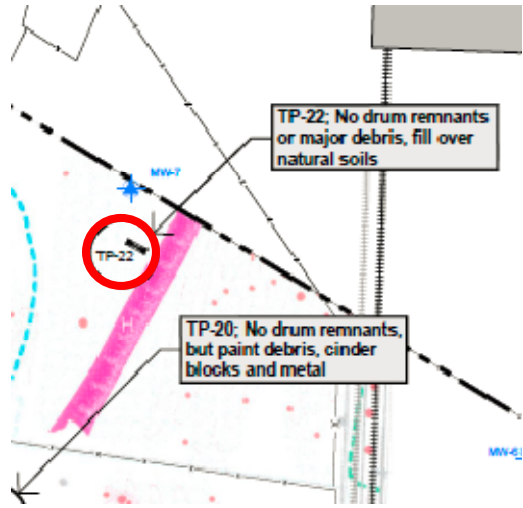
| Photo No. | Date | |
|---|---|---|
| <b>Description</b><br>TP-22 Location | | <p>The site map shows a pink shaded area representing the investigation site. A red circle highlights the location of TP-22. A blue star marks MW-7. A dashed line indicates a boundary. A text box points to TP-22, stating: 'TP-22: No drum remnants or major debris, fill over natural soils'. Another text box points to a nearby area, stating: 'TP-20: No drum remnants, but paint debris, cinder blocks and metal'. A blue line marks MW-6.</p> |

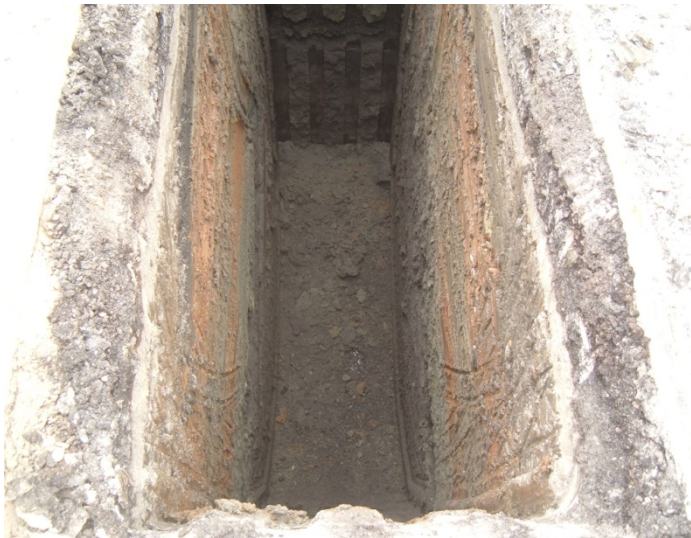
| Photo No. | Date | |
|---|---|---|
| <b>Description</b><br>Fill in sidewalls with no debris. Orange coloring is oxidized clay, not orange paint. | | <p>The photograph shows a cross-section of a trench or excavation. The sidewalls are composed of soil with a distinct orange-brown coloration, which is identified as oxidized clay. The bottom of the trench is filled with a similar material. There is no visible debris on the sidewalls.</p> |

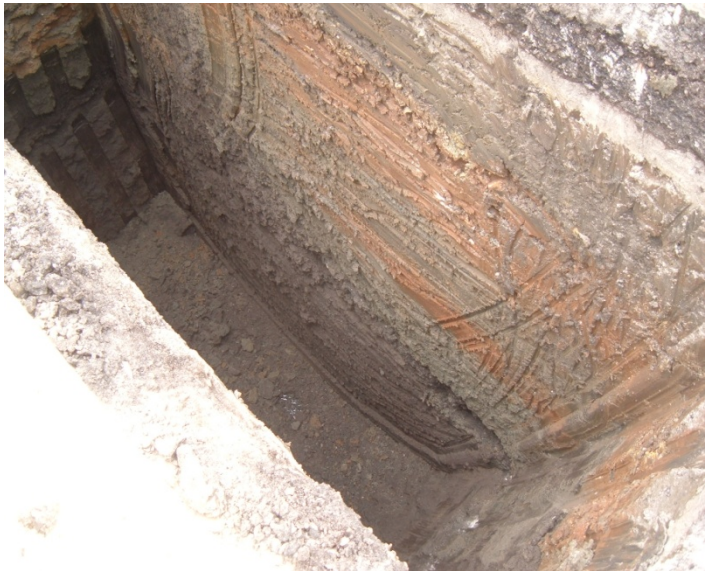
| Photo No. | Date | |
|---|---|---|
| 3 | 4/04/12 | |

| Photo No. | Date | |
|---|---|---|
| <b>Description</b><br>Fill in sidewalls with no debris. Orange coloring is oxidized clay, not orange paint. Natural soil at depth (dark brown) | | |

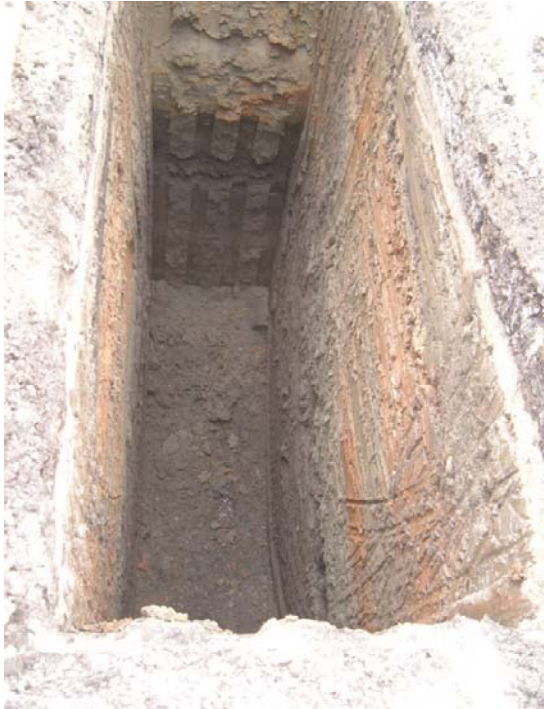
| Photo No. | Date | |
|---|---|---|
| 4 | 4/04/12 | |

| Photo No. | Date | |
|---|---|---|
| <b>Description</b><br>Fill over natural soil, no debris. | | |
