Re: Ley Creek PCB Dredgings Site
June 2007 OM&M Inspection

LEY CREEK PCB DREDGINGS SITE
SYRACUSE, NEW YORK
SITE REMEDIATION PROJECT

JUNE 2007
OM&M INSPECTION
PARTIAL SITE PLAN

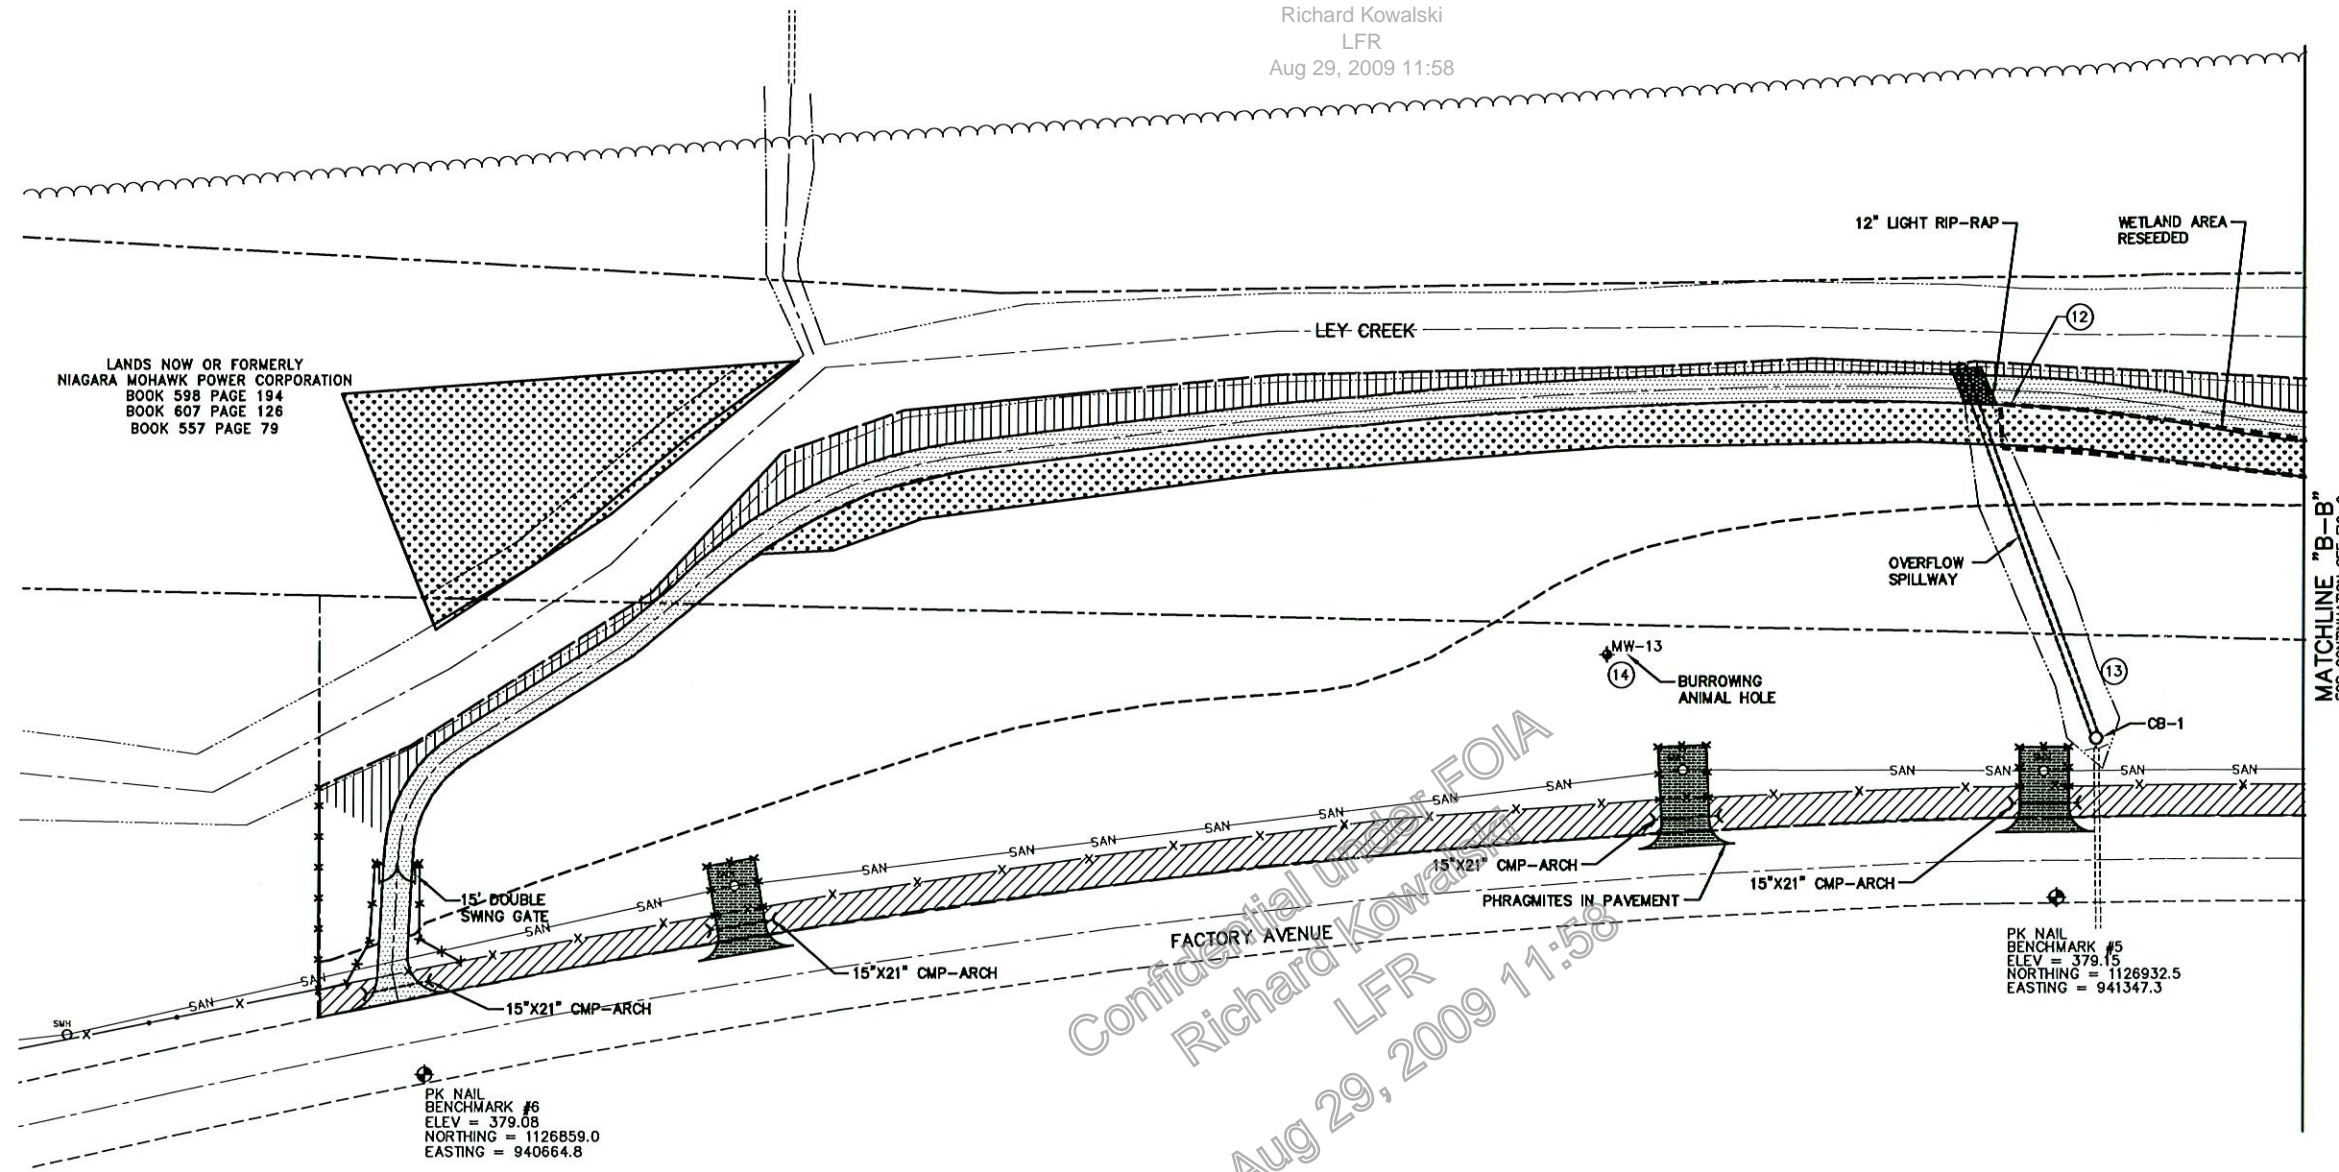
FIGURE 1

Also attached is a copy of the wetland vegetation mix that was placed by Royal Environmental, Inc. on May 25, 2007. The wetland area seeded is noted on Figures 1 and 2 and Photographs 11 and 12. This area will be inspected by O'Brien & Gere as part of the wetland inspection to be performed in Late Summer/Early Fall 2007.

- Animal burrow in vegetative cover (Figures 1, 2, and 4 and Photographs 5, 10 and 14)
- Exposed erosion control fabric within CB-3 overflow spillway (Figure 3 and Photograph 7)
- Lack of vegetation within CB-3 overflow spillway (Figure 1, 2, and 3 and Photograph 6, 11, and 12)
- Soil covering MW-12 and MW-13 monitoring well due to animal burrow (Figures 1 and 2 and Photographs 10 and 15)
- Phragmites in asphalt (Figure 1 and 2 and Photograph 16)
- Garbage near Factory Avenue (Figure 3)

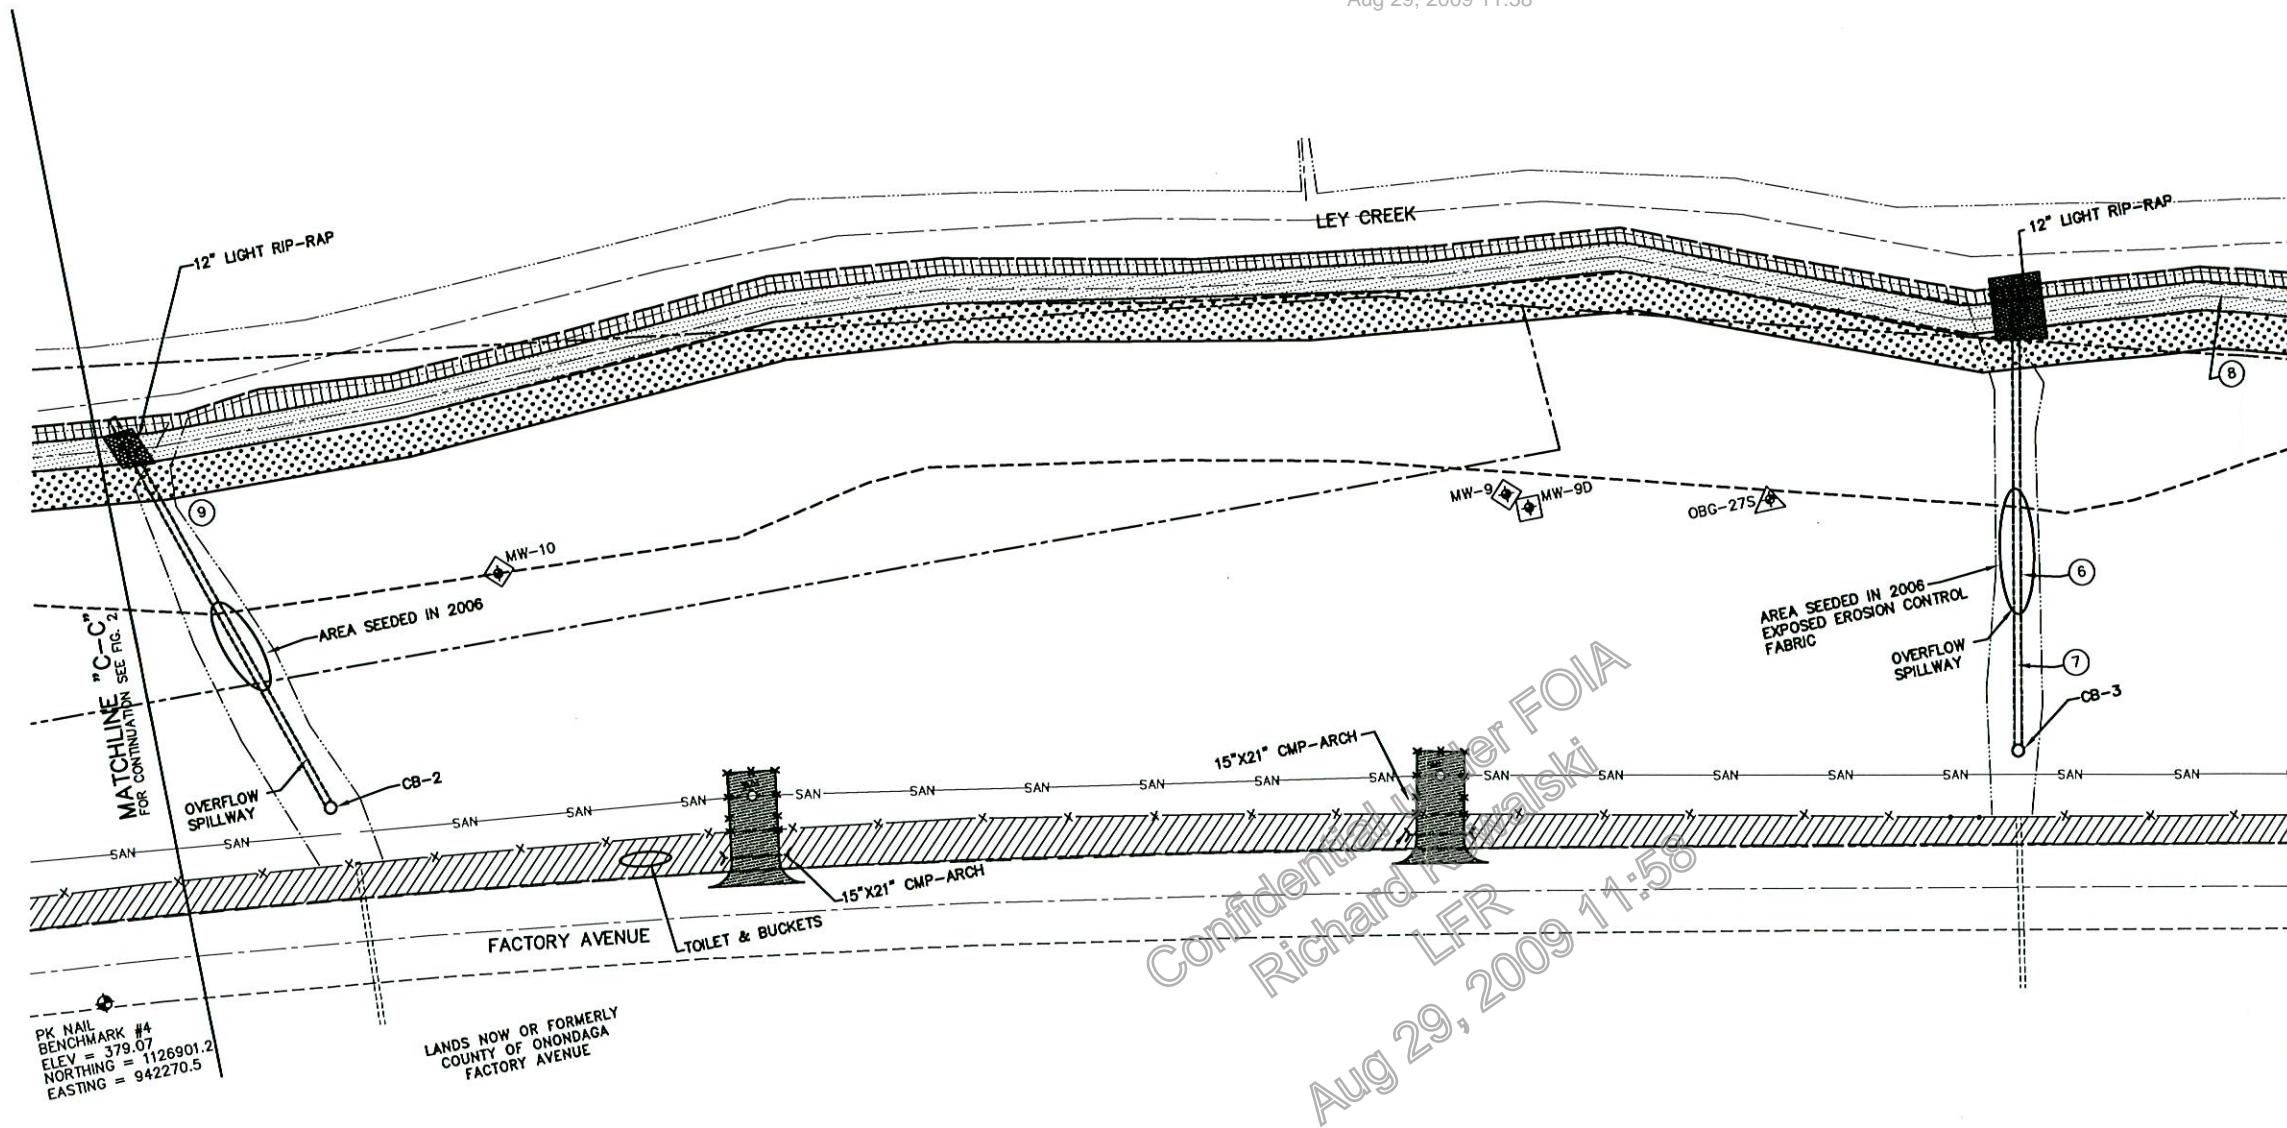
FIGURE 3

Establishment of vegetation in the areas that were repaired in the 2006 construction season to address erosion (Figures 3 and 4 and Photograph 4) has improved, but requires additional monitoring until fully established.
