April 15, 2022

RACER Pontiac North Campus – 2021 Property Inspection Report

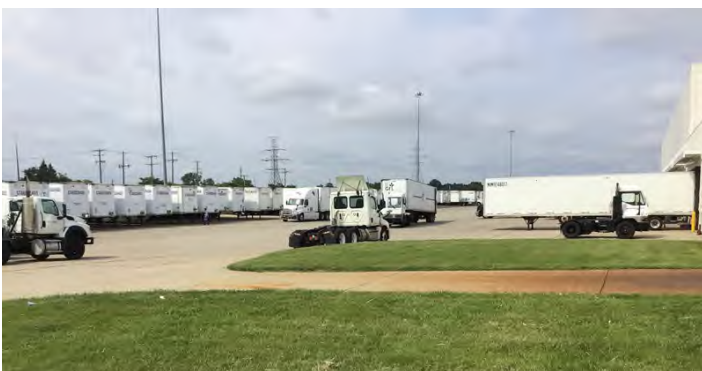
Photo of Concrete surfaced trailer storage and loading dock area at USPS southeast PCB Cap area facing west-southwest
