**Landfill Inspection Report
Coldwater Road Landfill
Flint, Michigan
MID 005 356 860**

**RACER TRUST
Detroit, Michigan**

February 2016

RE: 2015 Annual Landfill Inspection Report
Coldwater Road Landfill, Flint, Michigan
MID 005 356 860
FILE: 15388 /60794/rep

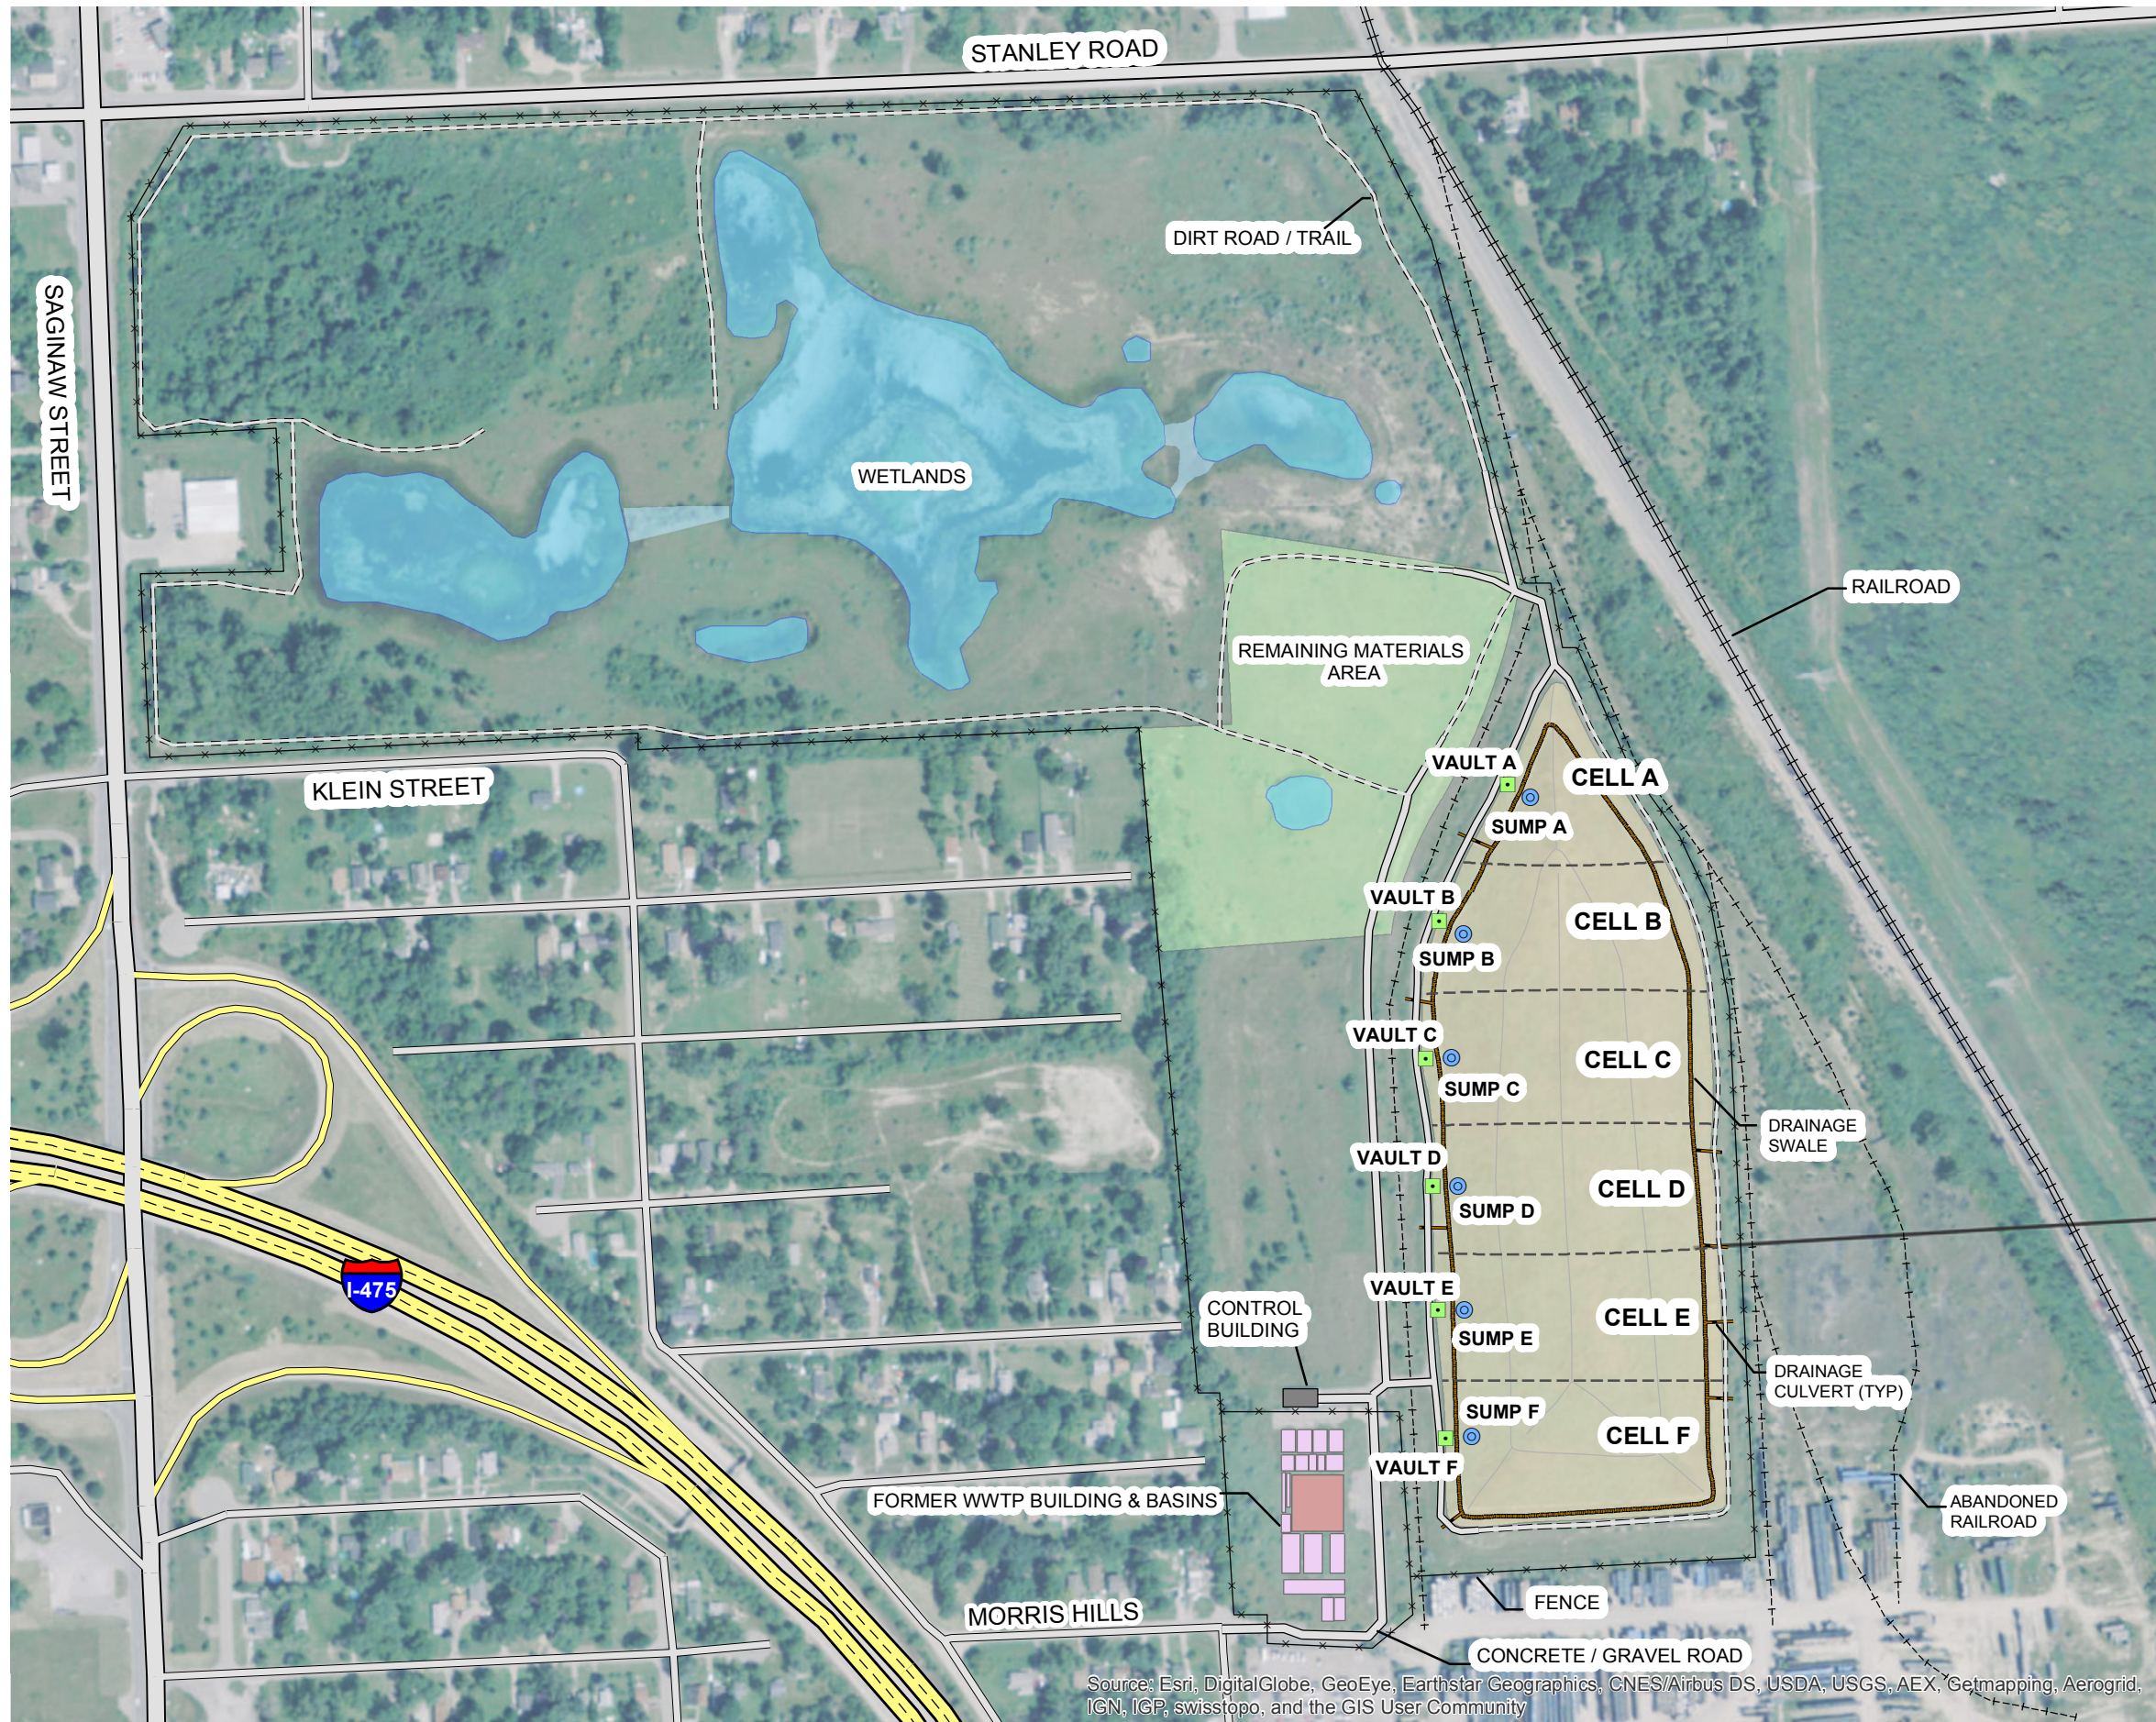
Damage to the site perimeter fence was noted at three locations during the 3rd and 4th quarterly inspections. During the 3rd quarter inspection, one previously repaired hole was reopened along the west perimeter fence. During the 4th quarter inspection, two previously repaired hole were reopened along the west and southwest perimeter fence, and one hole was located along the east perimeter fence.

The holes in the perimeter fence were repaired on September 24, 2015 and December 17, 2015.
