**Remediation and Liability Management Company Inc.**

Re: Ley Creek PCB Dredgings Site (Registry # 7-34-044)  
NYSDEC Order on Consent Index # D-7-0008-97-06  
2006 Annual OM&M Inspection Report

## O'BRIEN & GERE

Re: Ley Creek PCB Dredgings Site  
2006 OM&M Wetland Evaluation

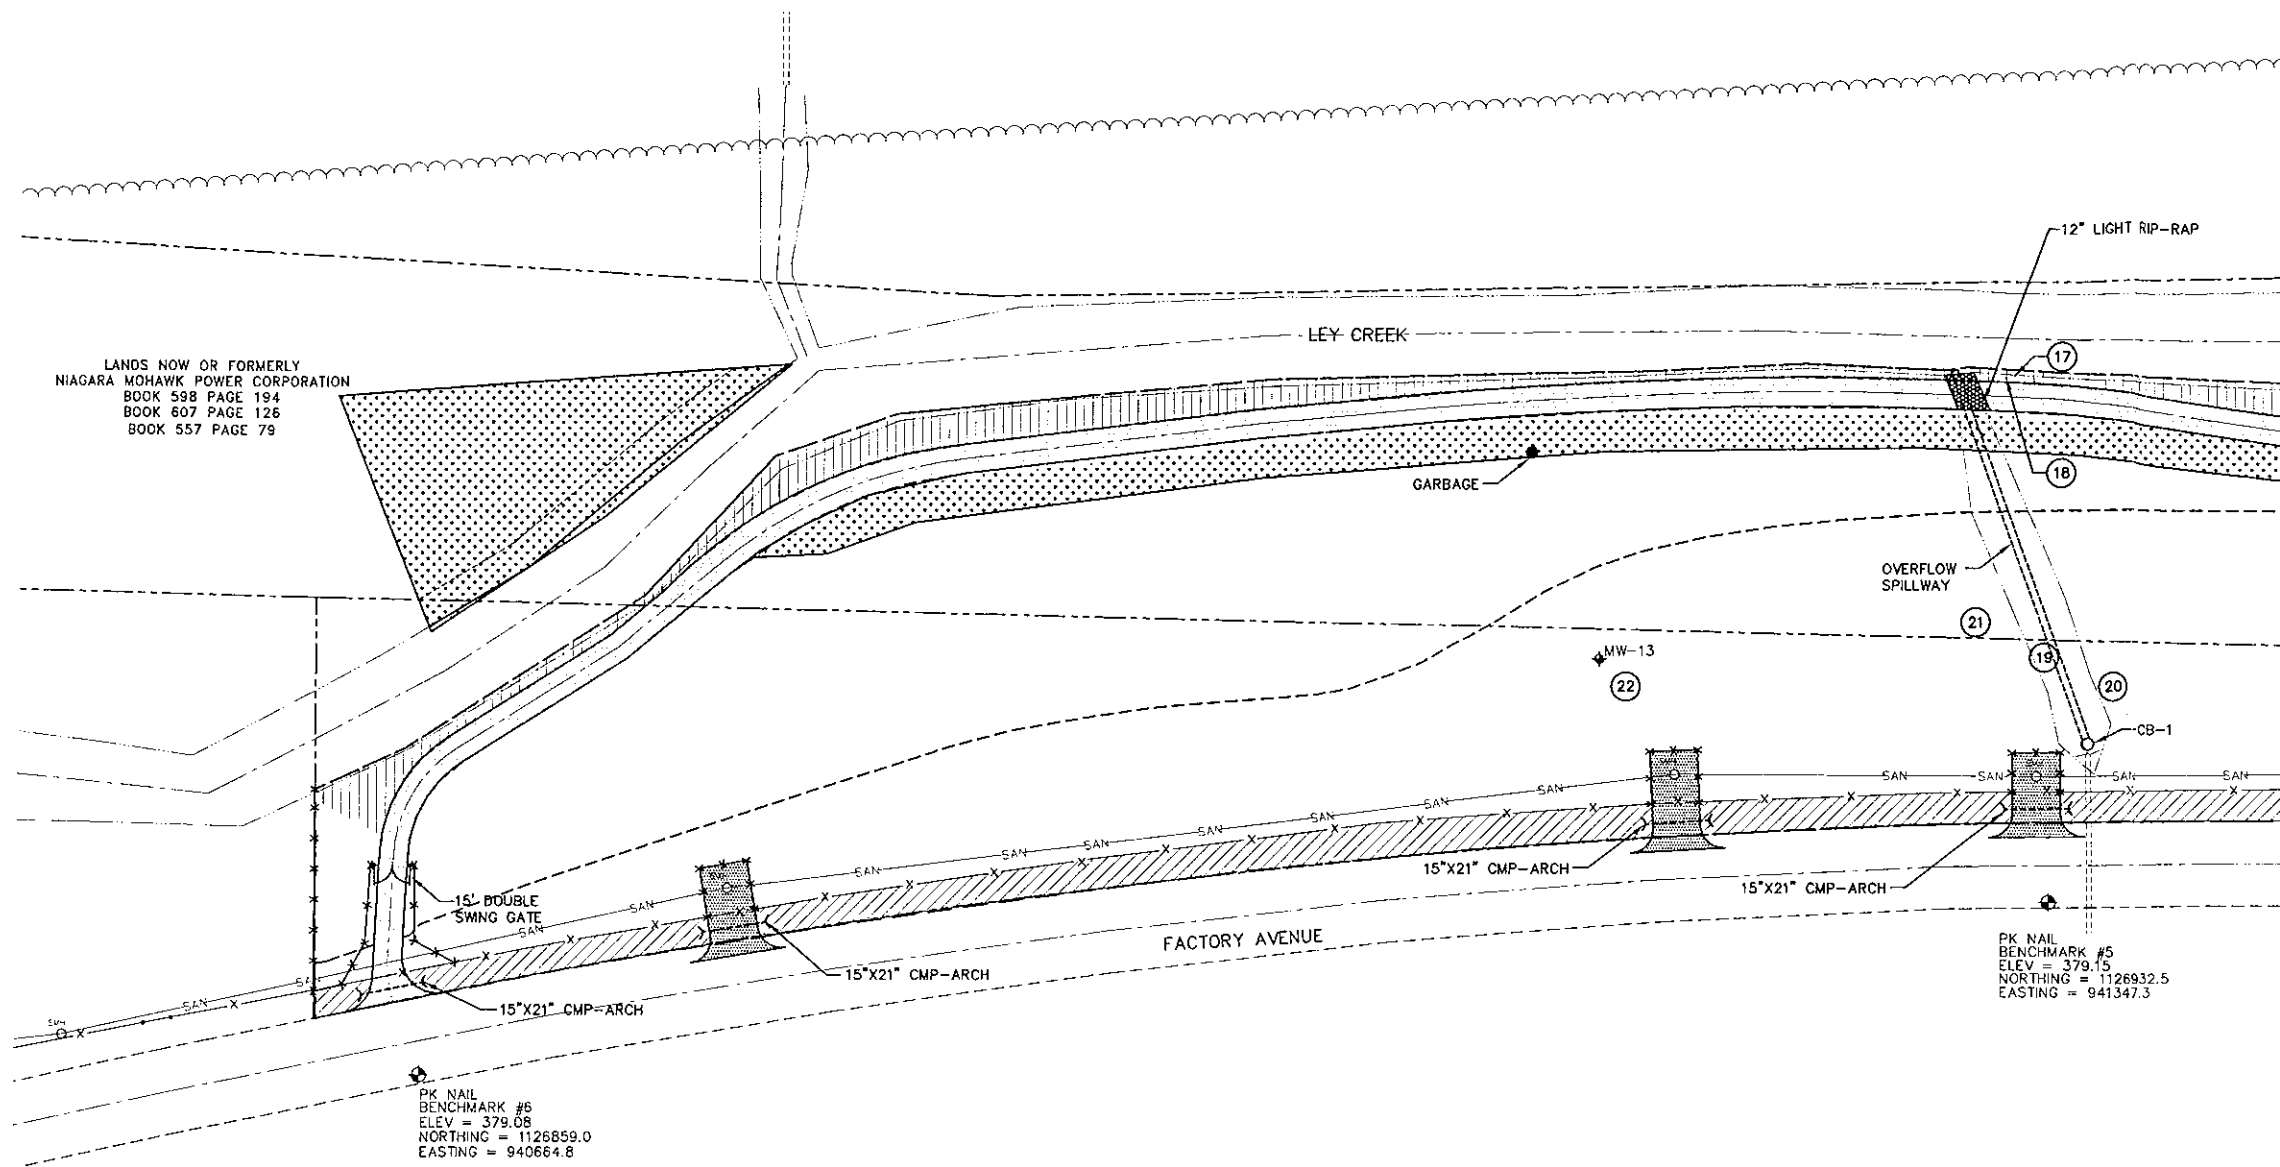
FIGURE 1

- Partially clogged grate at catch basin CB-3 (Figure 3 and Photograph 8)
- Animal burrow in vegetative cover (Figures 1, 3, and 5 and Photographs 12 and 20)
- Exposed non-woven geotextile fabric within CB-3 overflow spillway (Figure 3 and Photograph 9)

- Exposed non-woven geotextile fabric and erosion along creek bank near CB-1 outlet (Figure 1 and Photographs 17 and 18)
- Exposed erosion control fabric within CB-3 overflow spillway (Figure 3 and Photograph 11)
- Erosion at fenceline near CB-3 overflow spillway (Figure 3 and Photographs 6 and 7)
- Garbage near stone access road near western Site entrance (Figure 1)
- Soil covering MW-13 monitoring well (Figure 1 and Photograph 22)
- Access road rutting (Figures 2, 3, and 4)
- Phragmites in asphalt (Figure 2)
- Concrete rubble near Factory Avenue (Figure 3)
- Damage to asphalt (Figure 3)
- Significant vegetation growth along Factory Avenue site perimeter fence and within area around catch basins (Figures 1, 3, and 5 and Photographs 2, 8, 14, and 19).

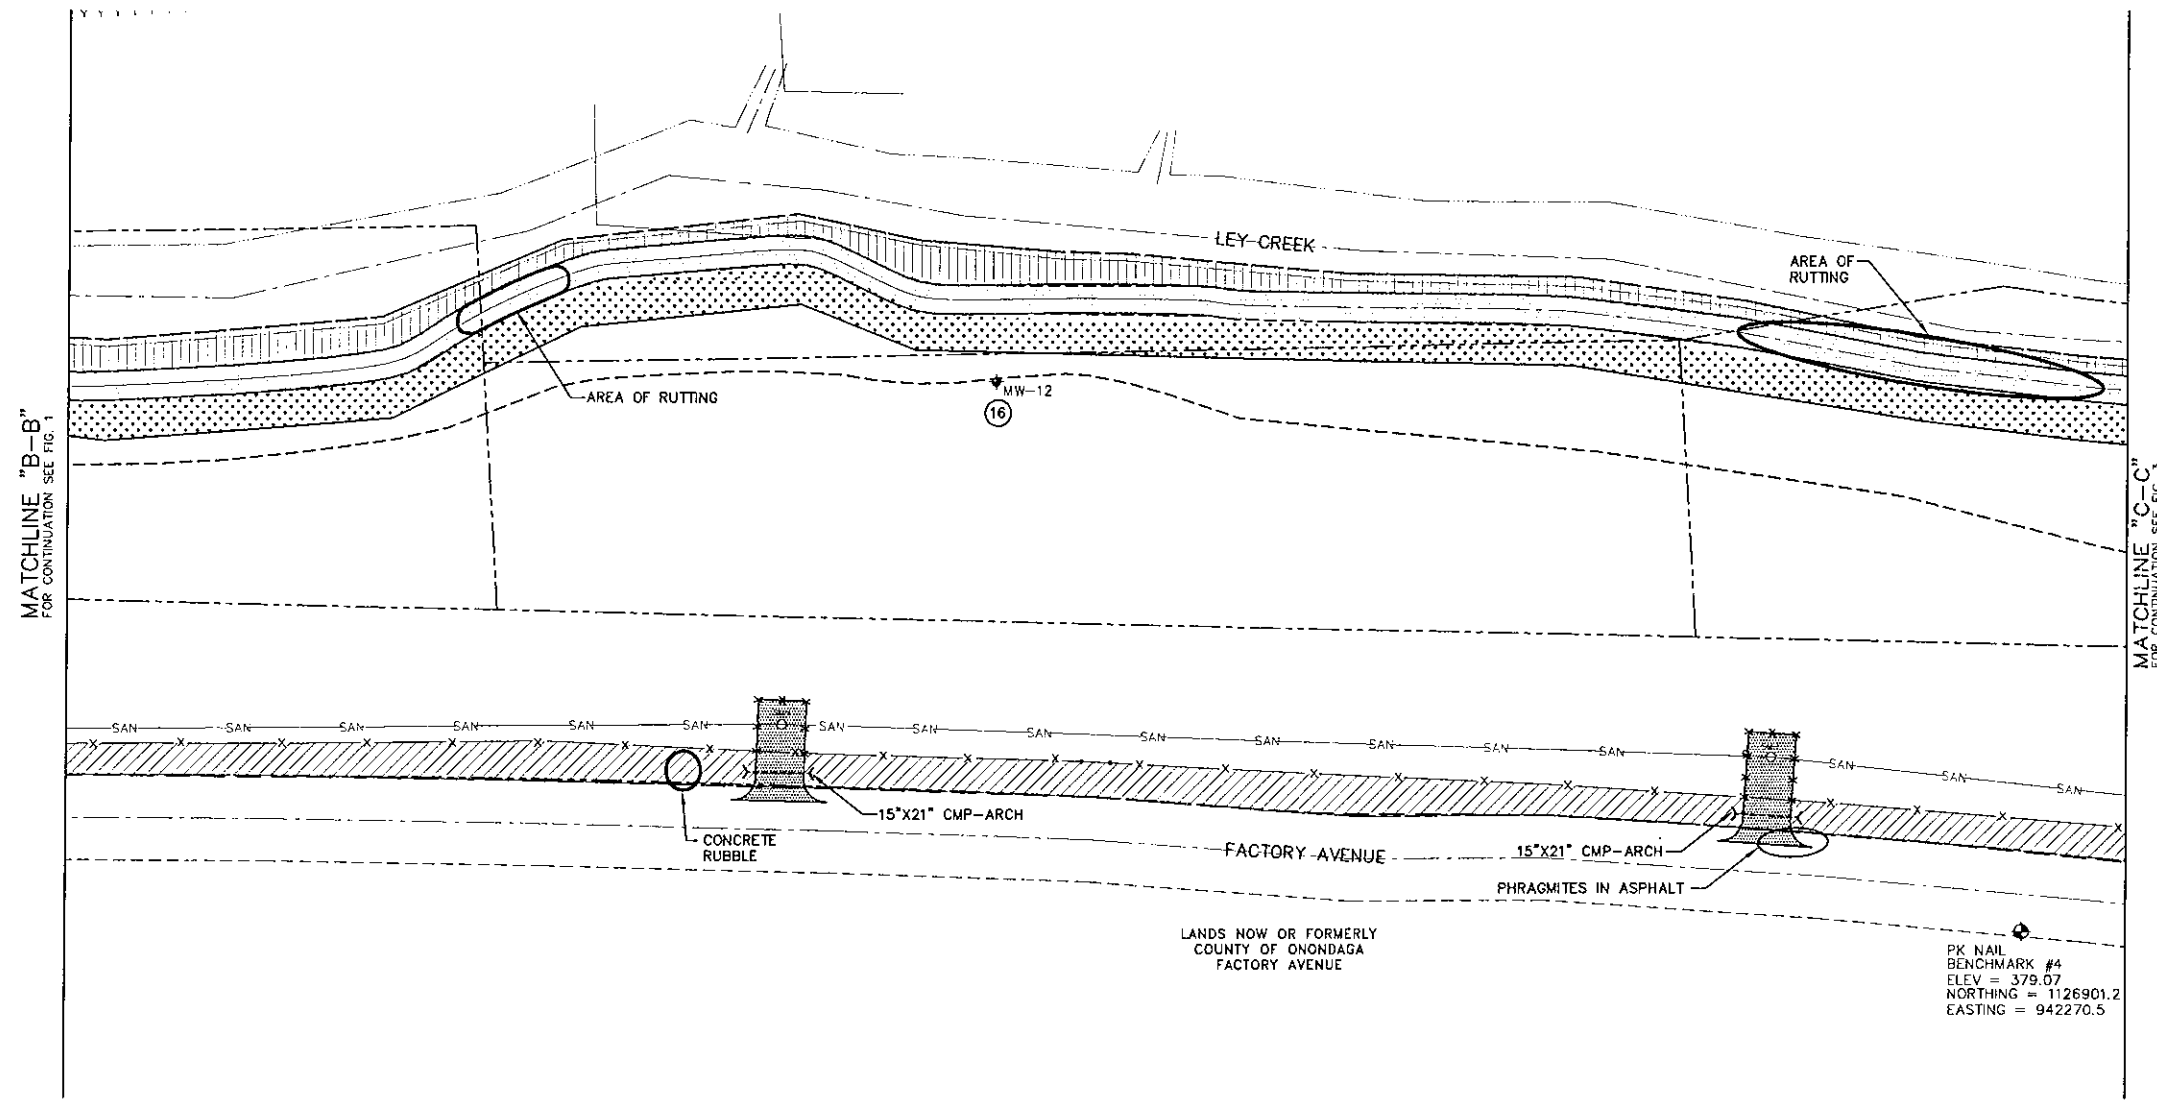
FIGURE 2

Item	Task	Response		Comments
		Yes	No	
<b>Access Road</b>	2. Areas of erosion?		<b>X</b>	
	3. Areas rutted or potholes present?	<b>X</b>		Figures 2, 3, and 4
	4. Areas of damage?		<b>X</b>	
<b>Surface Water Drainage</b>	<b>Visually inspect ditches, catch basins, etc.</b>			
	1. Accumulation of debris?	<b>X</b>		Figure 3 - Photograph 8
	2. Excessive scouring?		<b>X</b>	
	3. Areas of damage?		<b>X</b>	
<b>Ground Water Wells</b>	1. Casings secure and locked?	<b>X</b>		
	2. Areas of damage?		<b>X</b>	
<b>Sanitary sewer access paths</b>	<b>Visually inspect conditions.</b>			
	1. Cracks in asphalt?	<b>X</b>		Figures 2 and 3
	2. Manhole covers in place?	<b>X</b>

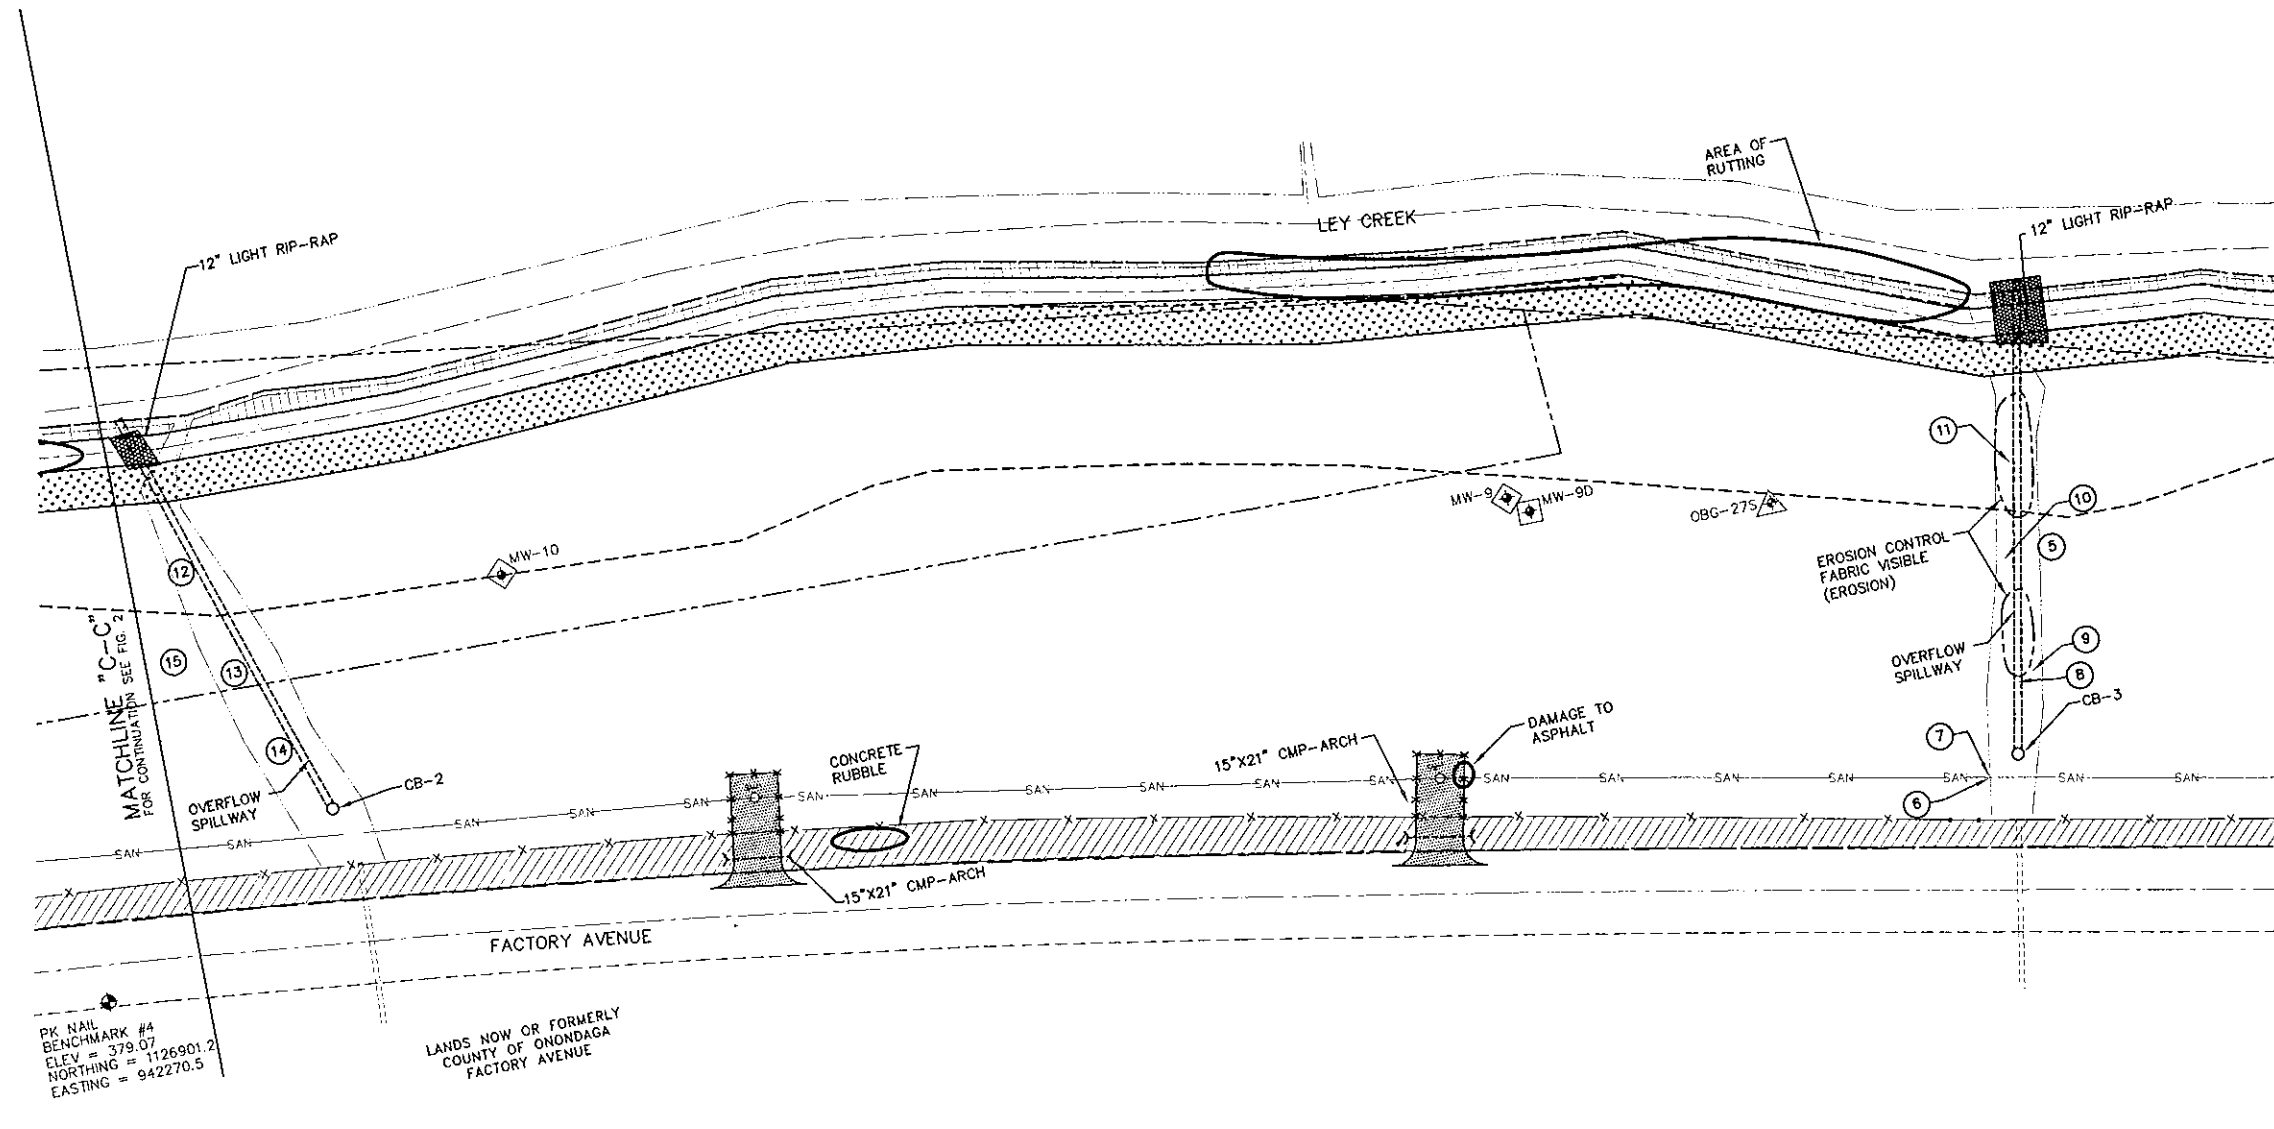
FIGURE 3

Areas that were repaired prior to the inspection to address erosion areas (Figures 3 and 4 and Photographs 4, 10, and 13) that were observed during the August 2006 inspection should be monitored during subsequent inspections to evaluate vegetation establishment.

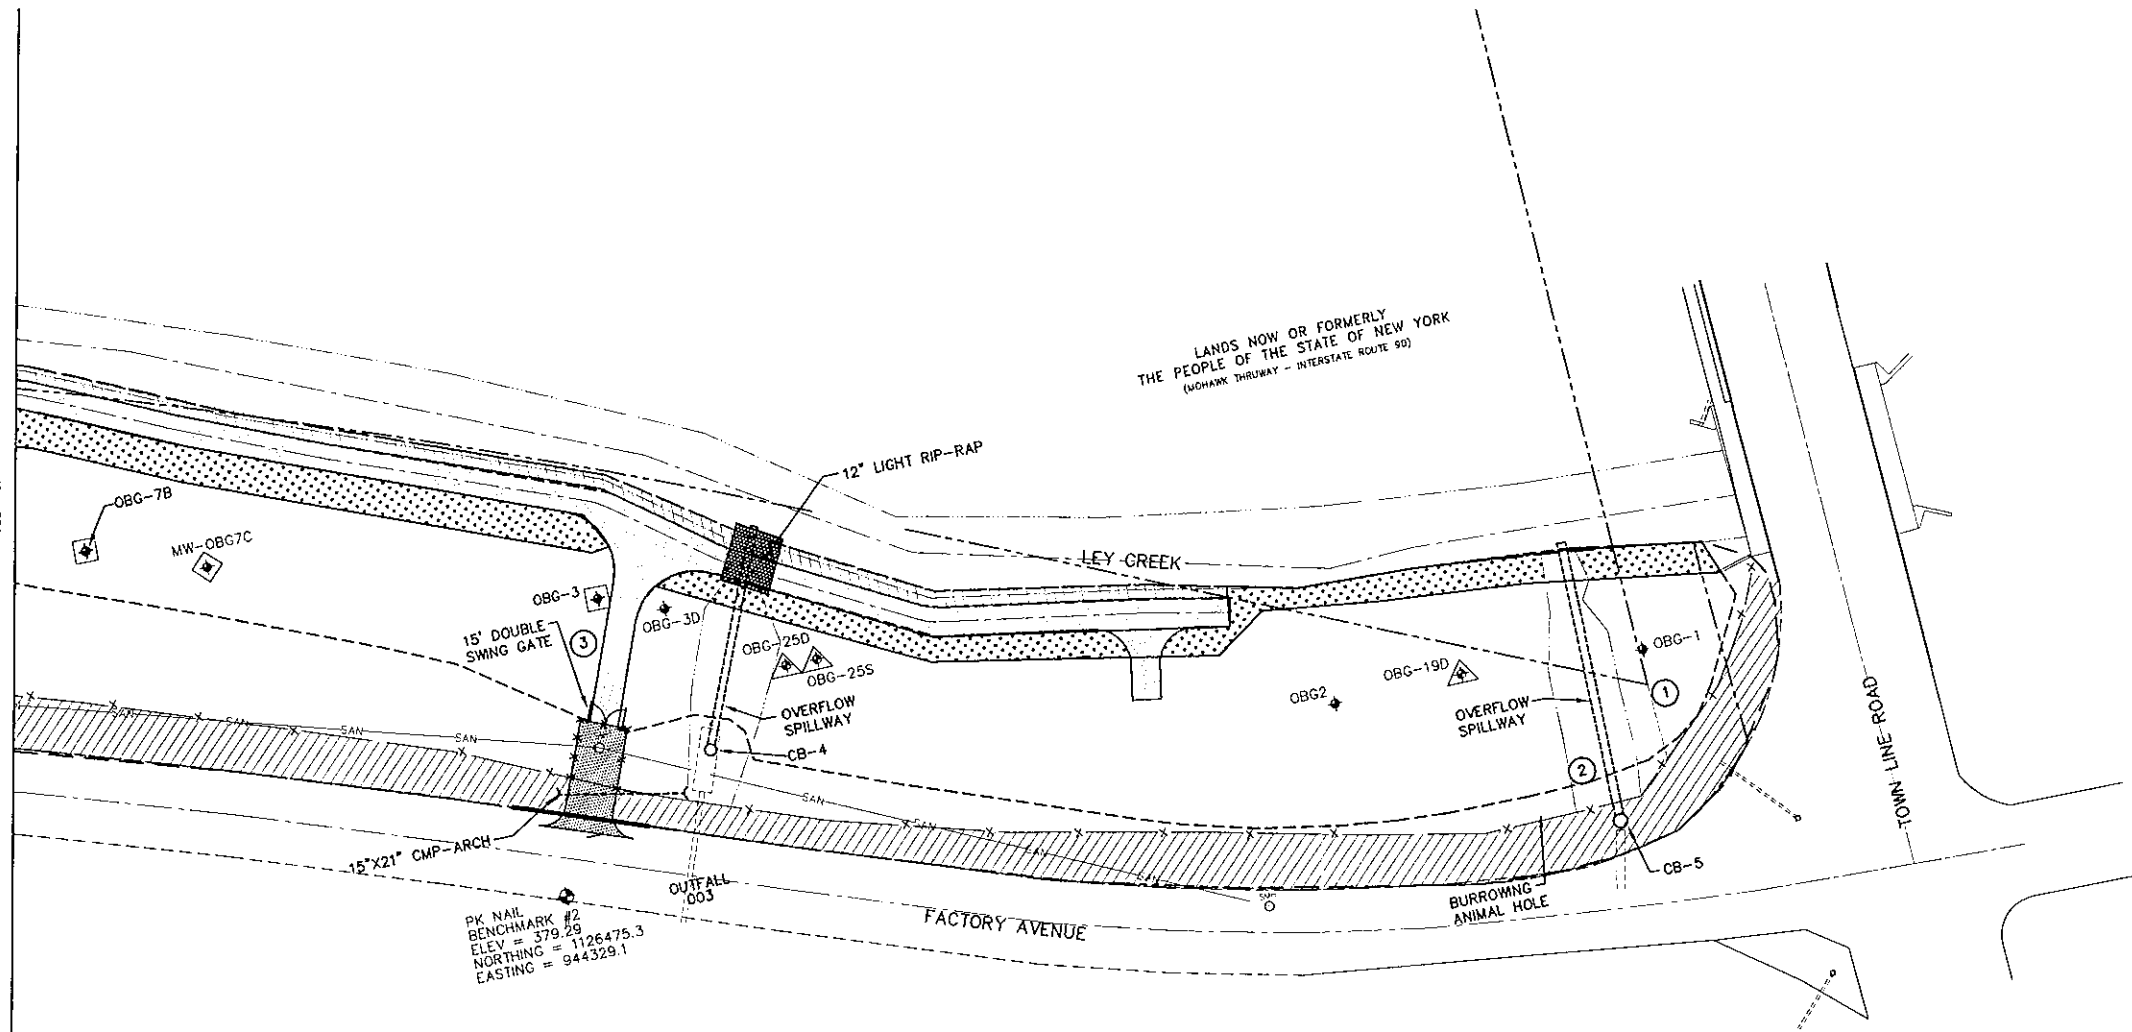
FIGURE 5

6. Presence of burrowing animals?	<b>X</b>		Figures 1, 3, and 5 - Photographs 12 and 20
	7. Areas of damage?	<b>X</b>		Figures 3 and 5 - Photographs 10 and 4 (areas repaired)
