Re: Ley Creek PCB Dredgings Site (Registry # 7-34-044)
NYSDEC Order on Consent Index # D-7-0008-97-06
2003 Annual OM&M Inspection Report

Re: Ley Creek PCB Dredgings Site
June 2003 OM&M Inspection

LEY CREEK PCB DREDGINGS SITE
SYRACUSE, NEW YORK
SITE REMEDIATION PROJECT

JUNE 2003
OM&M INSPECTION
PARTIAL SITE PLAN

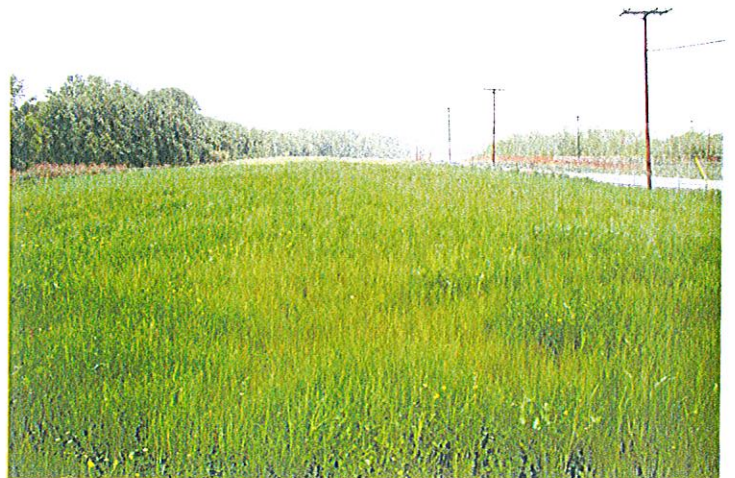
Photograph 4 - View from CB-1 looking east.

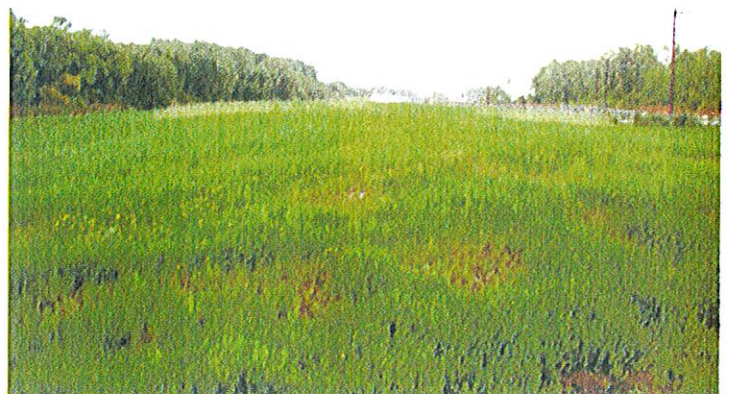
Photograph 12 - View looking east from CB-2 overflow spillway.

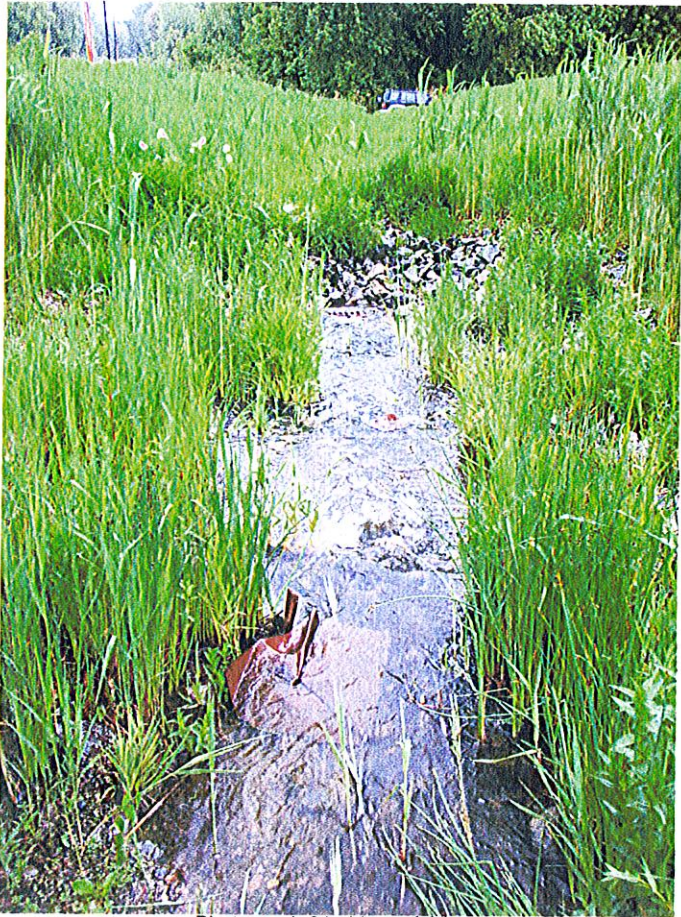
Photograph 21 - View of CB-3.

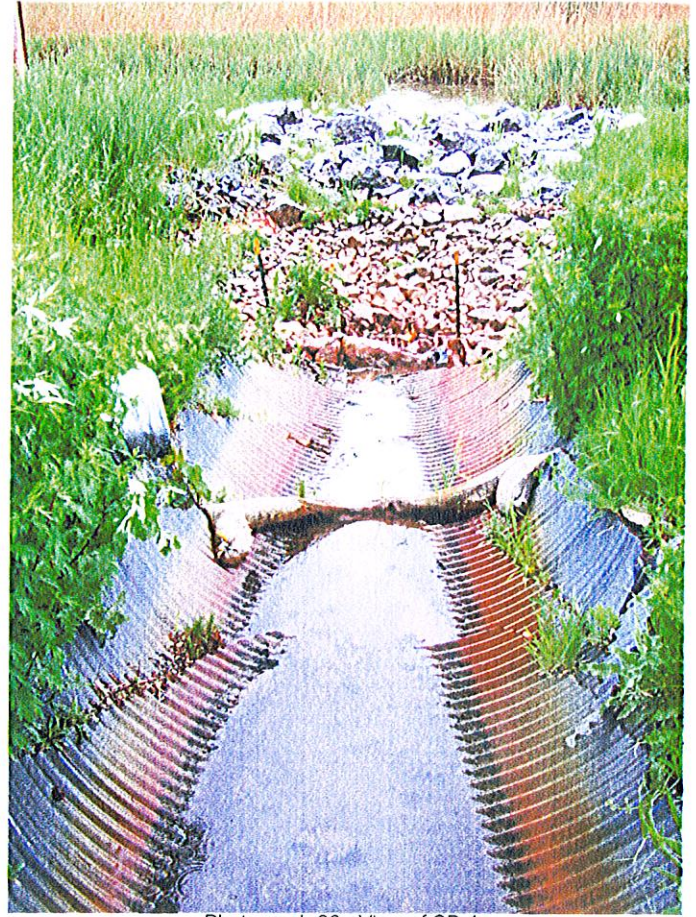
Photograph 26 - View of CB-4.

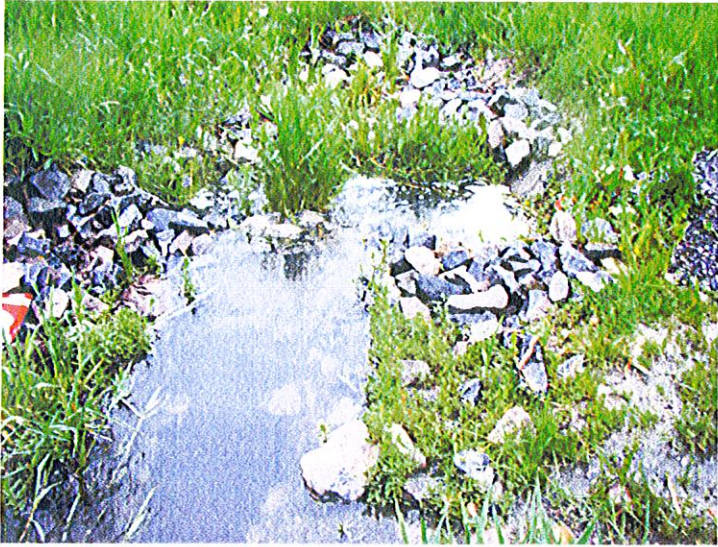
Photograph 29 - View of CB-5/004.

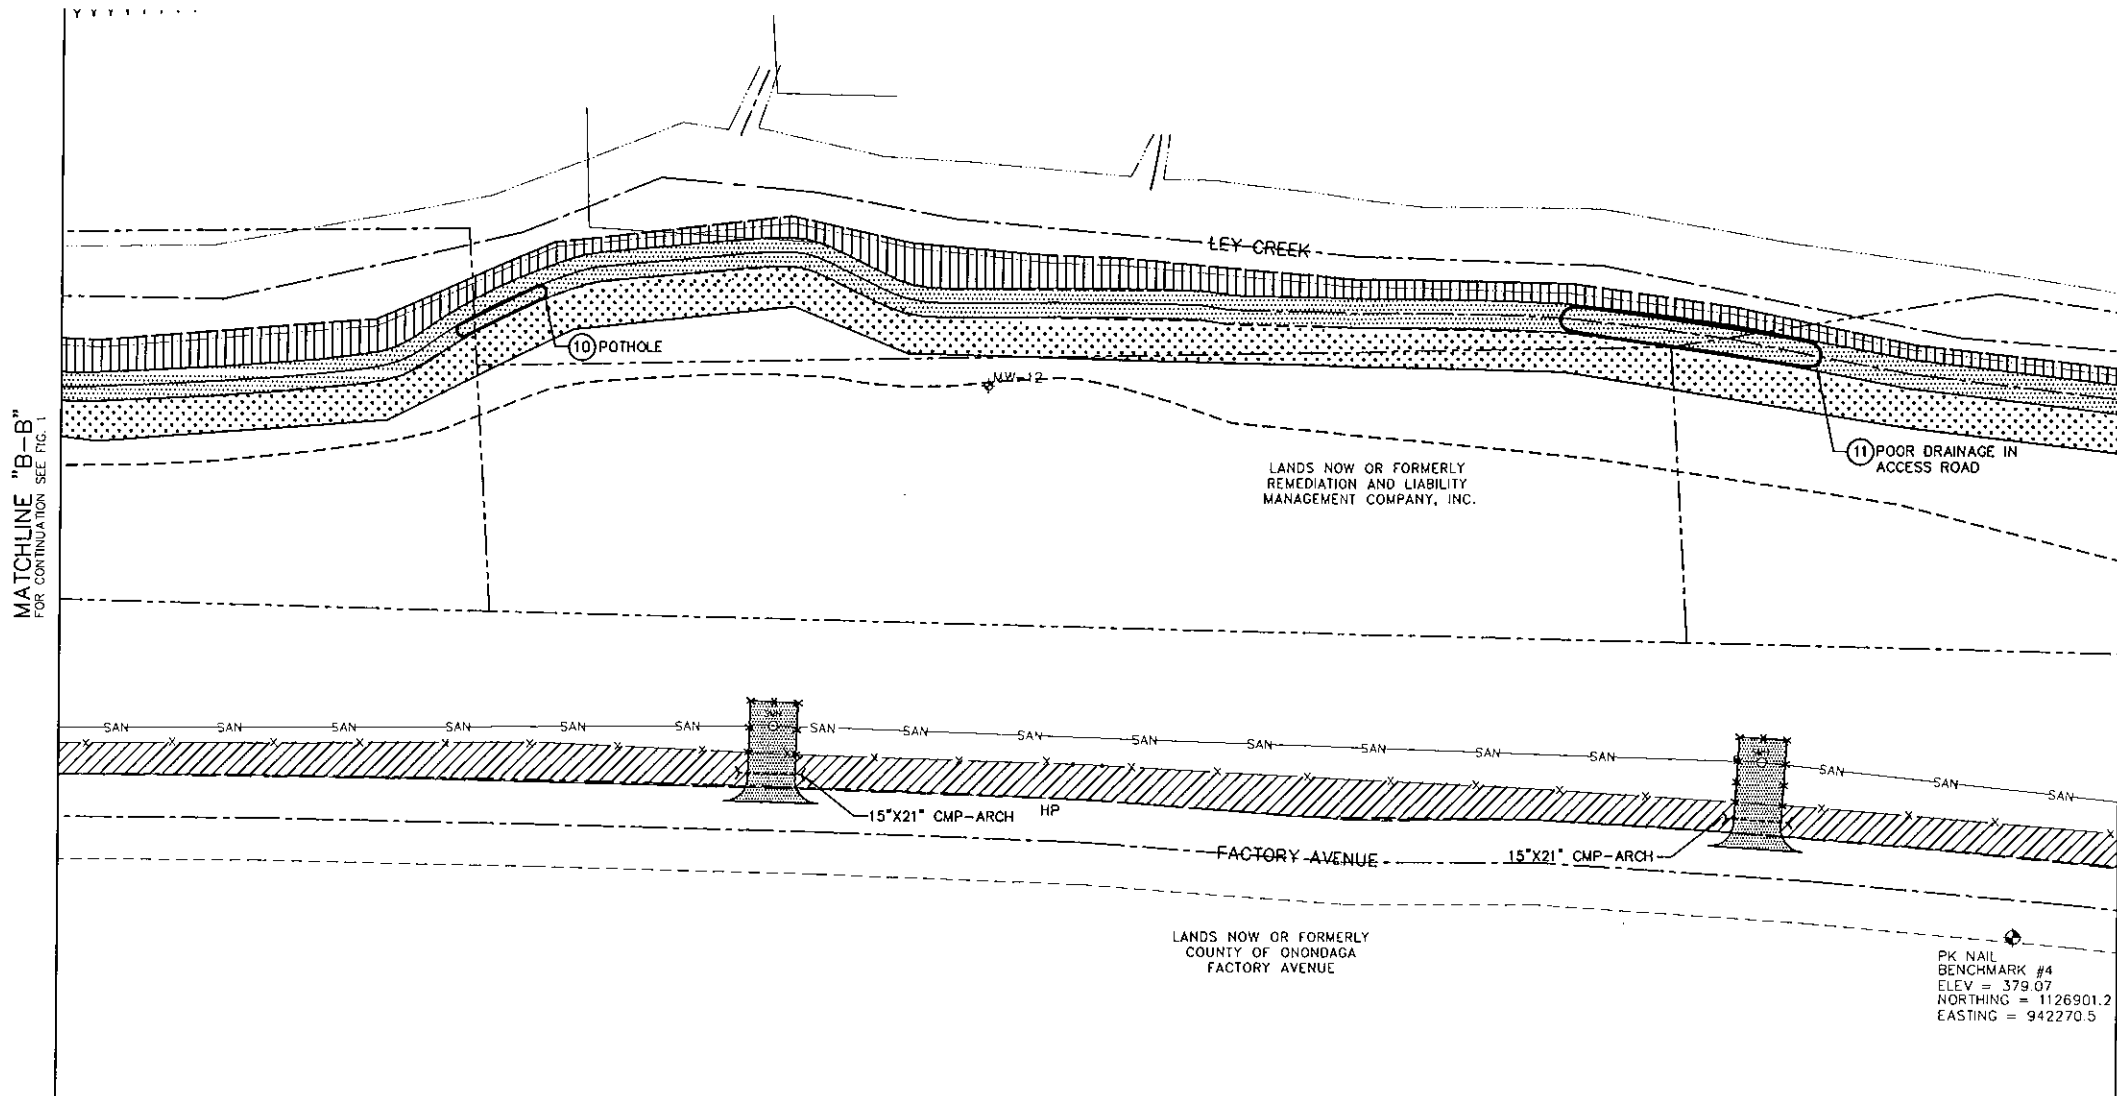
FIGURE 2

- Stone access road drainage: (Photographs 10, 11, 15, 16, 23, and 24. Figures 2, 3, and 4.) Several areas of the stone access road were observed to have poor drainage, which was characterized by ponded water being visible within the stone access road.

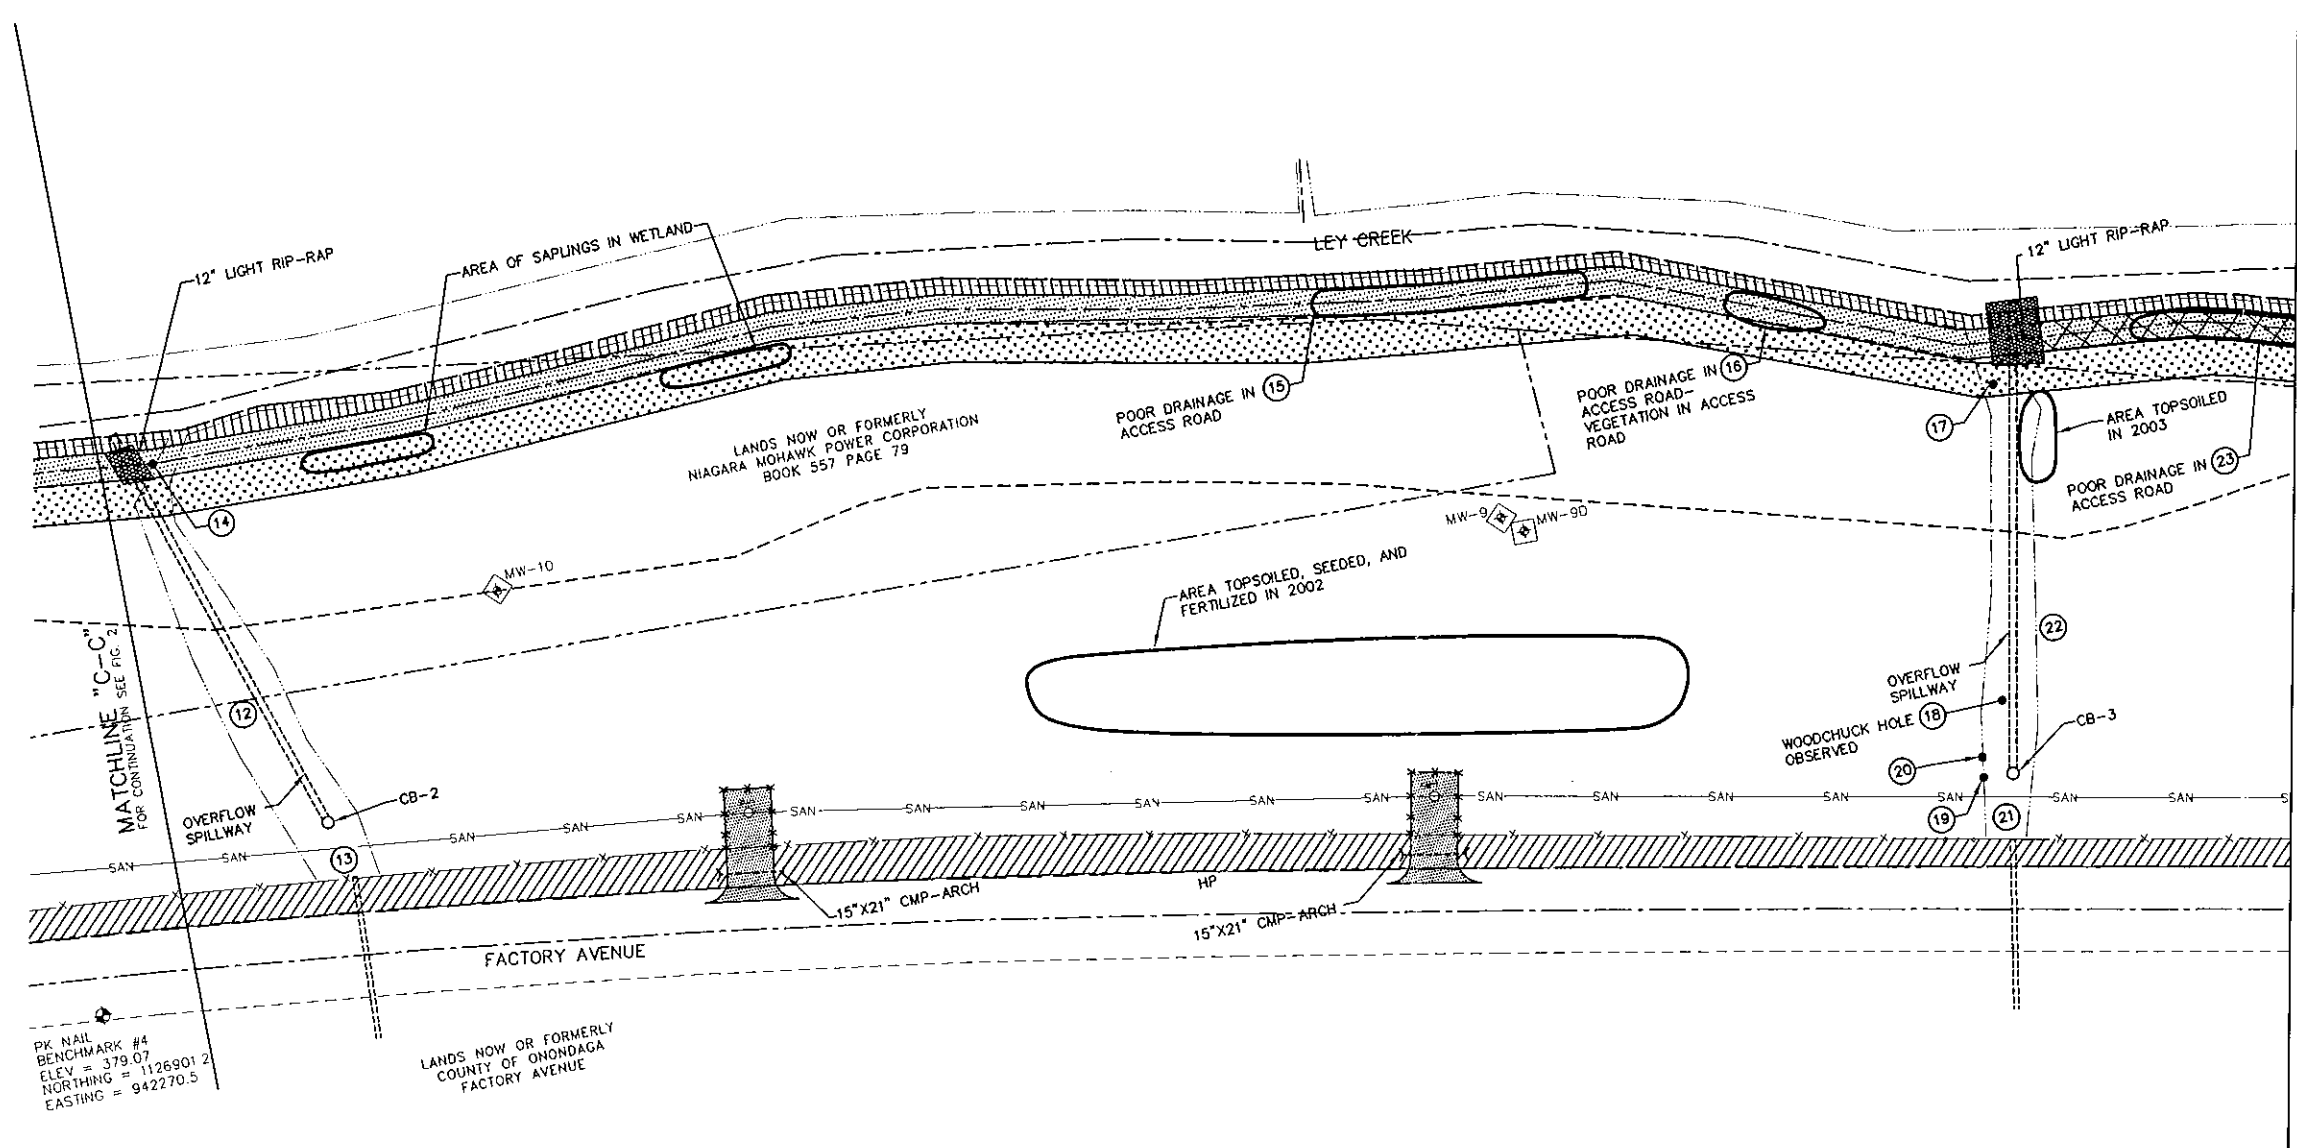
FIGURE 3

- Stone access road erosion: (Photograph 9 and 14. Figures 1 and 3.) Erosion of a section of the stone access road near the outlet of catch basin CB-3 was observed.

- Tree establishment: (Photographs 2 and 25. Figures 1, 3, 4, and 5.) Tree saplings were observed in several areas within the seeded wetlands along the stone access road.

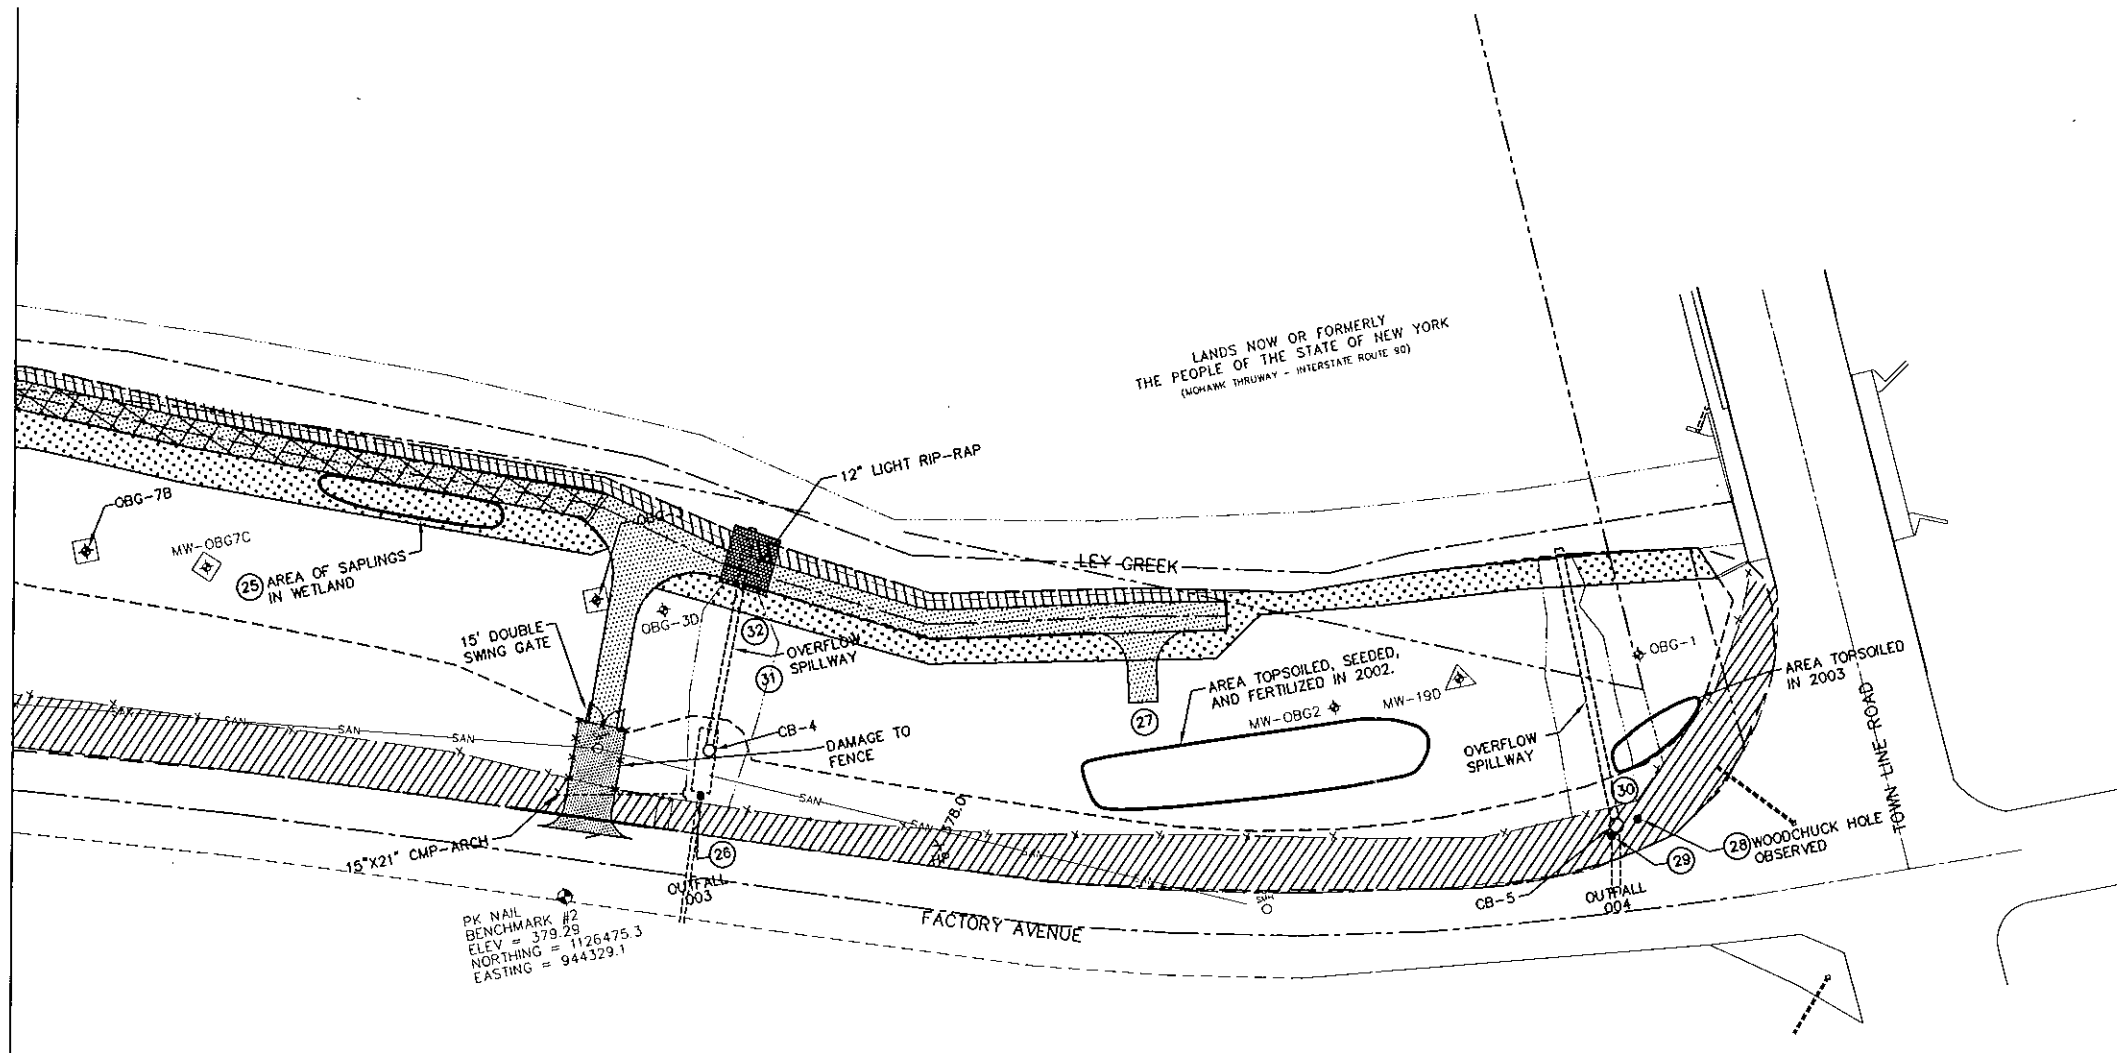
FIGURE 5

- Excessive scouring: (Photograph 30. Figure 5.) The excessive scouring that was observed in the August 2002 inspection requires repair.
- Area requiring mowing: The vegetation around the catch basins, monitoring wells, utility poles, guy wires, and along the fence line require mowing.

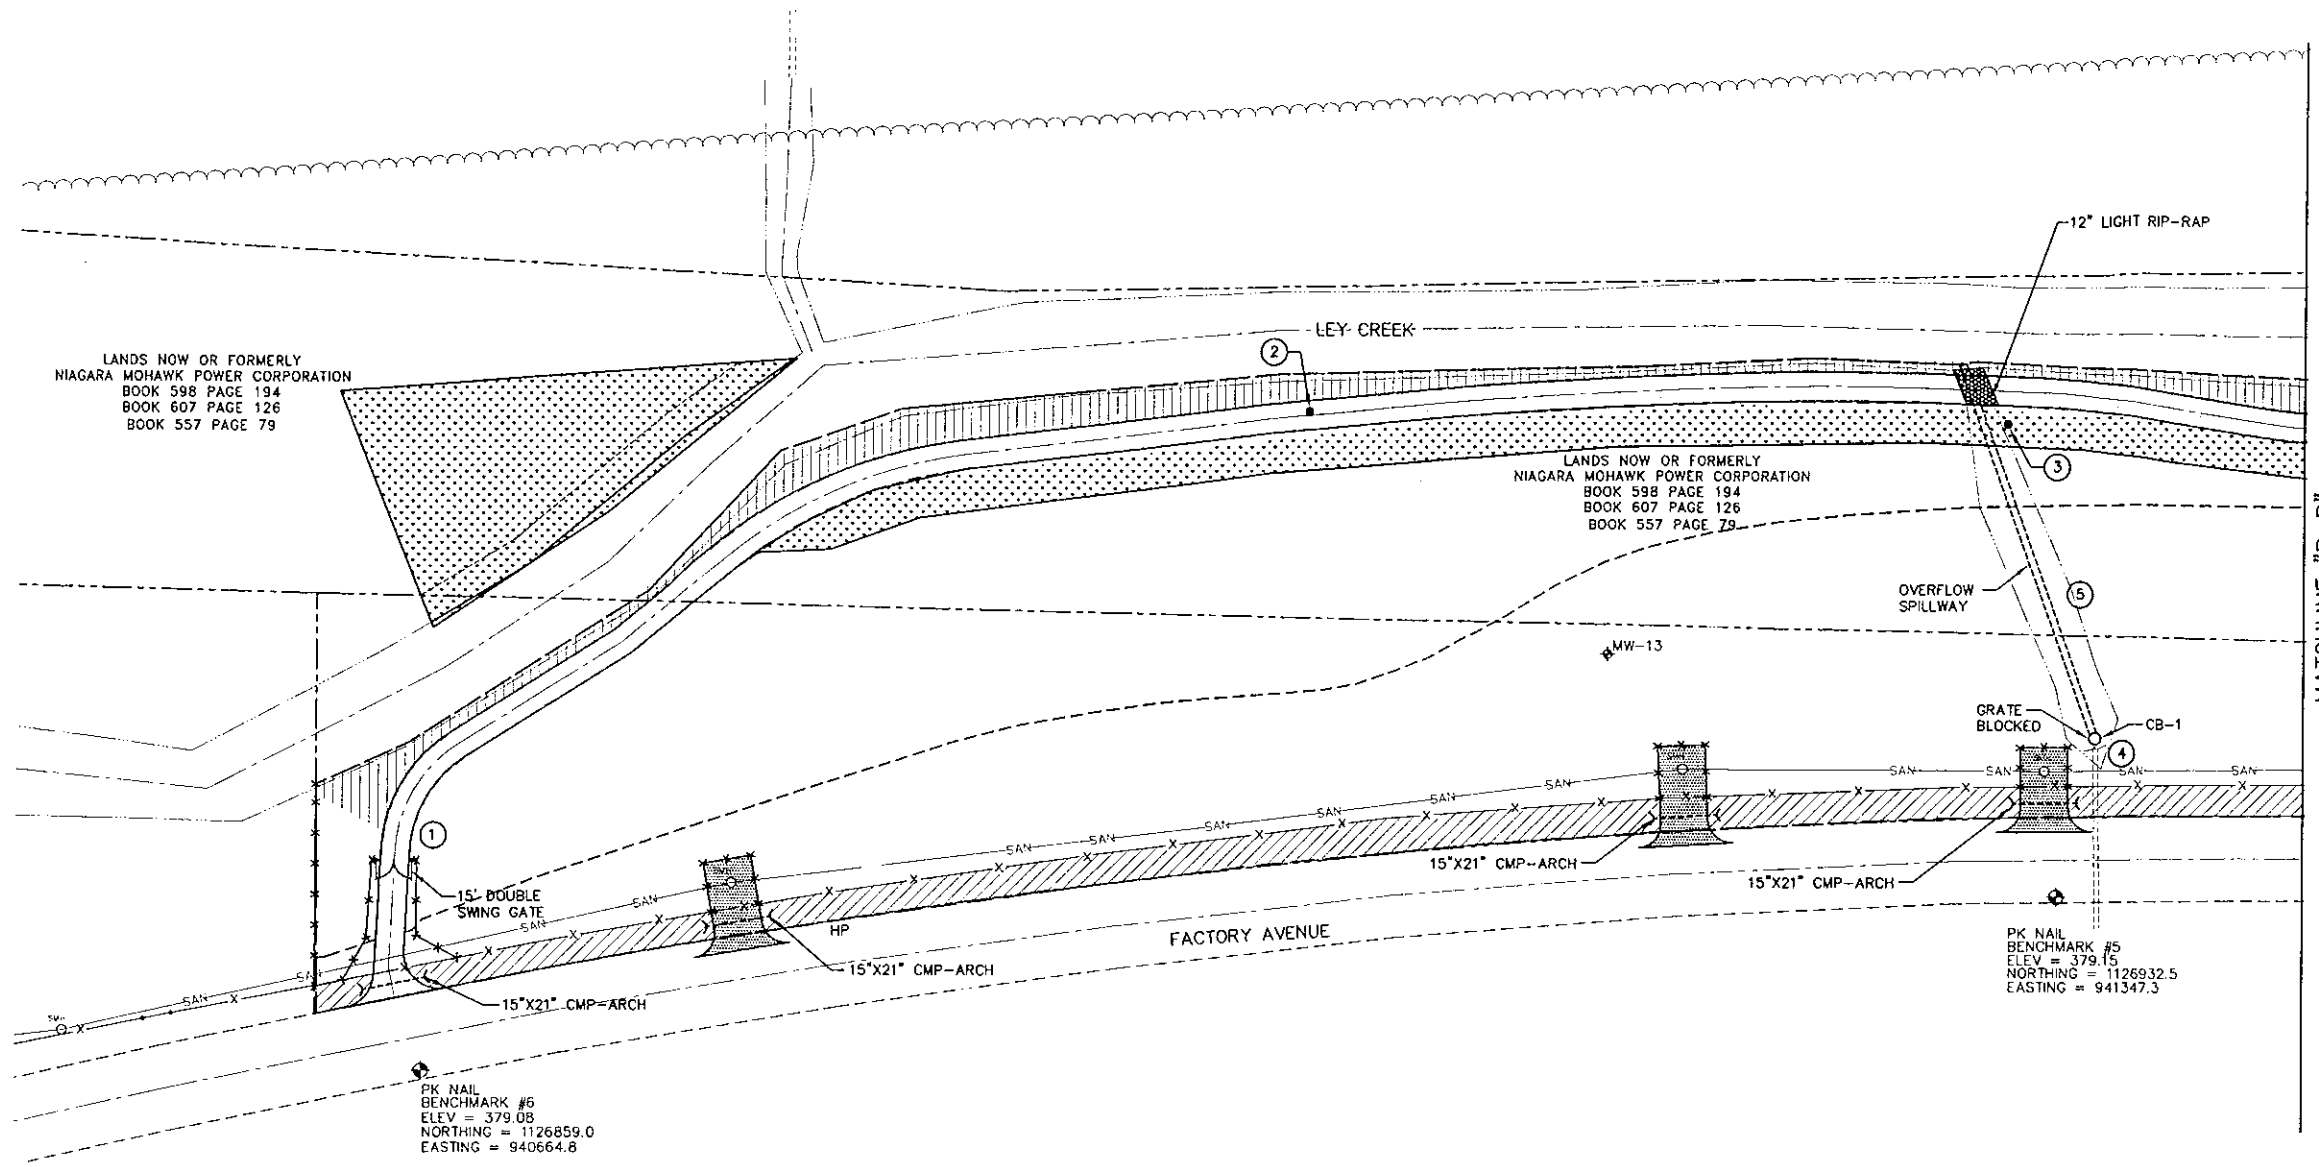
FIGURE 1

- Debris accumulation: (Photograph 7. Figures 1 and 3.) Debris was accumulated over the catch basin CB-1 grate and the grate for catch basin CB-2 was fully blocked, thus restricting flow

- Remove the debris around catch basin CB-1 and catch basin CB-2 grate
- Repair the area of excessive scouring by removal of rip-rap, placement of compacted crushed stone to meet surrounding grade, and replacement of rip-rap

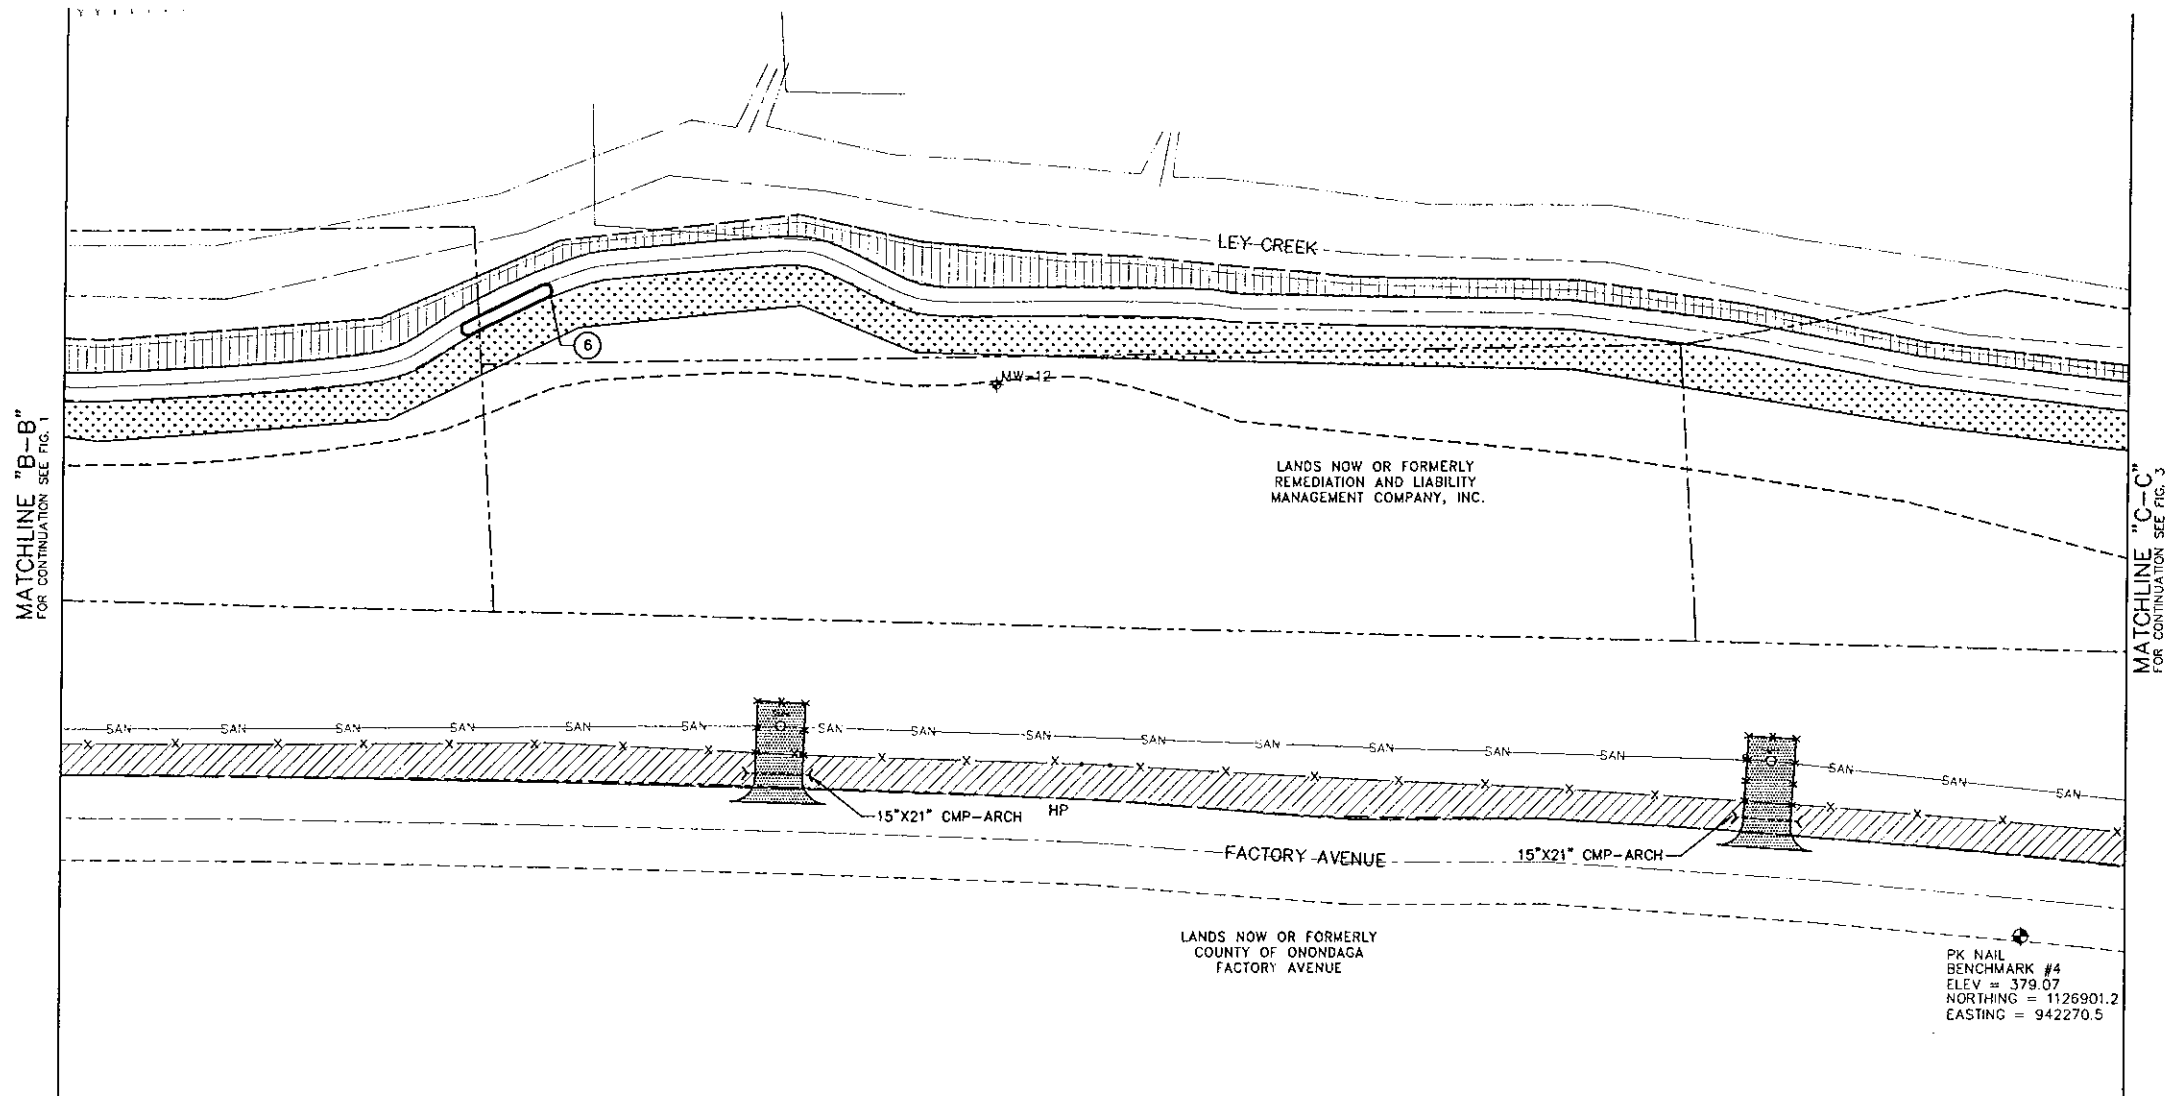
FIGURE 2

- Burrowing animals: (Figure 3.) A woodchuck hole observed in the June 2003 inspection, in the area of catch basin CB-3, requires repair
- Stone access road drainage: (Photograph 6. Figure 2.) One area of the stone access road observed during the June 2003 inspection to have rutting and poor drainage, which was characterized by ponded water being visible within the stone access road, requires repair

- Remove the woodchuck(s) from the Site, place topsoil in the hole, and apply seed and fertilizer
- Repair the areas of rutting of the stone access road by placement of additional crushed stone and improve drainage of the stone access road by constructing small drainage channels to convey ponded water from the stone access road to Ley Creek. This could be performed by removal of less than 1 foot of vegetative cover material with subsequent replacement of crushed stone

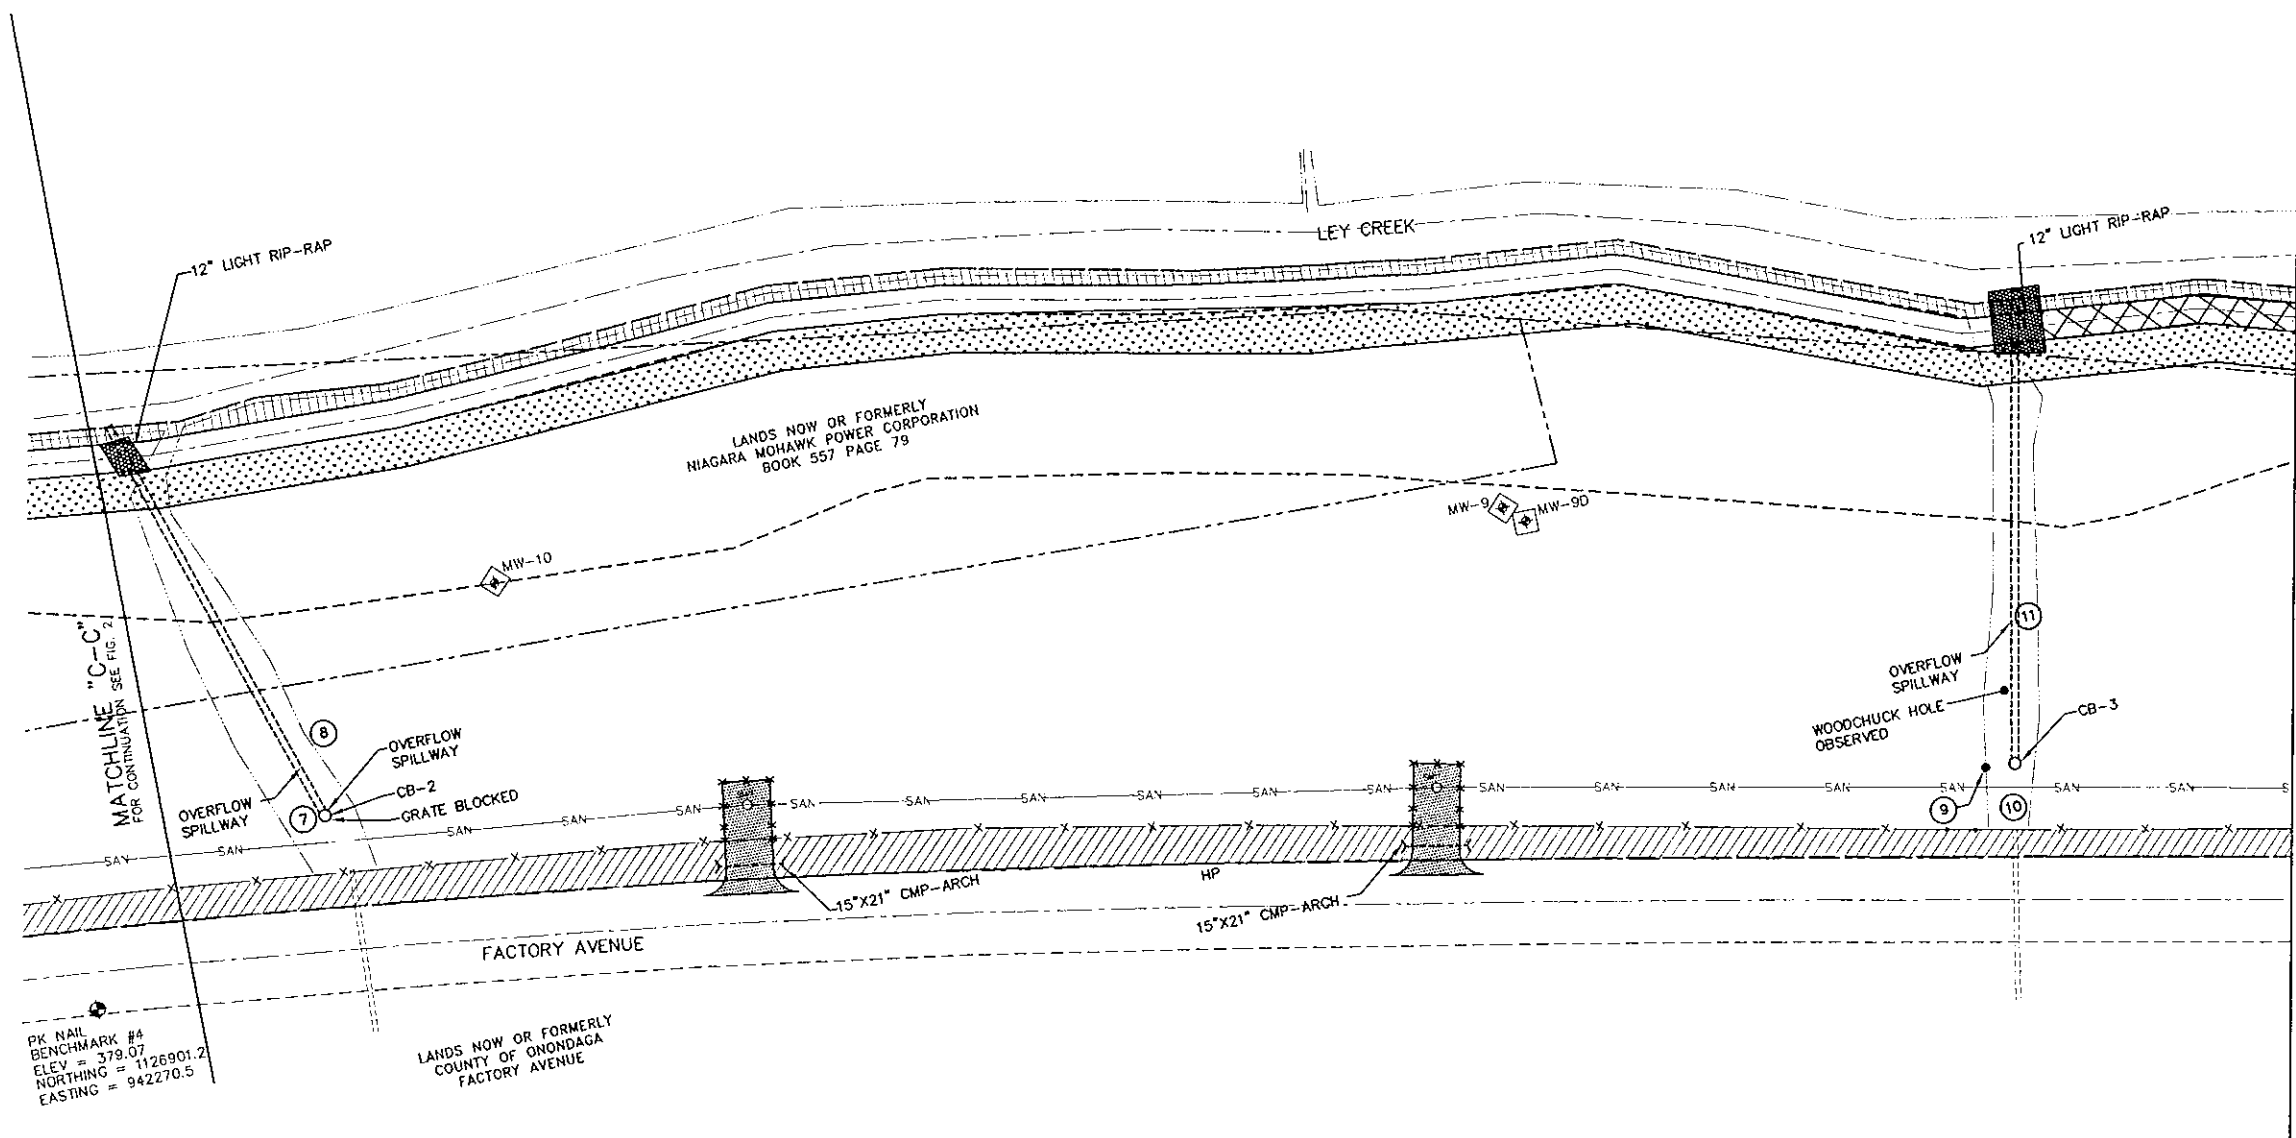
FIGURE 3

- Vegetative cover erosion: (Photograph 9. Figure 3). One area of erosion of the vegetative cover was observed

- Repair the damaged site security fence
- Repair eroded areas of the vegetative cover by placement of topsoil and subsequent application of seed and fertilizer

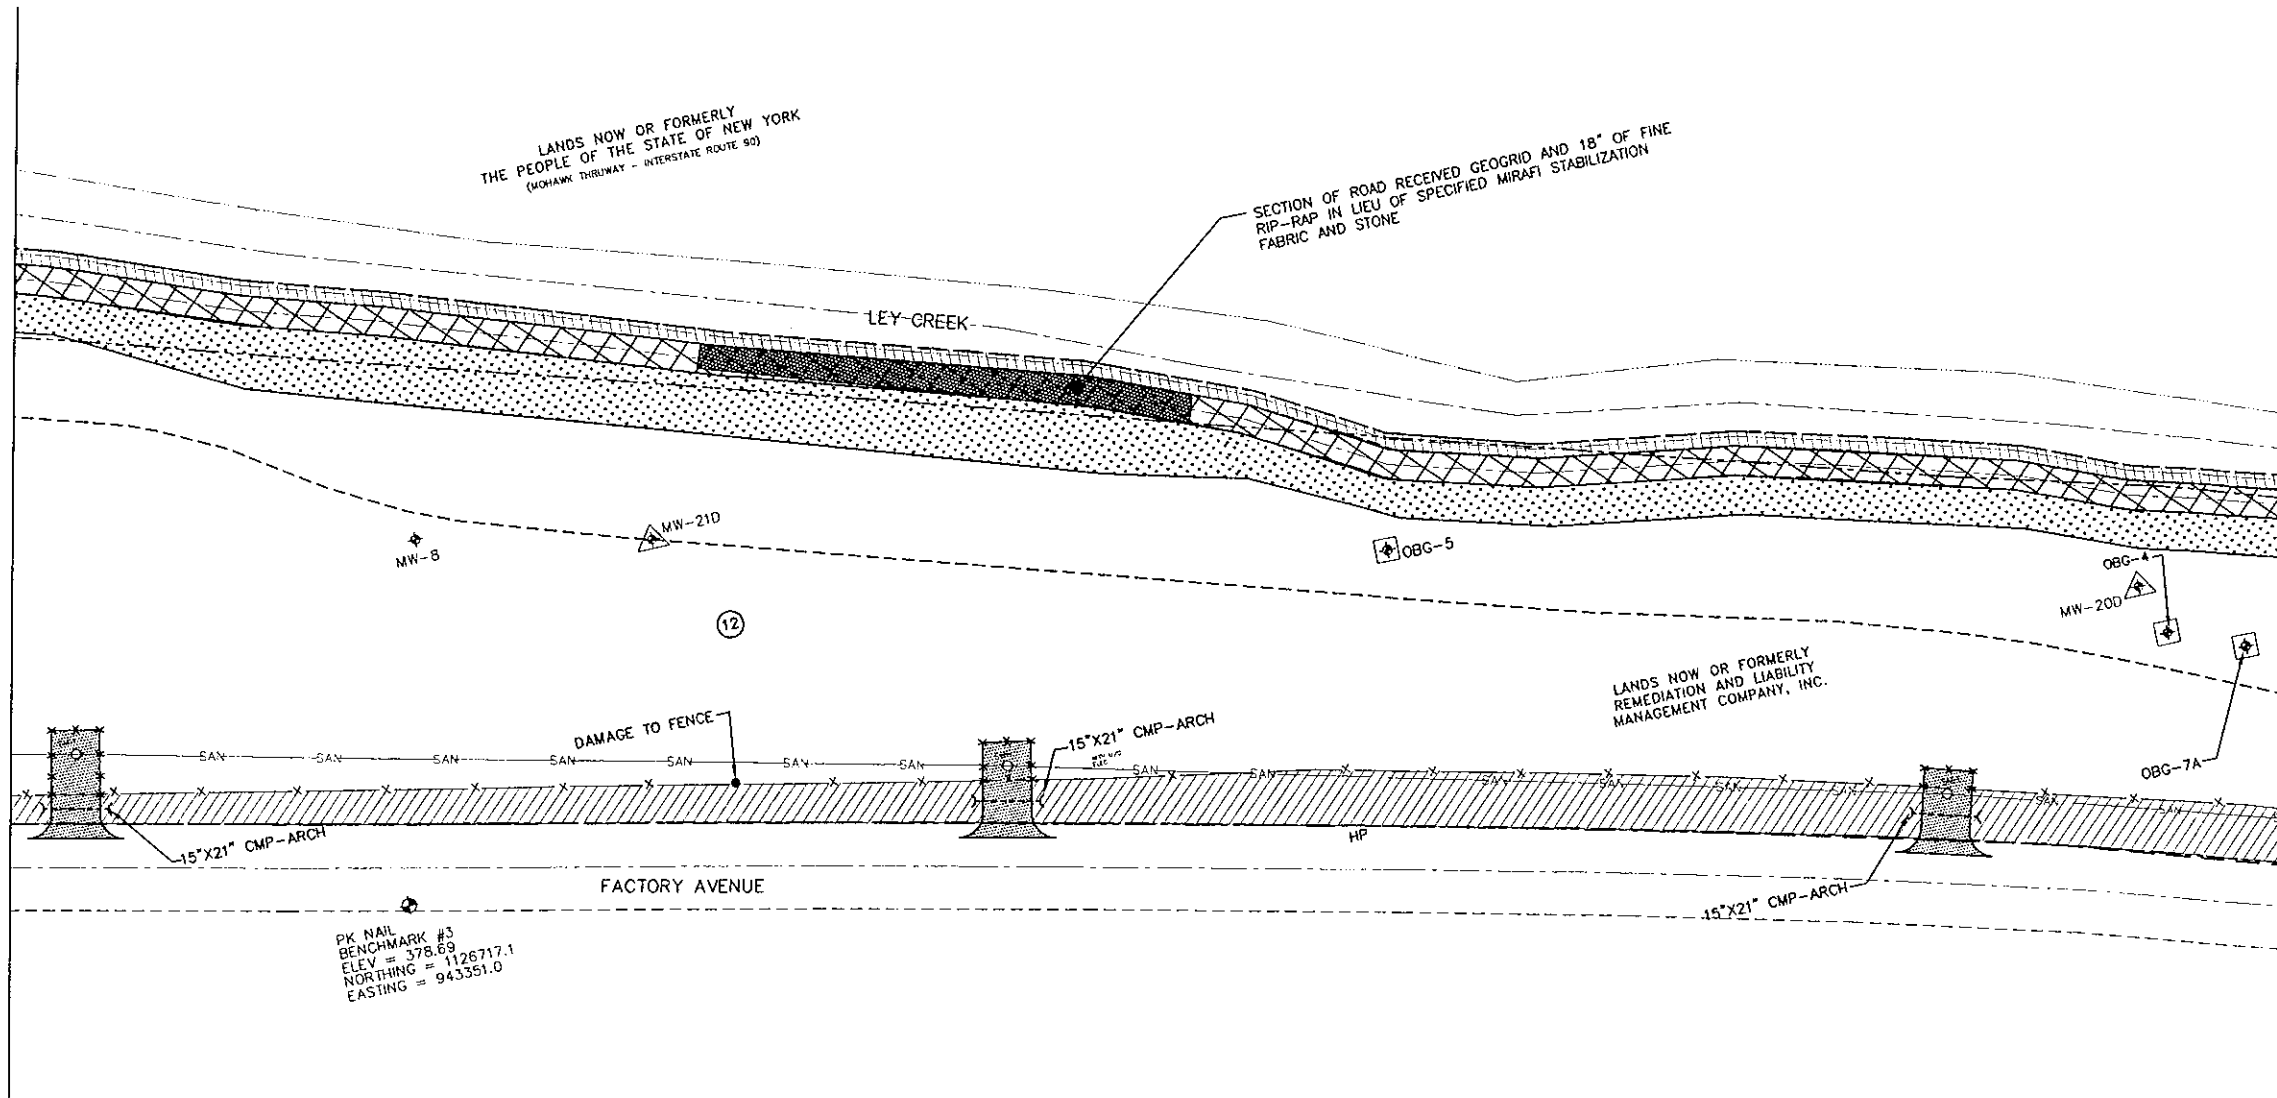
FIGURE 4

The two areas of the site security fence that were observed to be damaged during the August 2002 site inspection (Figures 4 and 5) have not been repaired and should be repaired as soon as practicable.

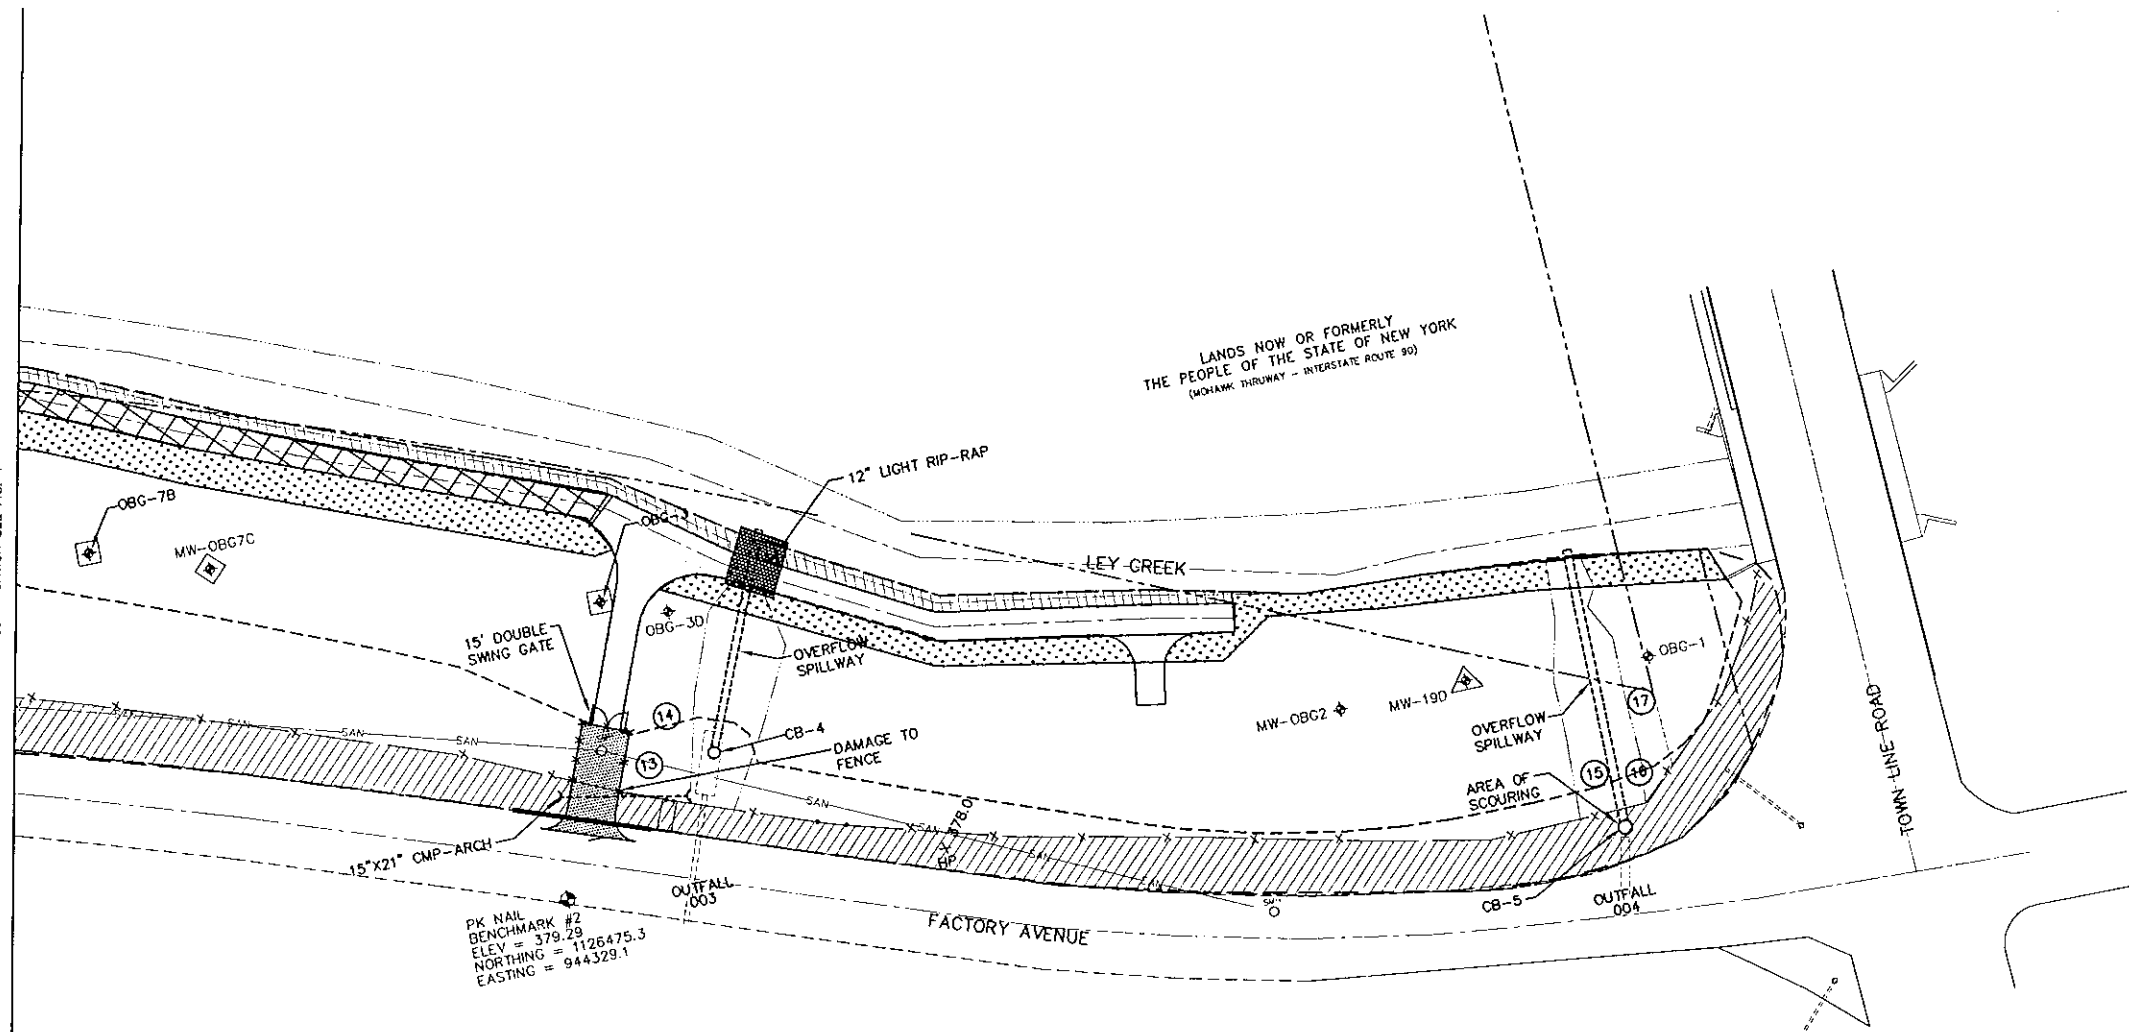
- Excessive scouring: (Photograph 15. Figure 5.) The excessive scouring that was observed in the August 2002 inspection requires repair
- Area requiring mowing: The vegetation around the catch basins, monitoring wells, utility poles, guy wires, and along the fence line requires mowing
