**Landfill Inspection Report 2022**

# **COLDWATER ROAD LANDFILL - MID 005 356 860 LANDFILL INSPECTION REPORT**

Project name **RACER Trust Coldwater Road Landfill**  
Project no. **15388/1940102192**  
Recipient **Nicole Sanabria, Christina Hebert, & John McCabe**  
Document type **Annual Report**  
Version **1**  
Date **February 24, 2023**  
Prepared by **Kevin Schneider**  
Checked by **Clifford Yantz**  
Approved by **Clifford Yantz**  
Description **Landfill Inspection Annual Report**

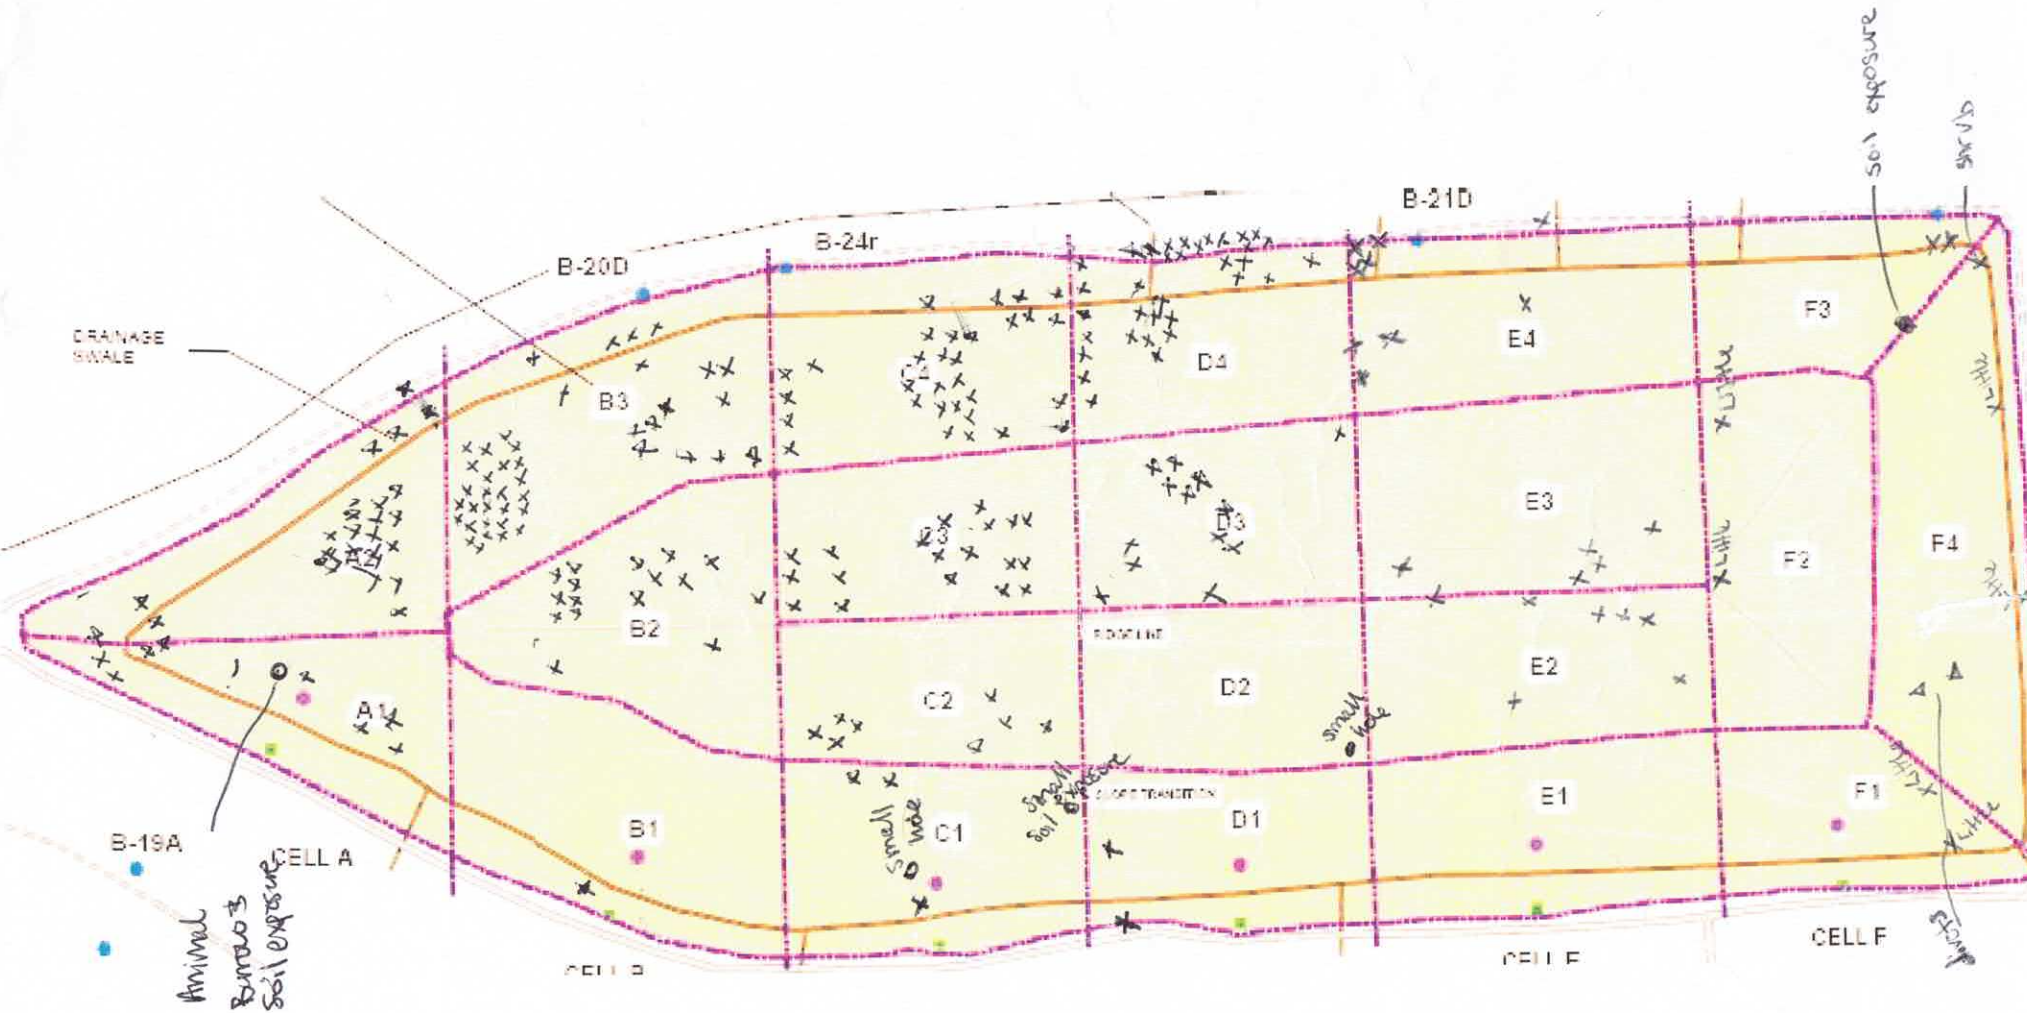
Area Inspected	Drainage problem or blockage observed?	Location (note on figure)	Description	Corrective Actions	Date Corrected
Perimeter of landfill and berm	None, some ponding on trail				
Drainage trenches at base of landfill	None				
RMA	Yes	In road	Slight gully due to rain		
Wetlands area	Ponds over flowing				
Culverts around landfill	Vegetation in culvert at C4 & D4	Culvert near F1 looks like some vegetation is growing			
Western drainage swale	None				
North landfill catch basin	None

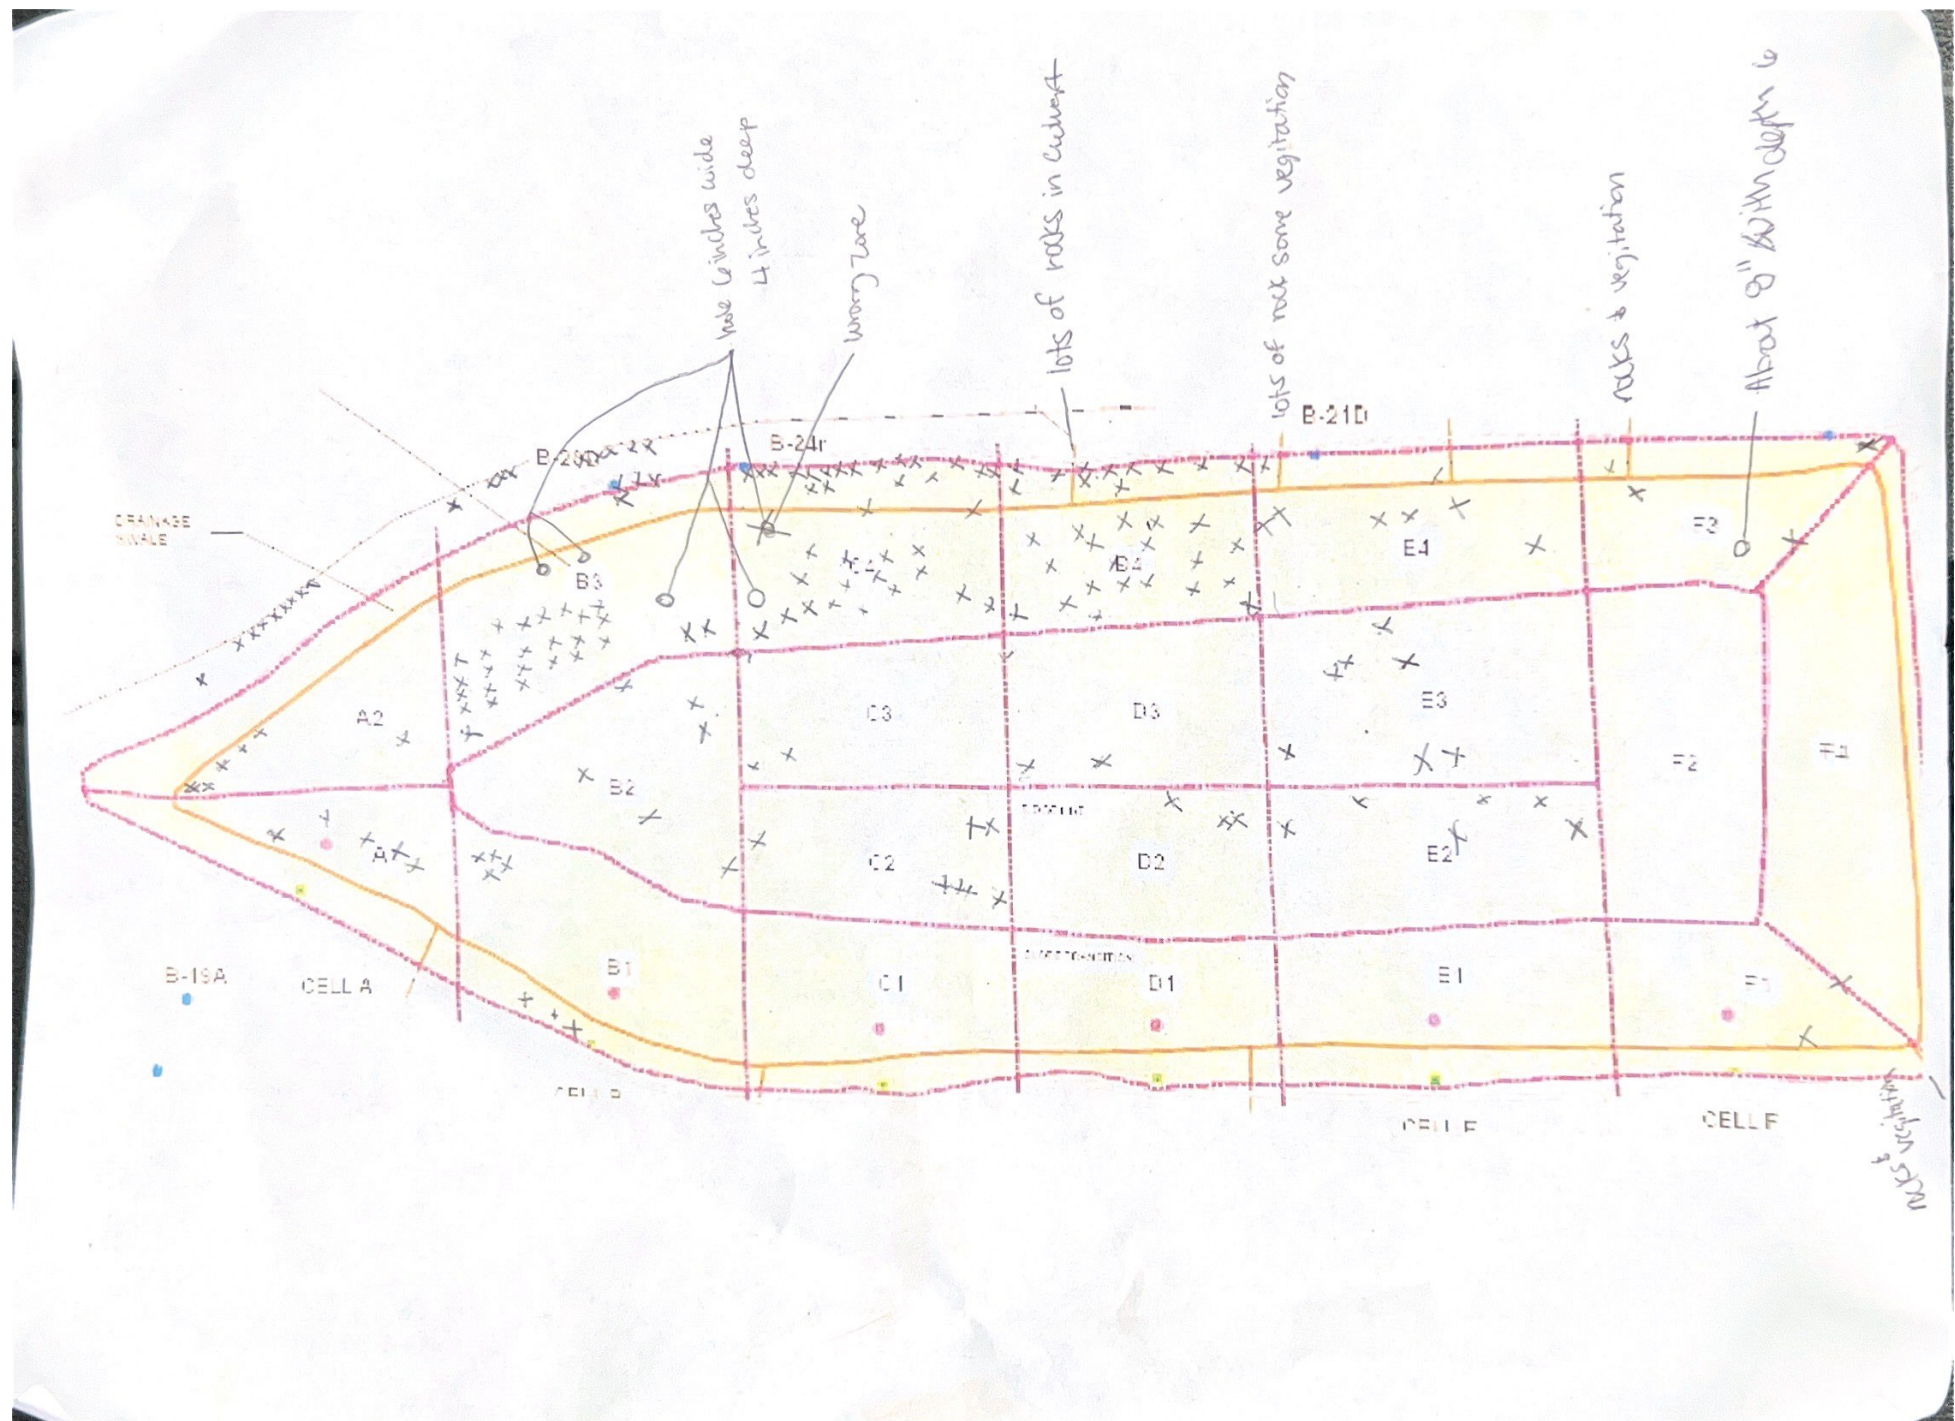
Area Inspected	Drainage problem or blockage observed?	Location (note on figure)	Description	Corrective Actions	Date Corrected
Perimeter of landfill and berm	No				
Drainage trenches at base of landfill	No				
RMA	No, previous gullyng from rain.	By access road	Gullyng in spring from rain.		
Wetlands area	No				
Culverts around landfill	No				
Western drainage swale	No				
North landfill catch basin	No
