RACER TRUST LANSING PLANTS 2, 3, & 6

2021 Second Quarter Progress Report | July 15, 2021

Site Introduction

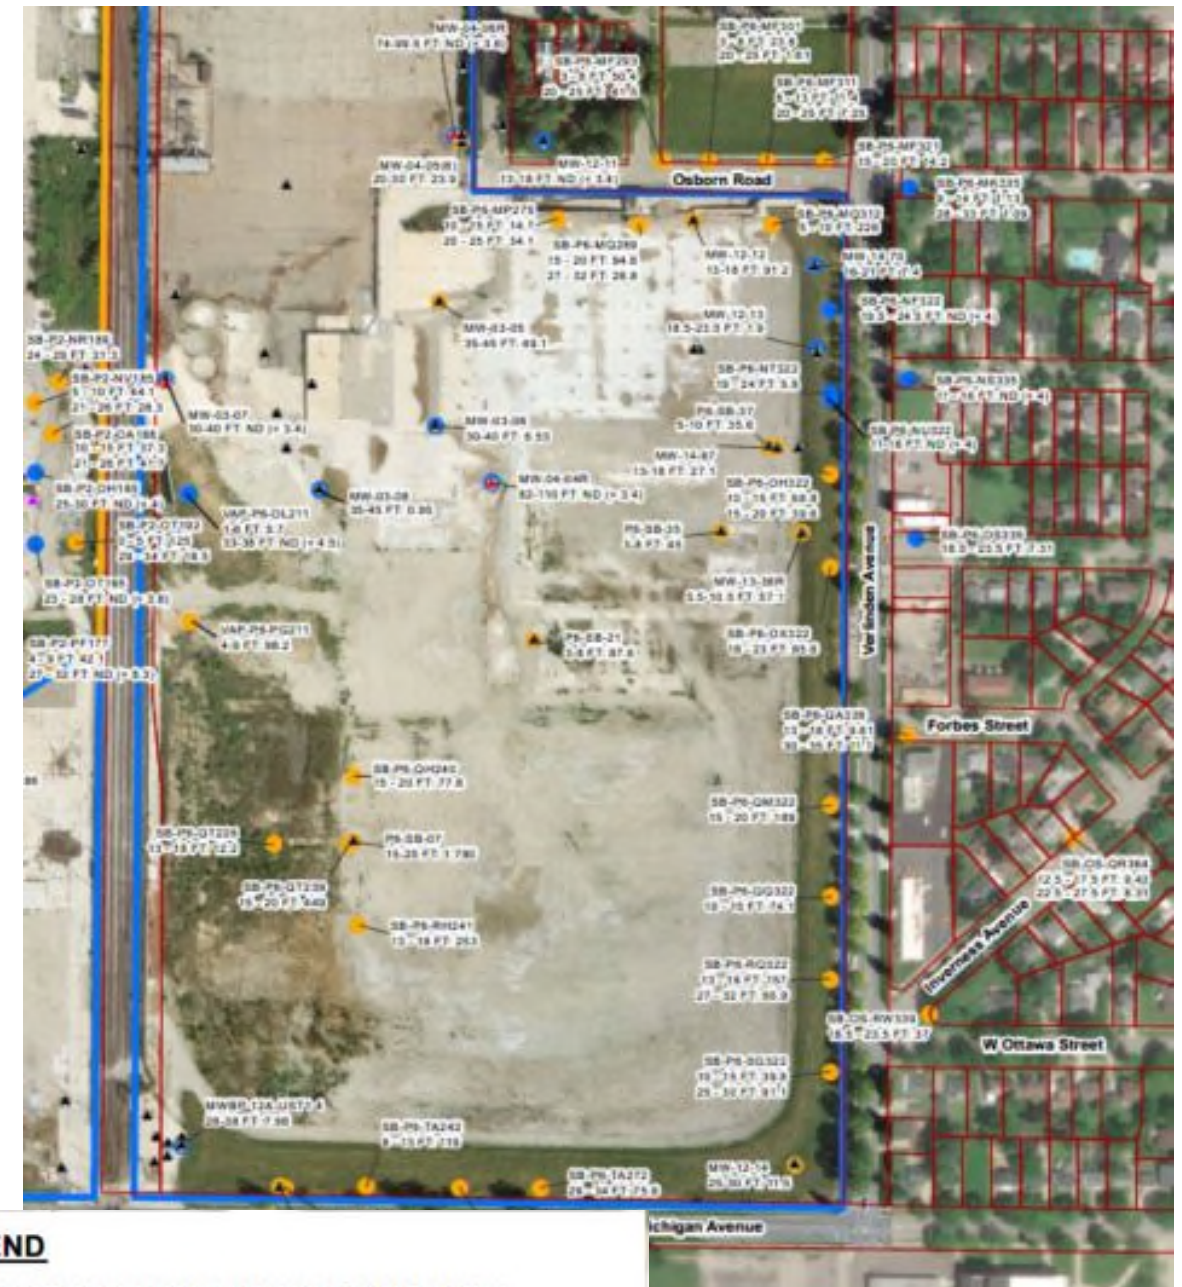
As a result of PFAS groundwater cleanup criteria being updated in December 2020, RACER began working with EGLE to provide notices of migration resulting from the presence of PFAS (specifically perfluorooctanoic acid [PFOA]) in groundwater north and east of Plant 6

- ▲ PERCHED ZONE MONITORING WELL
- ▲ WEATHERED BEDROCK MONITORING WELL
- ▲ BEDROCK MONITORING WELL
- WELLS SAMPLED AND PFOA EXCEEDS DW CRITERIA
- WELLS SAMPLED AND PFOA DOES NOT EXCEED DW CRITERIA

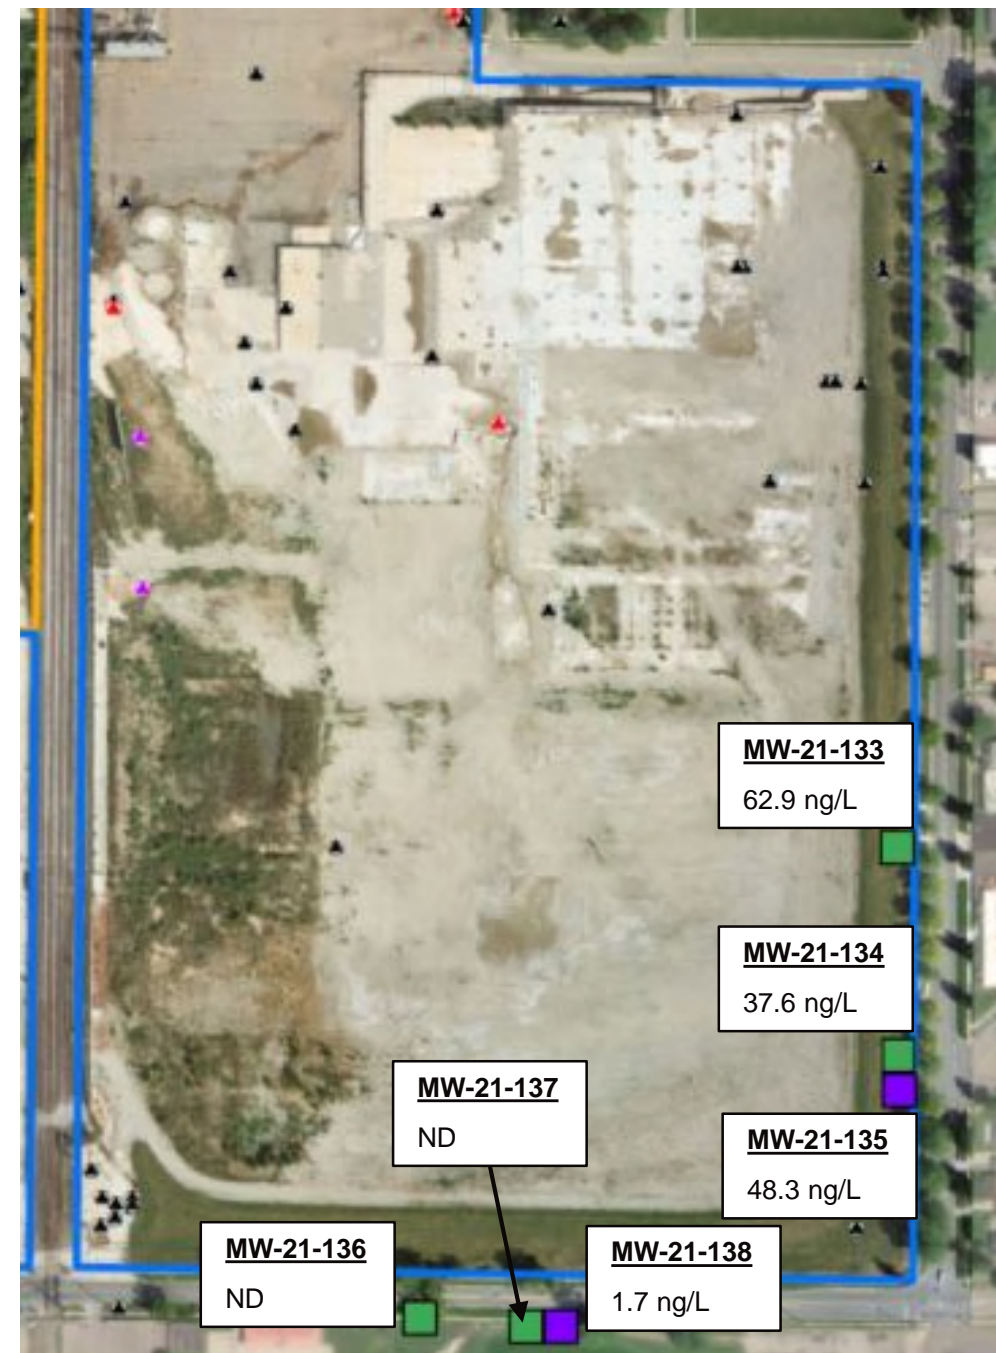
Plant 6 Well Installation

- Work completed in March 2021
- Installed three on-site monitoring wells on Plant 6 along the eastern property boundary to facilitate monitoring of PFAS identified in previous investigations

- Installed three off-site monitoring wells within the southern right of way of Michigan Avenue to provide delineation of impacts identified along the southern boundary of Plant 6

- Groundwater collected from the monitoring wells installed along the eastern portion of Plant 6 contained PFOA above EGLE drinking water criteria of 8 ng/L (parts per trillion); however, results of the wells installed along Michigan Avenue did not contain concentrations above criteria

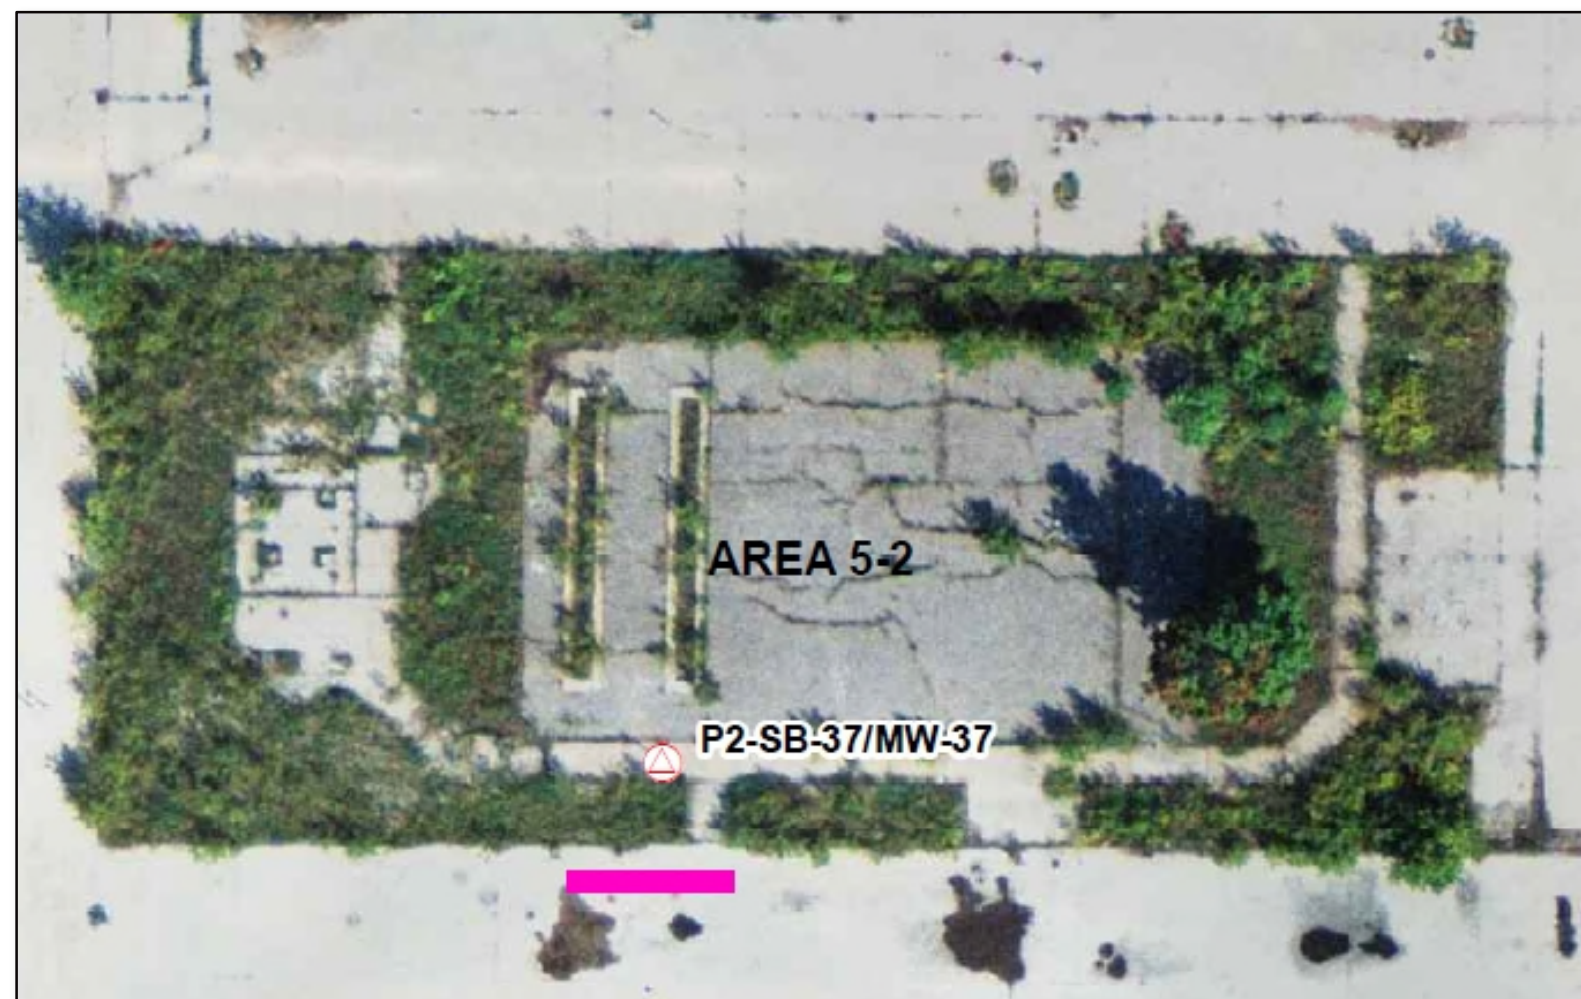
Closure of Plant 2 Vault

- A vault containing contaminated water is present at Plant 2 (pink box area in figure)
- A scope of work to properly clean and close the vault was submitted to EGLE on April 13, 2021 for approval
- Once approval is provided by EGLE, RACER will schedule closure activities for the vault
