RACER TRUST LANSING PLANTS 2, 3, & 6

2021 Third Quarter Progress Report | October 15, 2021

Site Introduction

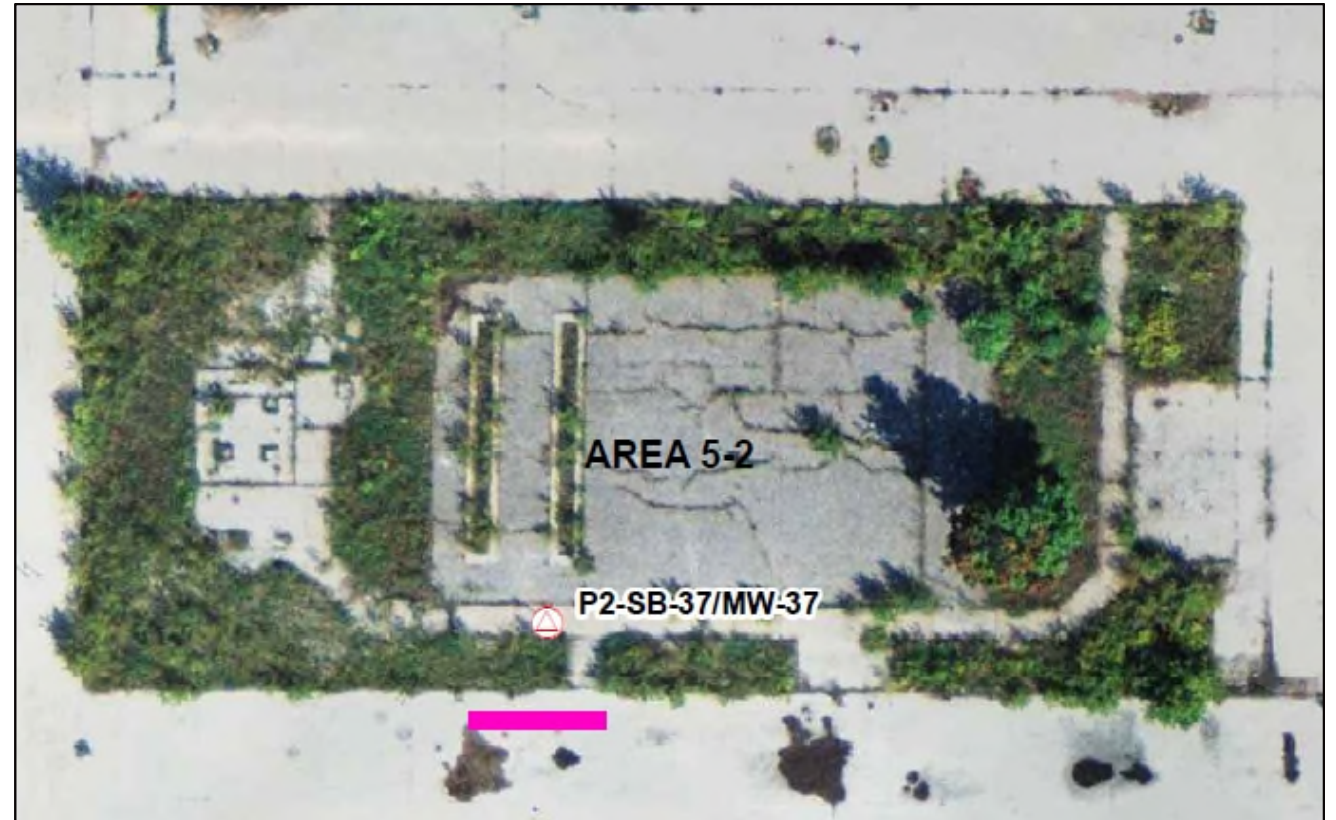
Closure of Plant 2 Vault

- A vault containing contaminated water is present at Plant 2 (pink box area in figure)
- A scope of work to properly clean and close the vault was submitted to EGLE on April 13, 2021, for approval
- EGLE approved the scope of work and activities are scheduled to be completed in October 2021

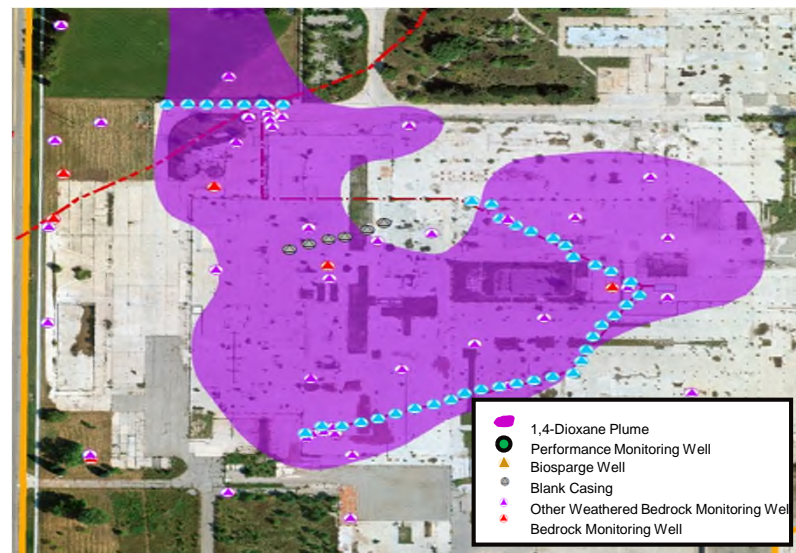
Plant 2 Biosparge Transect Layout

FULL-SCALE DESIGN

- 5 transects with 48 air sparge wells across Plants 2 and 4
- Nearly 5 miles of air hose and an air/propane injection network
- Groundwater flows from northwest to southeast and is cleaned by each transect
- Tubing installed above grade to save on costs and to accommodate future development
- Network of monitoring wells to track treatment progress

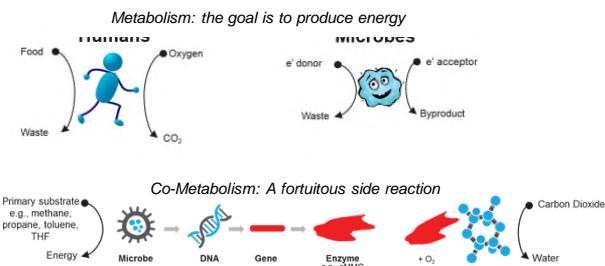
CO-METABOLIC BIODEGRADATION OF 1,4-DIOXANE:

Propane + Oxygen + Microbes = 1,4-Dioxane Treatment
