RACER TRUST LANSING PLANTS 2, 3, & 6

2023 Fourth Quarter Progress Report | January 15, 2024

Site Introduction

BIOSPARGING TREATMENT OF 1,4-DIOXANE

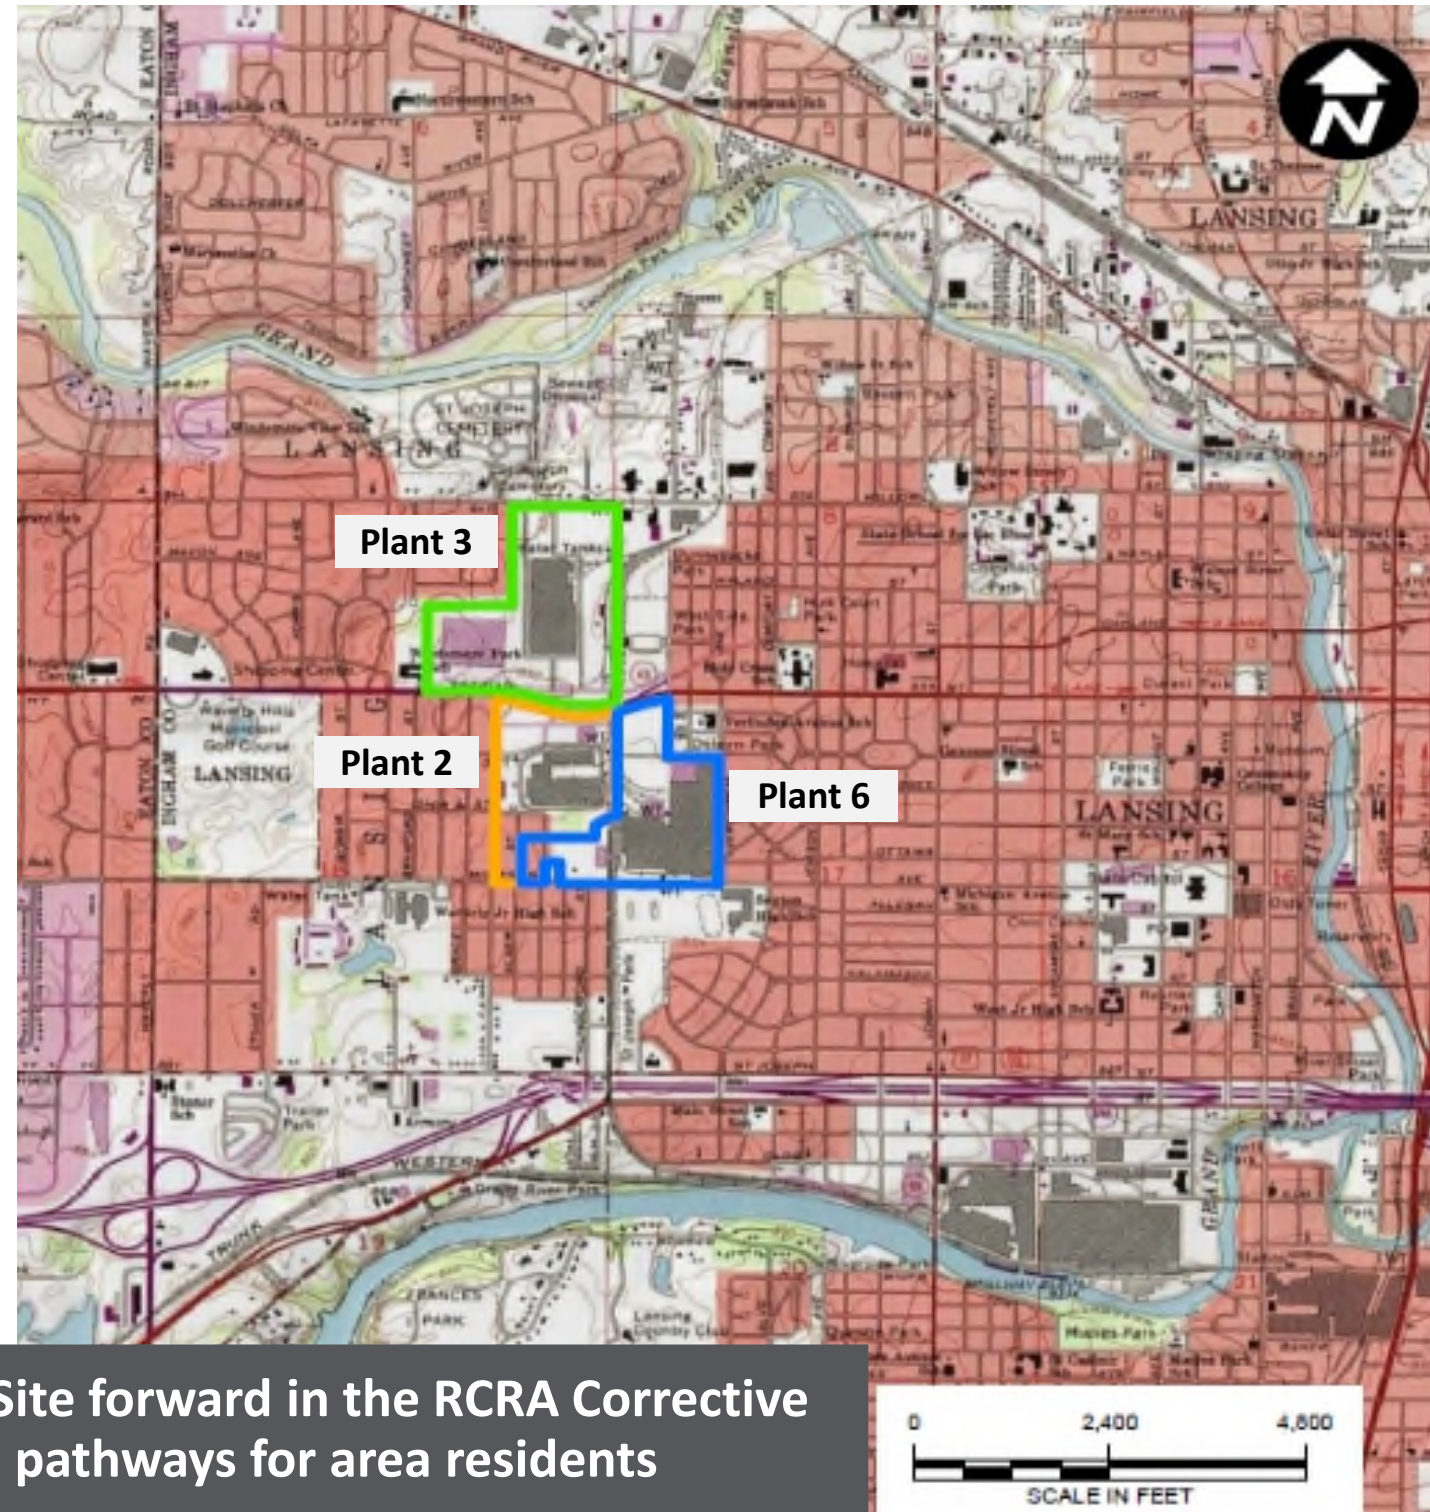
Remediation of 1,4-Dioxane in Weathered Bedrock

- Biosparge systems at Plant 2 and Plant 3 are fully operational
 - Minimal downtime at the Plant 3 system related to equipment repairs or regular system maintenance
- Results of performance monitoring show that the biosparge systems are achieving the short-term objective of reducing 1,4-dioxane concentrations and mass along the core of the weathered bedrock plume
- Next nutrient injection scheduled for Spring 2024.

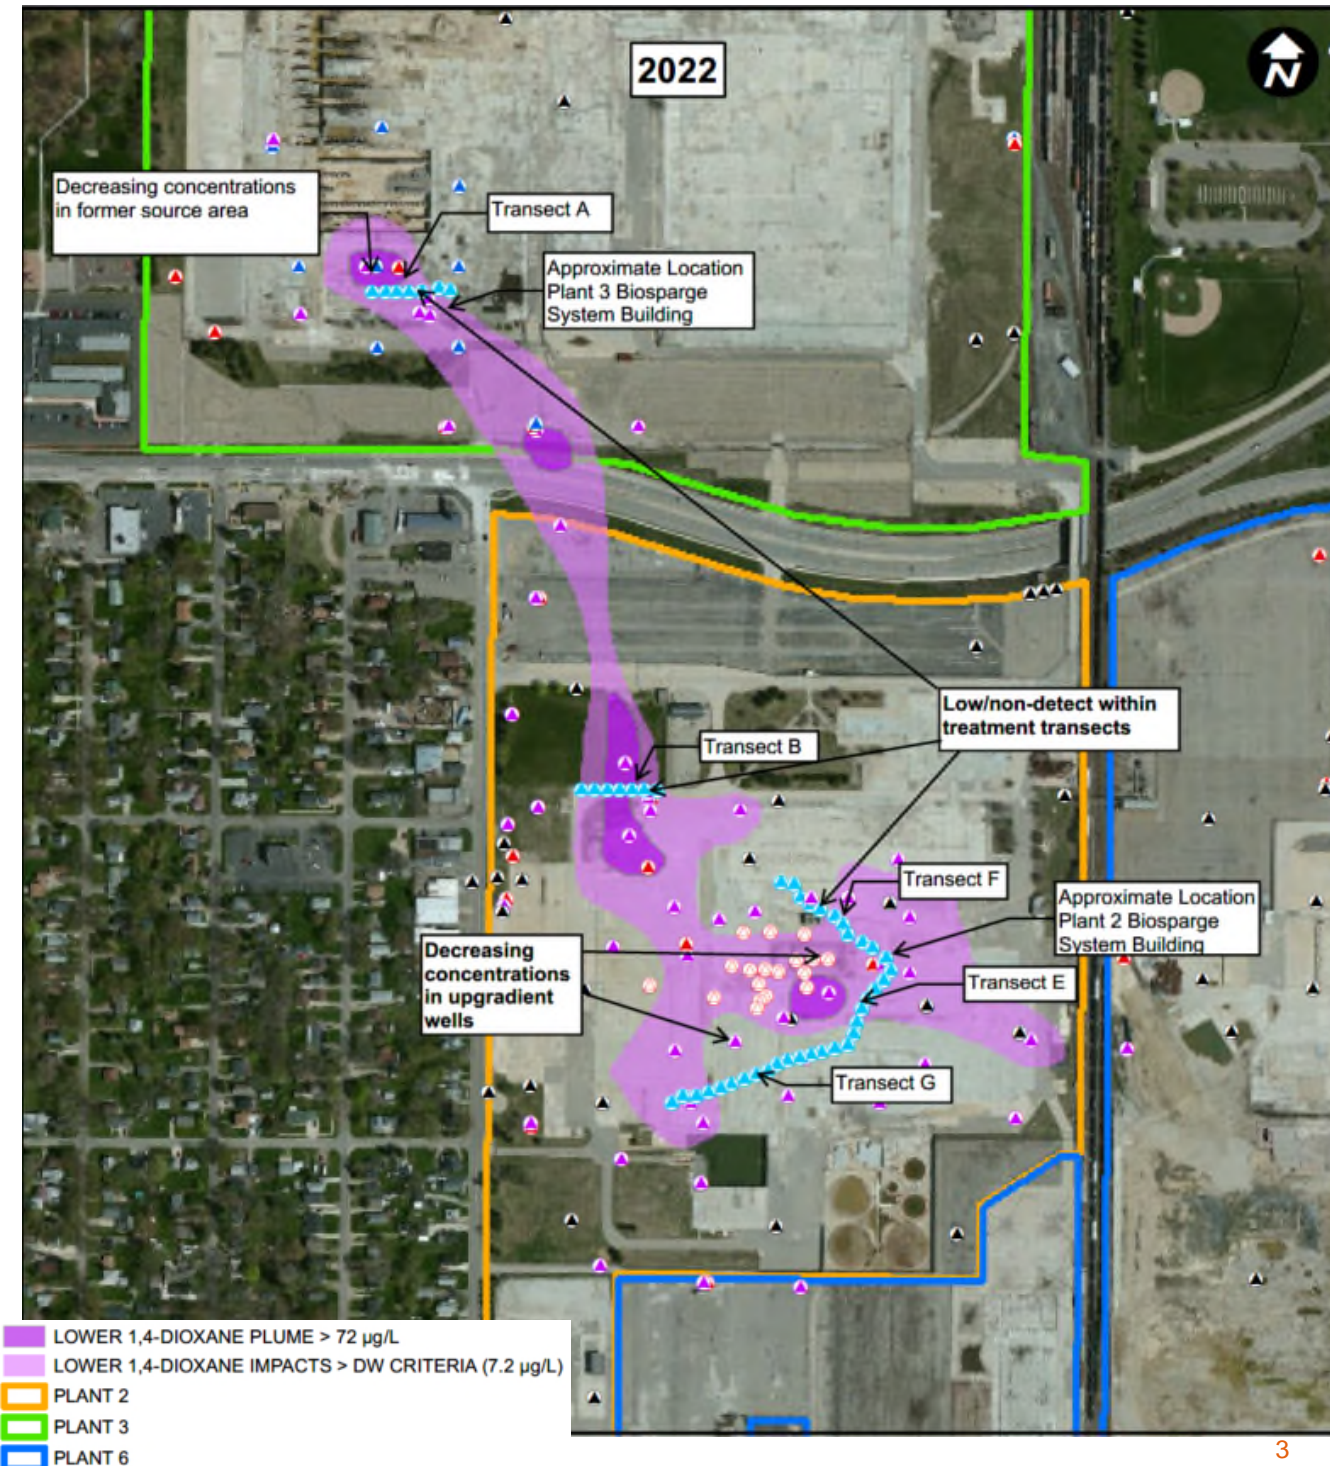
Remediation of 1,4-Dioxane in Weathered Bedrock

- The second full round of performance monitoring was conducted in Fourth Quarter 2023 to complete the semi-annual sampling schedule for 2023.
- Results from Fourth Quarter 2023 sampling continue to show stable to decreasing concentrations of 1,4-dioxane.
- A minor upward trend in one of the performance monitoring wells (TW-15-11) was detected; however, it is believed to be due to some short circuiting of the air being injected by the system due to damage sustained to a nearby well (TW-06-14). TW-06-14 is being evaluated for potential future abandonment.
- An annual Biosparge Summary Report summarizing the 2023-year data is anticipated to be submitted to EGLE during the First Quarter of 2024

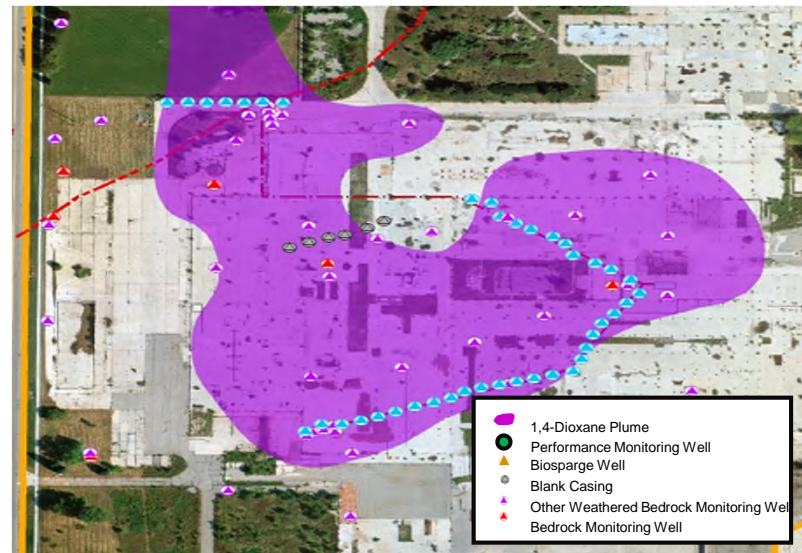
Plant 2 Biosparge Transect Layout

- 5 transects with 48 air sparge wells across Plants 2 and 4
- Nearly 5 miles of air hose and an air/propane injection network
- Groundwater flows from northwest to southeast and is cleaned by each transect
- Tubing installed above grade to save on costs and to accommodate future development
- Network of monitoring wells to track treatment progress

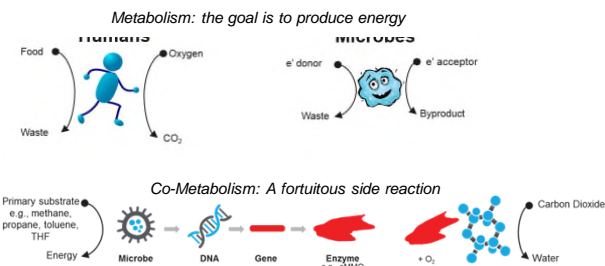
CO-METABOLIC BIODEGRADATION OF 1,4-DIOXANE:

Propane + Oxygen + Microbes = 1,4-Dioxane Treatment

- Air and small amounts of propane are injected into the ground through wells
- Promotes biodegradation of chemicals in groundwater, much faster than it would occur naturally
- 1,4-dioxane is treated in the ground, so minimal waste is generated
- Nearby wells are sampled to make sure treatment is occurring
