**PHASE I ENVIRONMENTAL SITE ASSESSMENT  
67.88 ACRES VACANT LAND (PARCEL A)  
NEC OF ECORSE ROAD AND MICHIGAN AVENUE  
VAN BUREN TOWNSHIP, MICHIGAN 48111**

**GENERAL MOTORS WORLDWIDE REAL ESTATE**

**ENCORE ENVIRONMENTAL CONSORTIUM, LLC**

**DATE: FEBRUARY 13, 2007**

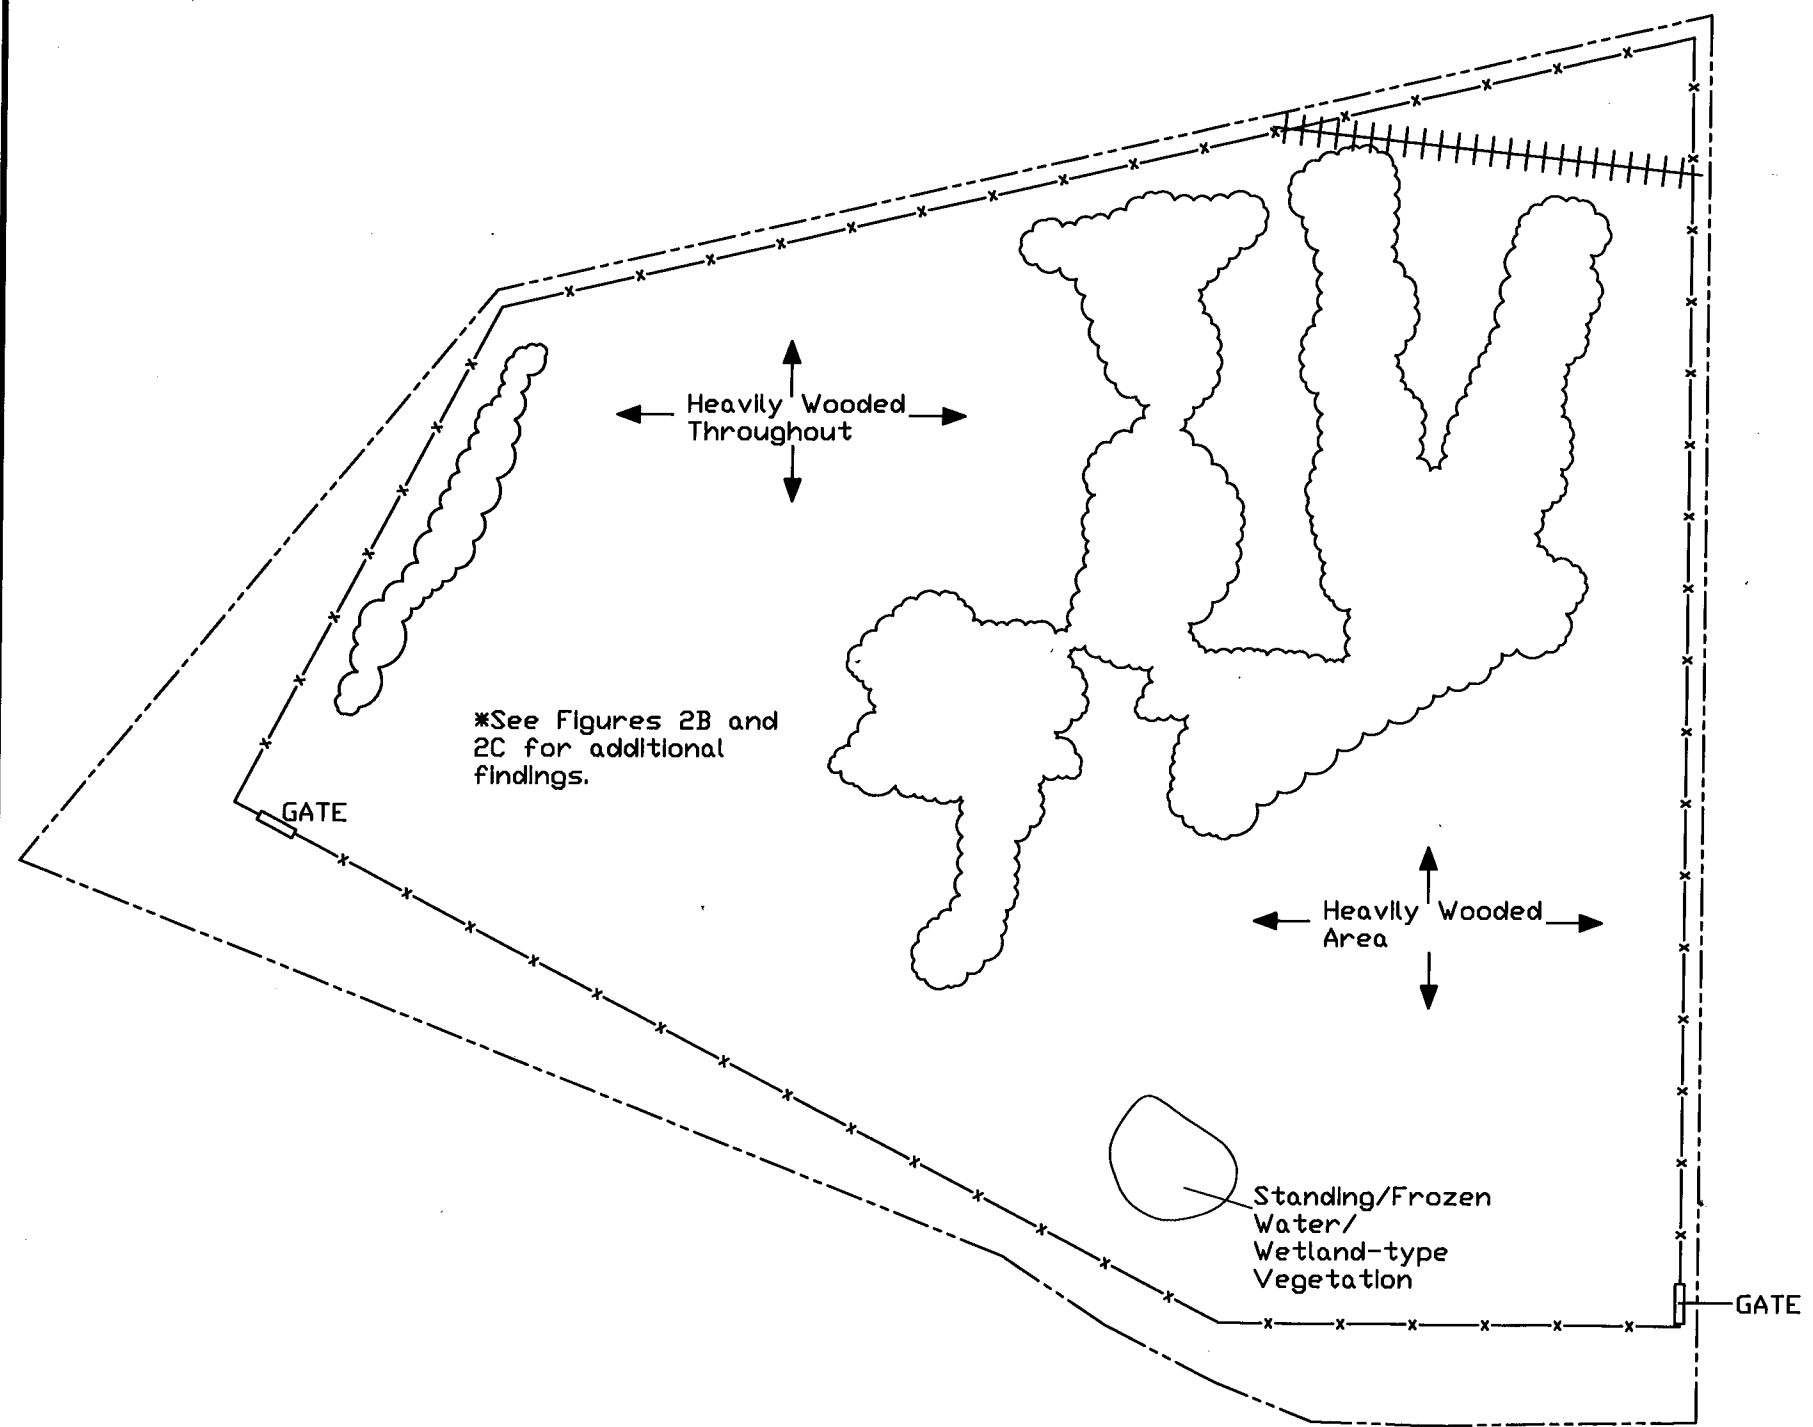
| | <b>2A</b> |

POTENTIAL LANDFILL TRENCH CELLS IDENTIFIED IN EEC's APRIL 2003 GEOPHYSICAL INVESTIGATION

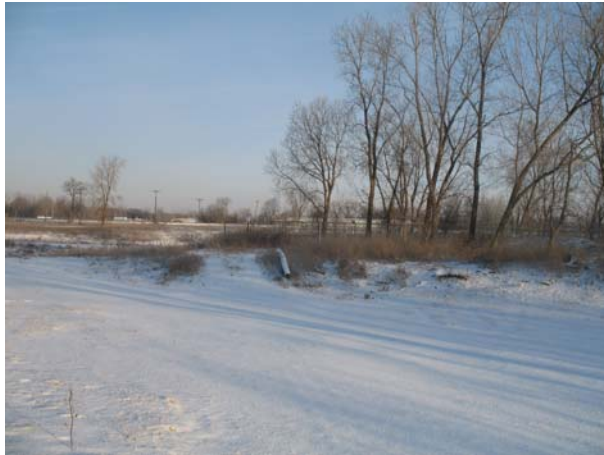
**Photograph 1. View of the southwestern portion of the Site, facing northwest.**

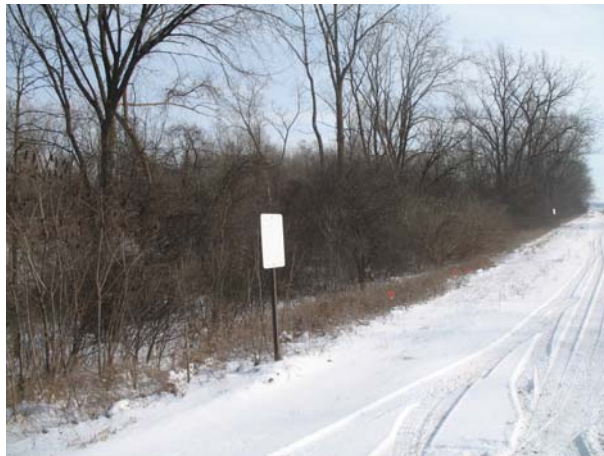
**Photograph 2. View of the southern Site boundary, along Ecorse Road, facing east-northeast.**

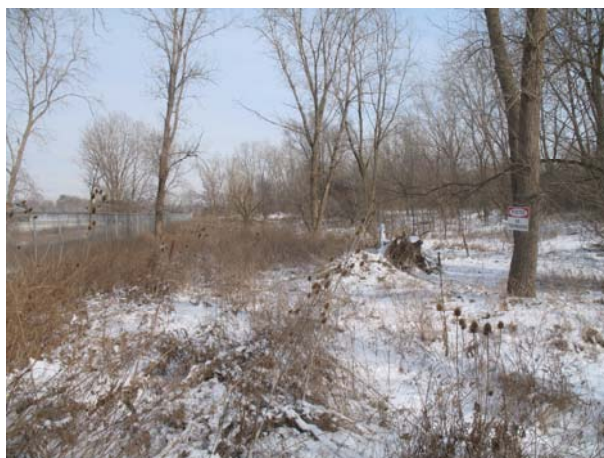
- EEC observed solid waste in piles aboveground sporadically throughout the Site. In addition, evidence of historic solid waste disposal was observed emerging from the ground over a broad area across the western portion of the Site. The types of waste included general garbage, building construction materials (e.g., concrete, wood, metal, shingles, tile, siding, carpet), household appliances (e.g., refrigerator, freezer, vacuum cleaners), furniture (e.g., chairs, couches), plastic and metal piping, hazardous material containers, scrap metal, and numerous unidentifiable items. The presence of large quantities of solid waste disposed aboveground at the Site represents an other environmental issue.

**Photograph 3. View of mounded debris piles located along the northwestern boundary of the Site, facing north.**

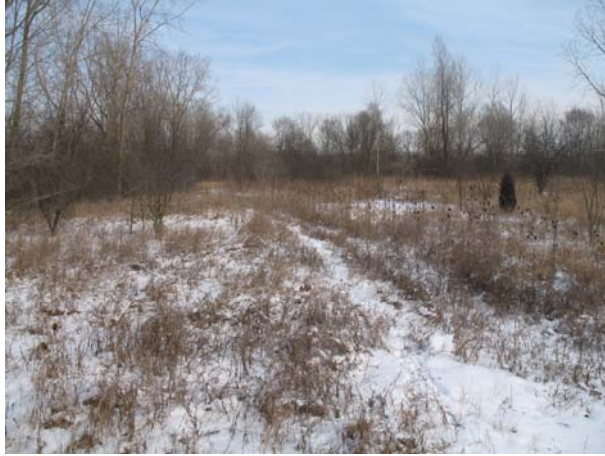
**Photograph 4. View of an open area located in the western portion of the Site.**

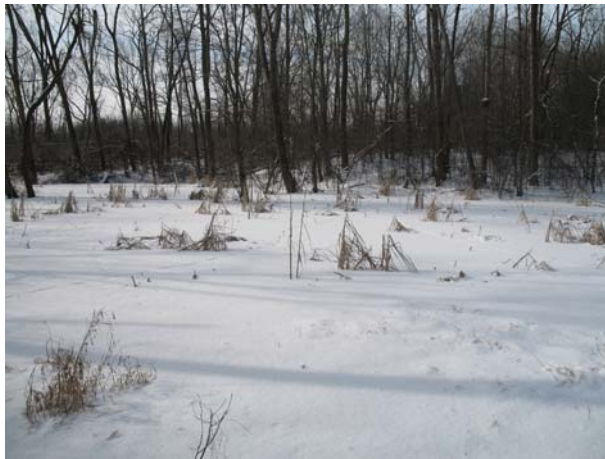
During previous investigations and the Site reconnaissance associated with this assessment, EEC observed evidence of wetland-type vegetation (i.e., cattails and grasses) on the south central portion of the Site. However, no regulated wetland areas are depicted on the Site in the EDR report. Furthermore, the area where EEC observed wetland-type vegetation did not appear to be connected to regulated wetland areas. Therefore, based on the information obtained from EDR and the Site reconnaissance, the Site does not appear to contain regulated wetlands.

**Photograph 5. View of wetland vegetation located in the south-central portion of the Site, facing southwest.**

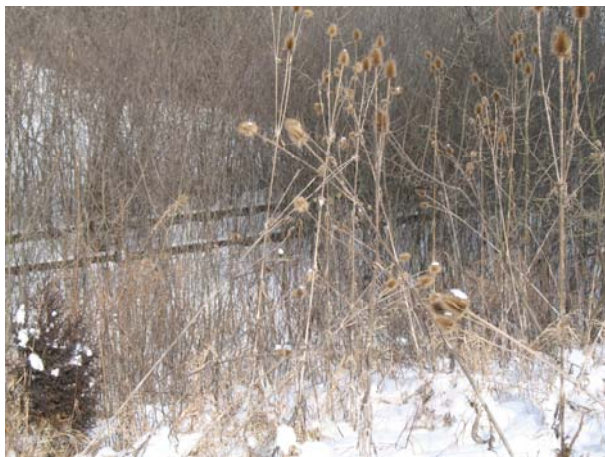
**Photograph 6. View of the Penn Central Railroad spur located in the northeastern portion of the Site, facing northeast.**

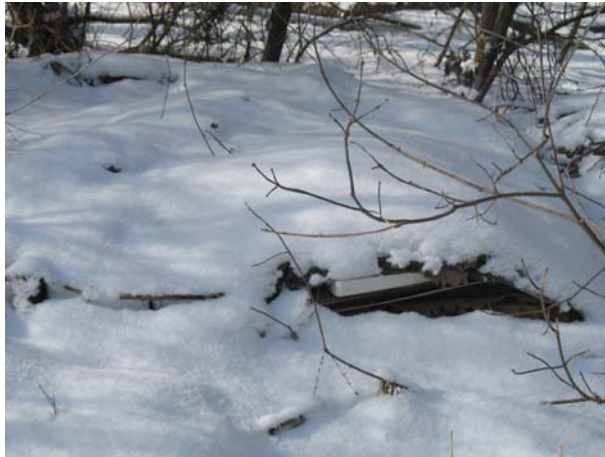
EEC observed solid waste in piles aboveground sporadically throughout the Site. In addition, evidence of historic solid waste disposal was observed emerging from the ground over a broad area across the western portion of the Site. The types of waste included general garbage, building construction materials (e.g., concrete, wood, metal, shingles, tile, siding, carpet), household appliances (e.g., refrigerator, freezer, vacuum cleaners), furniture (e.g., chairs, couches), plastic and metal piping, hazardous material containers, scrap metal, and numerous unidentifiable items. The presence of large quantities of solid waste disposed aboveground at the Site represents an other environmental issue.

**Photograph 7. View of a debris pile located in the western portion of the Site.**

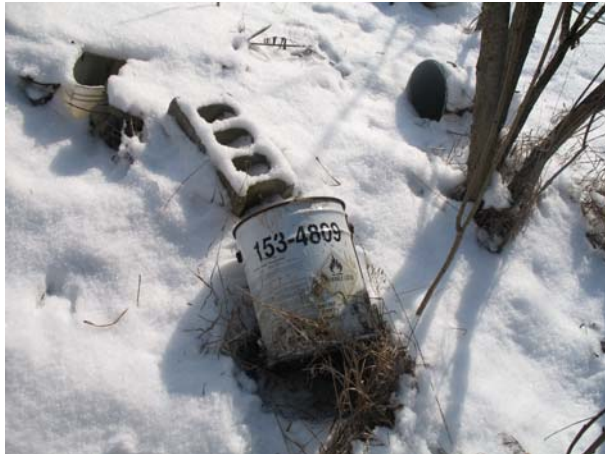
EEC observed evidence of hazardous substance and petroleum product containers discarded aboveground at several locations on the Site. Several of the containers observed appeared to be empty. EEC also observed evidence of product containers exposed from below the ground surface. Legible container labels reflected former contents of gasoline, petroleum oil, primer, thinner, lacquer/paint, and several household items. Other product containers were illegible. A sitewide REC associated with the historic use of the Site as a solid waste landfill and an other environmental issue associated with aboveground disposal of solid waste are described in Section 2.1.13.

The EDR database report does not contain hazardous waste listings for the Site. However, evidence of hazardous waste disposal was observed on the Site. Through observation of product containers, EEC observed evidence that gasoline, primer, thinner, lacquer/paint, and several hazardous household wastes may have been discarded on the Site.

**Photograph 8. View of construction debris and empty 5-gallon paint thinner canisters located in the western portion of the Site.**

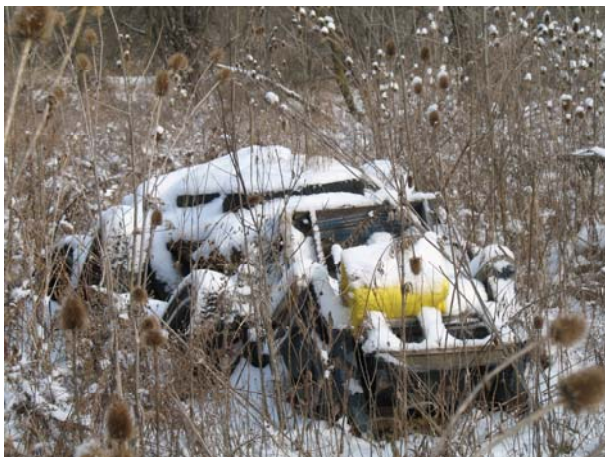
**Photograph 9. View of debris and tires located in the western portion of the Site.**
