### Hydrant Flow Test – RACER Genesee Industrial Land

Job Number/Name: 401.2401267.000 DRP-RACER Genesee Industrial Land

Address: 7017 Dort Hwy, Mount Morris, MI 48458

Scope of work - Conduct water Flow Testing

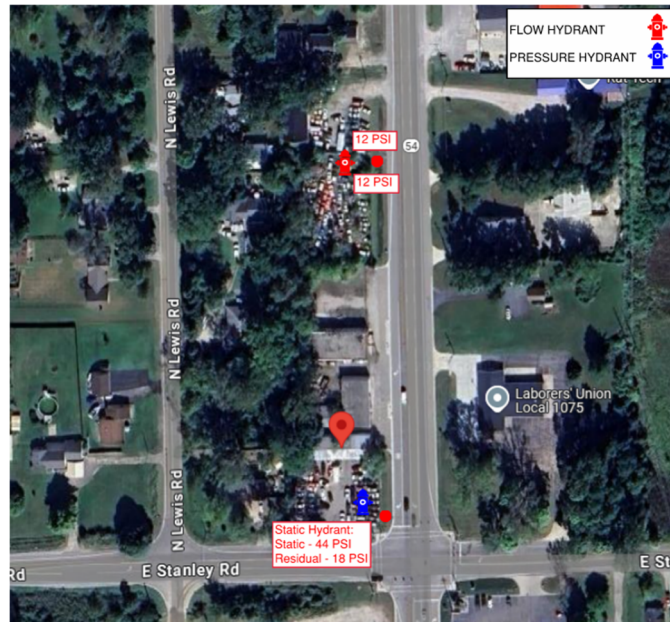
MSG conducted a water flow test, also known as a hydrant flow test, to measure the water supply available to the site. The test was performed for the Detroit Regional Partnership (DRP) through the Verified Industrial Properties (VIP) program, assisting site owners within the 11-County Detroit Region to cover the costs associated with due diligence and promotion. The hydrant flow test is one of the due diligence tests performed. This flow test will also assist with future building fire protection system designs (by others) within the development. The test involved measuring flow of water out of a municipal fire hydrant while recording how much the water pressure has dropped (from no flow to test flow). Our procedure in performing the water flow test did adhere to the requirements set forth by the National Fire Protection Association (NFPA). The test was performed on the west side of Dort Hwy North of E Stanley Rd. at 9:30AM on October 28, 2024. MSG representative Charlie Cook was in attendance to witness the test. Exact hydrant locations are shown in the photo below:

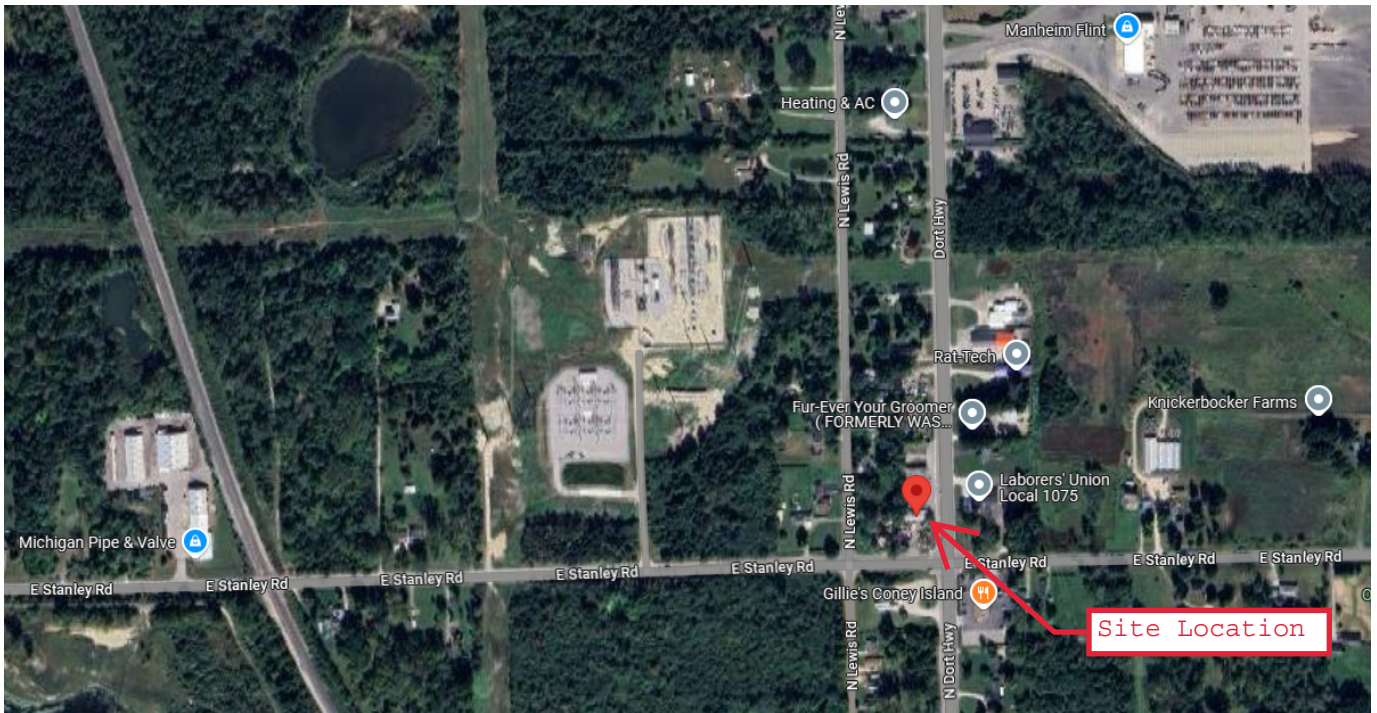
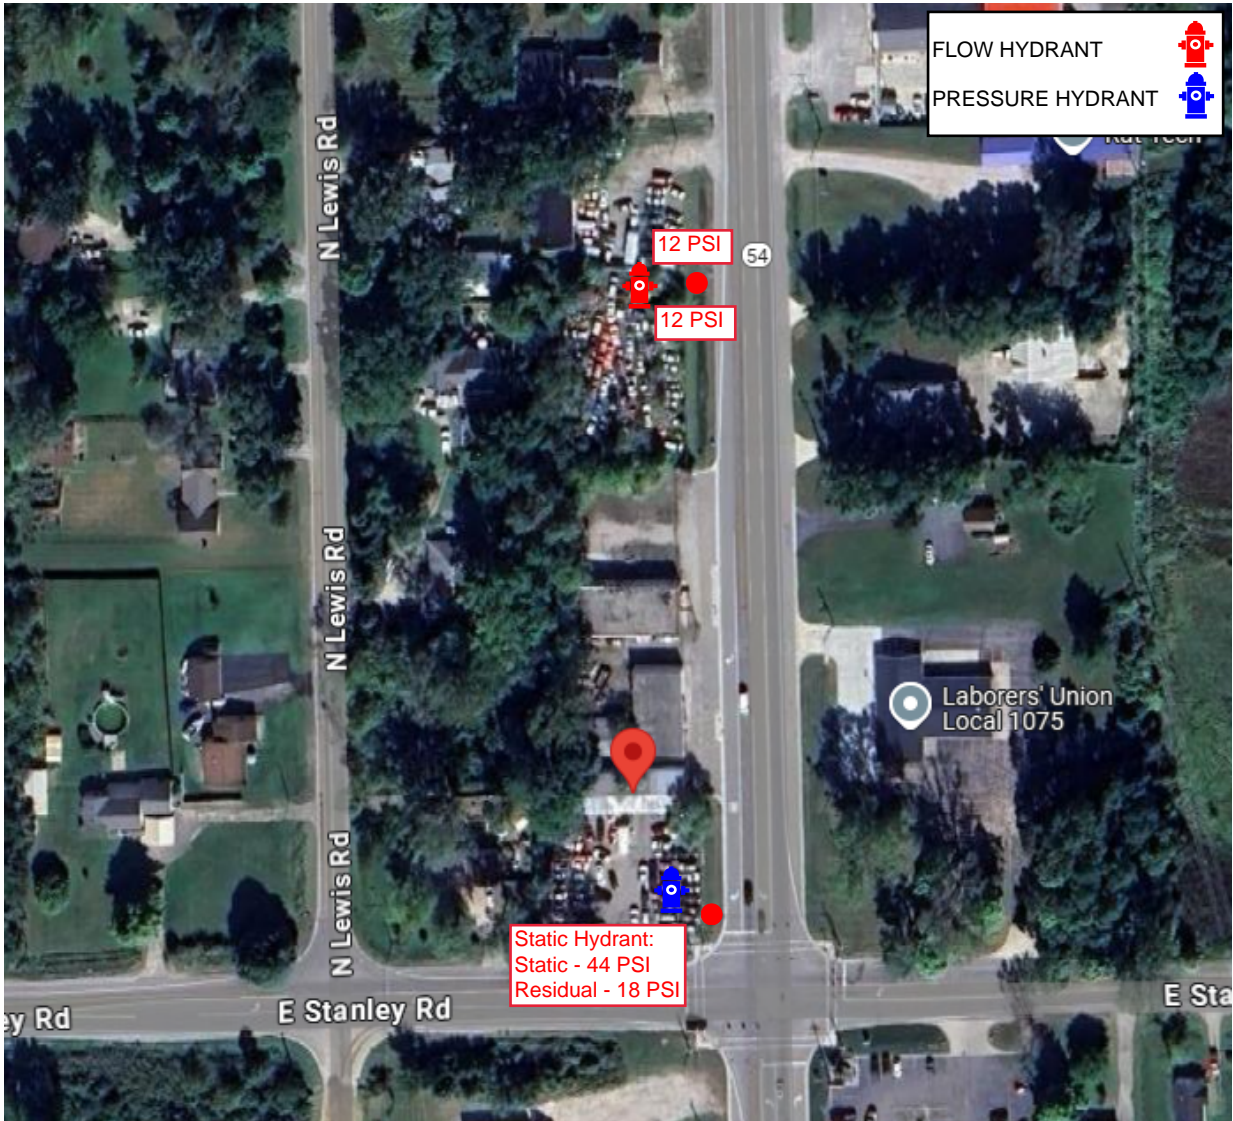
Hydrant Locations: See attached map

Static Hydrant:

Static Pressure: 44 PSI

Residual Pressure: 18 PSI

Flowing Hydrant: (2) 2 1/4" openings flowed

Pitot Pressure of each opening: 12 PSI

Gallons per minute: 942 GPM (See attached Flow Chart for clarification)
