**CITY OF DETROIT PROPOSED RIGHT-OF-WAY  
PHASE I ENVIRONMENTAL SITE ASSESSMENT**

**GENERAL MOTORS CORPORATION  
CLARK AVENUE FACILITY  
DETROIT, MICHIGAN**

**MAY 2000  
REF. NO. 8889 (42)**

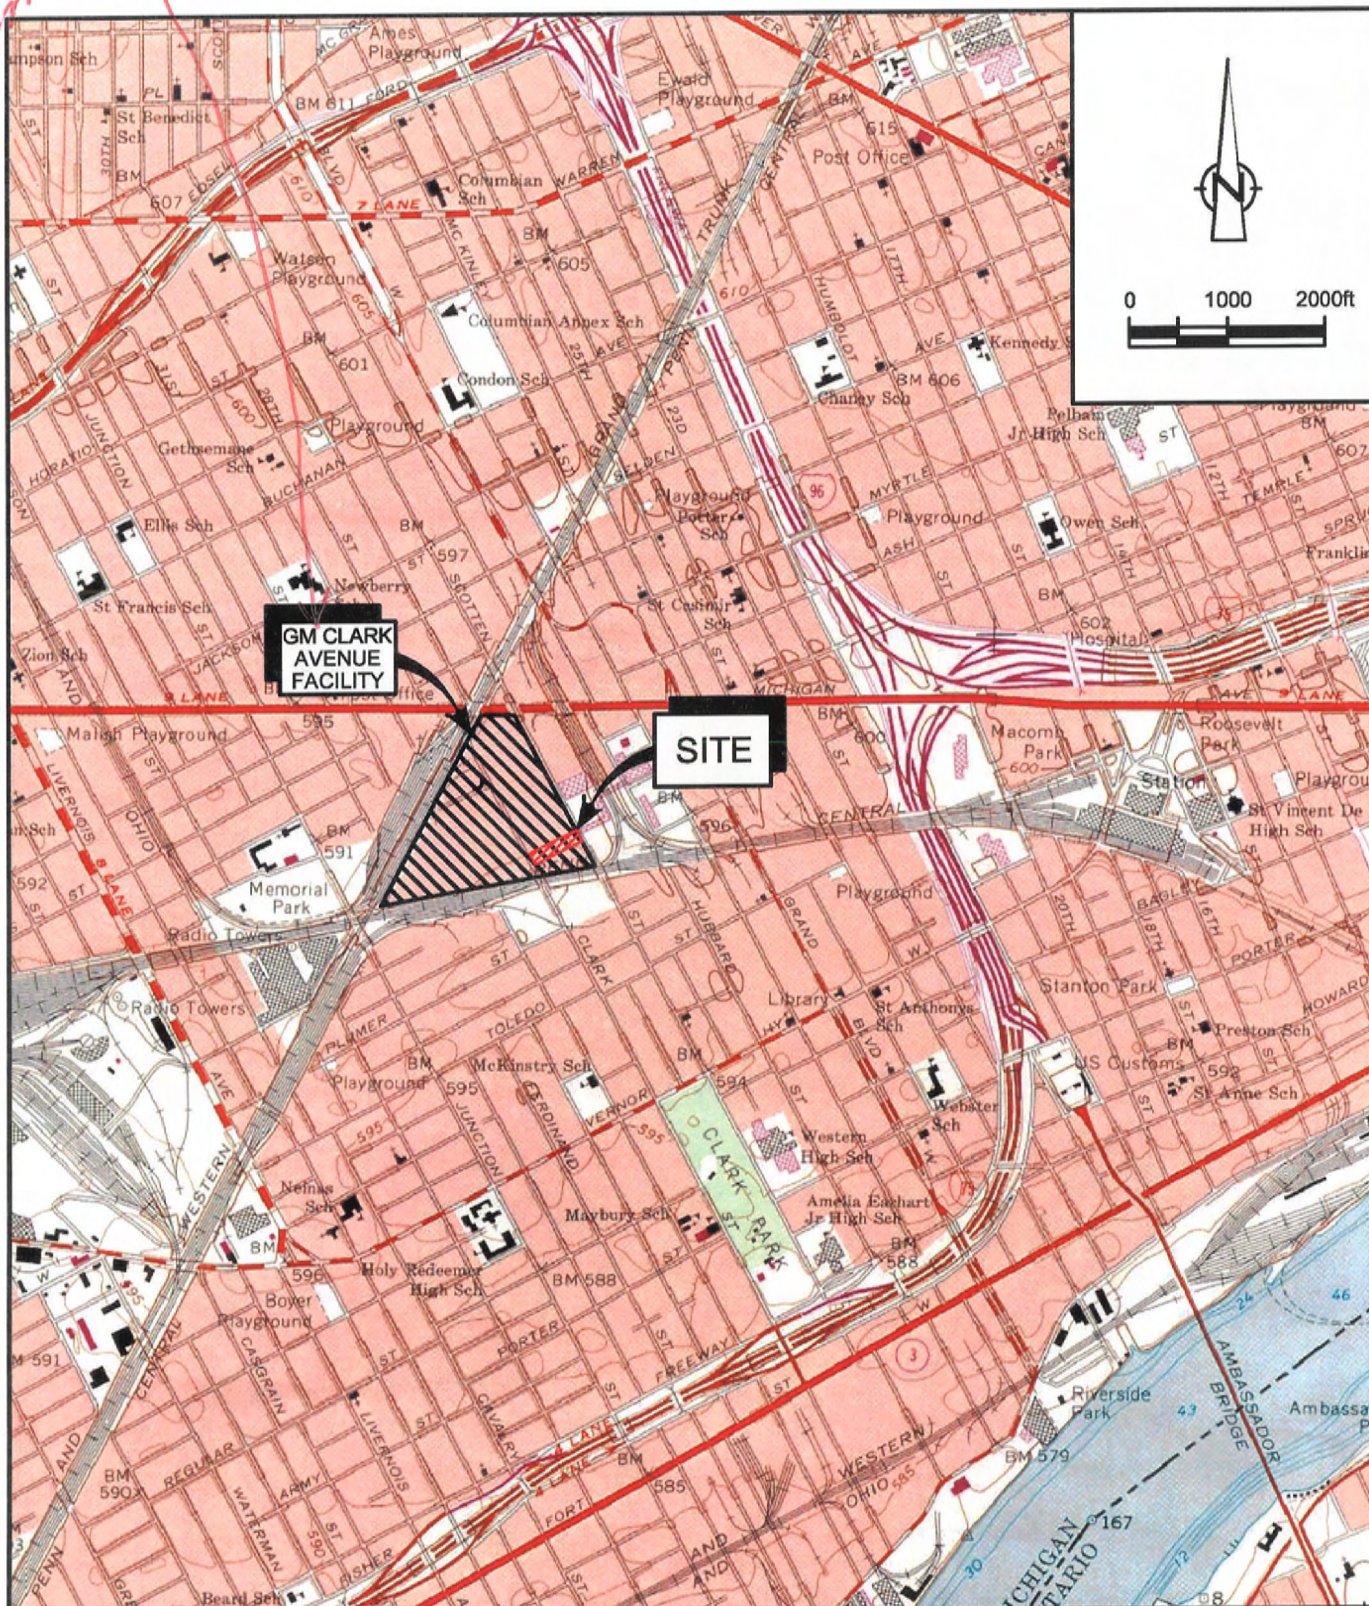
figure 1.1  
**SITE LOCATION**  
**CITY OF DETROIT PROPOSED RIGHT-OF-WAY**  
**GM CLARK AVENUE FACILITY**  
*Detroit, Michigan*

The Site is located in a mixed residential, commercial, and industrial area of Detroit, Michigan (see Figure 1.1). The Site is comprised of approximately 3/4 acre of industrial zoned land formerly owned by GM.

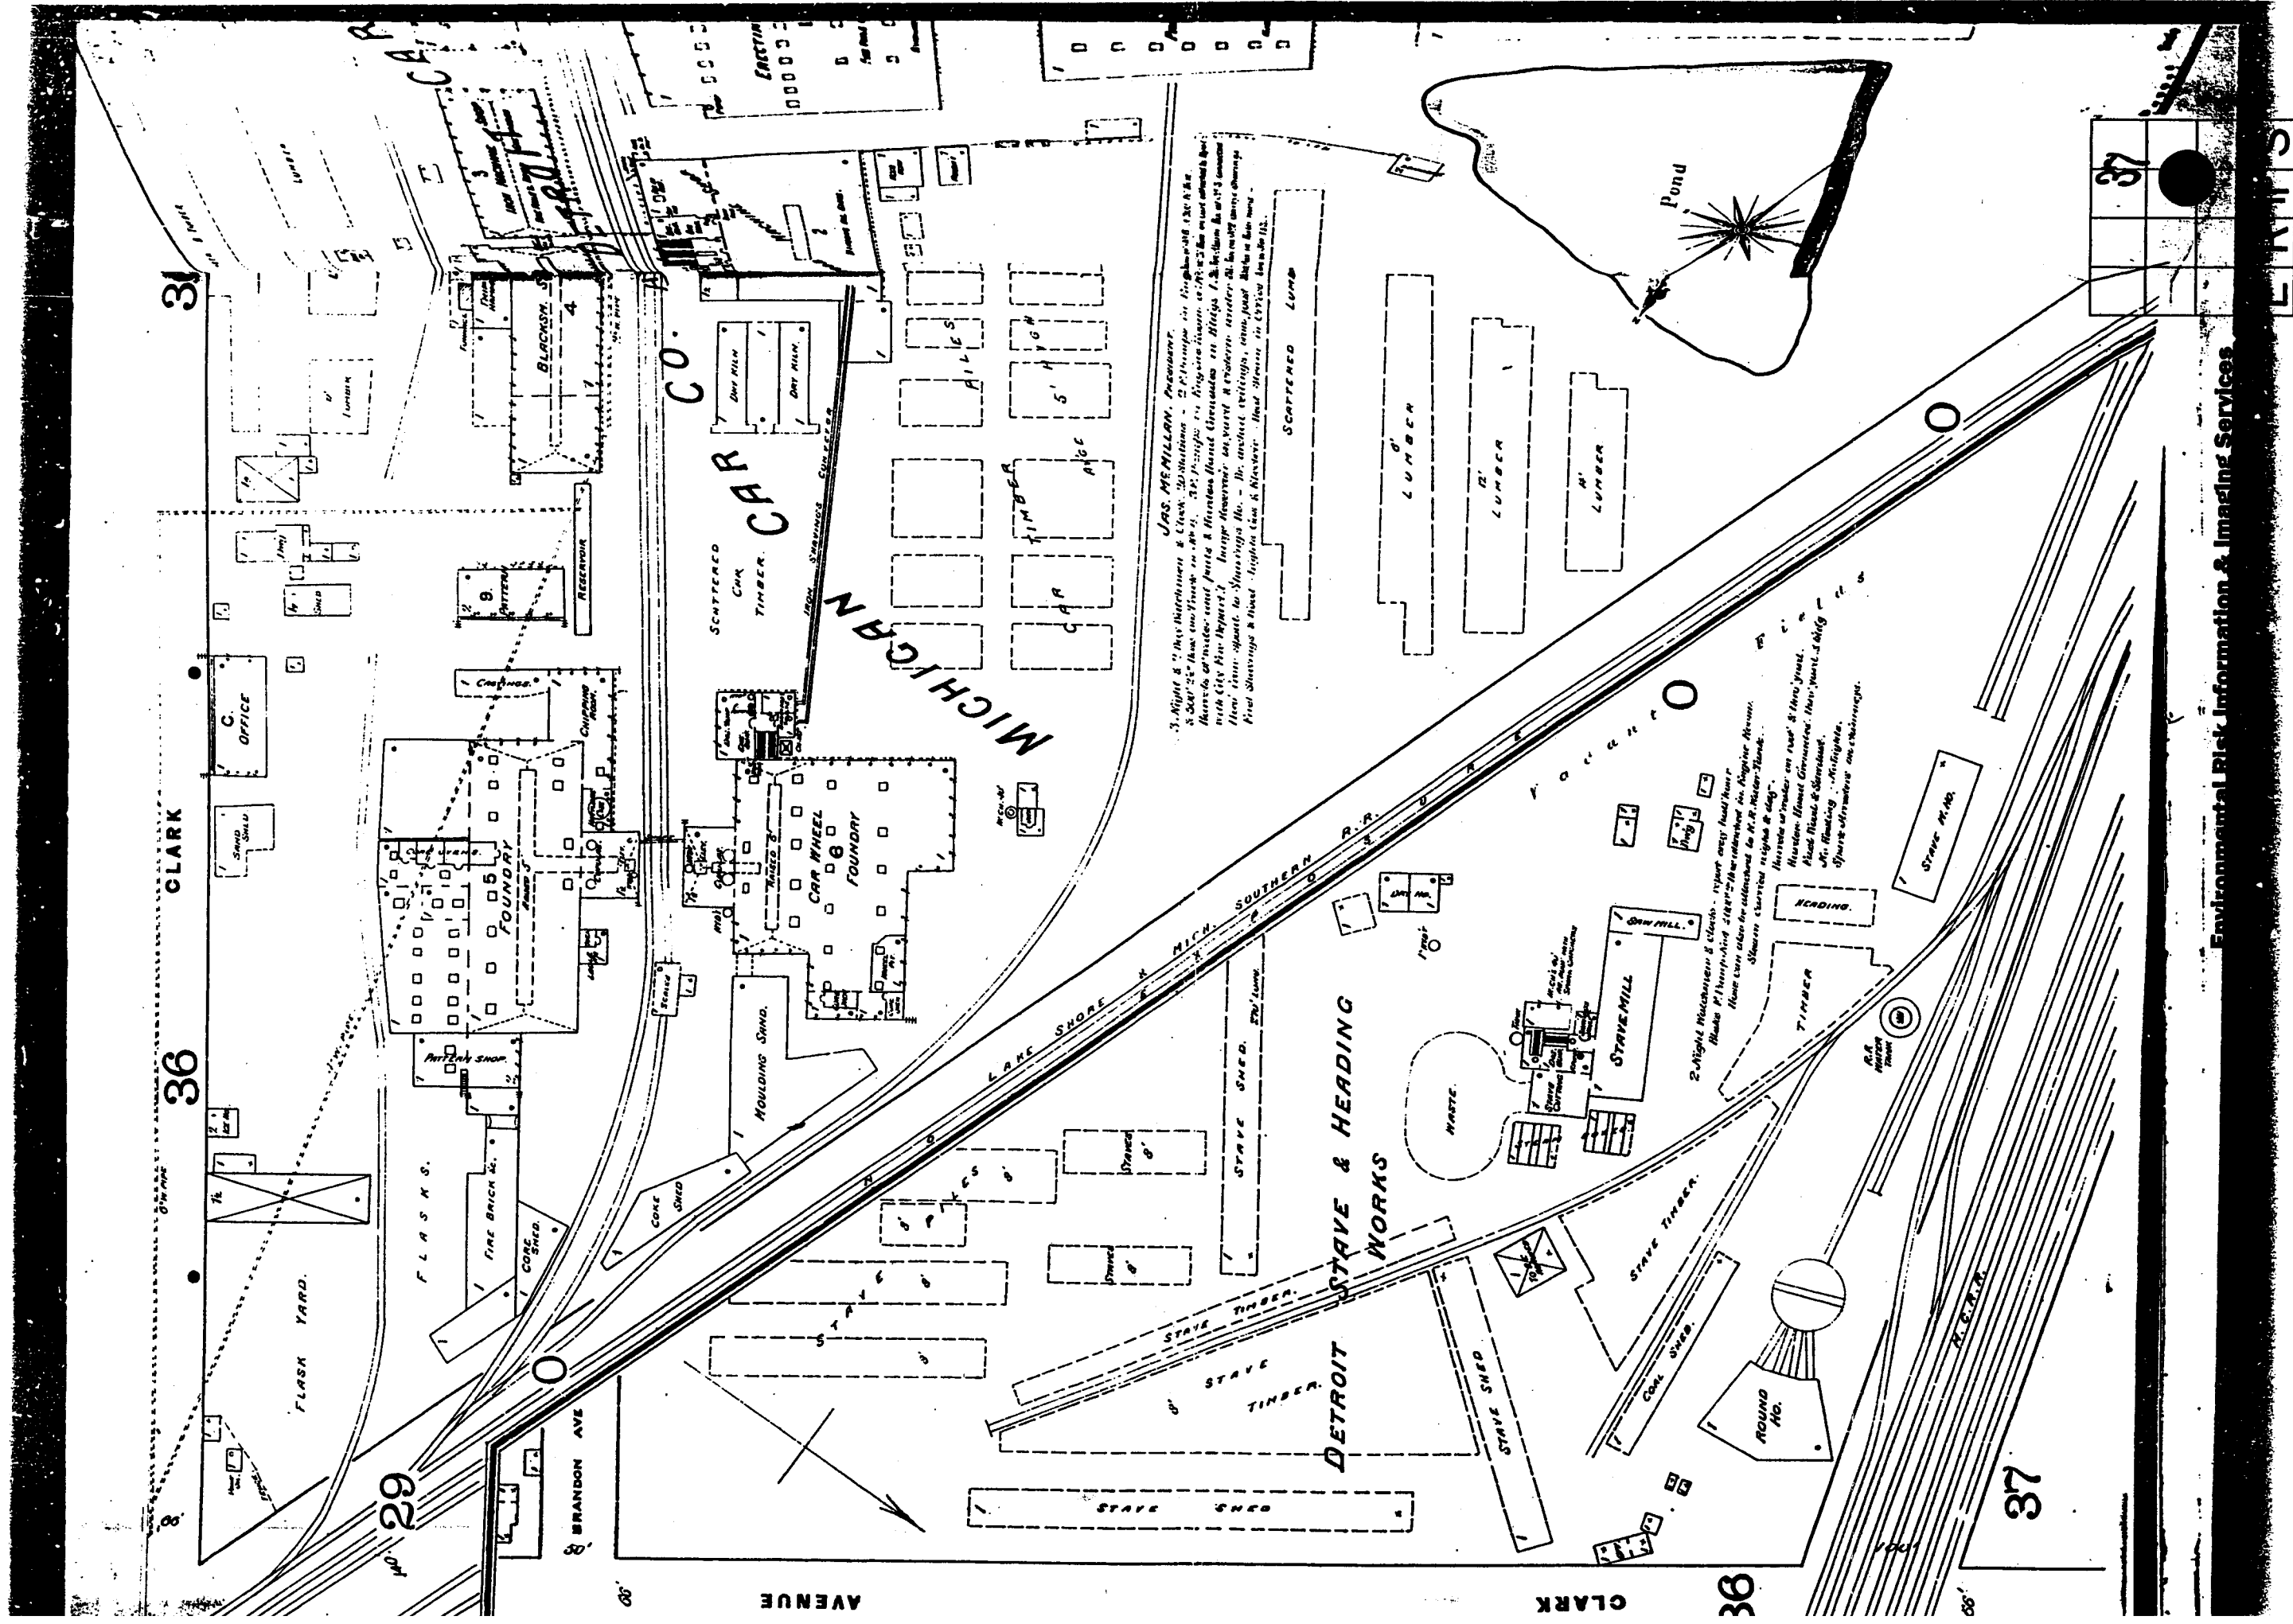
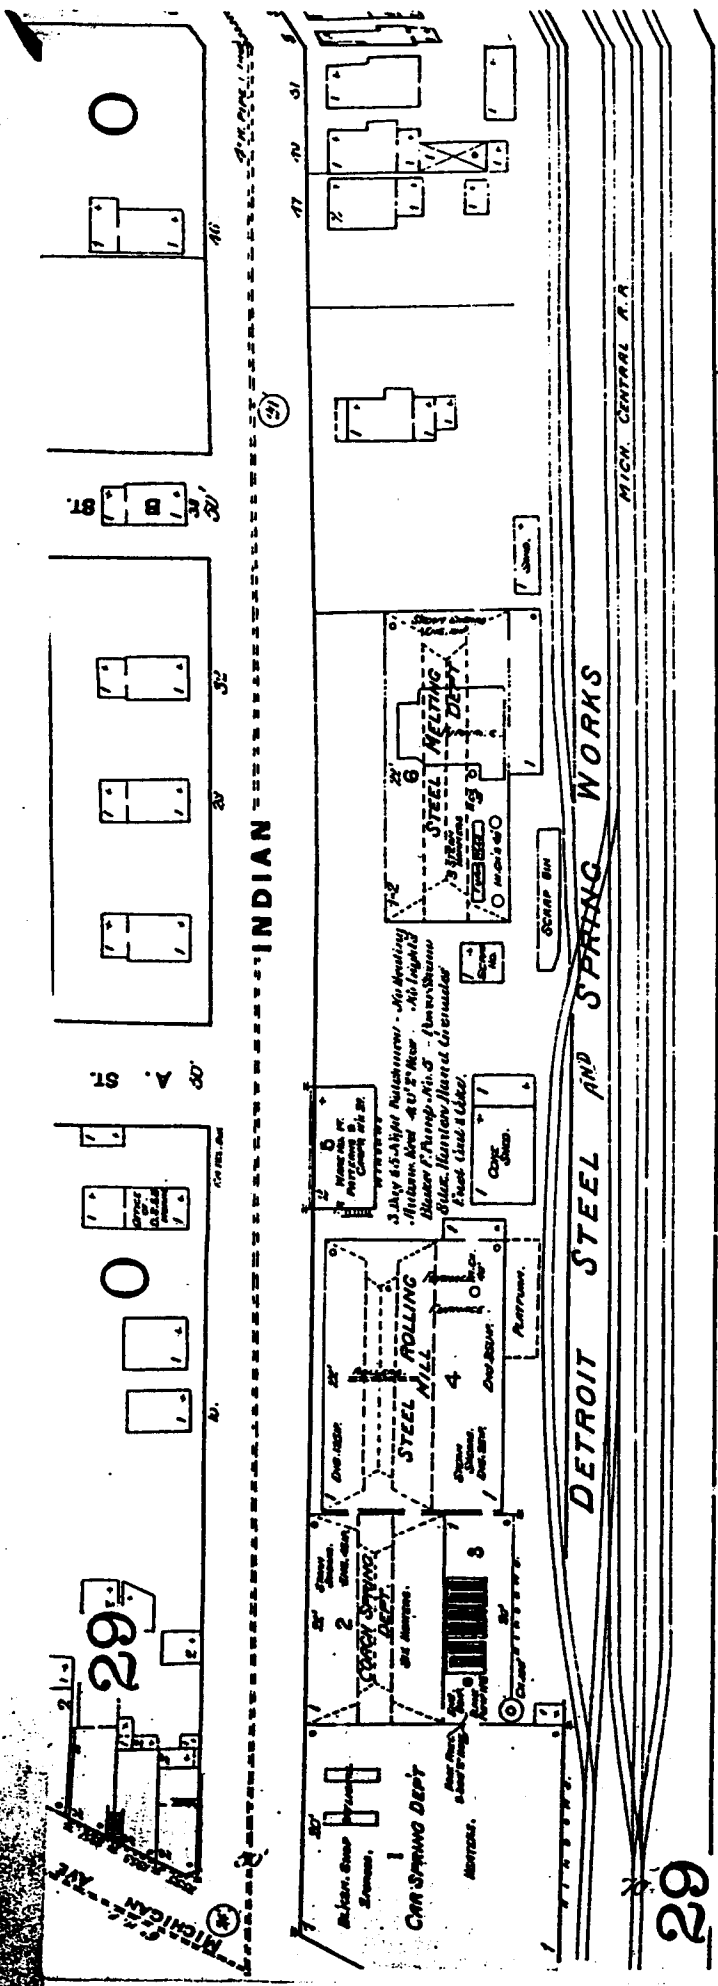
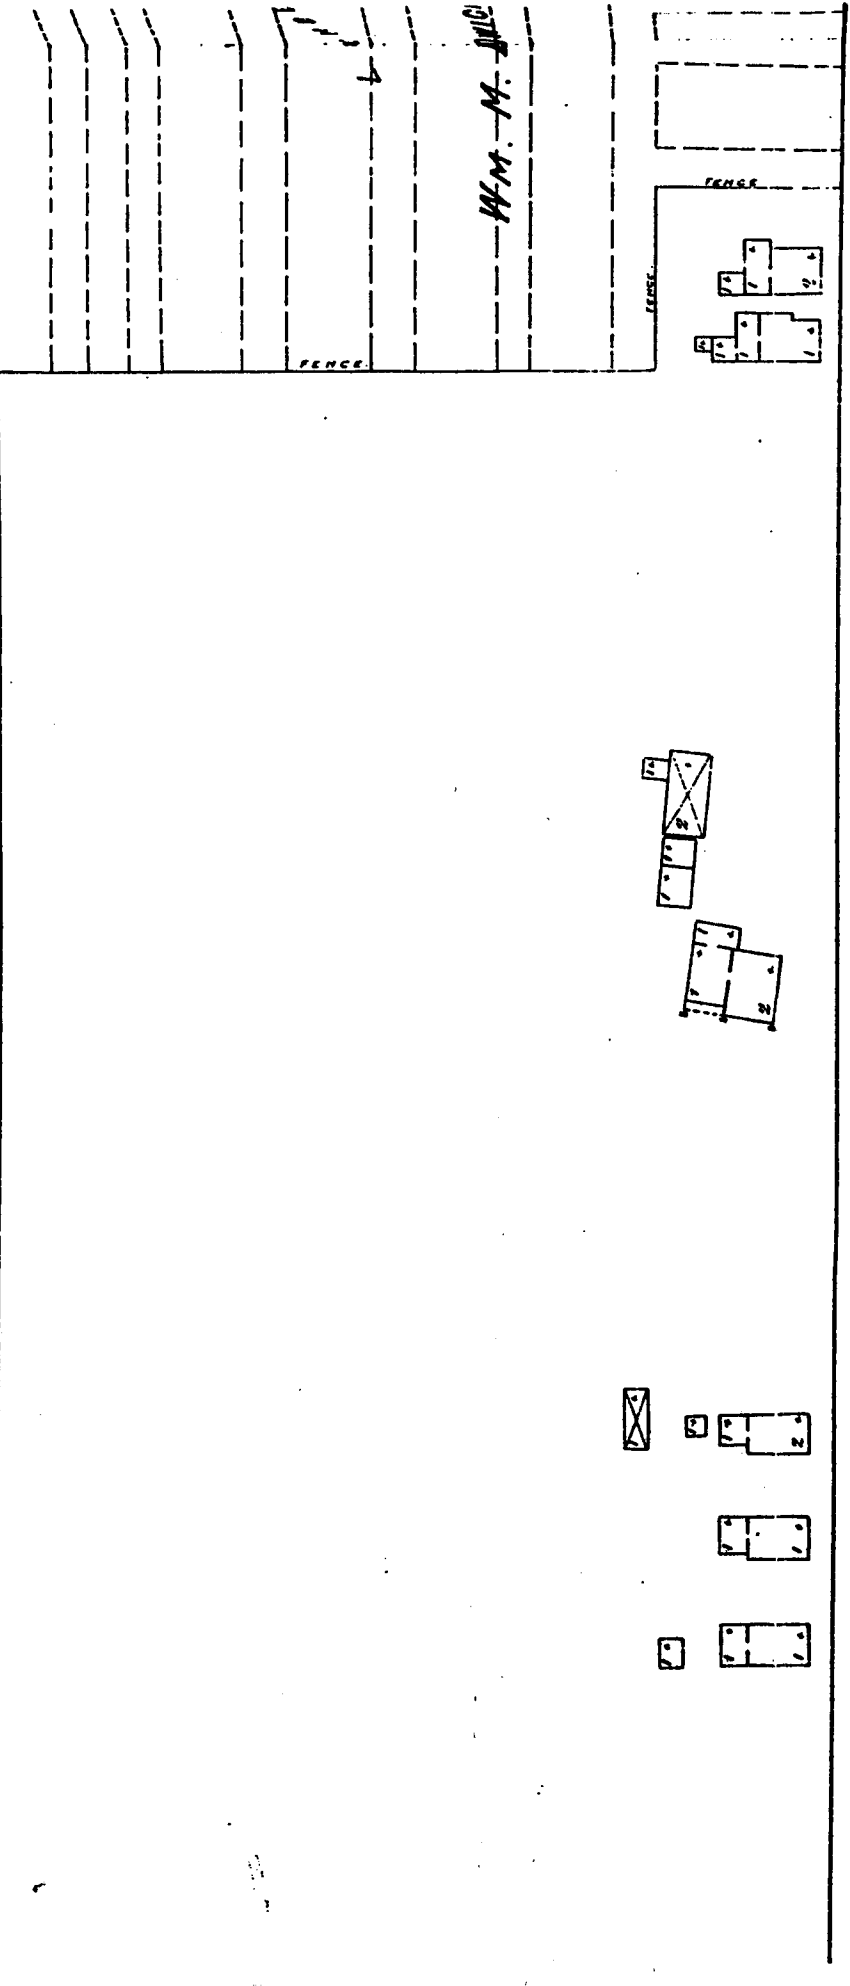
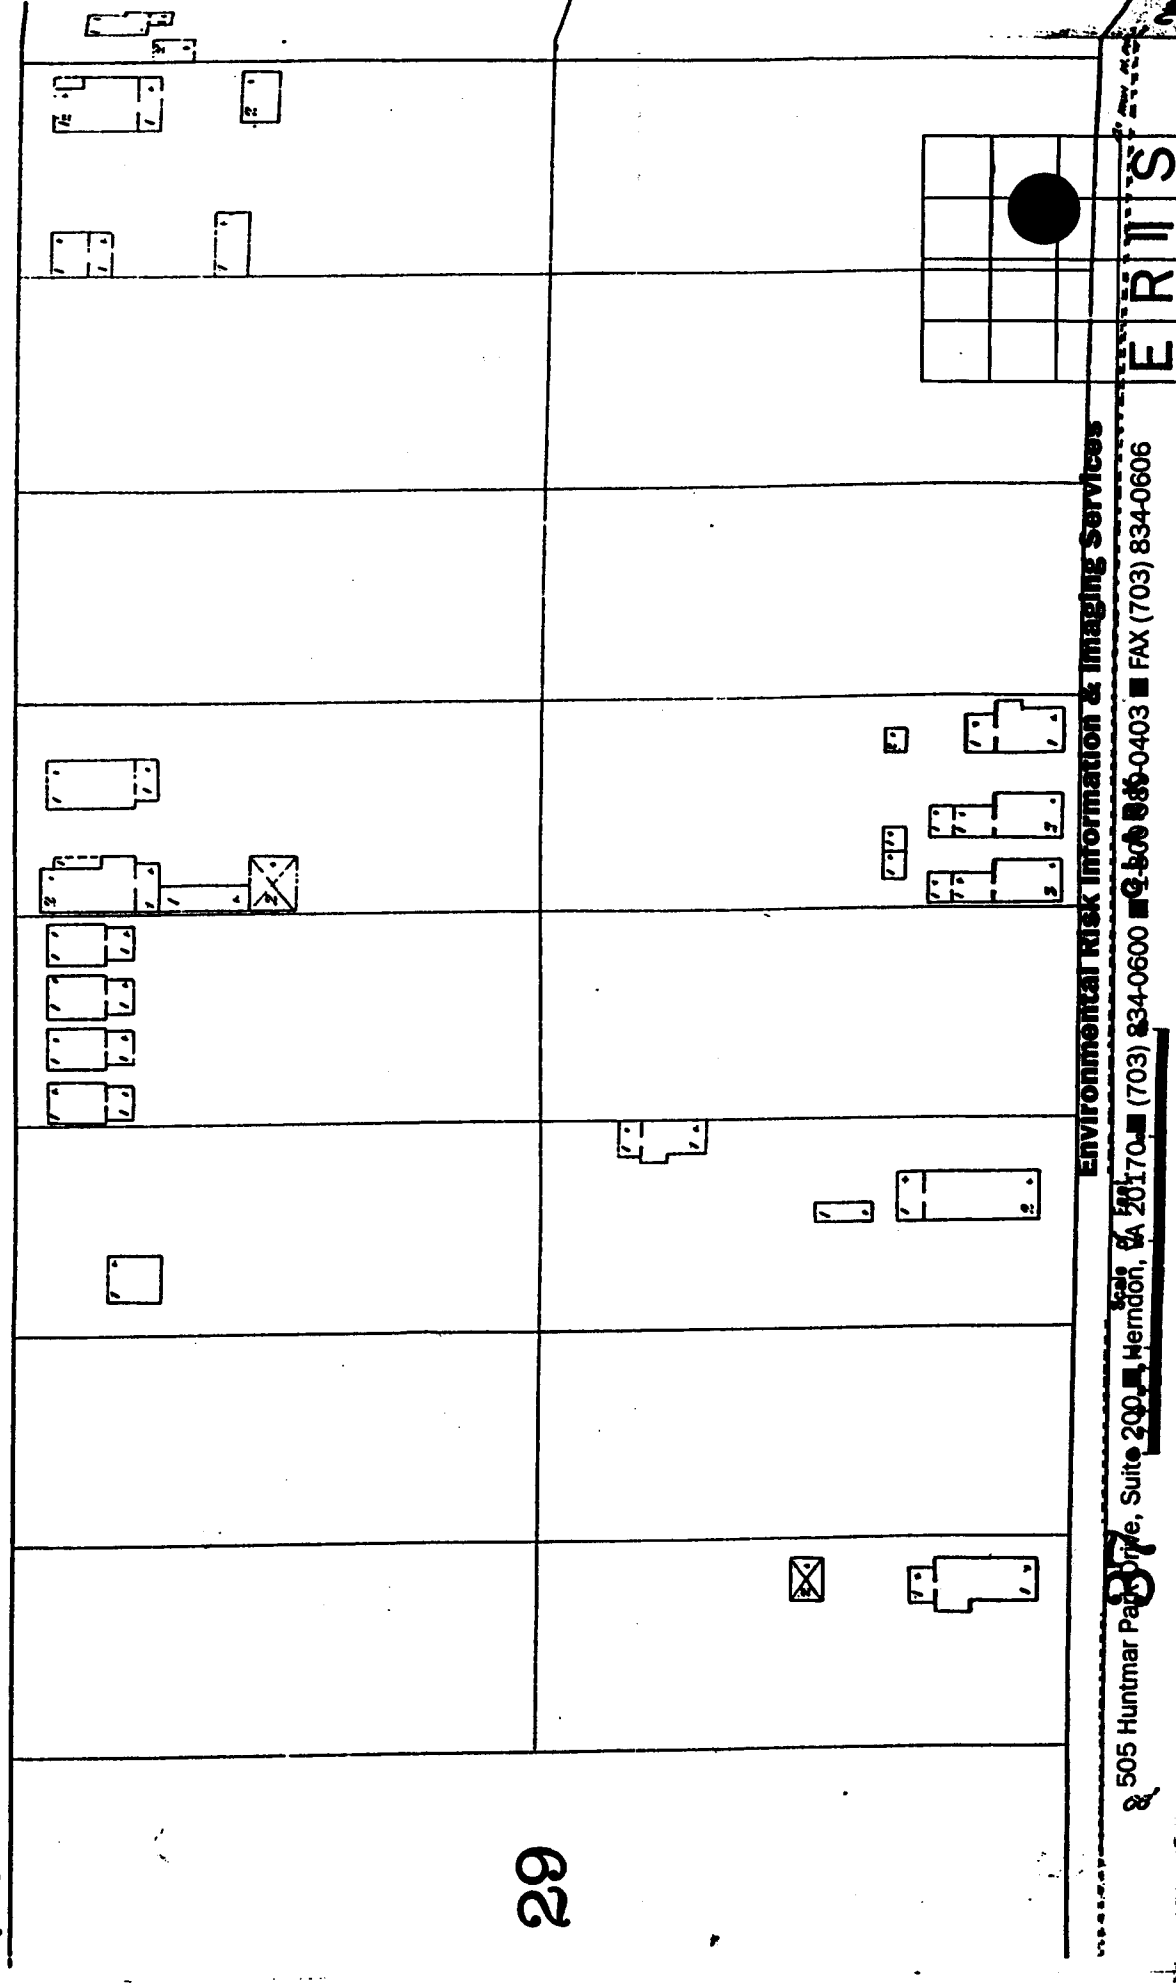
The 1884 Sanborn Map indicated that the Site was occupied by residential dwellings. The Site was bordered to the east by Scotten Avenue, and beyond by residential dwellings, and the William W. Dwight & Company, wholesale lumber and hardwood dealers. The Site was bordered to the south by railroad tracks, and beyond by residential dwellings and a varnish works, including a kiln. The Site was bordered to the west by Clark Avenue, and beyond by the Detroit Car Wheel Company and the Michigan Car Company, including several foundries, sheds, dry kilns, car timber piles, a blacksmith shop, a wood machine shop, a repair shop, and a metal shavings conveyor and storage area. The land use of the property north of the Site was not indicated on the map.

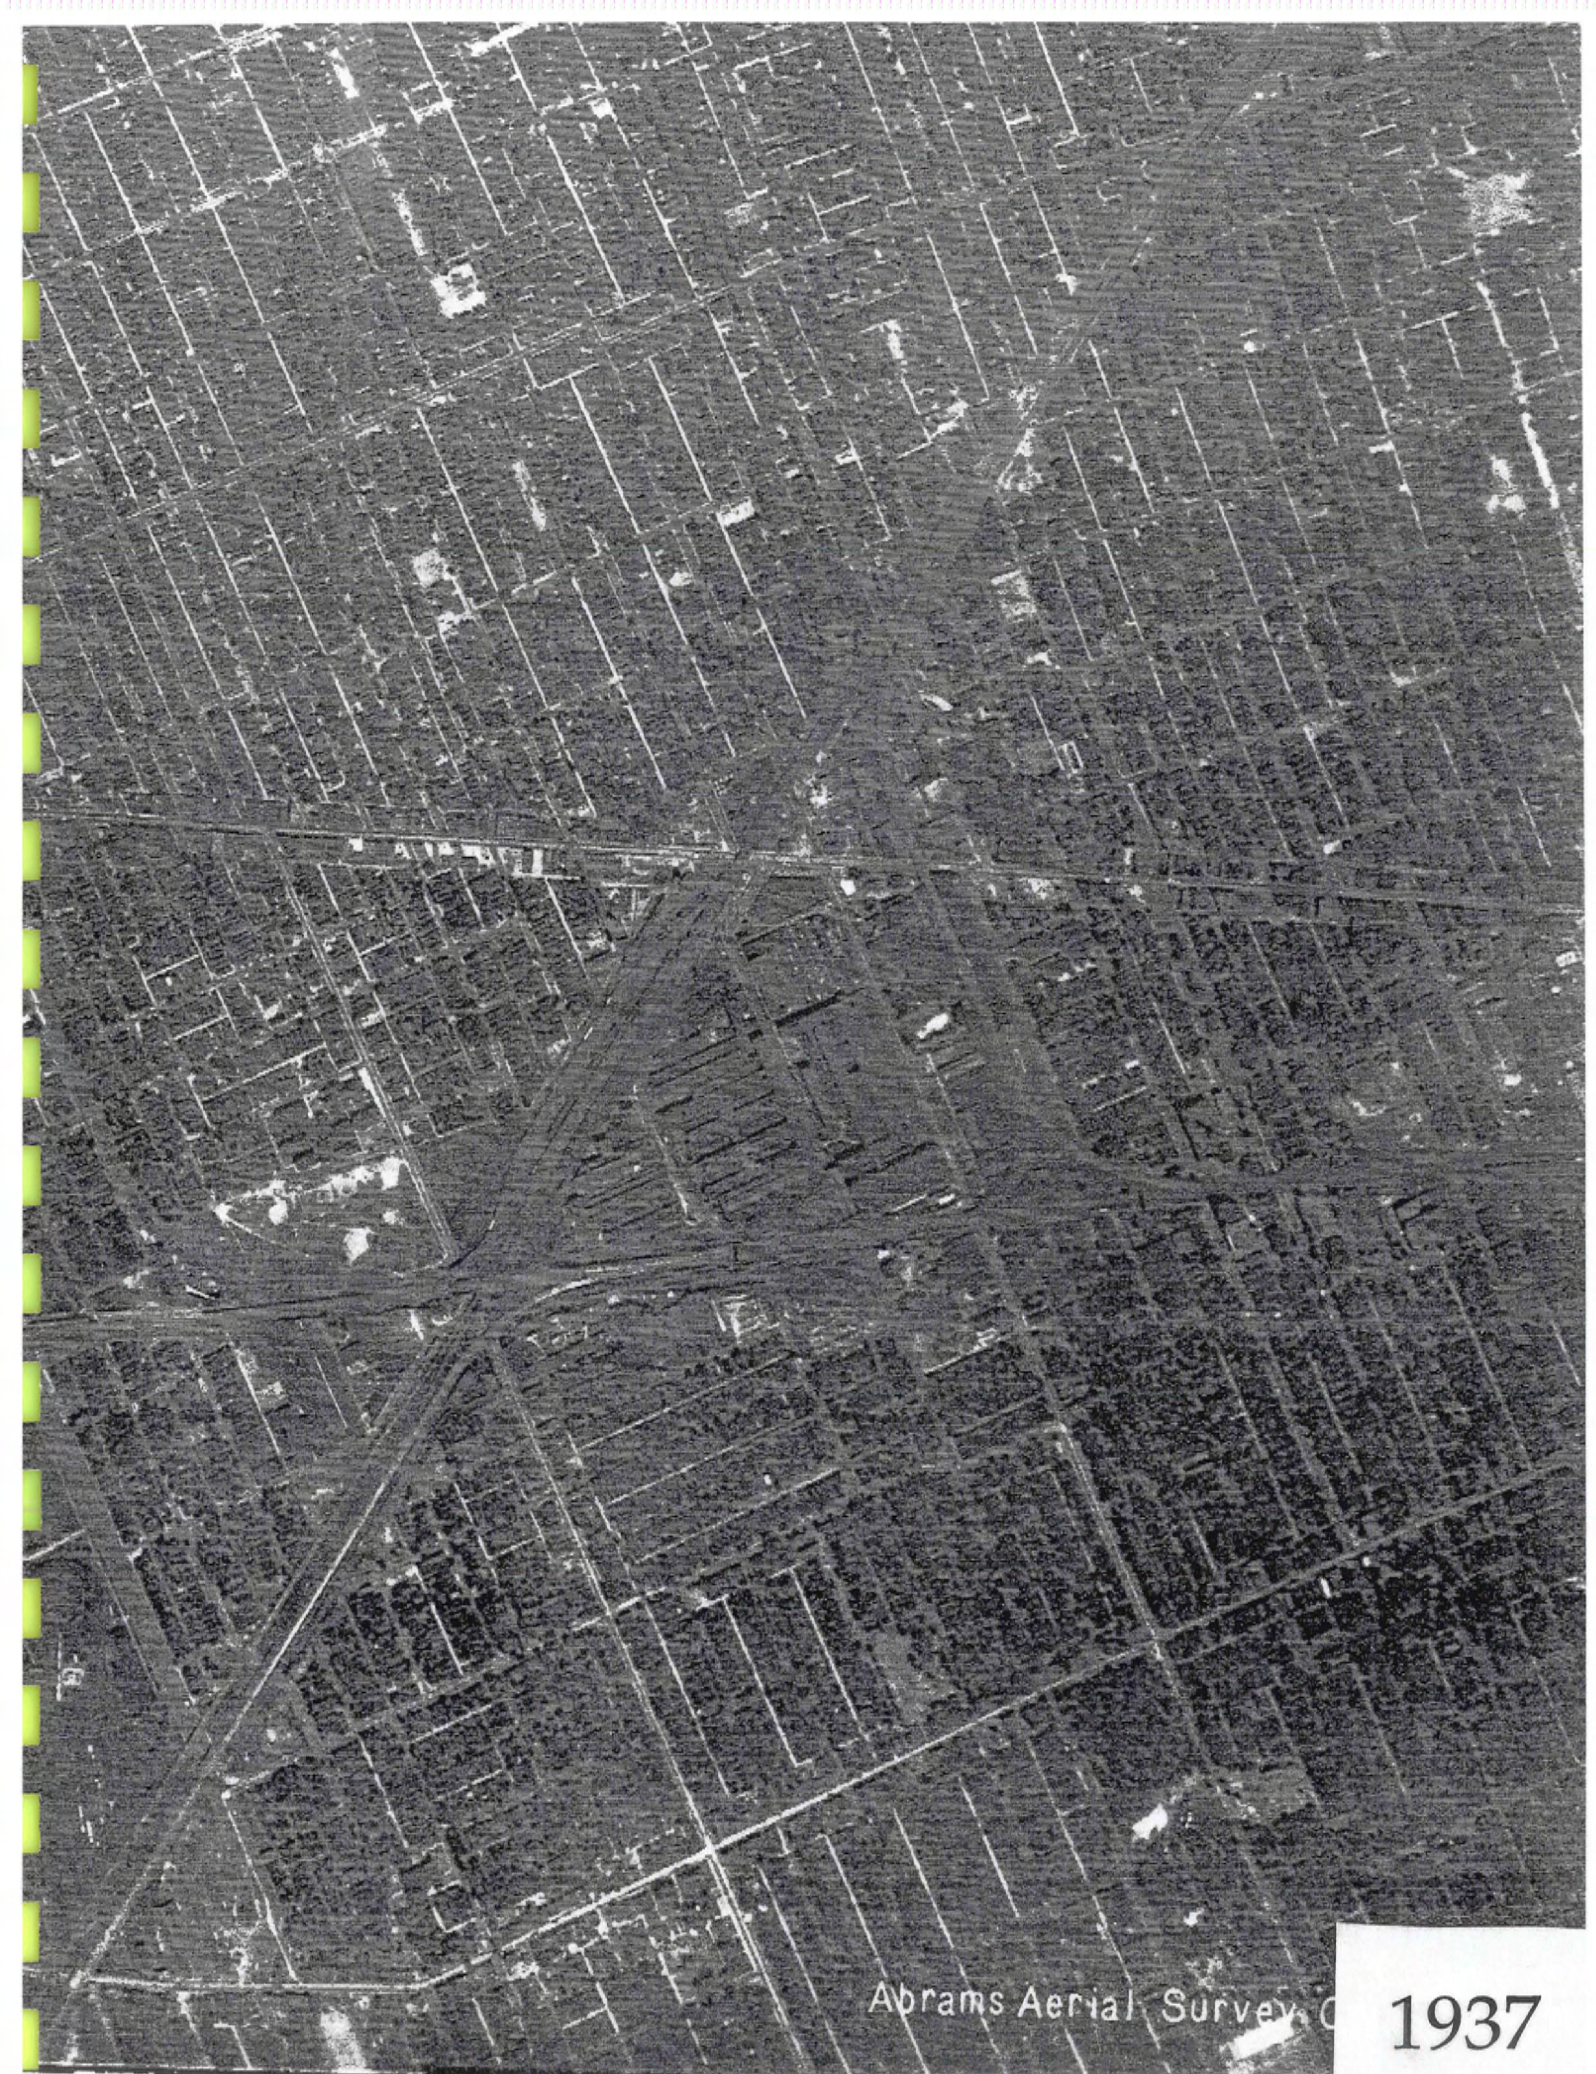
Abrams Aerial Survey of 1937

Aerial photographs were reviewed for the Site for several years between 1937 and 1995. The aerial photographs show the various states of construction and demolition of Site buildings. The photos from 1990 and 1995 show the progressive demolition of Site buildings. No potential on-Site fill areas were observed in any of the aerial photographs.

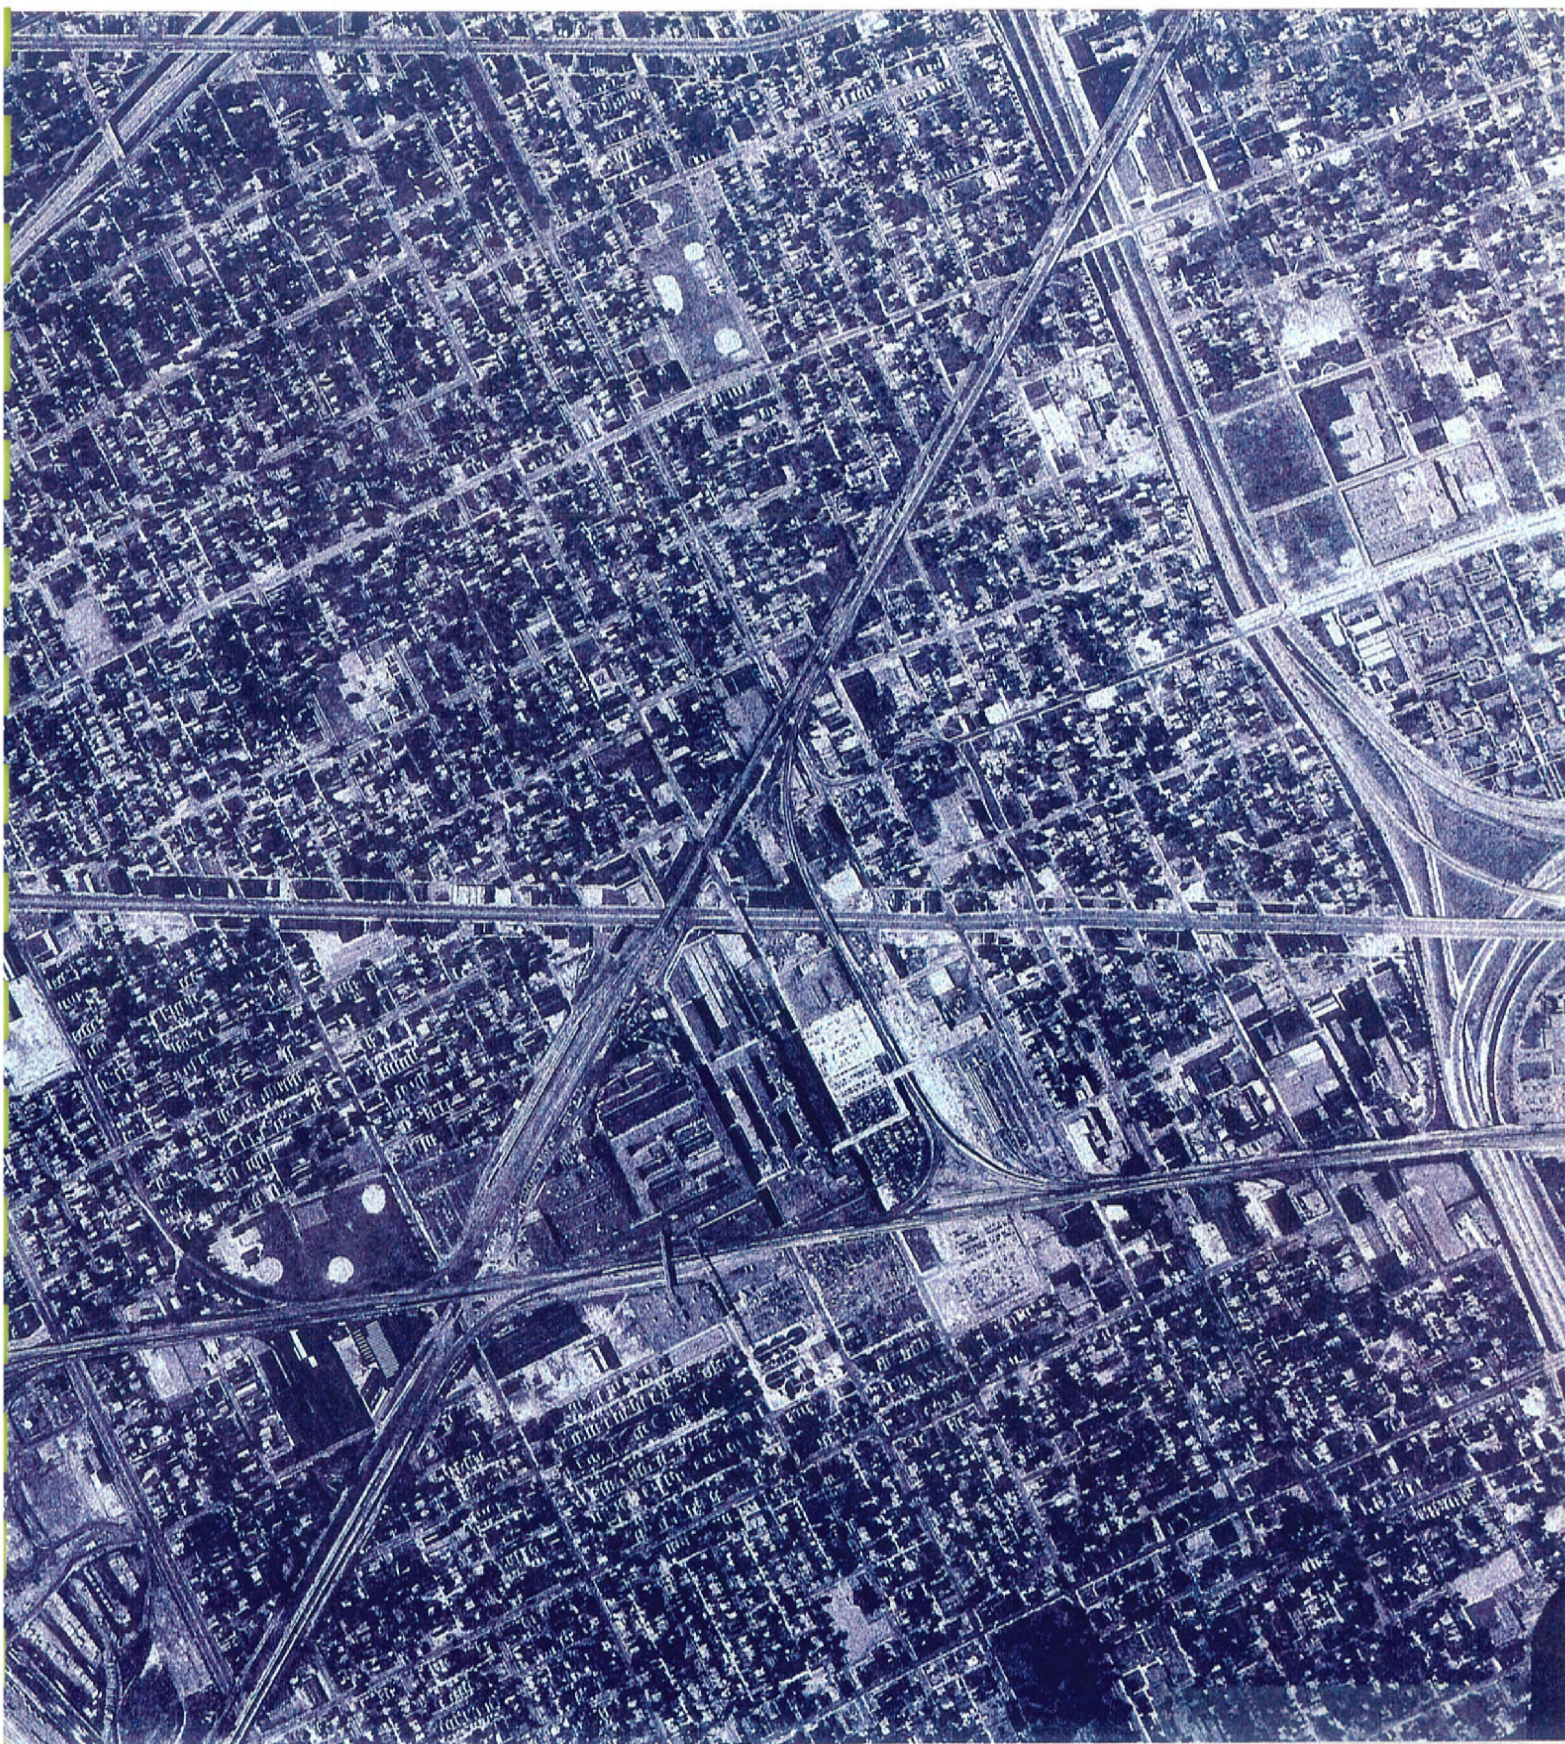
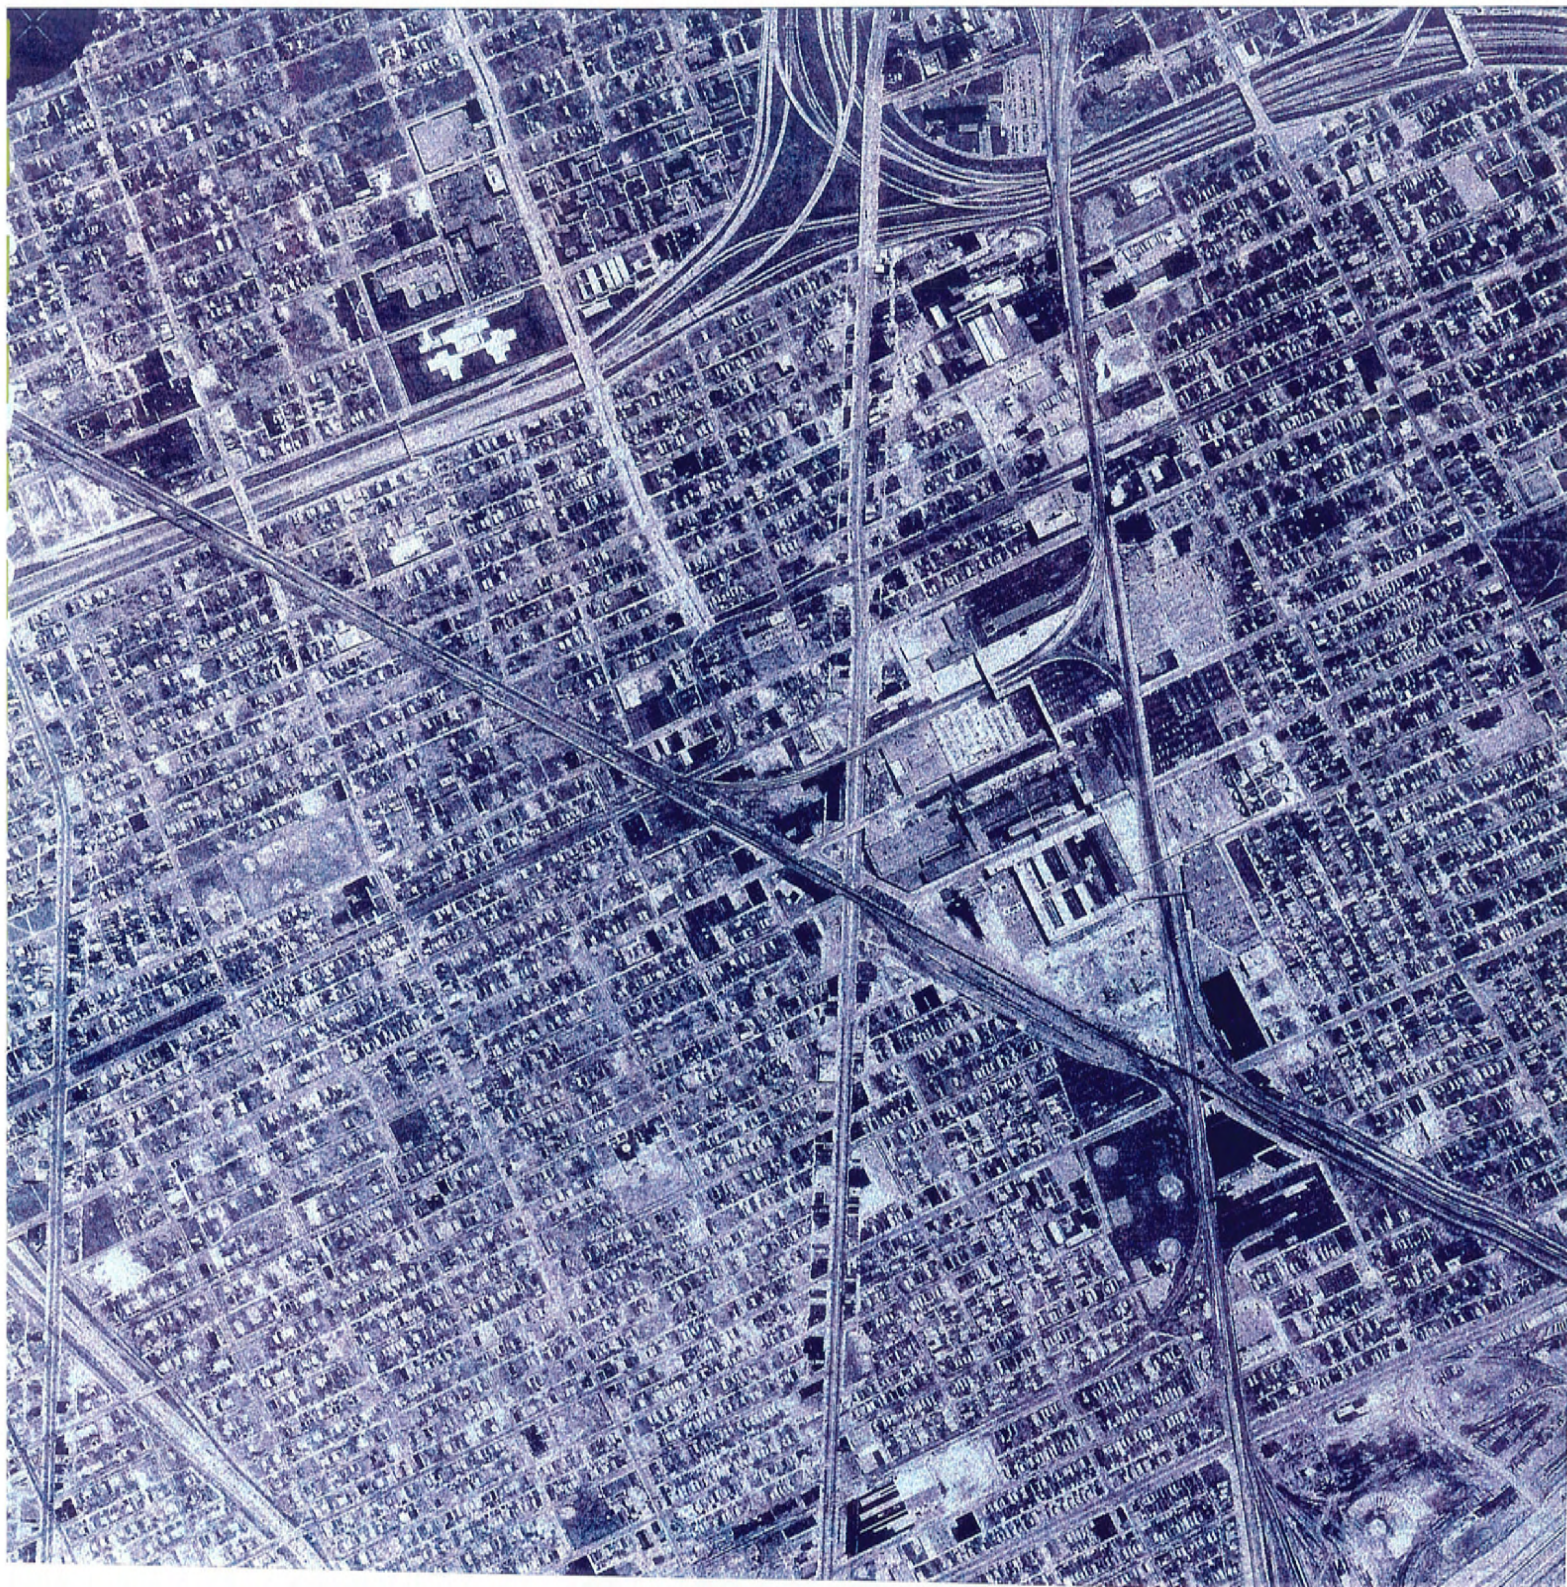
1990

The remaining aerial photographs showed minimal changes in Site buildings and parking lots until 1990, when demolition of building structures was observed. Surrounding property use was a consistent mixture of residential, industrial, and commercial. In the 1985 photograph, the eight aboveground storage tanks observed on the industrial property north of the Site appeared to have been removed.
