RE: Windiate Park/Dixieland Subdivision Landfill, Pengelly Road Site, Genesee County, Michigan  
(Site ID No. 25000689)

FILE: 1088190/1940102168 - Soil Cover Inspection Report

# WINDIATE PARK SOIL COVER MAINTENANCE CHECKLIST

# INSPECTION MAP

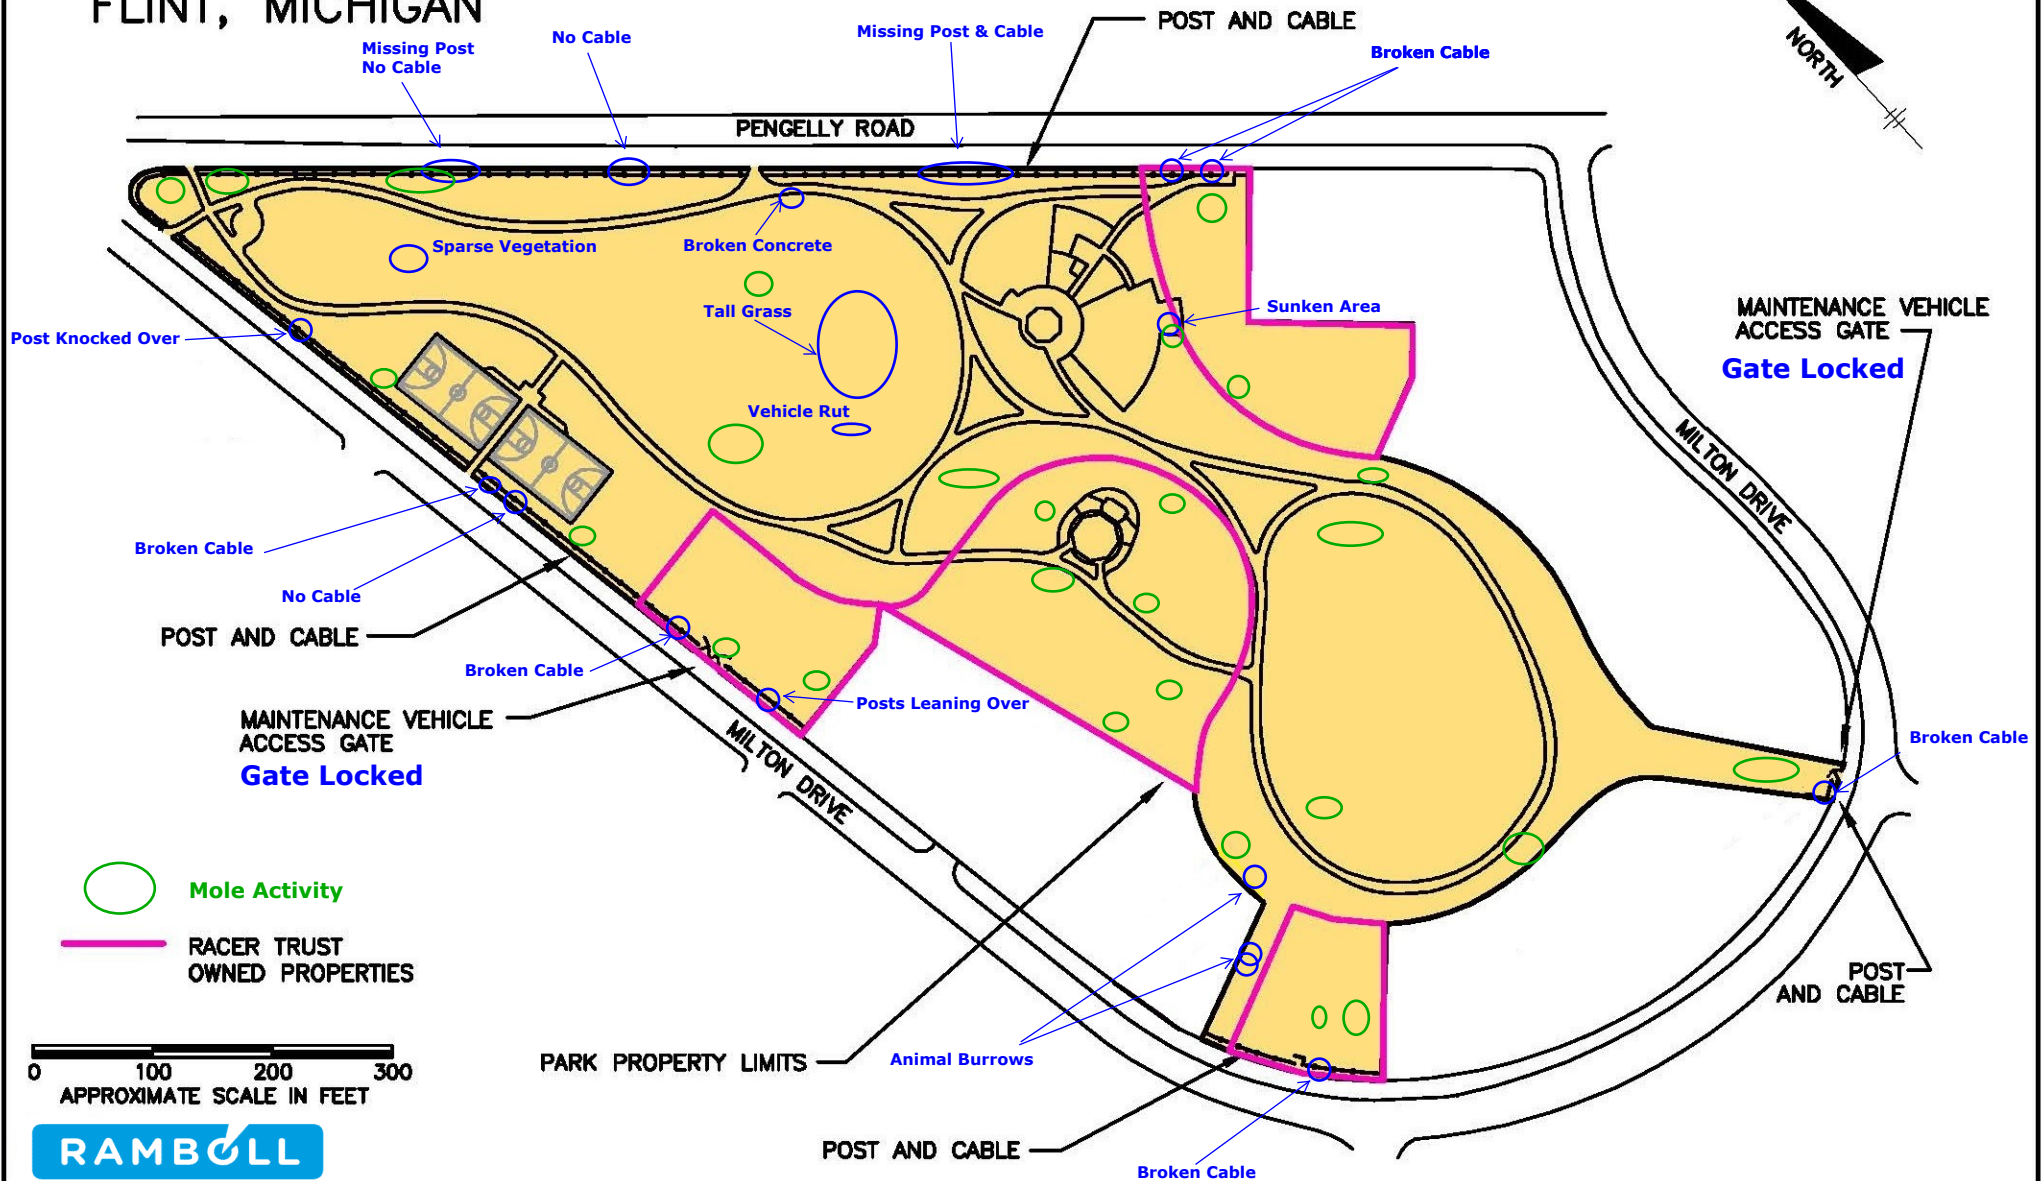
Some small areas of exposed soil throughout site due to mole activity (mole mounds/trails).

Acceptable. No maintenance required at this time. On the City of Flint property: One area was observed with tall grass and tall woody plants. One area was observed with sparse vegetation.

Approximately twenty damaged posts were observed during the site inspection (either partially down or completely down). Approximately ten sections of down cable were observed. The south and west maintenance vehicle access gates were locked.

A number of mole mounds and/or trails were observed. Unable to determine if the mounds are from recent activity or from older activity. Two animal burrows were observed. At one burrow an entry and exit were observed and at the other burrow only an entry was observed. Attempts have been made to manage the burrows, but additional efforts may be needed to remove the animals if burrows are still active. No signs of waste were observed in the animal burrow spoils. One section of concrete was observed where the concrete collapsed around manhole on sidewalk along Pengelly Road. Vehicle ruts were observed near the area with tall vegetation.

**Grass has been mowed**

Add grass seed to area of sparse vegetation.  
Manage animal burrows.  
Replace cable and posts that are missing or damaged.
