April 15, 2022

RACER Pontiac North Campus – 2021 Property Inspection Report

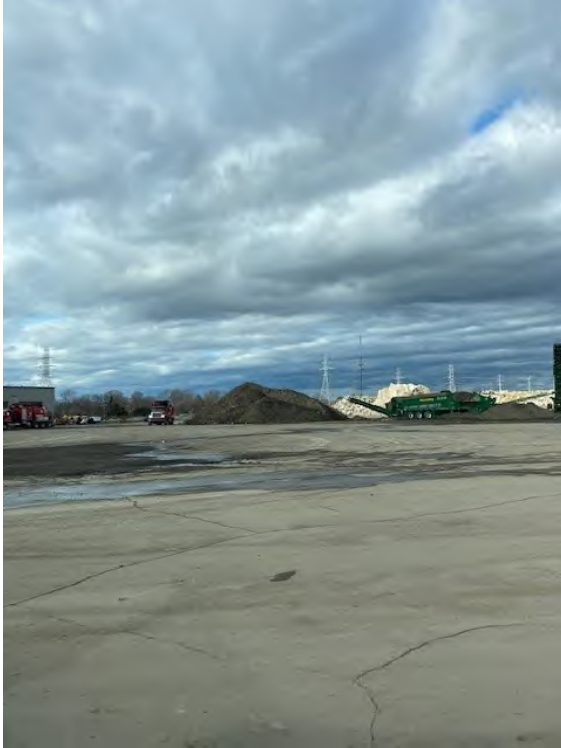
**Photograph: 1**

**Description:** Facing northwest, view of soil and landscaping material piles.

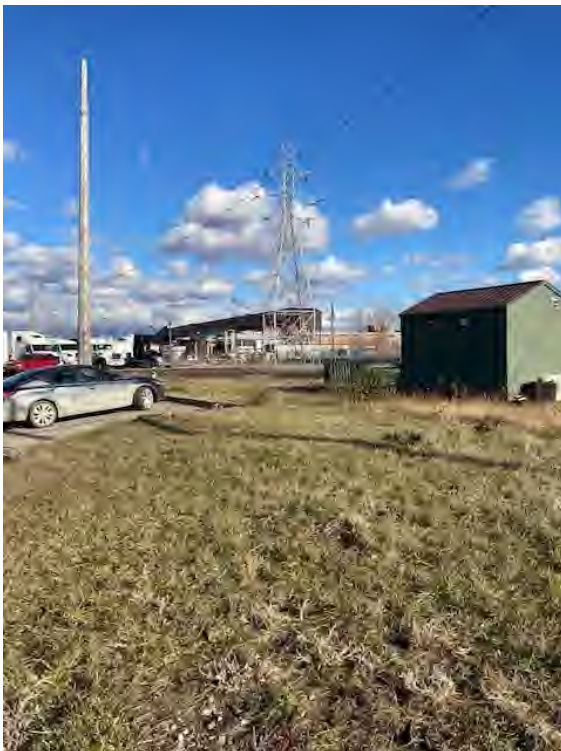
**Photograph: 3**

**Description:** Marker observed in one of the PCB cap areas at the property.

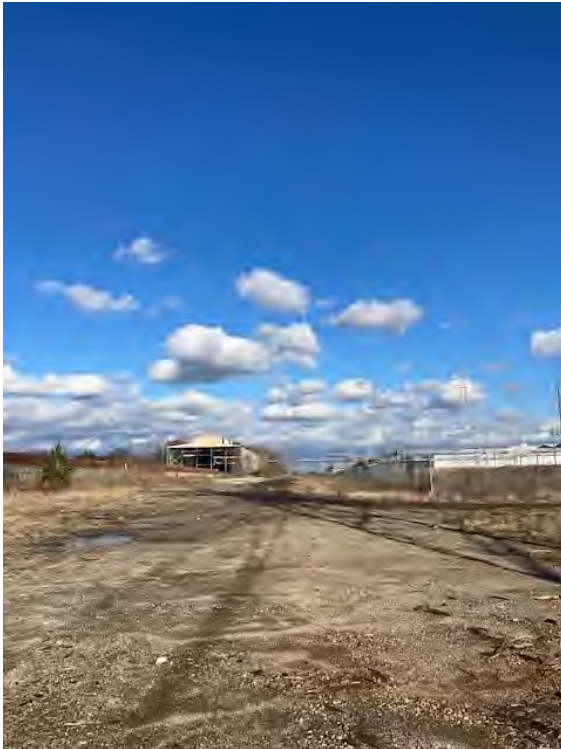
**Photograph: 1**

**Description:** Southern portion of property near Tatro property, facing north.

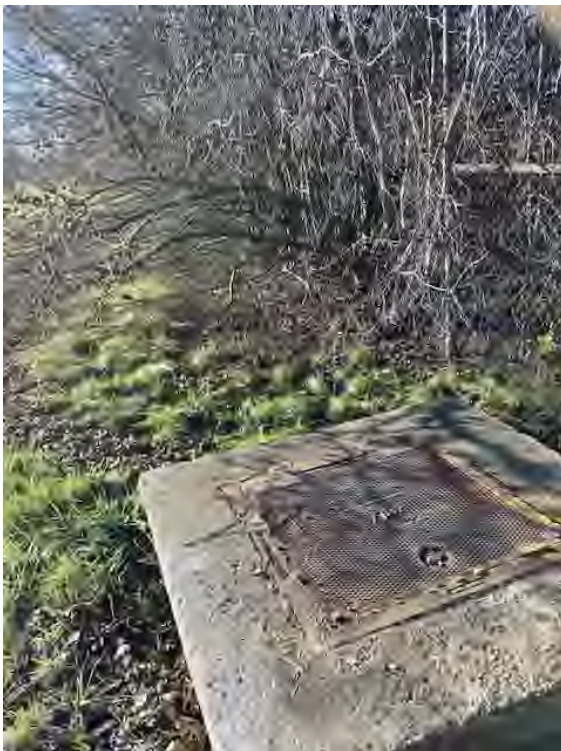
**Photograph: 4**

**Description:** Structure in the northwestern portion of the property.

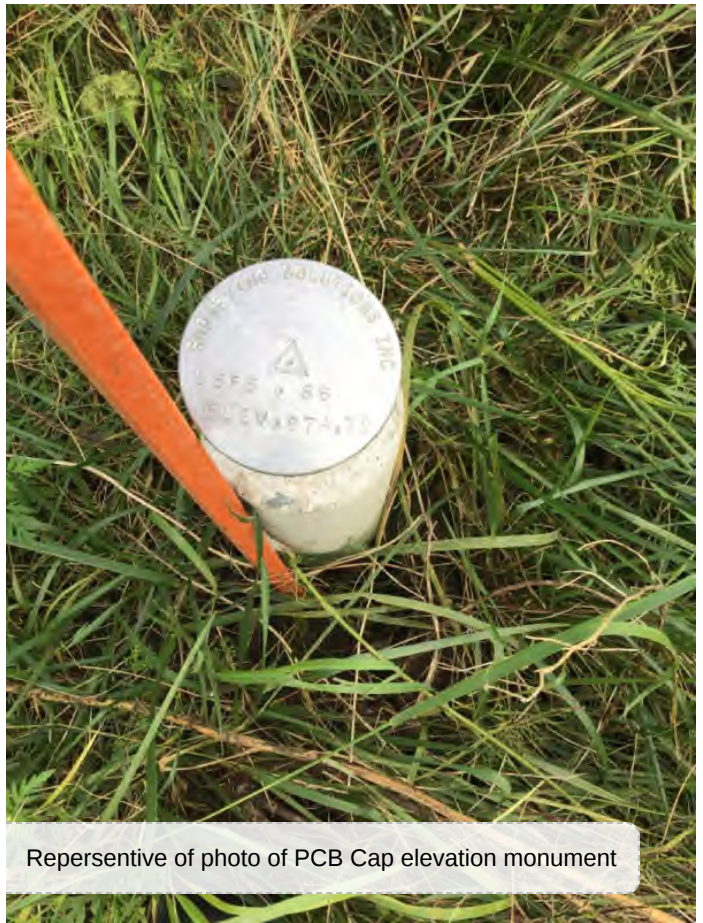
Photo of area facing north fence in back ground

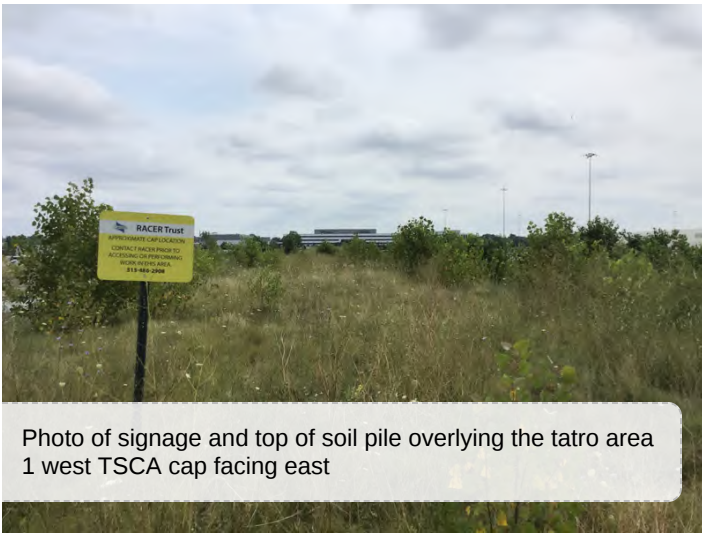
Photo of signage and top of soil pile overlying the tatro area 1 west TSCA cap facing east

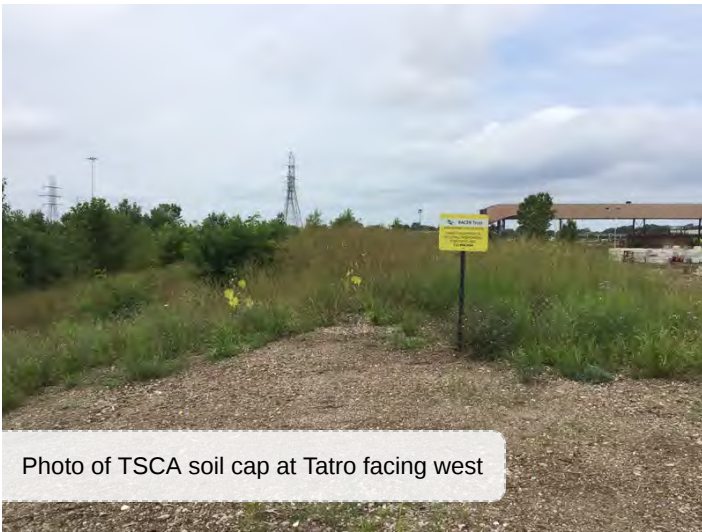
Photo of TSCA soil cap at Tatro facing west

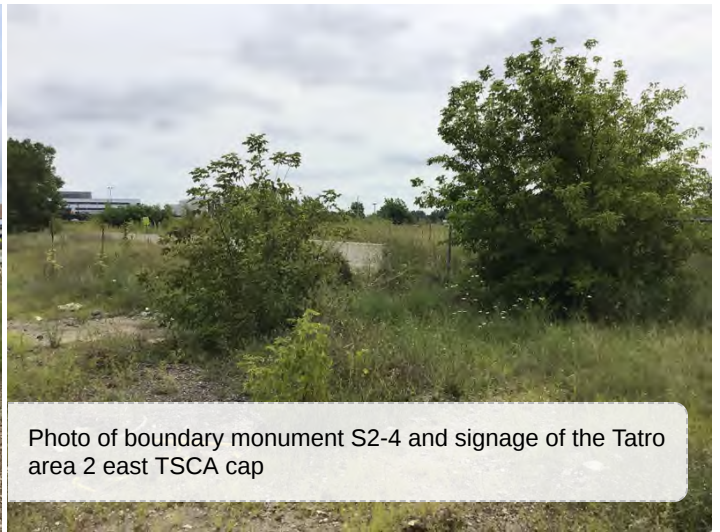
Photo of boundary monument S2-4 and signage of the Tatro area 2 east TSCA cap
